Robert Squires - Squires Consulting LLC
Landowner Advocate

Opening Statement for May 5, 2021 Subcommittee on Civil Rights and Civil Liberties Hearing:
“Pipelines Over People (Part II): Midship Pipeline’s Disregard for Landowners in Its Pathway”

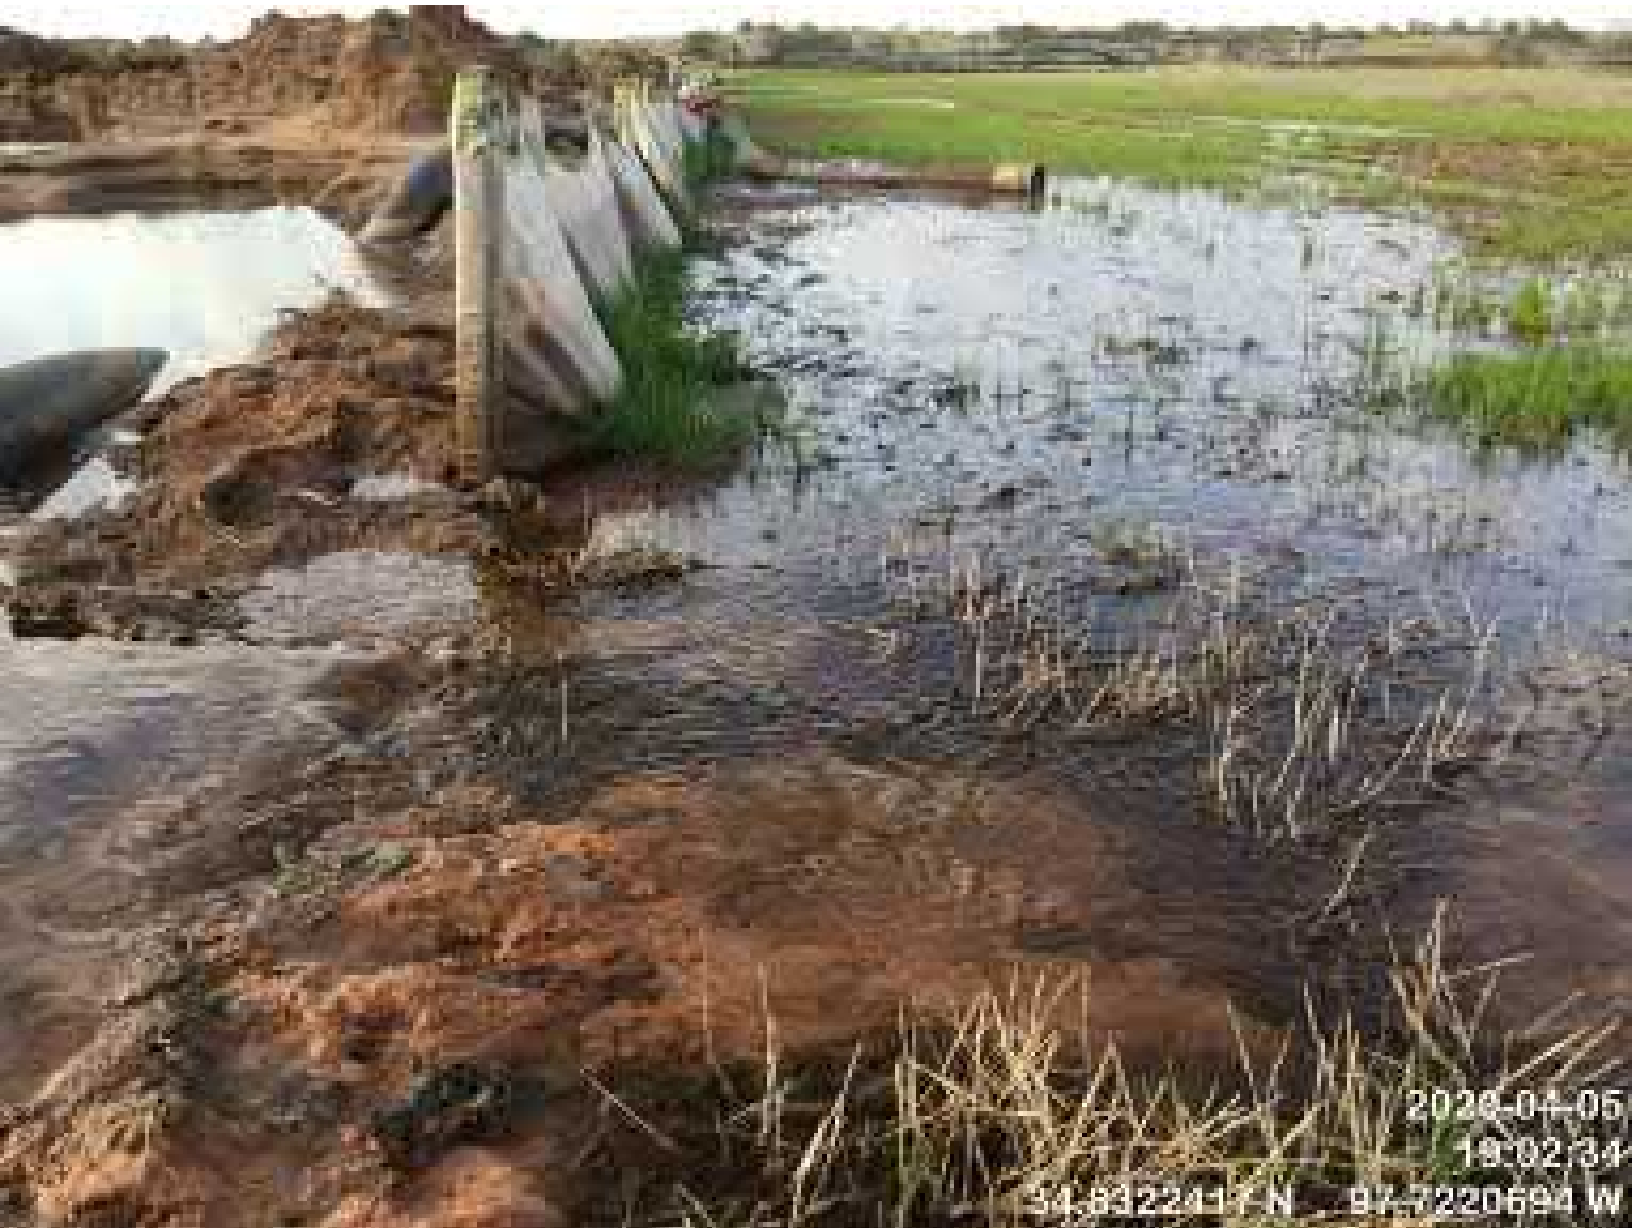
Photo Section 6
Continual Sediment and Erosion Control
Violations

Off Right-of-Way

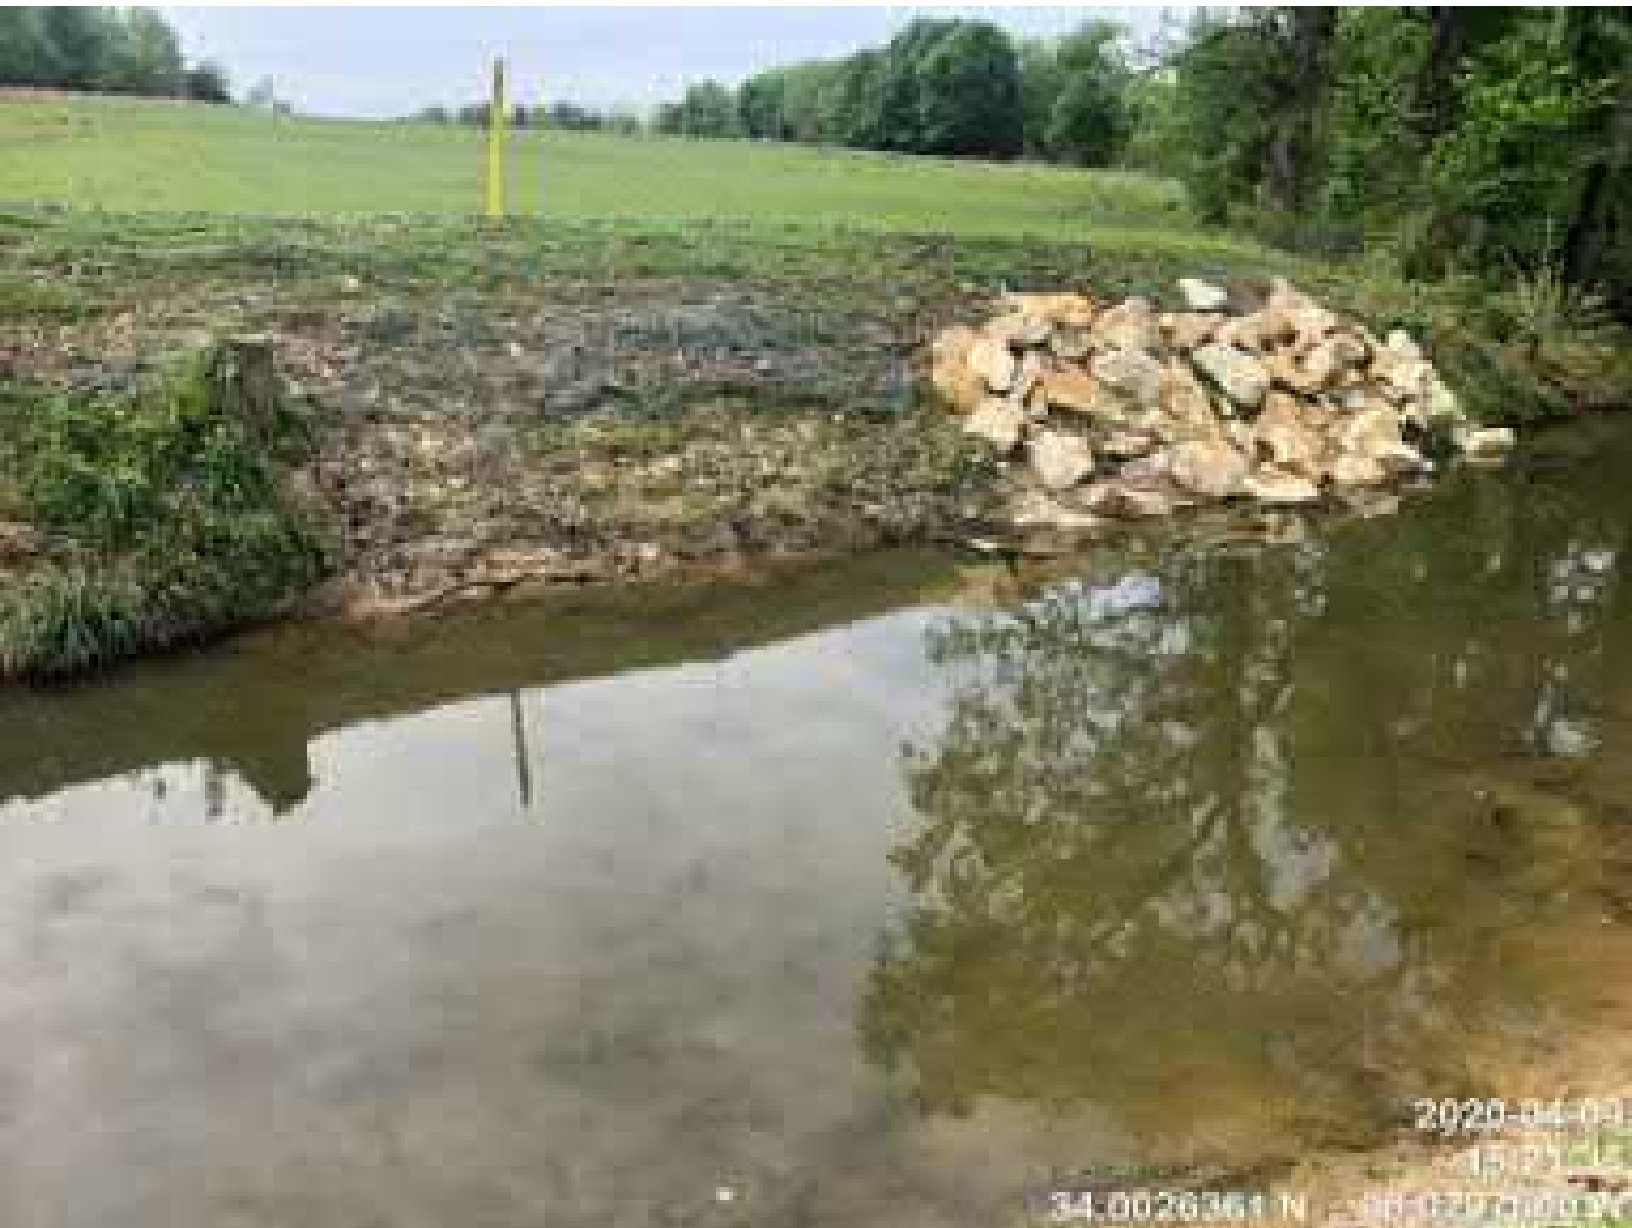
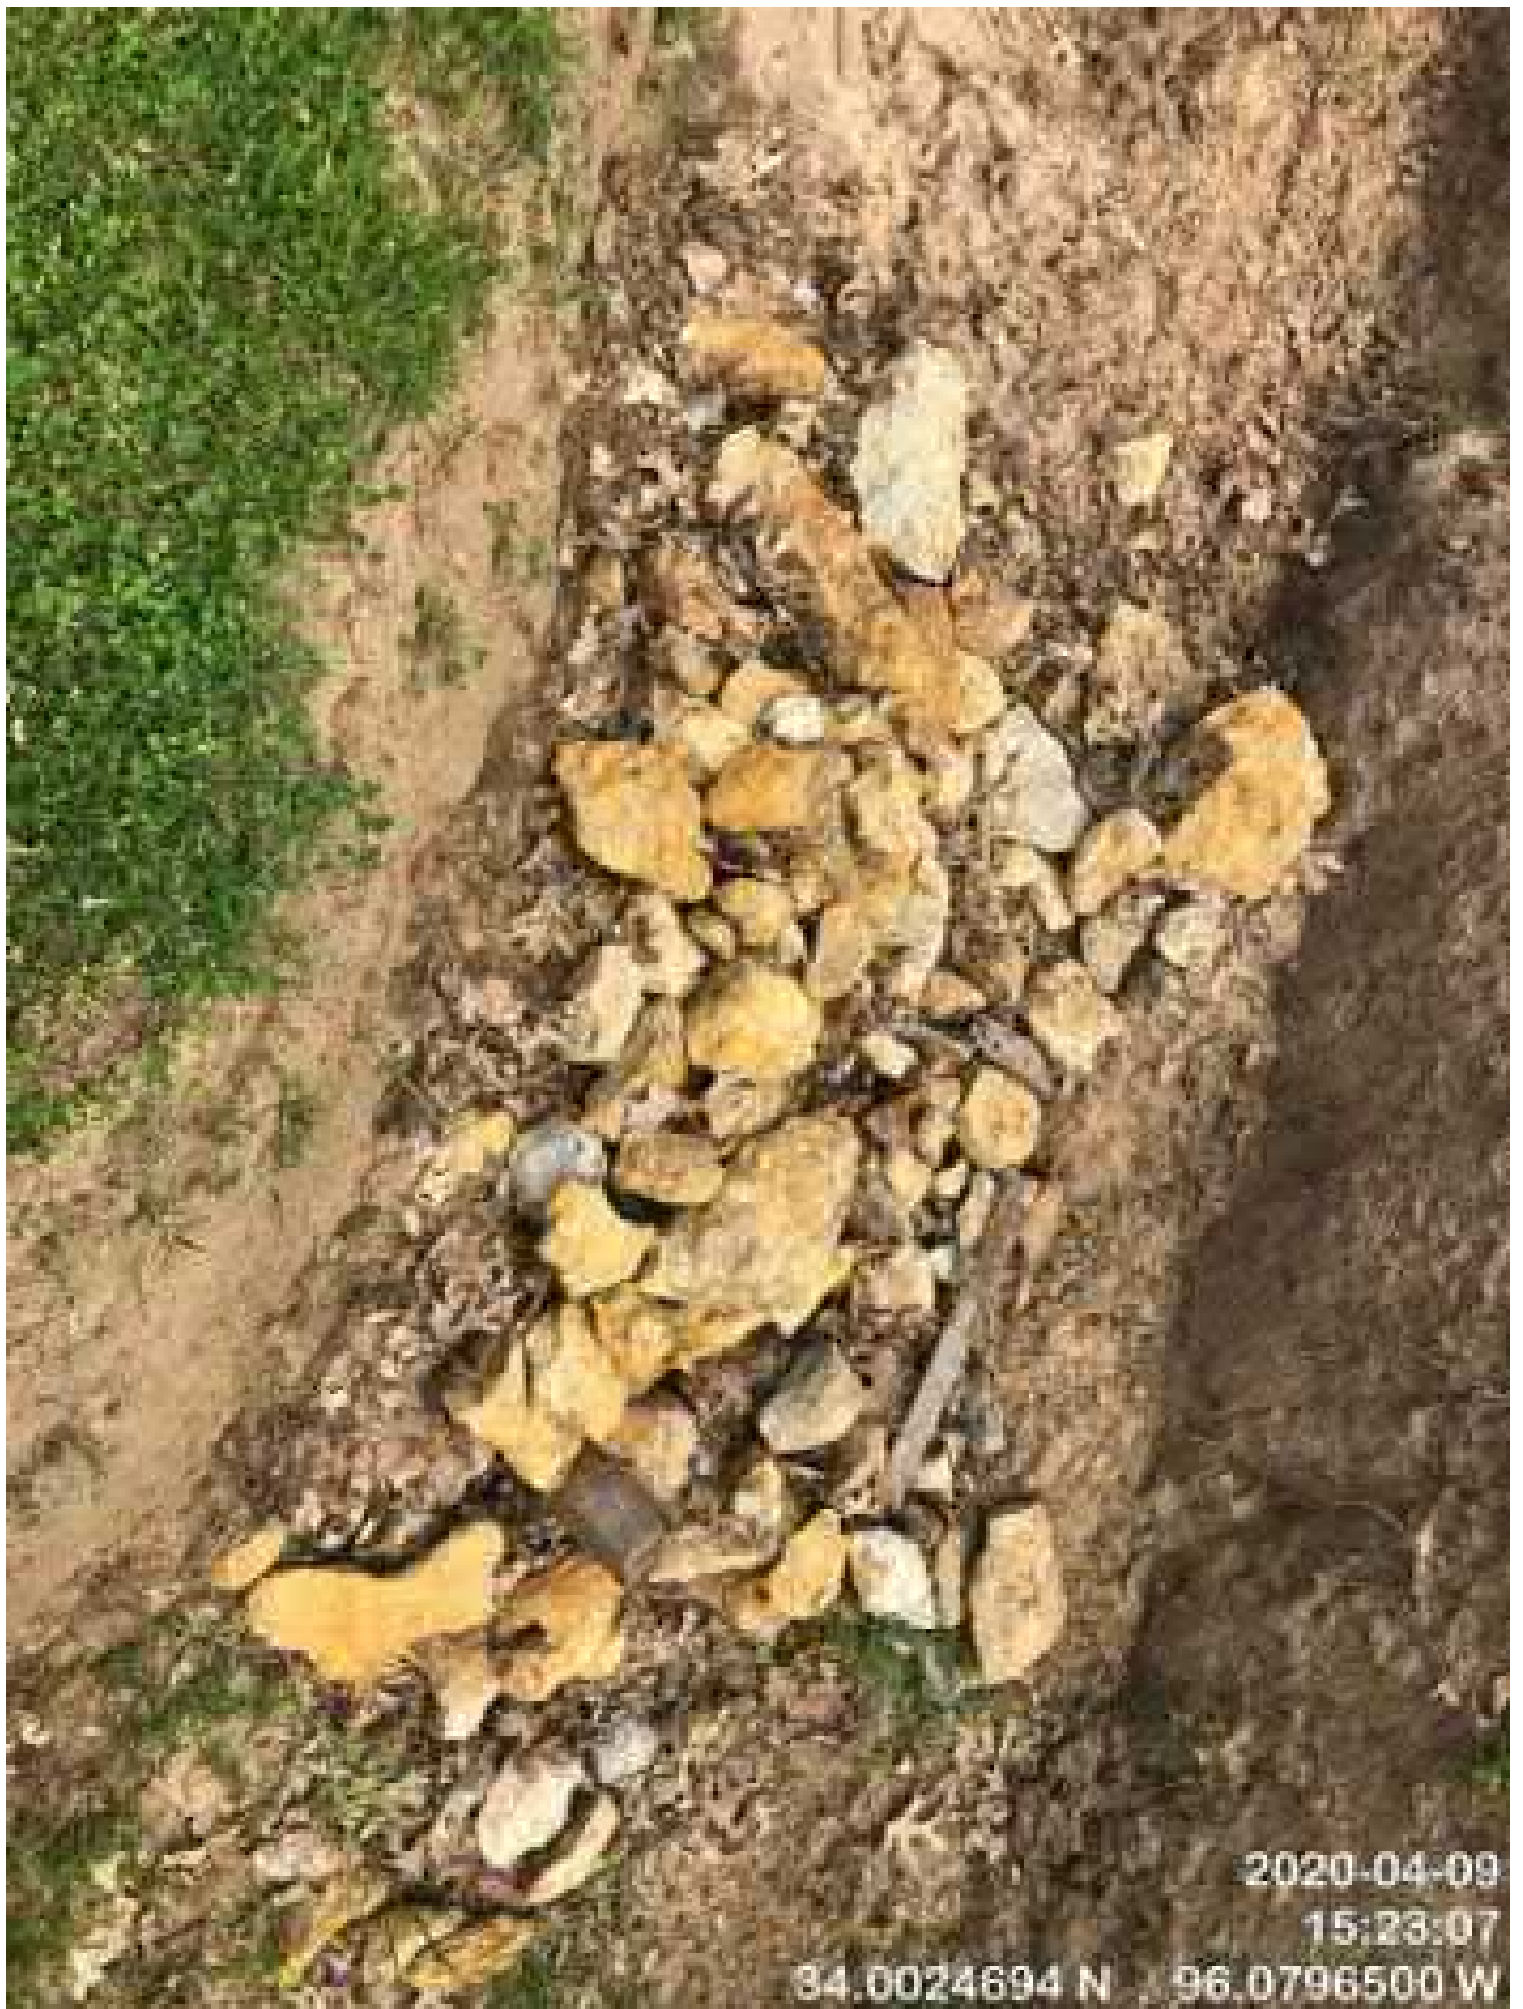
Site Inspection Findings:

- 1.) High levels of rock and blasting material mixed into soil. (FERC Plan: V. A. 3-6.)
 - a. Affected areas naturally have less than 1% rock fragments with a maximum size of 74 mm (NRCS).
- 2.) Importation of approx. 31,000 cubic yards of topsoil for 16.69 acres of ROW. (FERC Plan: IV. B. 1-6.)
 - a. Off-ROW topsoil: 14" (verified by existing NRCS soil surveys)
 - b. In-ROW topsoil: 0" found in multiple locations.
- 3.) Soil Compaction (FERC Plan: V. C. 1-3.)
 - a. Off-ROW Penetrometer reading: Around 180 psi in multiple locations.
 - b. In-ROW Penetrometer reading: 300 psi limit exceeded in every off-ROW location.

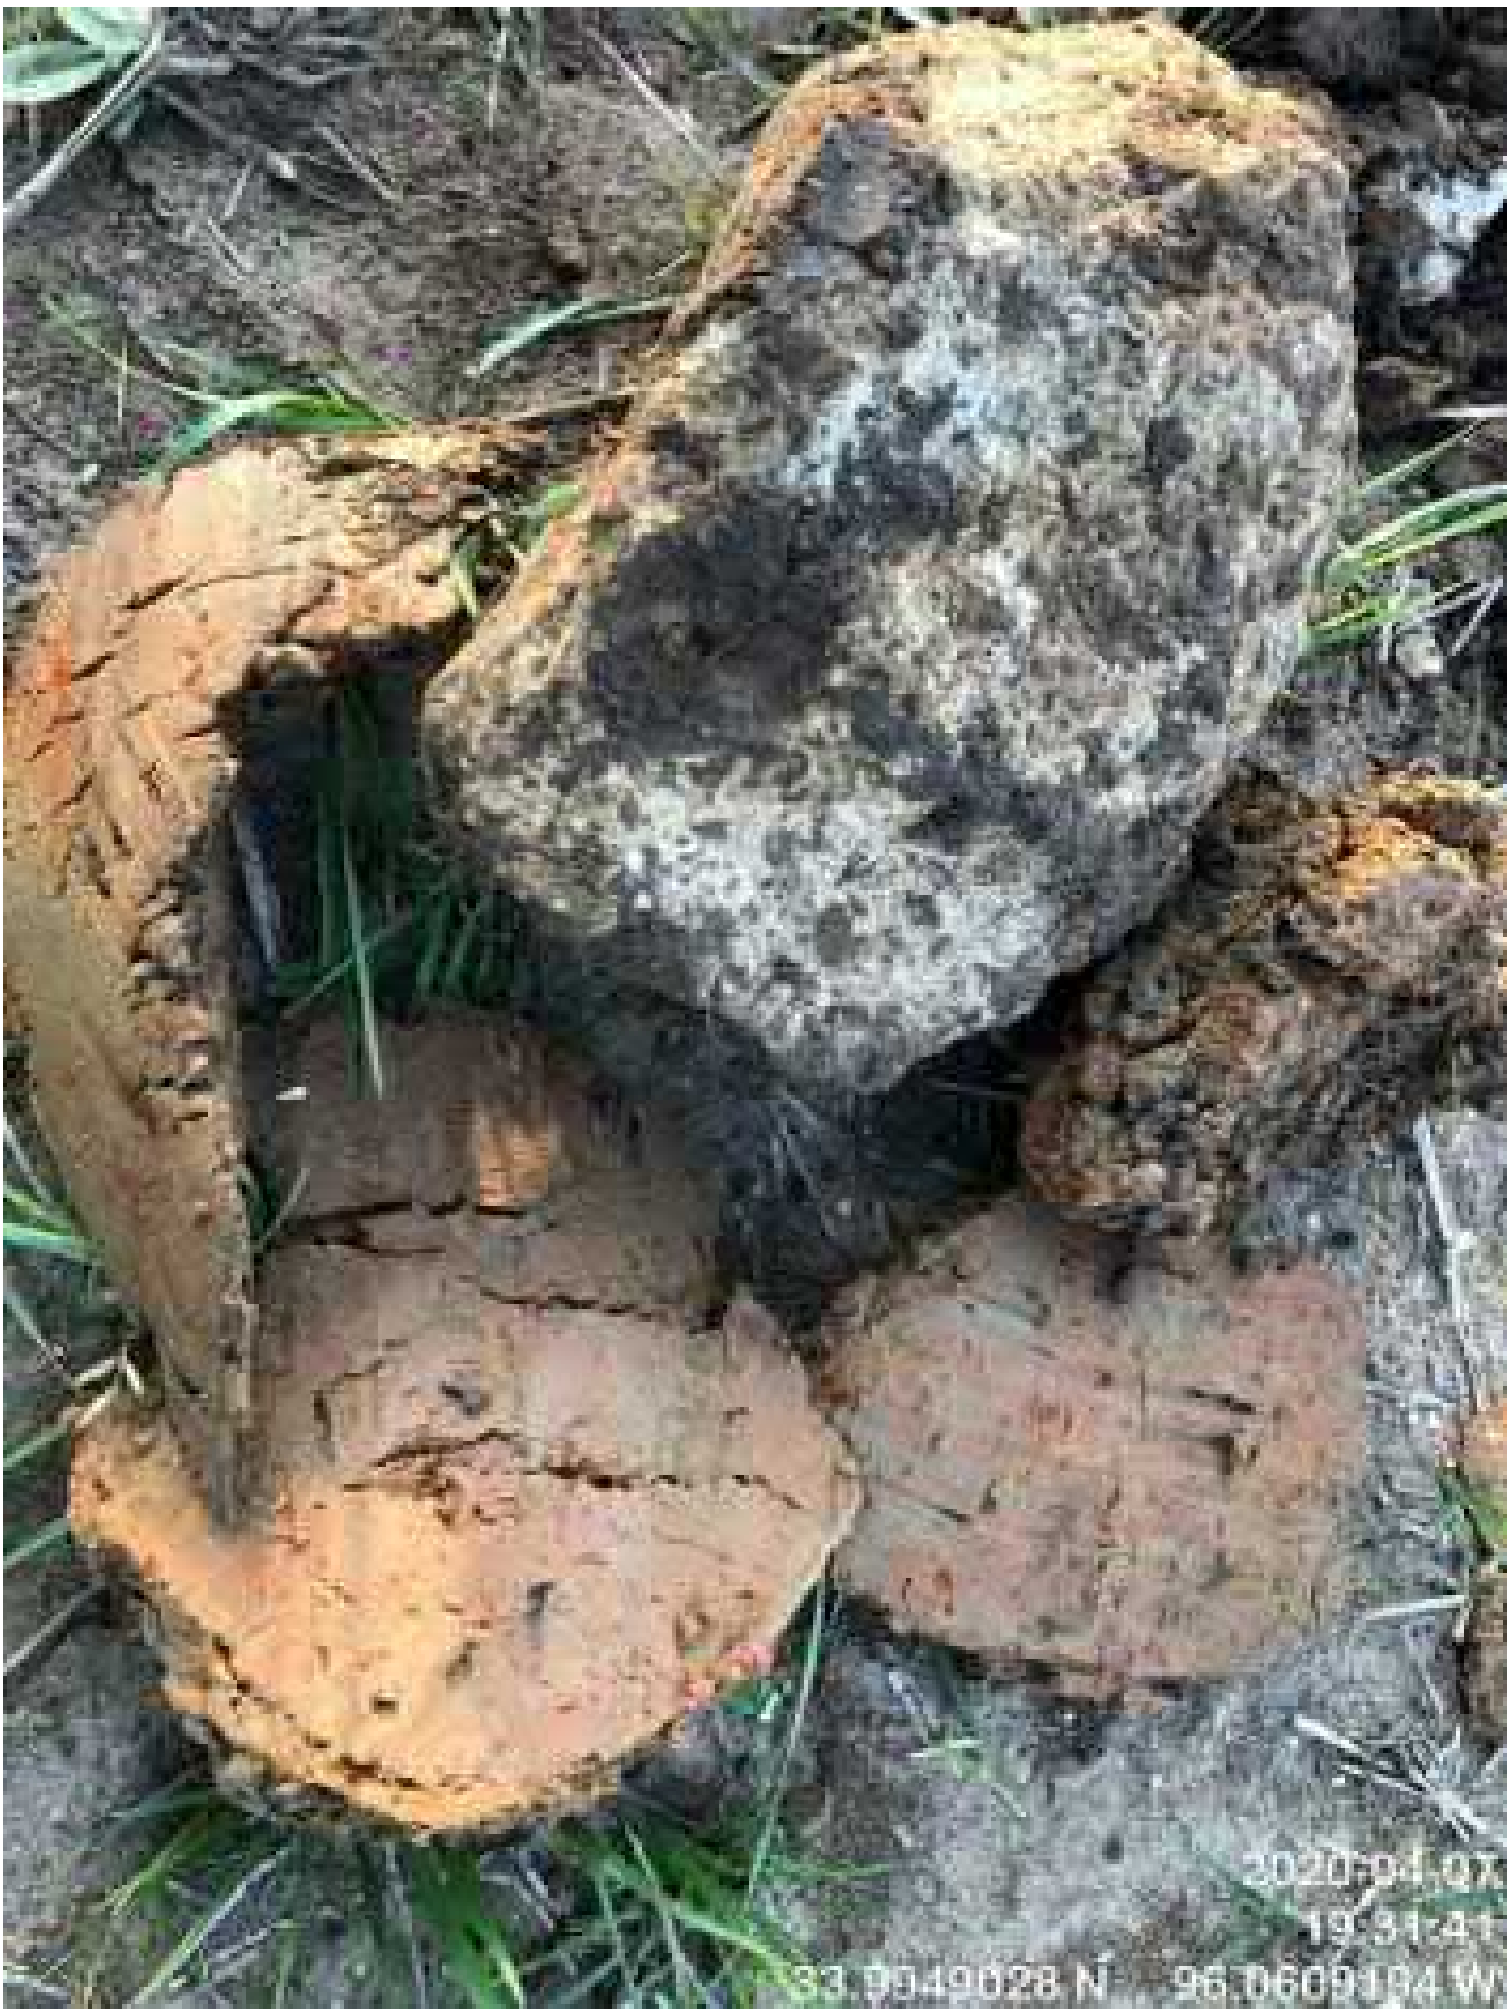
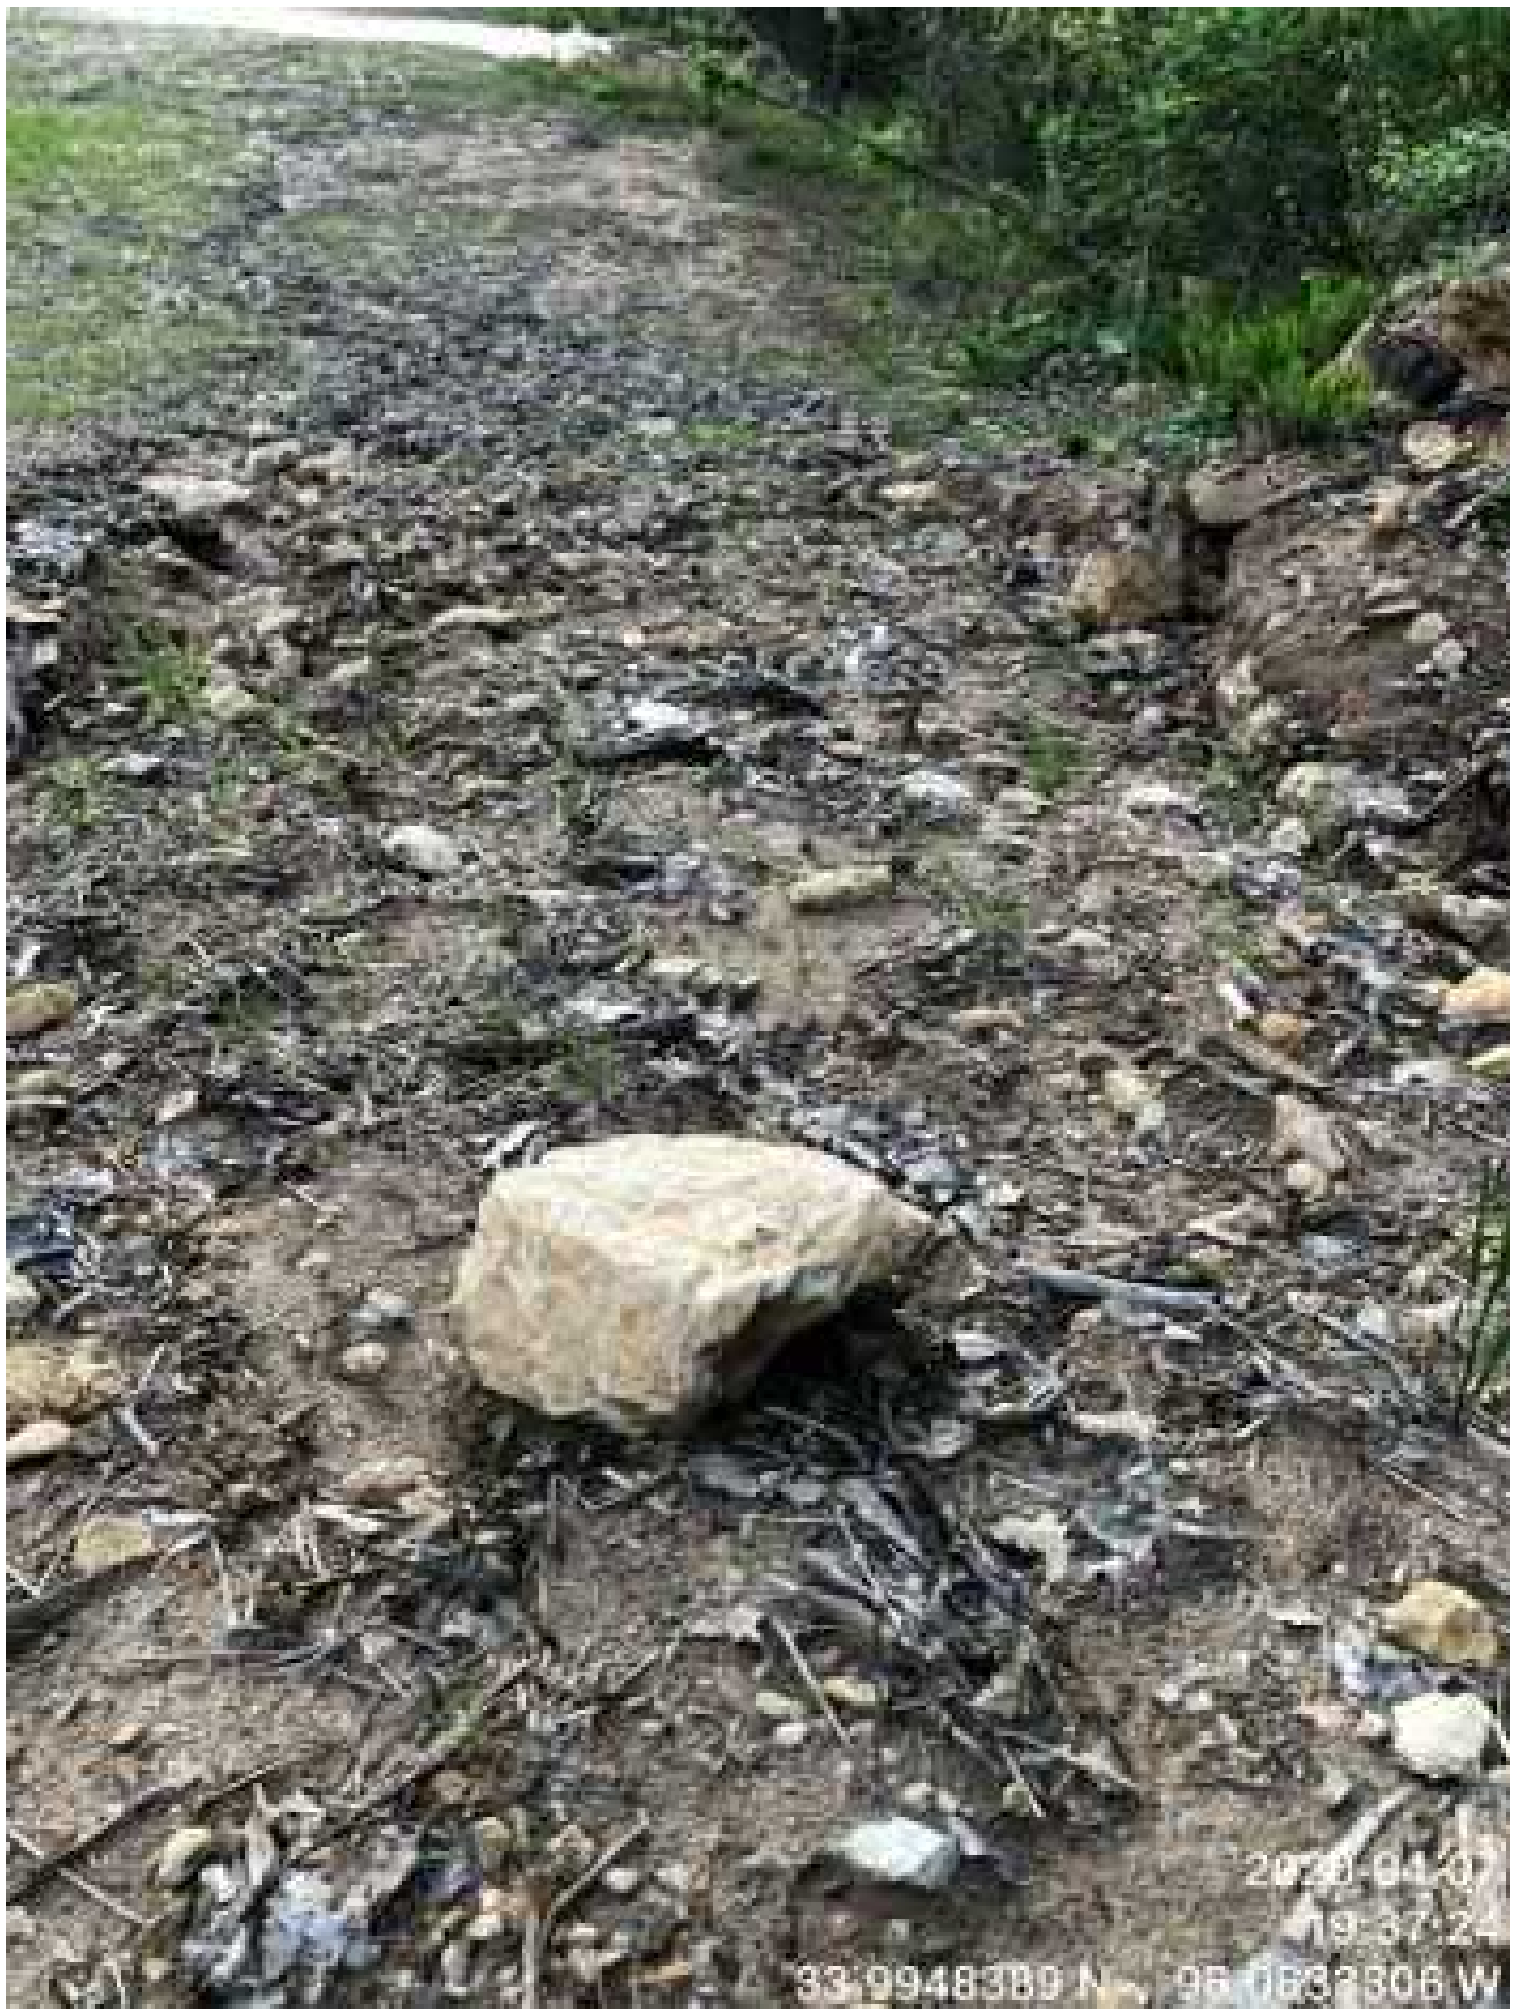
Site Inspection Findings:

- 1.) High levels of rock and blasting material mixed into soil. (FERC Plan: V. A. 3-6.)
 - a. Affected areas naturally have less than 1% rock fragments with a maximum size of 74 mm (NRCS).
- 2.) Importation of approx. 27.860 cubic yards of topsoil for 12.19 acres of ROW. (FERC Plan: IV. B. 1-6.)
 - a. Off-ROW topsoil: 17" (verified by existing NRCS soil surveys)
 - b. In-ROW topsoil: 0" found in multiple locations.
- 3.) Soil Compaction (FERC Plan: V. C. 1-3.)
 - a. Off-ROW Penetrometer reading: Around 150-180 psi in multiple locations.
 - b. In-ROW Penetrometer reading: 300 psi limit exceeded in every off-ROW location.
- 4.) Construction debris used for creek lining without landowner permission. (FERC Plan: V. A. 3.)

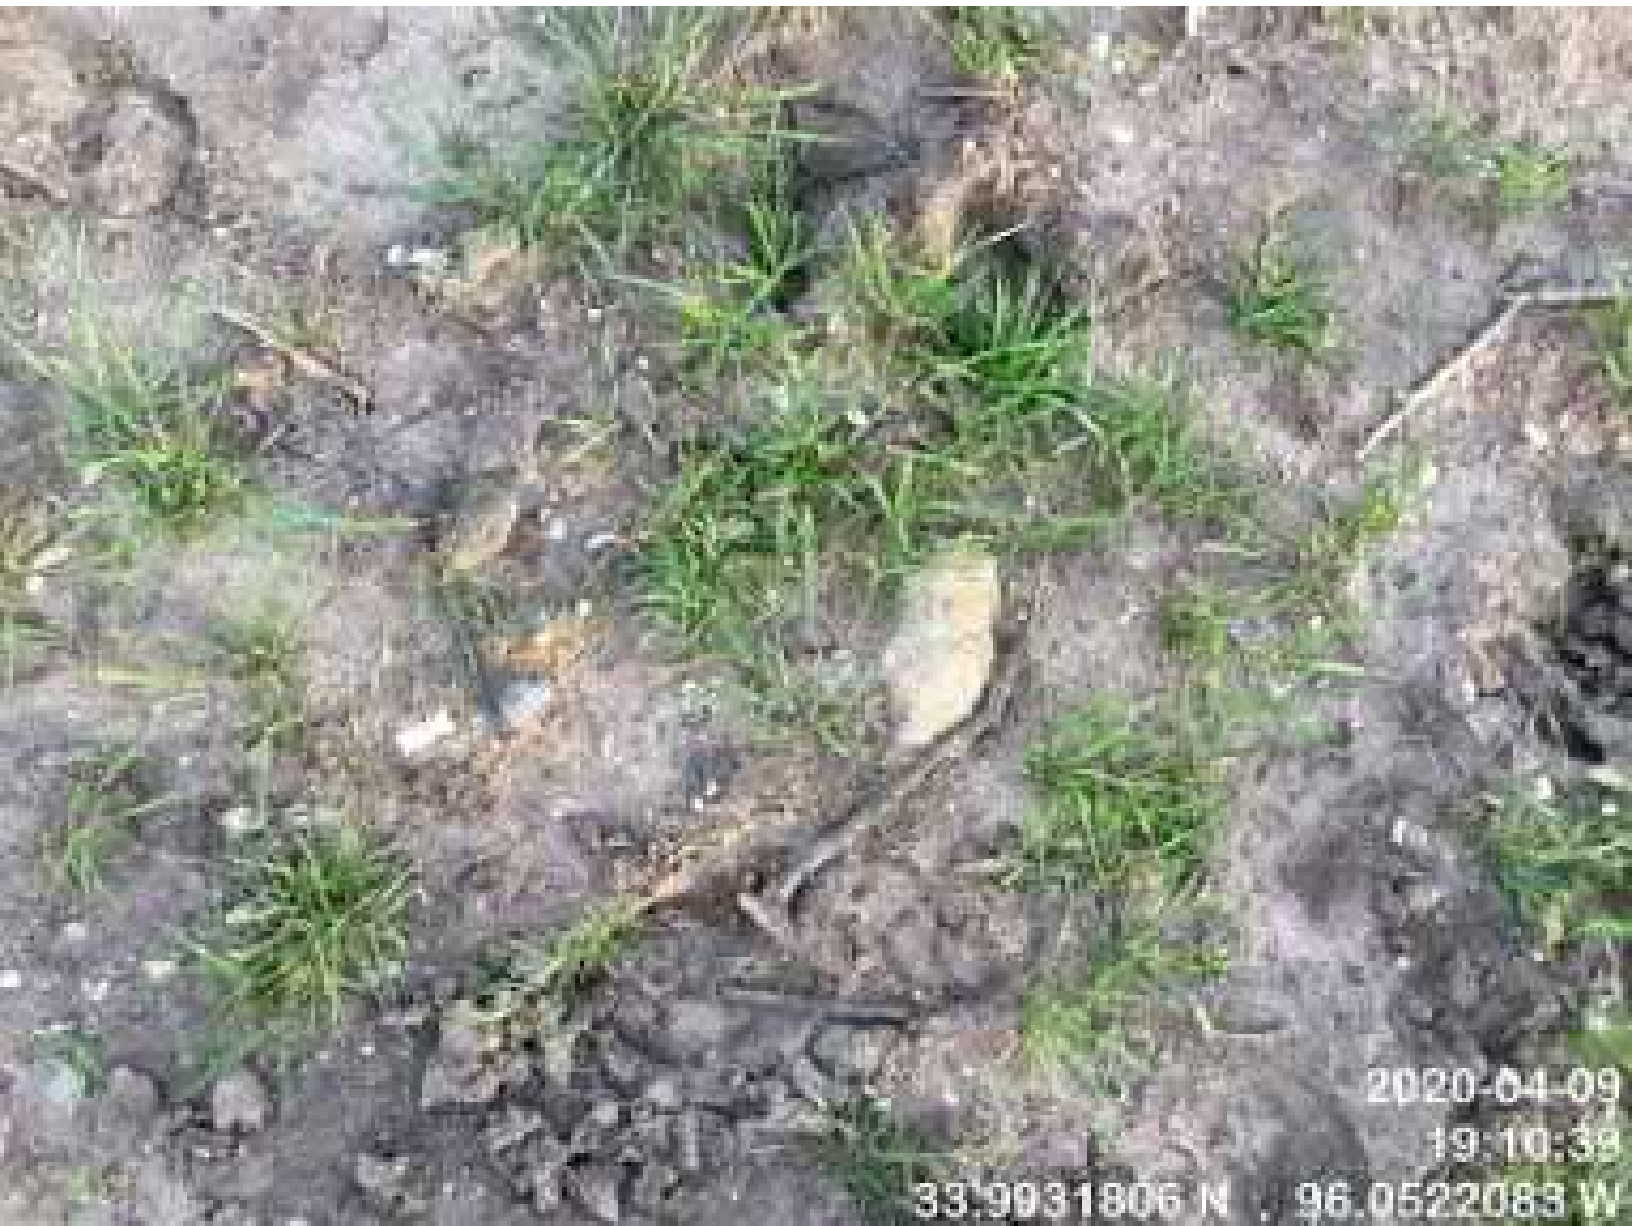
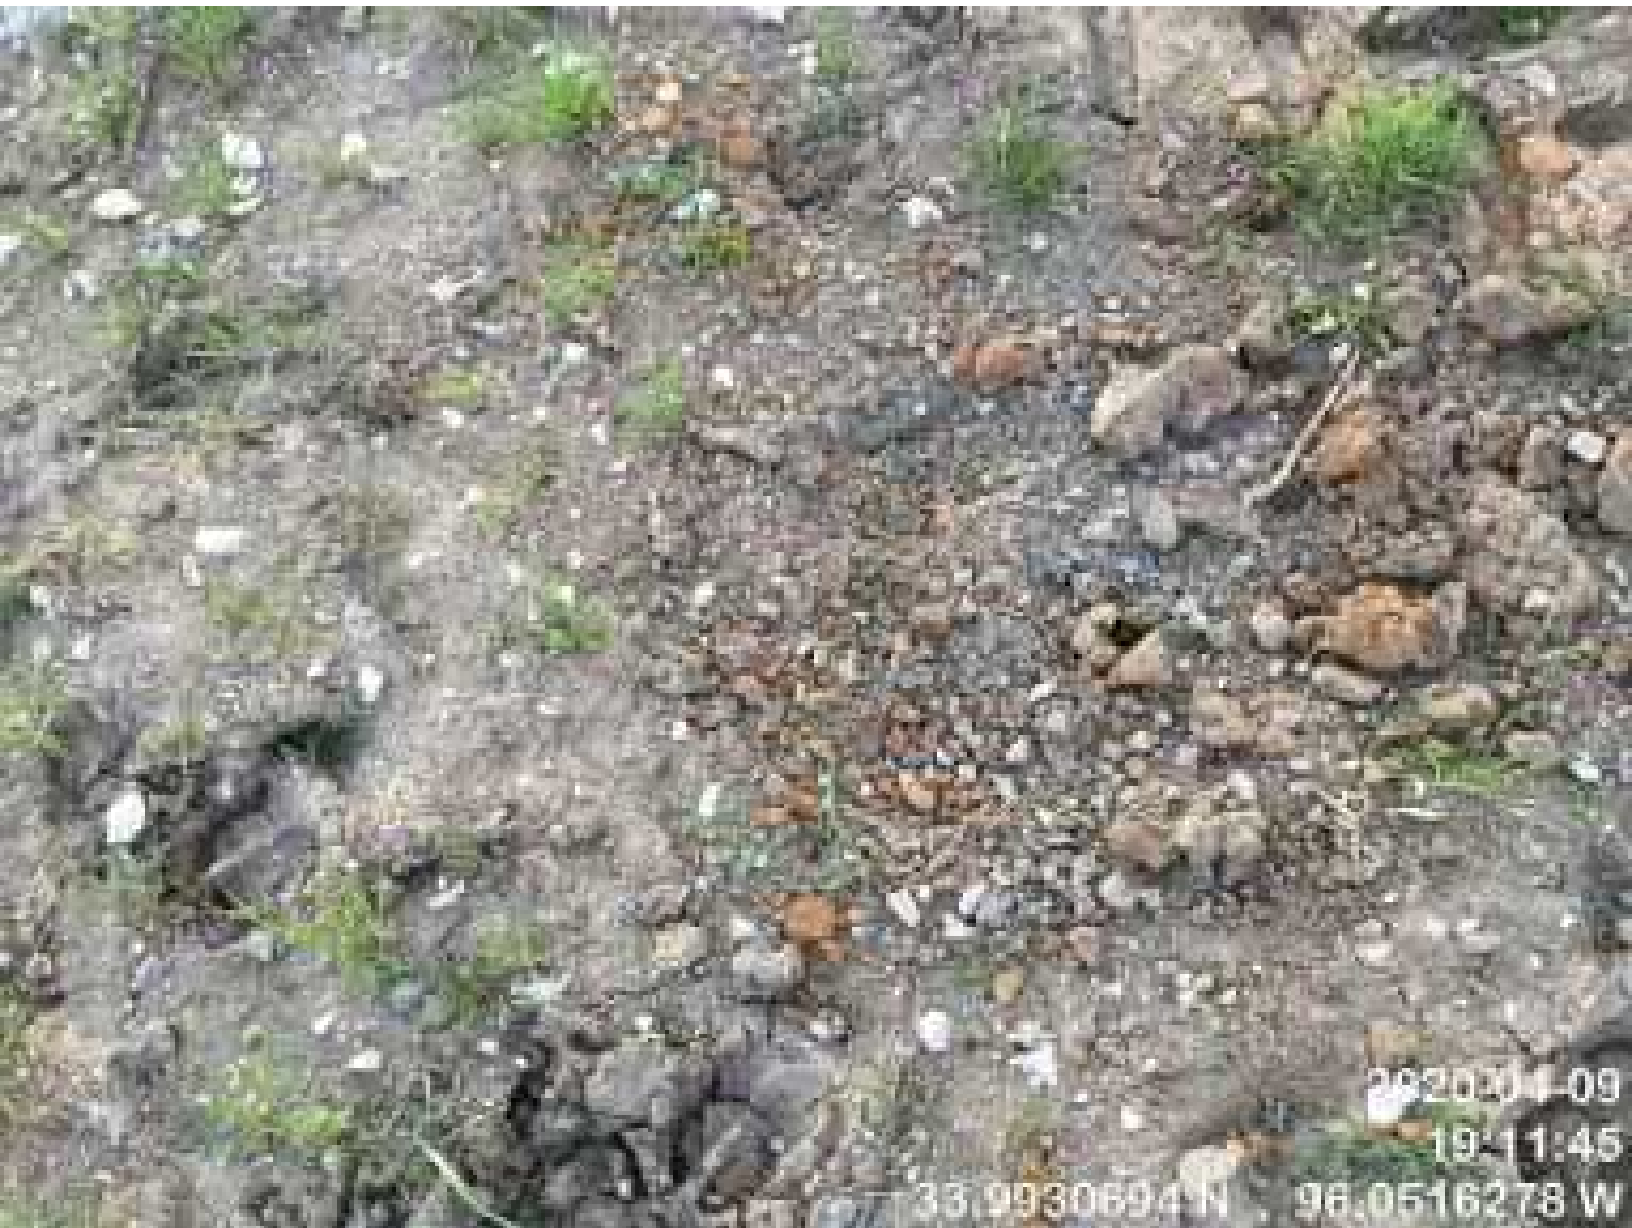
Site Inspection Findings:

- 1.) High levels of rock and blasting material mixed into soil. (FERC Plan: V. A. 3-6.)
 - a. Affected areas naturally have around 1% rock fragments with a maximum size of 74 mm (NRCS)
- 2.) Importation of approx. 3,256 cubic yards of topsoil for 1.73 acres of ROW. (FERC Plan: IV. B. 1-6.)
 - a. Off-ROW topsoil: 14" (verified by existing NRCS soil surveys)
 - b. In-ROW topsoil: 0" found in multiple locations.
- 3.) Soil Compaction (FERC Plan: V. C. 1-3.)
 - a. Off-ROW Penetrometer reading: Around 150 psi in multiple locations.
 - b. In-ROW Penetrometer reading: 300 psi limit exceeded in every off-ROW location.

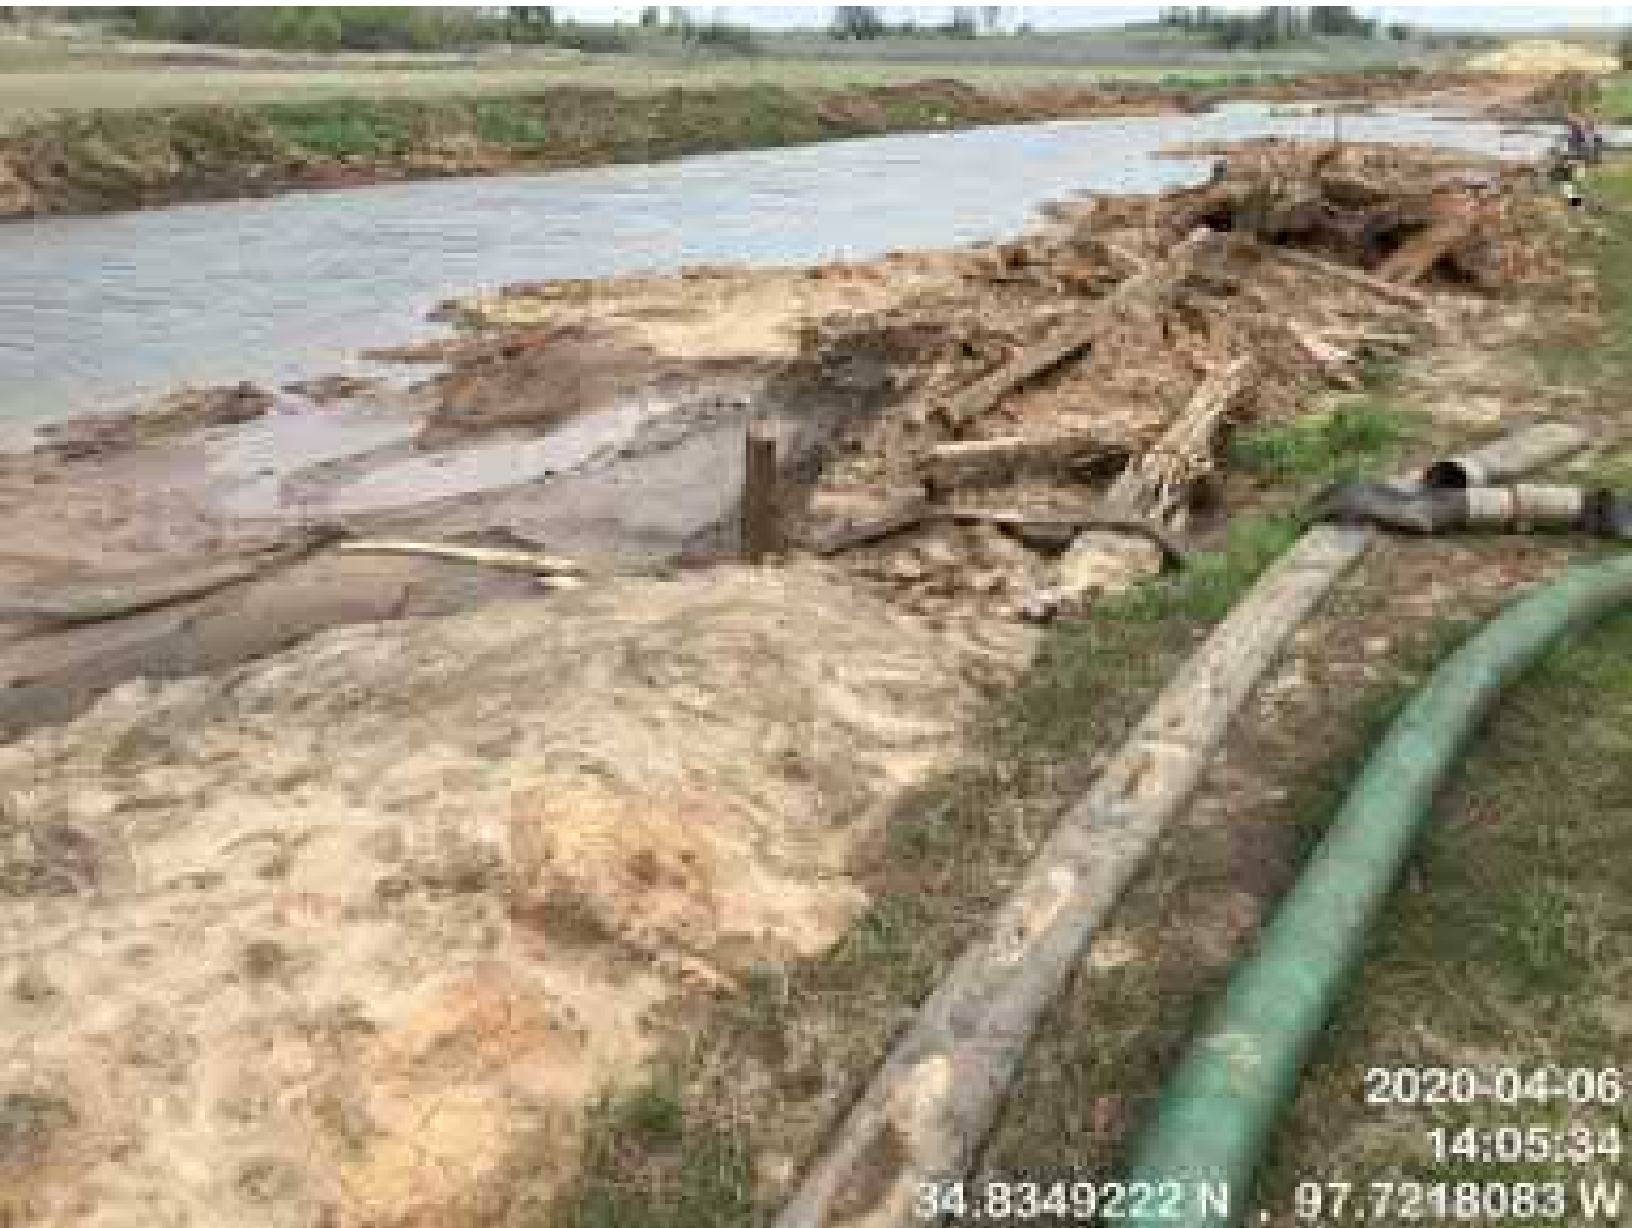
- 1.) Trenches remain open and full of water on tract GR-0338. No catch basins found on property.
- 2.) Sandy Creek (SGR-008)
 - a. Unfiltered trench water continues to be pumped directly into Sandy Creek. (FERC Procedures: V. B. 11.)
 - b. Banks are unstable and slipping into stream. (FERC Procedures: V. C. 2-3.)
 - c. Sediment deposited into stream have partially dammed stream impeding natural flow. (FERC Procedures: V. B. 10-11.)
- 3.) Importation of 50,000 - 100,000 cubic yards of topsoil for 26.27 acres of ROW (FERC Plan: IV. B. 1-6.)

- a. Off-ROW topsoil: 16-29" (verified by existing NRCS soil surveys)
- b. In-ROW topsoil: 0" found in multiple locations.
- 4.) Soil Compaction (FERC Plan: V. C. 1-3.)
 - a. Off-ROW Penetrometer reading: Around 150 psi in multiple locations.
 - b. In-ROW Penetrometer reading: 300 psi limit exceeded in every off-ROW location.
- 5.) Large rocks and debris mixed into soil and scattered throughout entire property. (FERC Plan: V. A. 3-6.)
 - a. NRCS indicates very little natural rock throughout soils in this area.
 - 1. Affected cropland areas naturally have 0% rock fragments on GR-0338.

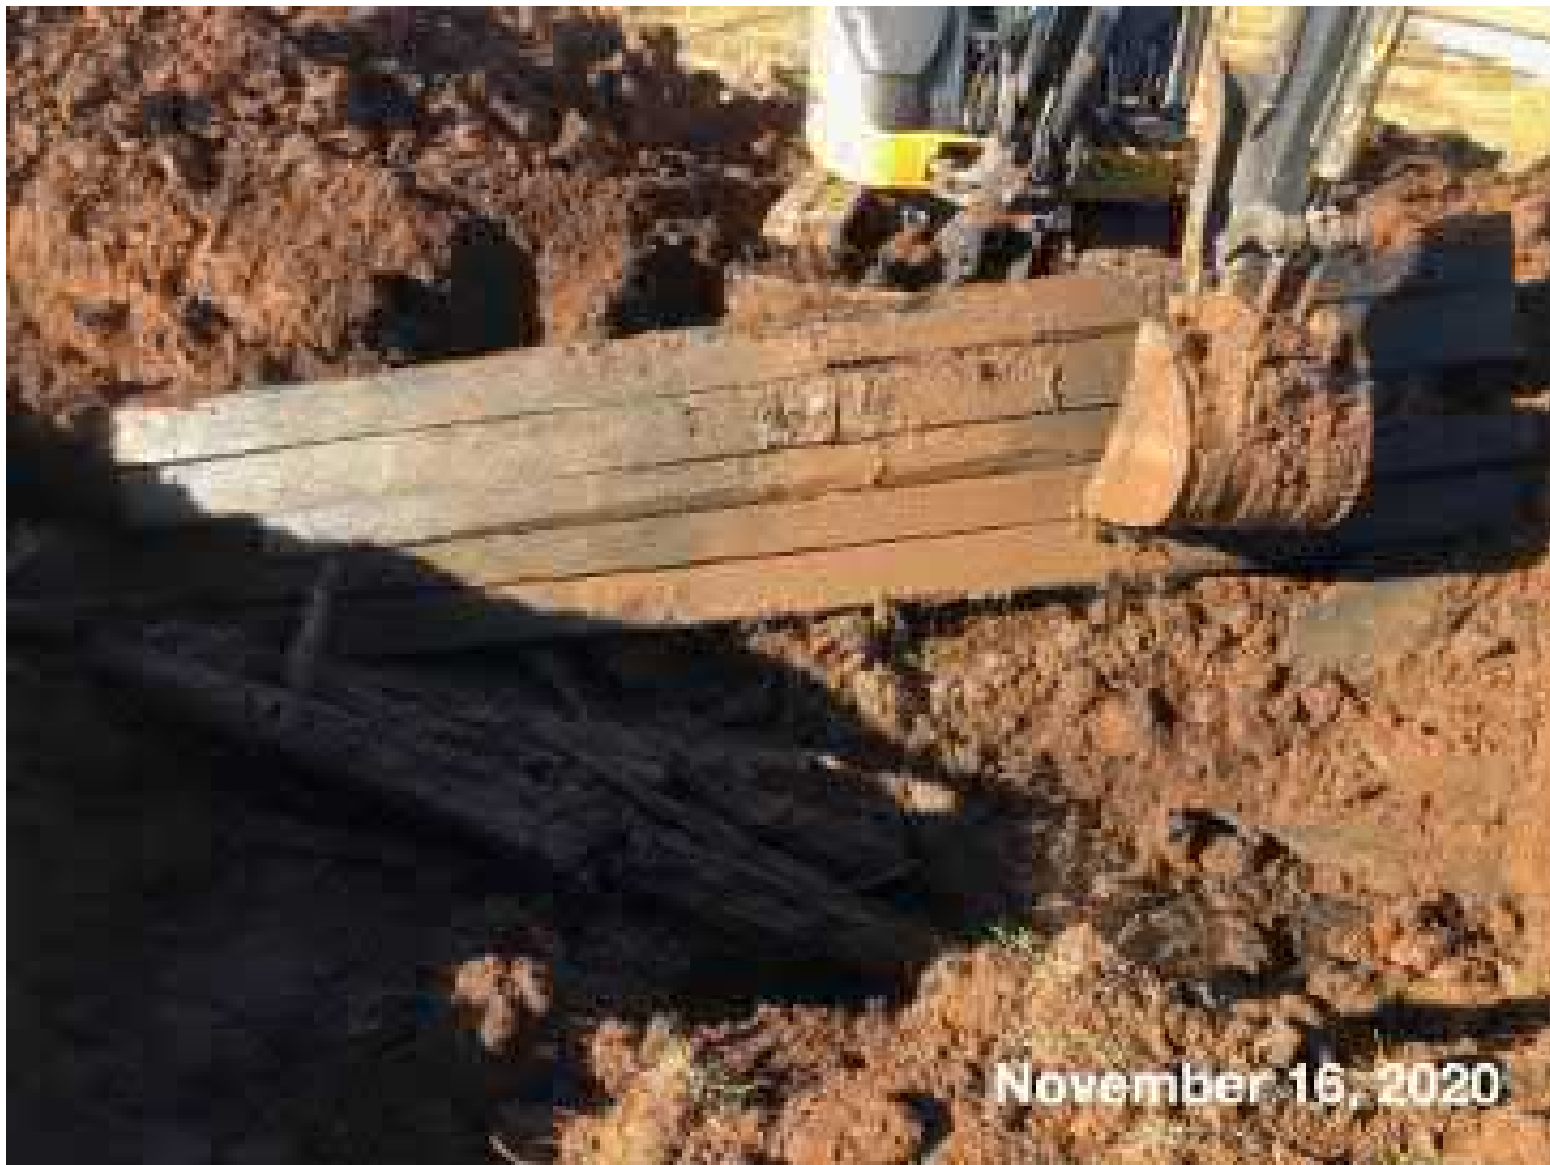
On November 16, 2020 the Landowners Verified Several Large Sections of Matting Were Found in the Topsoil and as Deep as 60”
