Robert Squires - Squires Consulting LLC
Landowner Advocate

Opening Statement for May 5, 2021 Subcommittee on Civil Rights and Civil Liberties Hearing:
“Pipelines Over People (Part II): Midship Pipeline’s Disregard for Landowners in Its Pathway”

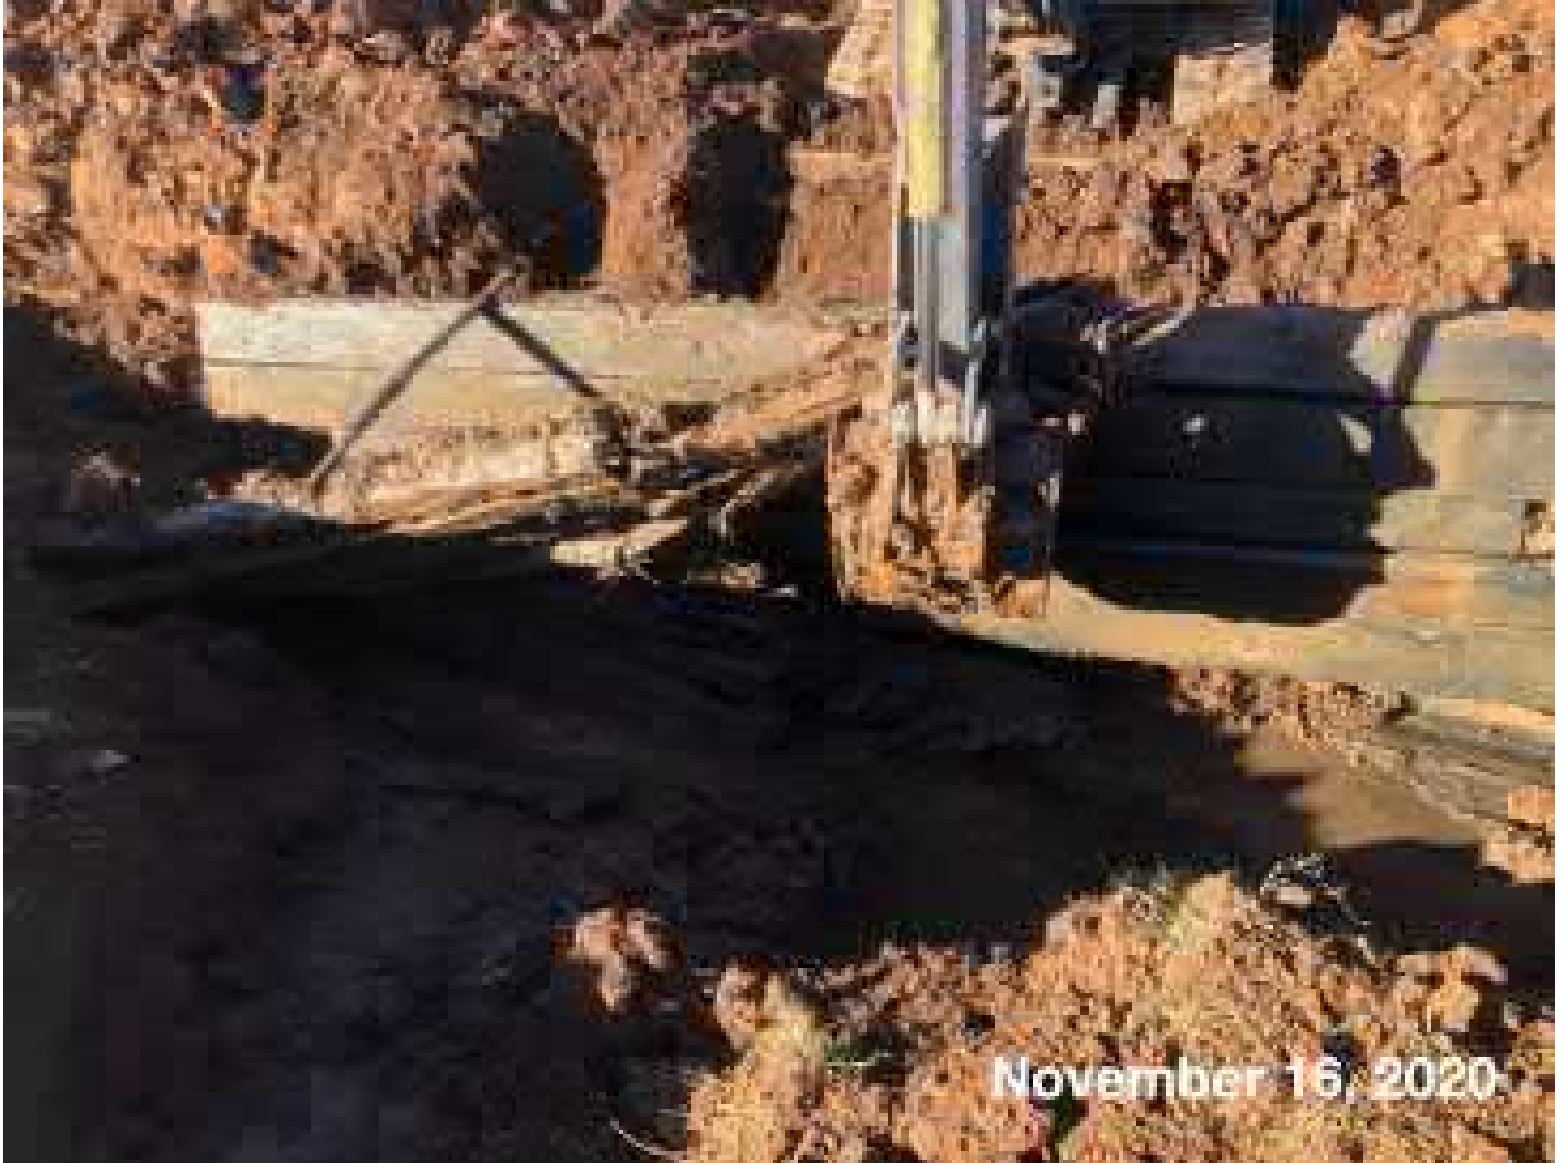
Large Sections of Matting Were Found in Several Locations North and South on Tract # GR-0338

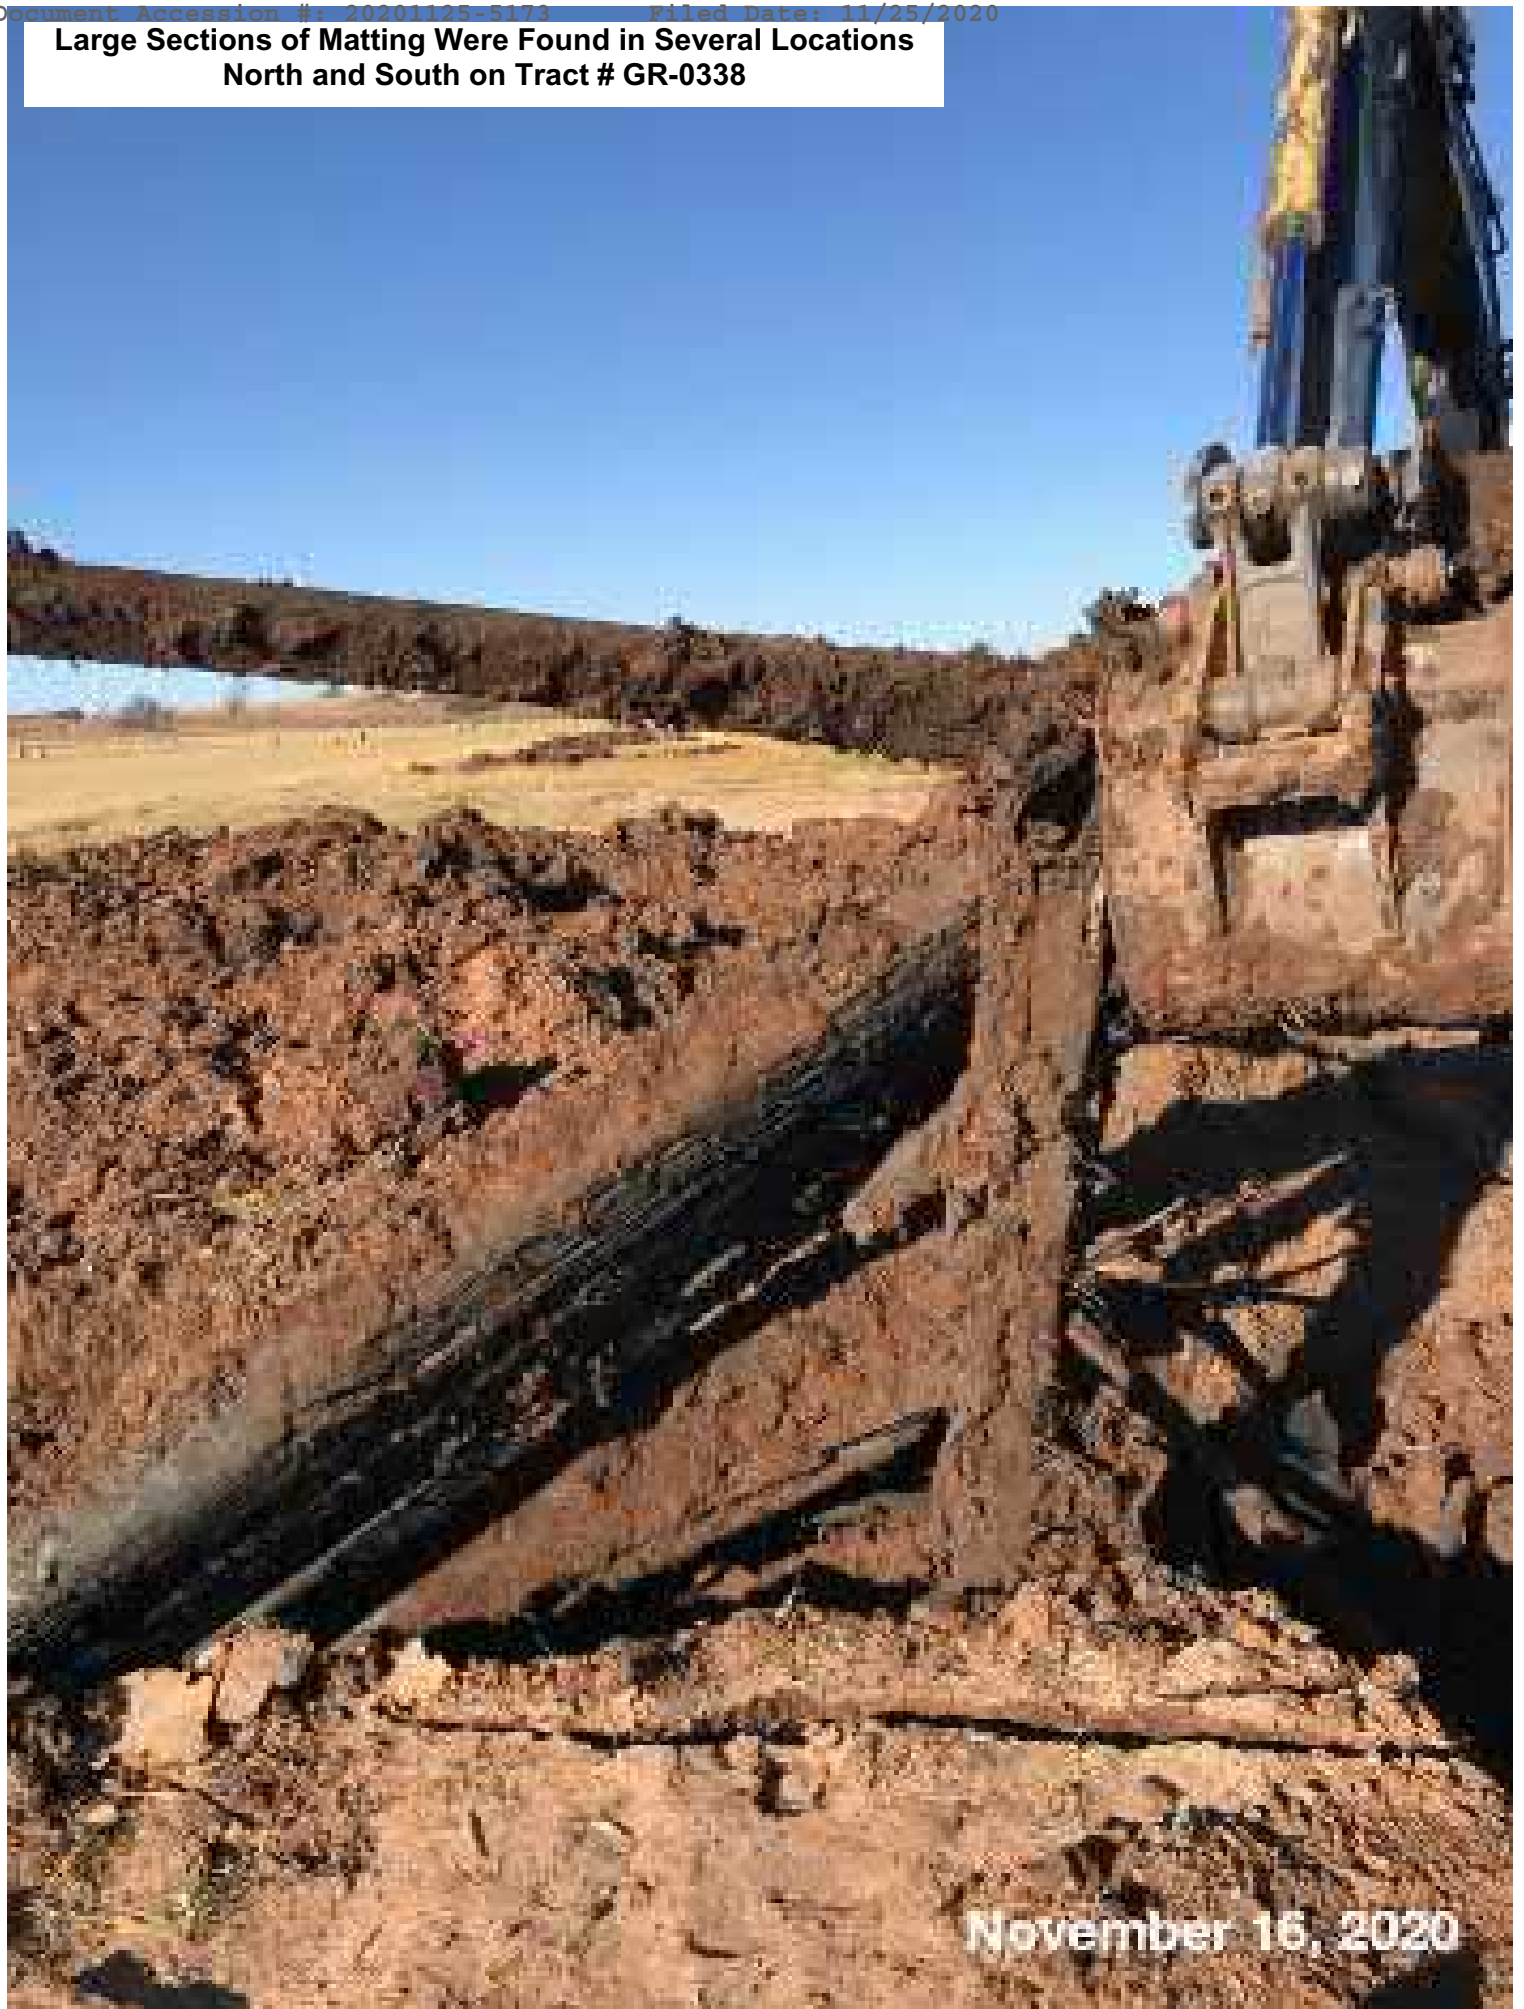
**Large Sections of Matting Were Found in Several Locations
North and South on Tract # GR-0338**

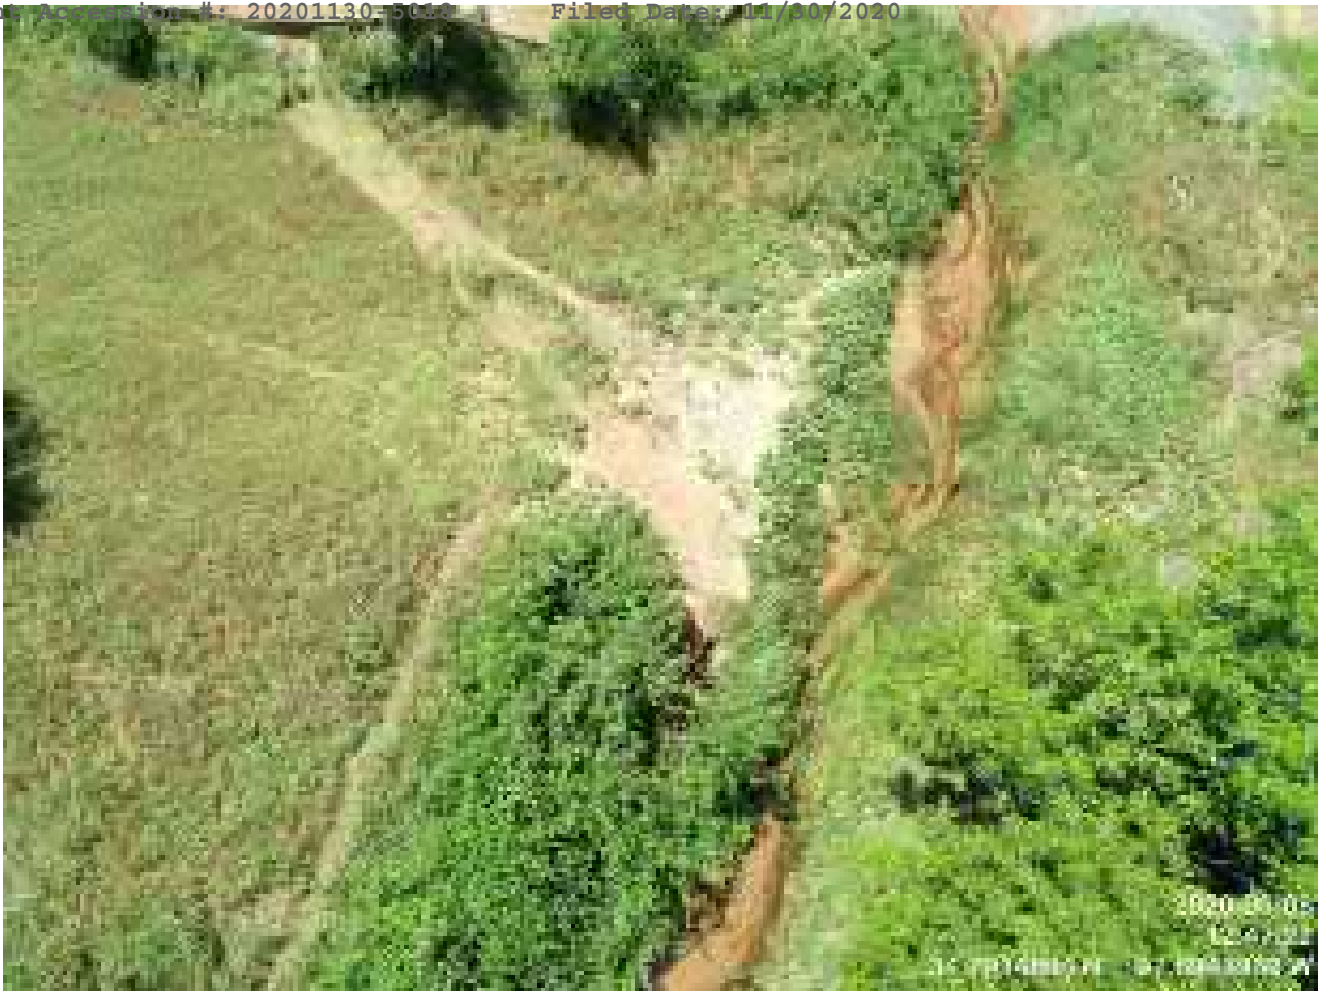
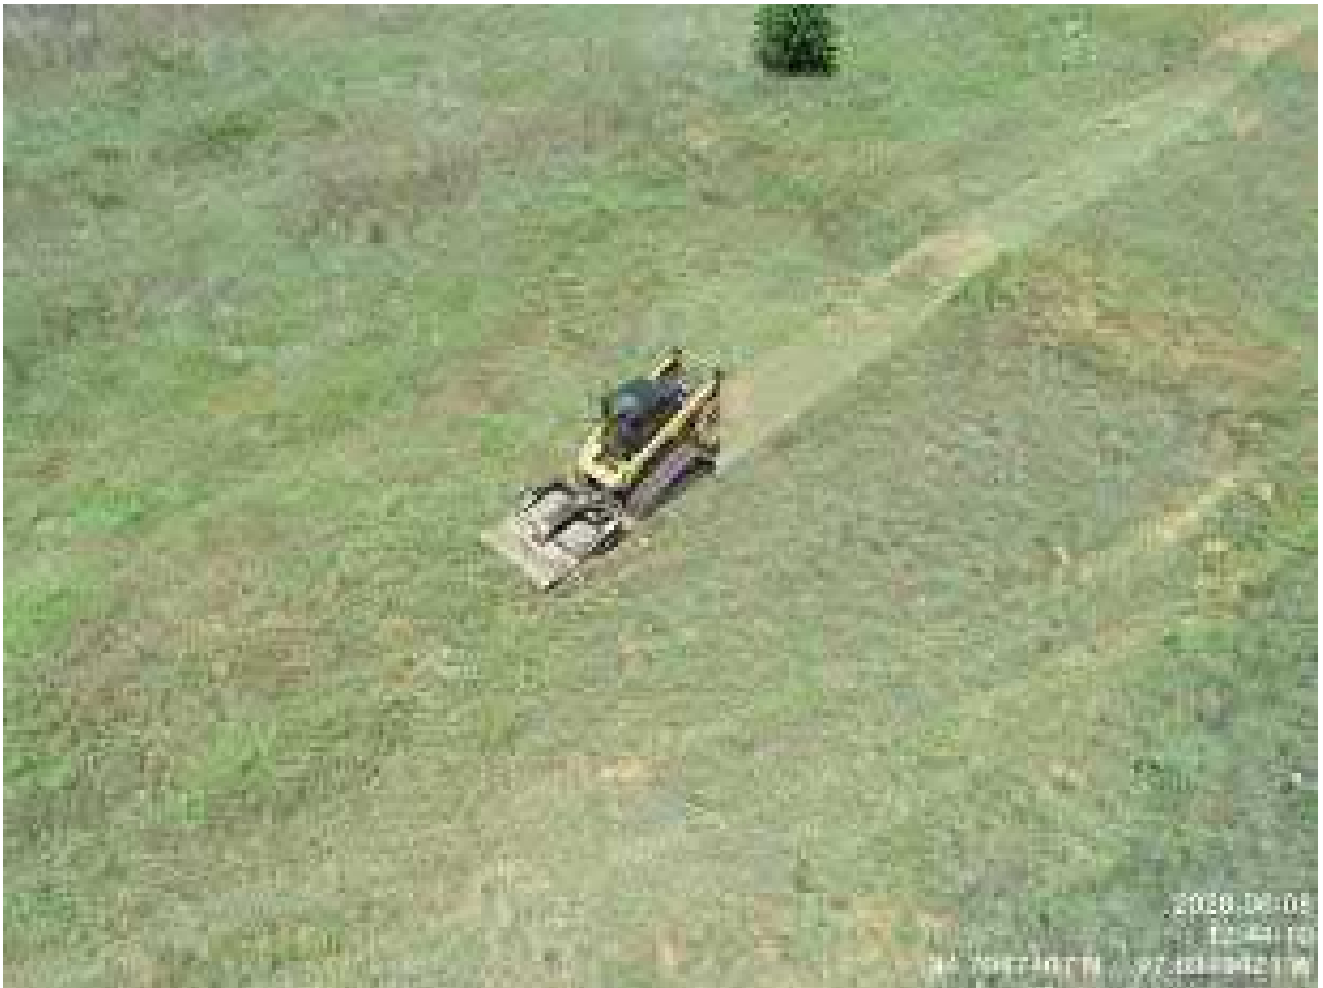
Section 2

Off-ROW Activity on June 8, 2020

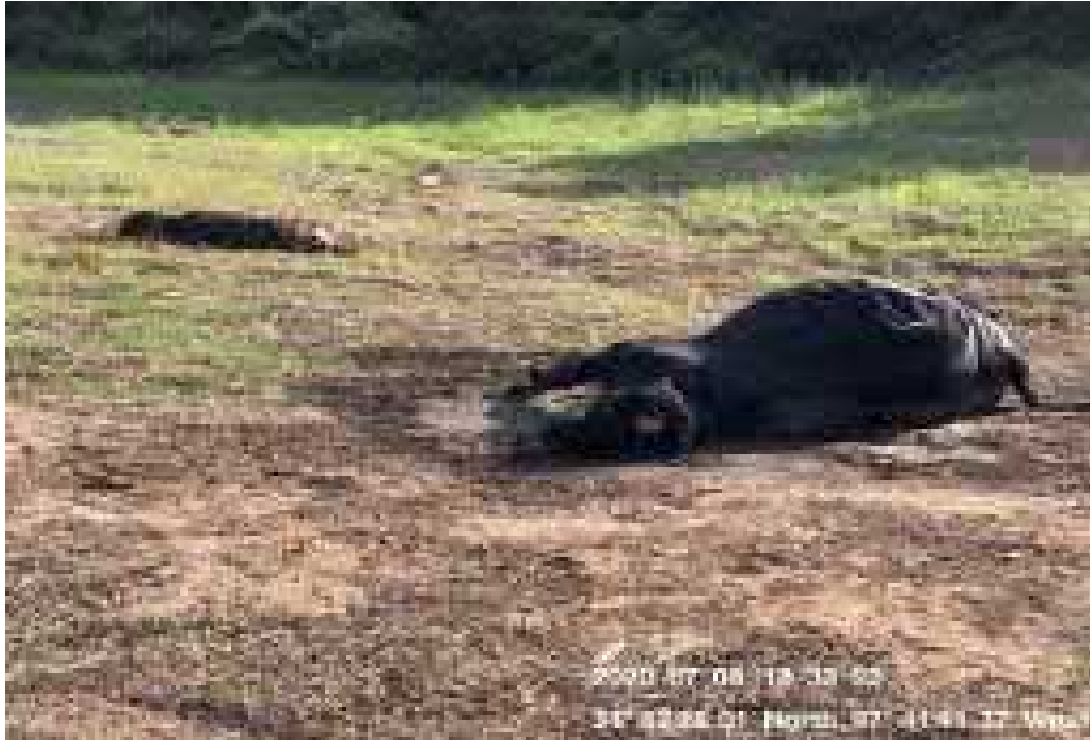
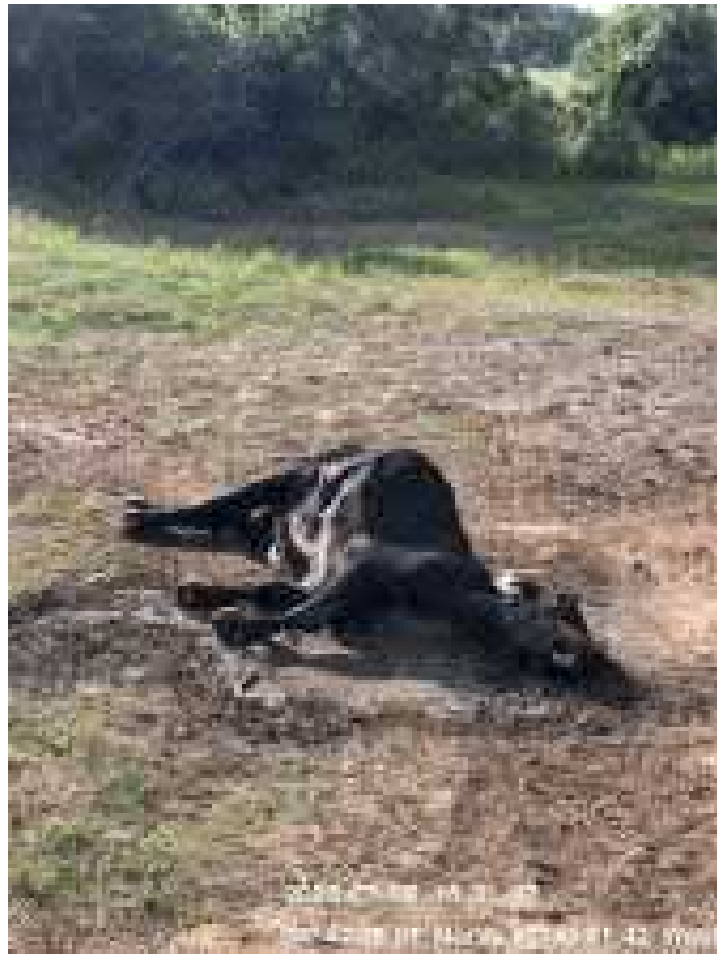
Exhibit A
Section 3.1

Cattle Found Dead in Easement

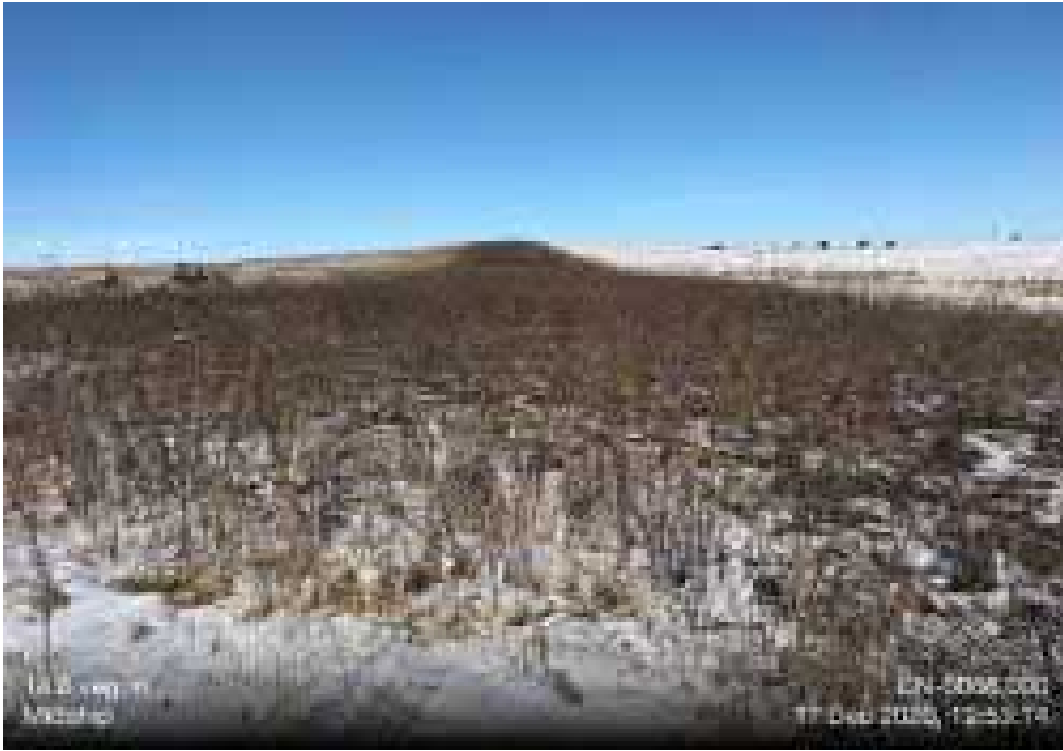
Photo 1: View of mature vegetation on tract CN-0066.000, North Spread, MP 14.8 (see EV-8931 issued on 12/17/2020).

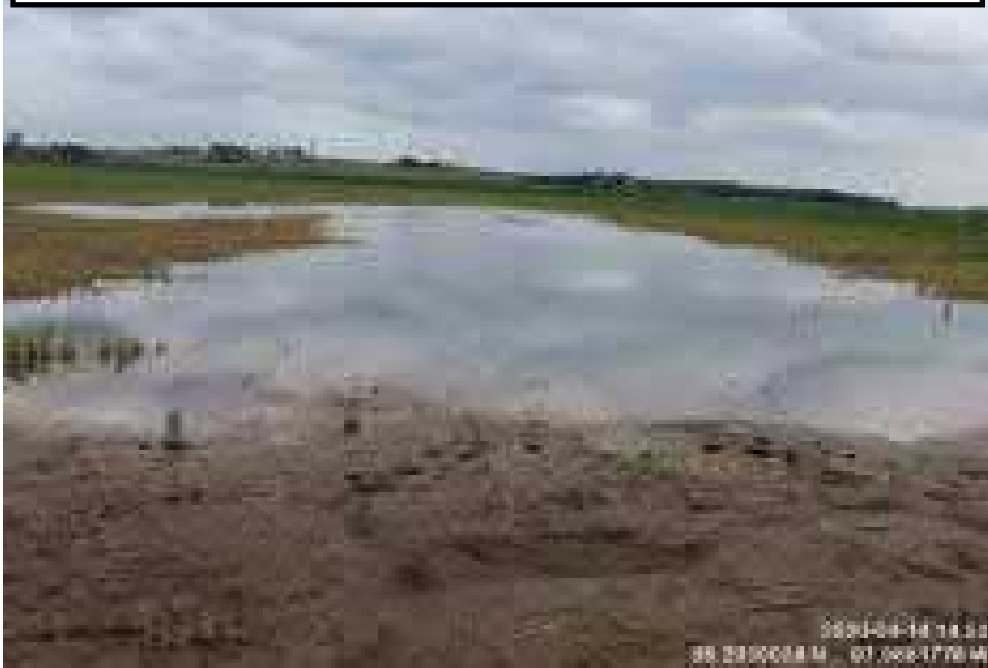
Large Area of Off-ROW Ponding Due to Impacted Drainage

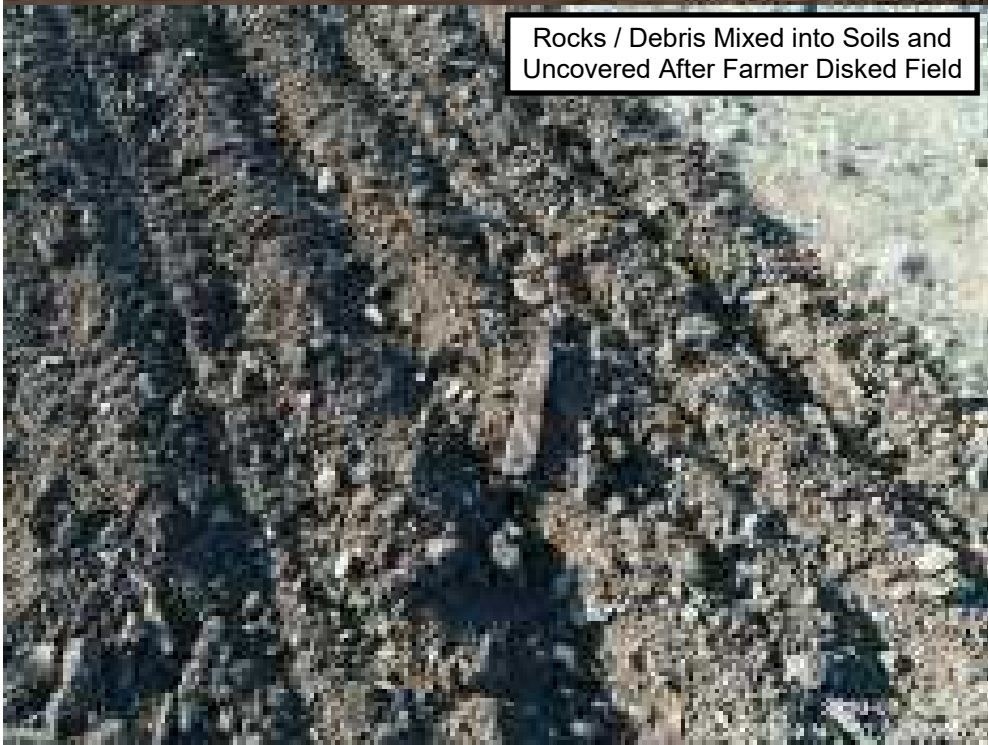
Rocks / Debris Mixed into Soils and Uncovered After Farmer Disked Field

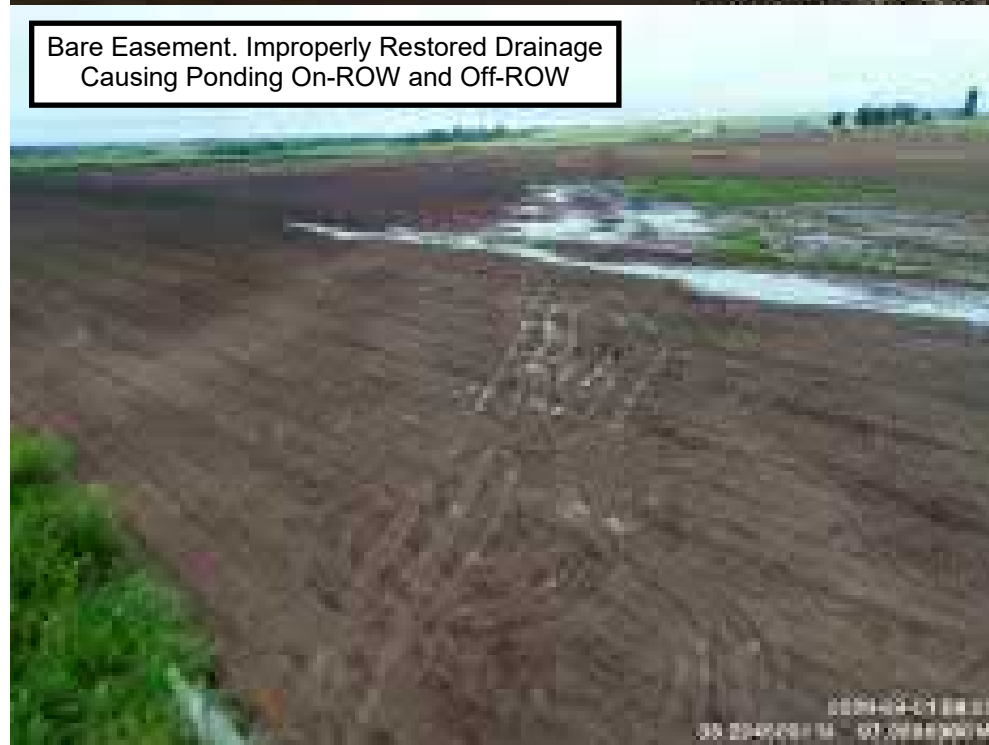
Bare Easement. Improperly Restored Drainage Causing Ponding On-ROW and Off-ROW

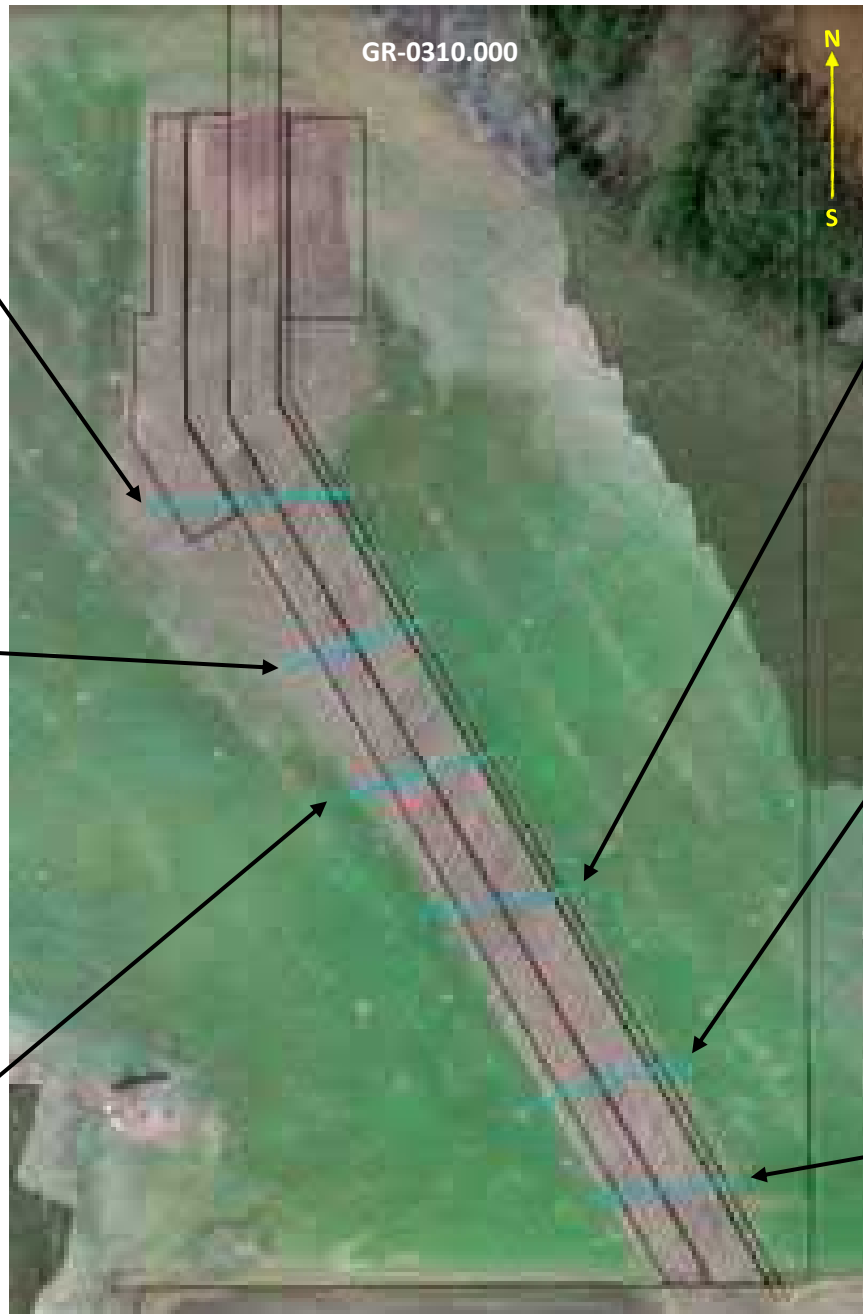
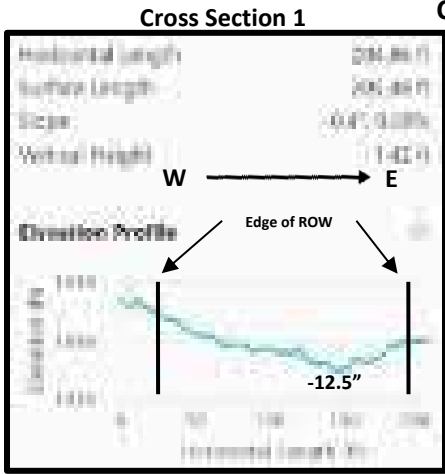
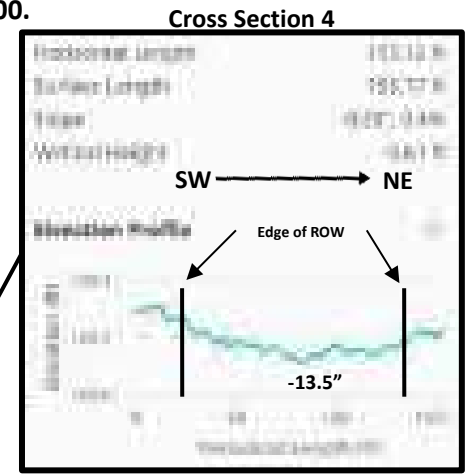
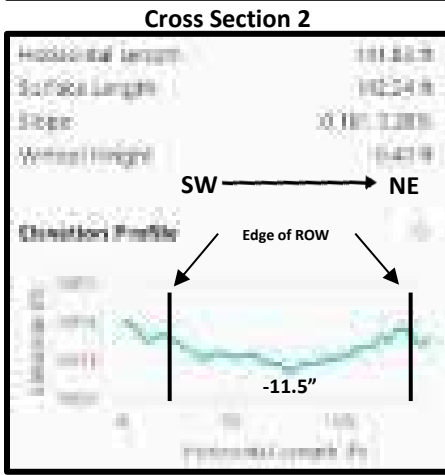
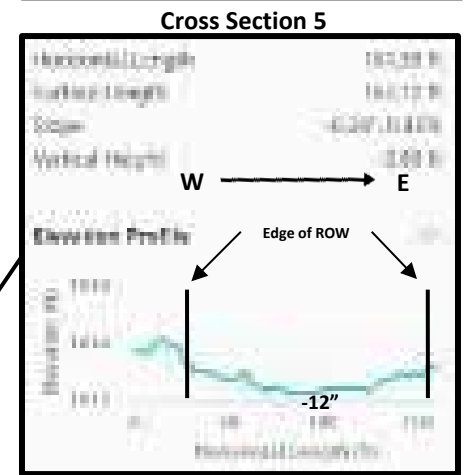
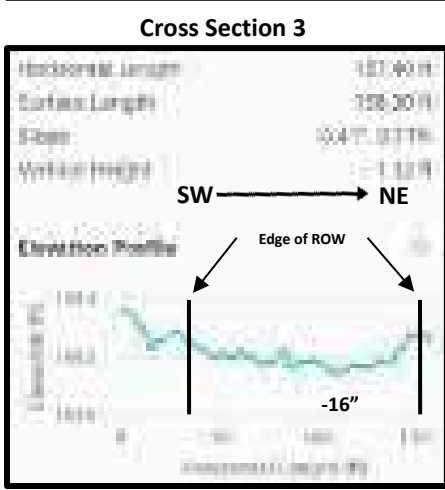
Cross Sectional Grade Evaluation for James McElvany Pertaining to Tract GR-0310.000.
Data Collected November 23, 2020.

**Easement is Mostly Bare.
Approximately 8% of the Easement is Vegetated.
Easement Appears Sunken Compared to Off-ROW.
Easement is Extremely Saturated and Muddy.**

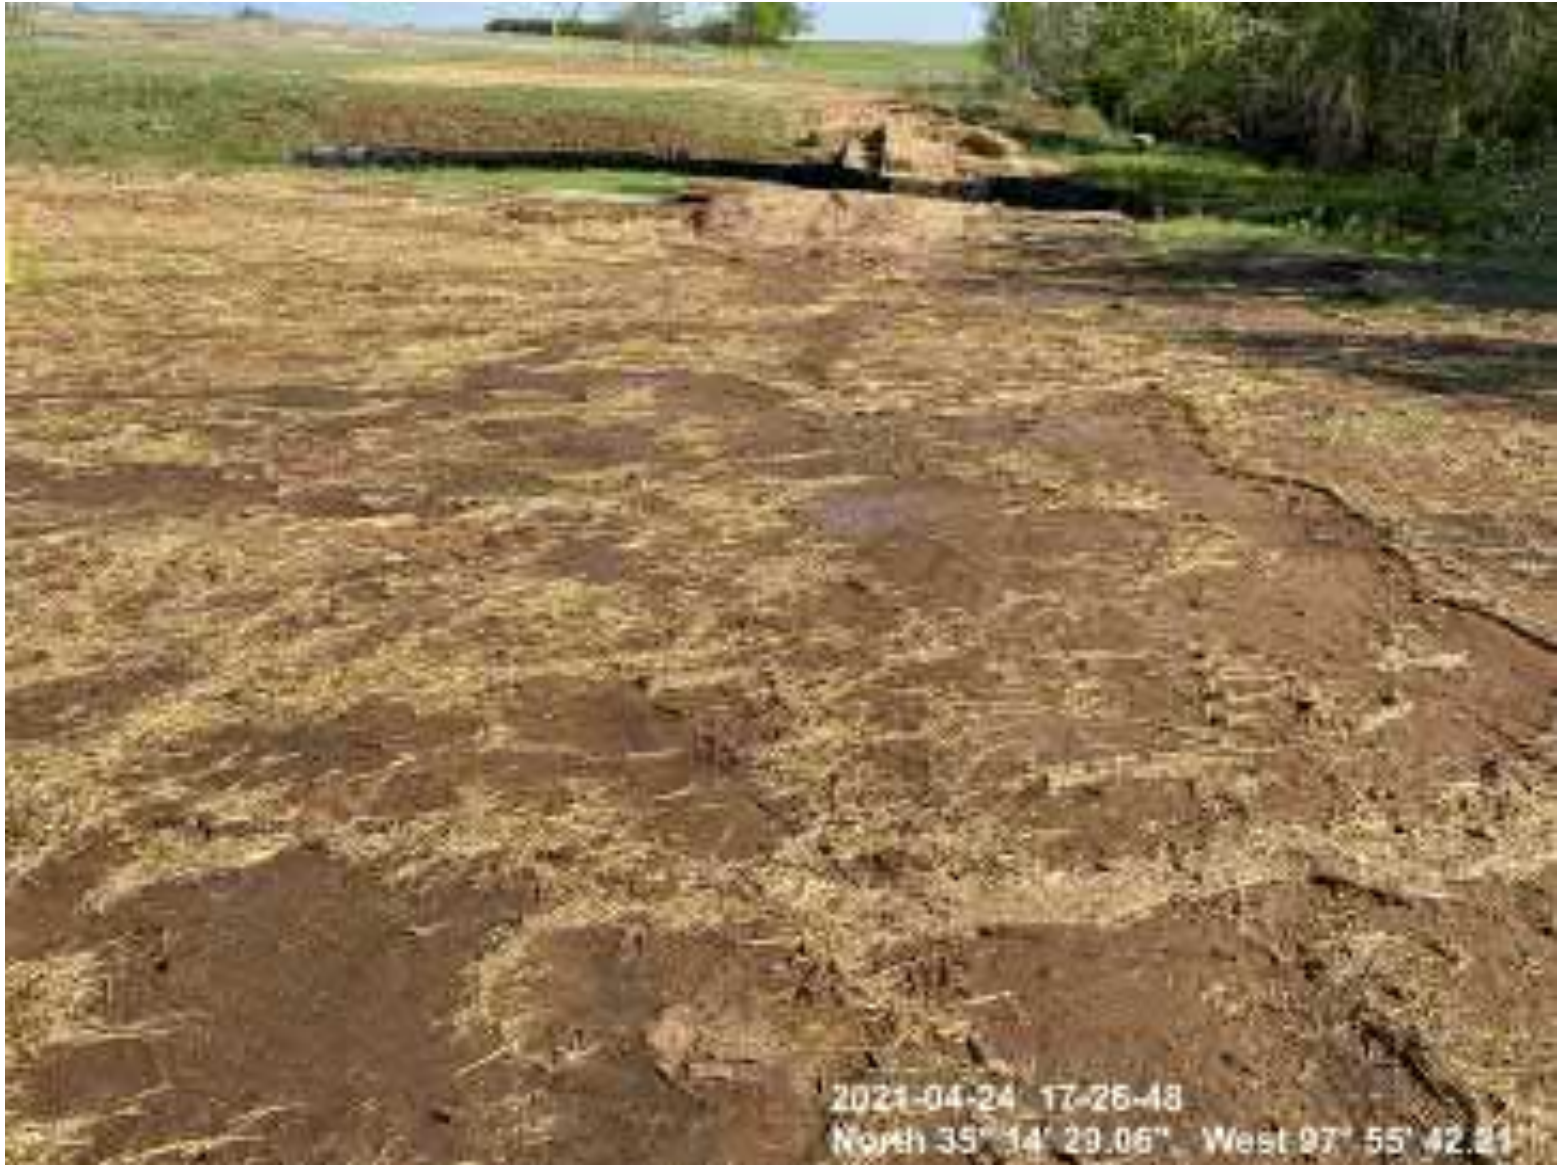
Erosion and Runoff Towards the Creek
