**OFFICE OF DEFECTS INVESTIGATION  
CALSPAN ON-SITE AIR BAG NON-DEPLOYMENT FATAL CRASH INVESTIGATION  
SCI CASE NO: CA09022**

**VEHICLE: 2005 CHEVROLET COBALT  
LOCATION: PENNSYLVANIA  
CRASH DATE: APRIL, 2009**

<i>16. Abstract</i> <p>This on-site investigation focused on the fatal air bag non-deployment crash of a 2005 Chevrolet Cobalt. The Chevrolet was involved in a severe head-on collision with a 2001 Hyundai Sonata that resulted in three fatalities. The 2005 Chevrolet Cobalt was equipped with dual-stage air bags for the driver and front right passenger positions that did not deploy in the crash. The vehicle's Event Data Recorder (EDR) was imaged during the SCI investigation and a non-deployment event was recovered. The driver air bag in the Hyundai Sonata deployed during the impact. The 73-year old unrestrained driver and the 13-year old unrestrained front right passenger of the Chevrolet and the 47-year old unrestrained driver of the Hyundai were all pronounced deceased at the crash site. A 12-month-old male was restrained in a forward facing convertible Child Restraint System (CRS) in the center rear position of the Chevrolet. The child sustained a critical cervical spine

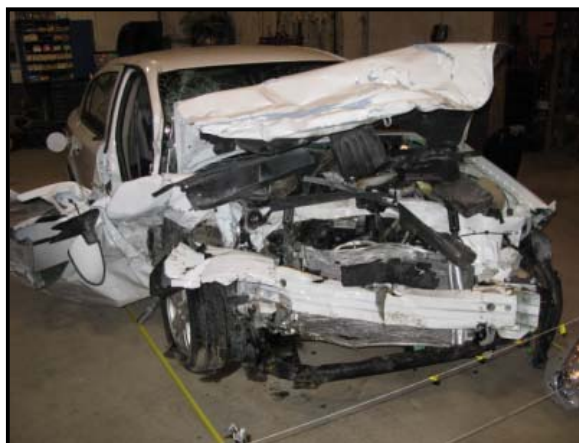
This on-site investigation focused on the fatal air bag non-deployment crash of a 2005 Chevrolet Cobalt (**Figure 1**). The Chevrolet was involved in a severe head-on collision with a 2001 Hyundai Sonata that resulted in three fatalities. The 2005 Chevrolet Cobalt was equipped with dual-stage air bags for the driver and front right passenger positions that did not deploy in the crash. The vehicle's Event Data Recorder (EDR) was imaged during the SCI investigation and a non-deployment event was recovered. The driver air bag in the Hyundai Sonata deployed during the impact. The 73-year old unrestrained driver and the 13-year old unrestrained front right passenger of the Chevrolet and the 47-year old unrestrained driver of the Hyundai were all pronounced deceased at the crash site. A 12-month-old male was restrained in a forward facing convertible Child Restraint System (CRS) in the center rear position of the Cobalt. The child sustained a critical cervical spine injury and was transported from the crash site to a pediatric trauma center via air ambulance.

**Figure 1: Front right oblique view of the Chevrolet.**

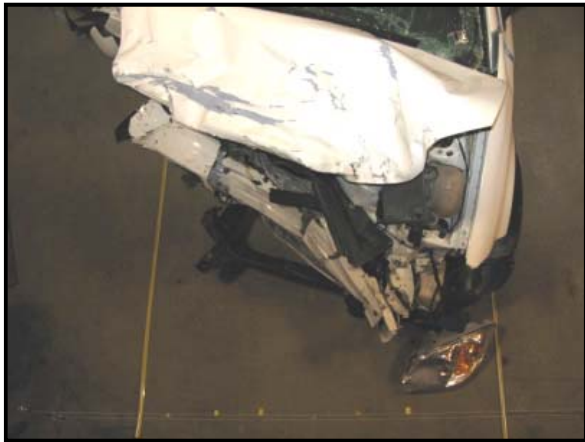
The 2005 Chevrolet Cobalt sustained severe damage from the off-set frontal collision with the Hyundai. **Figures 6 and 7** are an overhead and right side view of the deformation. The width of the direct contact damage measured 117 cm (46.1 in). The direct contact began 51 cm (20.1 in) left of center and extended to the right corner. The combined direct and induced damage extended across the entire 132 cm (52.0 in) end width. The damage pattern was biased to the right indicative of the offset impact configuration and the evasive left steering by the Chevrolet's driver. The damaged components included but were not limited to the front bumper fascia, bumper reinforcement beam, upper and lower radiator supports, headlight assemblies, fenders, right A-pillar, and the right front suspension components. As the vehicles crushed, the right wheel was displaced rearward into the wheelhouse and right cowl. The wheel rim fractured.

The right A-pillar was deformed rearward 40 cm (15.8 in) and the lower third of the pillar deformed to a vertical orientation. The front right door was compressed 19 cm (7.5 in) and buckled outboard. The right roof side rail was buckled to the right B-pillar location. The upper aspect of right front shock absorber tower deformed rearward 53 cm (21.0 in). The right wheelbase was reduced 41 cm (16.1 in). The left wheelbase lengthened by 8 cm (3.1 in) due to body distortion of the Cobalt. The residual crush profile documented along the bumper reinforcement was as follows: C1 = 7 cm (2.8 in), C2 = 40 cm (15.7 in), C3 = 73 cm (28.7 in), C4 = 81 cm (31.9 in), C5 = 89 cm (35.0 in), C6 = 79 cm (31.1 in). The maximum crush was 89 cm (35.0 in) at C5. The left front and right side doors were jammed closed by the impact. The left front and right front doors were opened by rescue personnel evidenced by extrication damage to the respective B-pillar areas. The right rear door compressed rearward and overlapped the quarter panel and C-pillar. The maximum overlap measured 2 cm (1 in). The windshield was fractured and the right front door glazing disintegrated during the crash. The left side, backlight, and right rear door glazing were intact. The Collision Deformation Classification (CDC) of the Cobalt was 12-FDEW5.

**Figure 6: Overhead view of the Cobalt's frontal damage.**

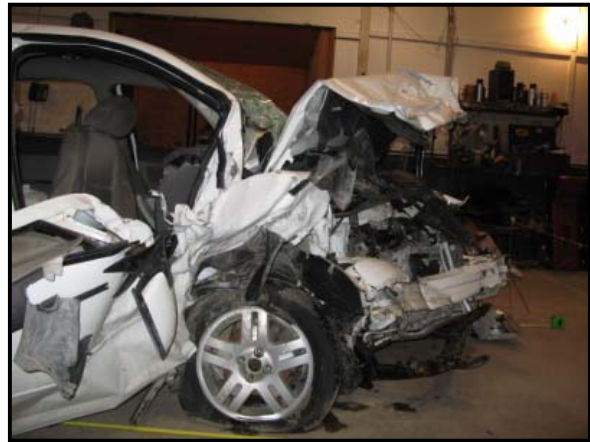
**Figure 7: Right lateral view of the frontal damage.**

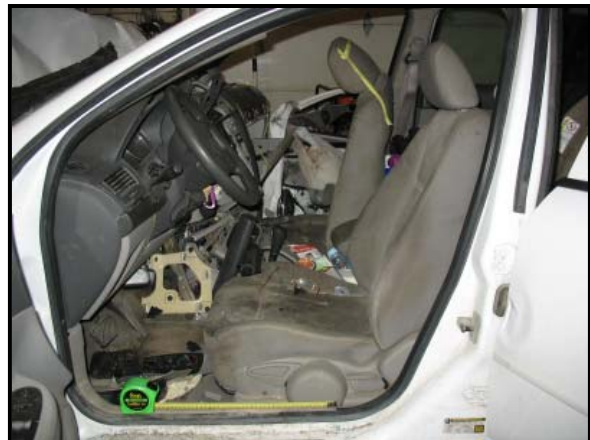
The interior of the Chevrolet sustained severe center and right frontal intrusion as a result of the exterior crash force. The unrestrained Row 1 occupants translated forward and contacted the vehicle's interior forward of their respective seat positions in response to the frontal impact force. This pattern was evidenced by multiple occupant contact points. **Figure 8** is a left lateral view of the front interior.

**Figure 8: Left lateral view of the front interior.**

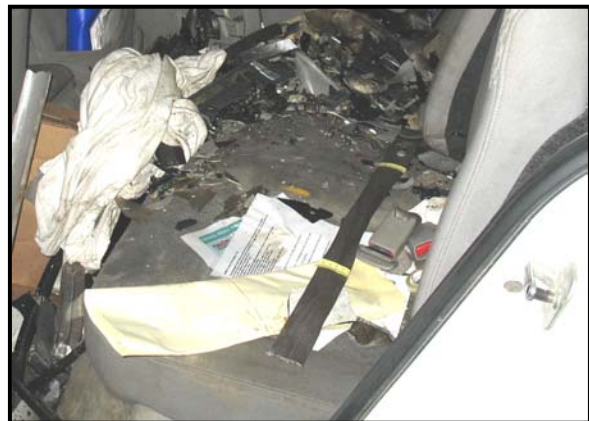
The three rear belt systems utilized switchable ELR/ALR retractors. The rear center safety belt was used to install the convertible CRS in the forward facing mode. The lap and shoulder belt webbing was routed through the forward facing belt path of the child safety seat. The webbing was cut post-crash by rescue personnel in order to remove the seat. The cut section of the belt webbing measured 77 cm (30.3 in), **Figure 10**. The balance of the webbing had spooled back into the retractor. The cut webbing contained a 45 cm (17.7 in) section that was loaded from its interaction with the belt path of the CRS. The loading began 13 cm (5.1 in) above the seat bight. The latch plate was found fastened in the center rear buckle. Extensive frictional abrasions were noted to both sides of the latch plate friction surface. These abrasions occurred as a result of the CRS loading of the webbing during the crash event. Refer to the *Child Restraint System* section of this report regarding further information regarding the use of the CRS.

**Figure 10: View of the center rear safety belt.**

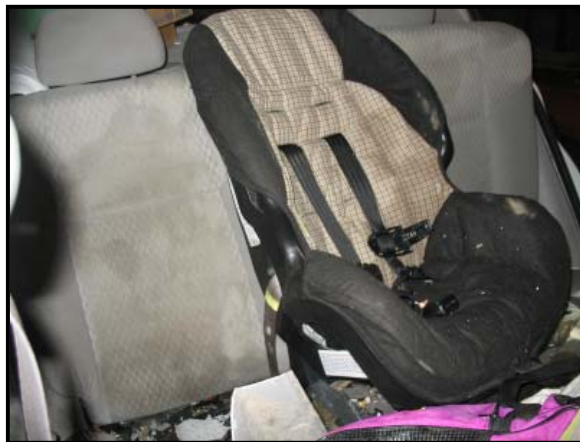
The 12-month-old male child was restrained by the five-point harness system of a Cosco Scenera S convertible CRS in the second row center position of the Cobalt, **Figure 11**. The CRS was restrained to the vehicle by the center three-point belt webbing routed through the forward facing belt path. The adjustable foot was in the extended position for forward facing use.

**Figure 11: View of the Cosco CRS.**

The shell was designed with four slots for adjustment of the harness straps. The straps were positioned in the second row from the top. The left strap was twisted one turn and the strap was roped in the chest retainer clip and left buckle. There was no residual evidence of loading to the harness. The chest retainer clip and buckle were operational. Examination of the upper shell was unremarkable for damage. Minor abrasions from interaction with the vehicle's safety belt were noted adjacent to the slot of the forward facing belt path.

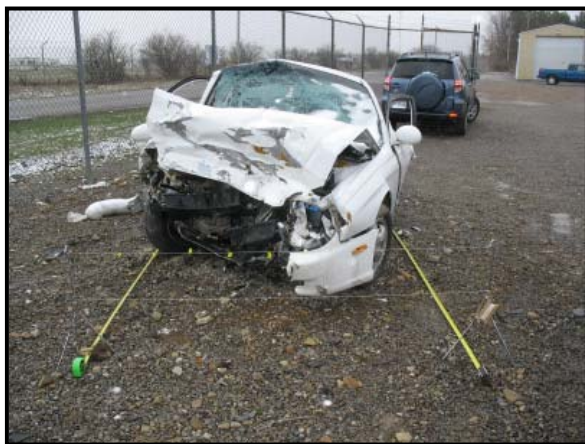
The 2001 Hyundai Sonata sustained severe frontal damage as a result of the impact with the Chevrolet (**Figures 12 and 13**). The width of the direct damage extended across the entire 147 cm (58 in) frontal end width of the Sonata. The right bias of the impact and extent of crush deformed the left front corner 23 cm (9 in) to the right. The bumper reinforcement and forward components deformed into the engine compartment. The front right wheel assembly crushed rearward into the lower A-pillar. The upper aspect of the A-pillar deformed and was near vertical. The rake angle measured 80 degrees from horizontal. The roof was buckled vertically above the front right position. The rake angle of the undeformed left upper A-pillar measured 35 degrees. The rearward displacement of the right upper shock absorber tower measured 65 cm (25.6 in). The left upper shock tower was displaced 10 cm (4.1 in). The residual frontal crush documented along the bumper reinforcement was as follows: C1 = 46 cm (18.1 in), C2 = 86 cm (33.9 in), C3 = 94 cm (37.0 in), C4 = 104 cm (40.9 in), C5 = 117 cm (46.1 in), C6 = 110 cm (43.3 in). The maximum crush was 117 cm (46.1 in) at C5. The right wheelbase was reduced 86 cm (33.8 in). The left wheelbase was reduced 12 cm (4.7 in). The front right door crushed 48 cm (19 in), bowed outboard and was jammed closed. The right rear door and the left doors remained closed during the impact. These were opened by the first responders and could not be relatched due to body deformation. The windshield was fractured. The front left and front right glazings disintegrated. The rear left, backlight and rear right glazings were intact. The CDC of the Hyundai was 12-FDEW5.

**Figure 12: Front view of the Hyundai.**

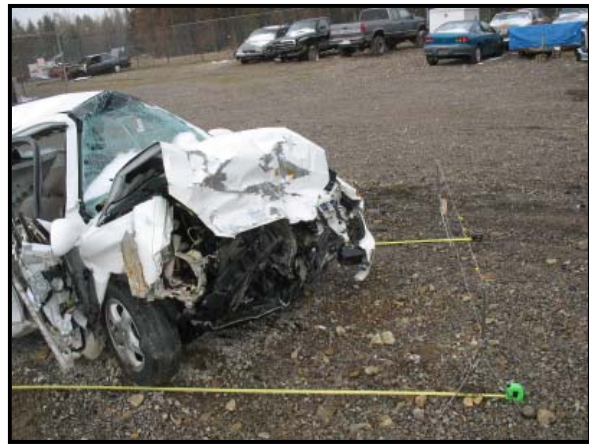
**Figure 13: Right lateral view of the frontal deformation.**

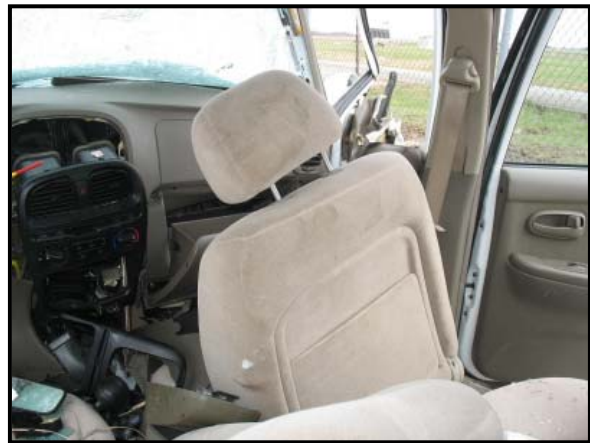
The interior of the Hyundai sustained severe right side intrusion. **Figure 14** is a right lateral view across Row 1. The right floor pan deformed and buckled vertically. The tow pan was crushed rearward to the leading edge of the front right seat cushion. The intrusion of the right instrument panel measured 51 cm (20 in). The horizontal distance from the front right seat back to the face of the instrument panel measured (17 in). The right floor pan deformed due to the extent of frontal crush. The floor pan deformation resulted in the inboard displacement of the front right seat relative to its original location. The upper aspect of the front right seat back and head restraint rotated inboard approximately 30 cm (12 in). The front right head restraint was raised at the time of the crash. The outboard aspect of the head restraint was raised 5 cm (2 in). However, the inboard aspect of the head was raised approximately 4 cm (1.5 in). The inboard aspect was lower due to a possible rebound head contact by the driver (**Figure 15**).

**Figure 15: View of the Hyundai's front right head restraint.**

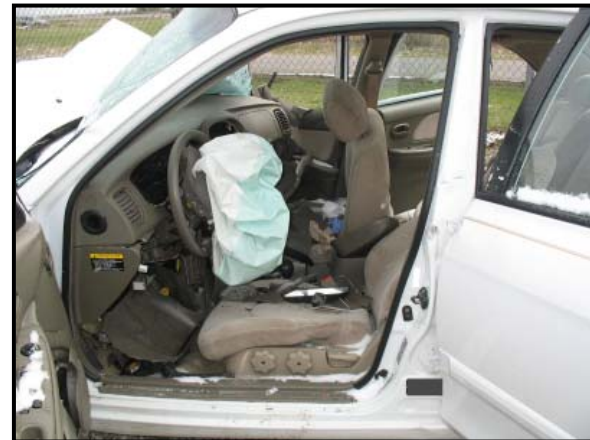
**Figure 16** is a left lateral view of the driver compartment. The driver seat was adjusted to a full rear track position. The seat cushion was deformed vertically downward from driver loading. The seat back was reclined 45 degrees at the time of the SCI inspection and appeared to have been moved to that position by the first responders. The center aspect of the toe pan intruded to the brake pedal, an estimated 10 cm (4 in). There was no left instrument panel intrusion.

**Figure 16: Left lateral view of the Hyundai's intrusion.**
