**From:** Raymond DeGiorgio  
**To:** Joseph Joshua  
**CC:** Arnaud Dessirieux; David M. Trush  
**BCC:**  
**Sent Date:** 2005-03-07 14:59:03:000  
**Received Date:** 2005-03-07 14:59:07:000  
**Subject:** Re:Torque Study ----- X001 Ign Cylinder rotation effort  
**Attachments:** GMX001 Lock Module Detent in RUN 20050216.ppt

# GMX001 Lock Module Detent in RUN

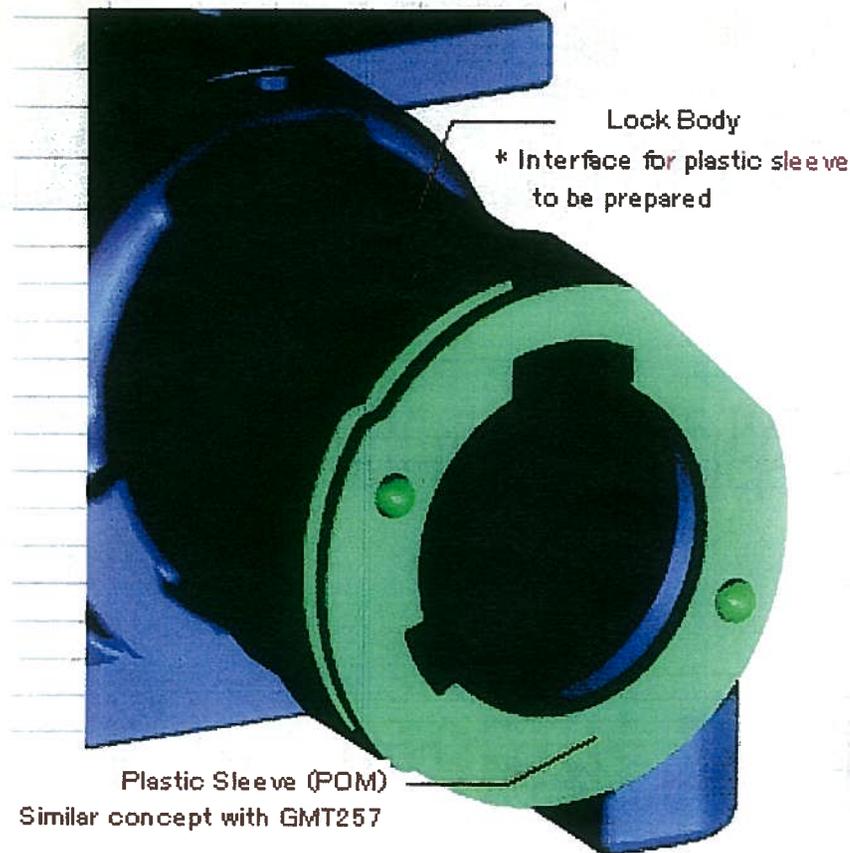
- Adding a plastic sleeve to the lock housing-lock cylinder interface:

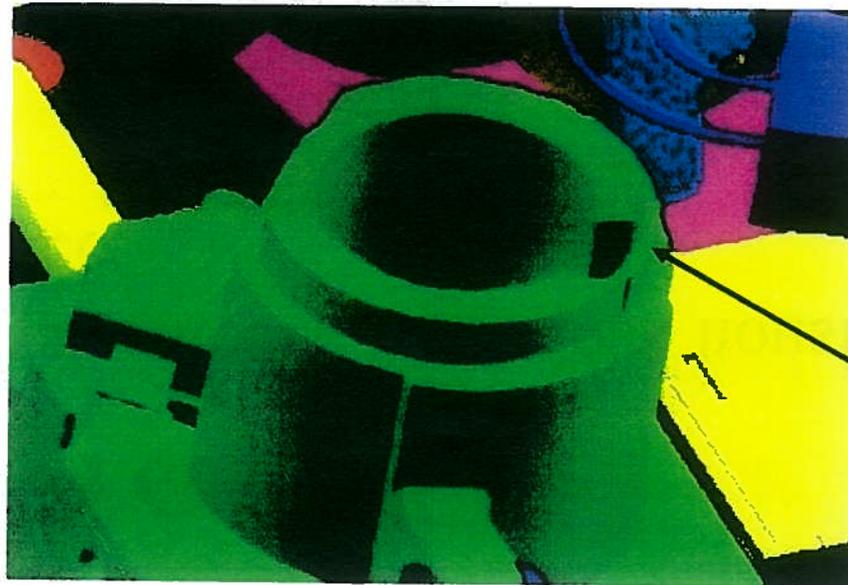
- Main concern with trimming of the lock housing to accommodate plastic sleeve

Material thickness  
creates concern for  
GMX001 lock hosing

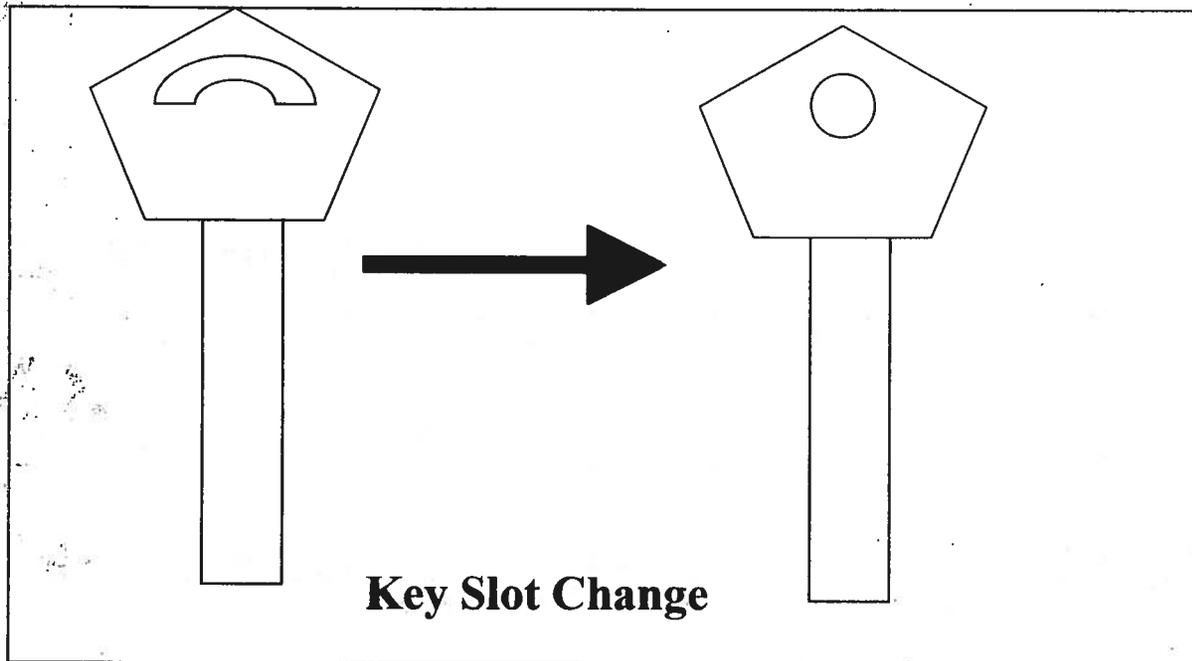
- Changing the slot in the key in order to reduce lever arm and thus the torque:

- It was determined that the lever arm still present due to the fob ring.
