2005-7 Cobalt Airbag Presentation

ISR Presentation for 11/5/13

GMX351 HVAC Faceplate / Defrost (N130380) Janik
2013 SRX rear seat entertainment Baron
SRX Spare Wheel Marking Voyt
Cobalt/Ion/HHR Potential Airbag Non Deploy Stouffer

2005-7 Cobalt, G5, Pursuit, 2003-2007 Ion, 2006-2007 HHR

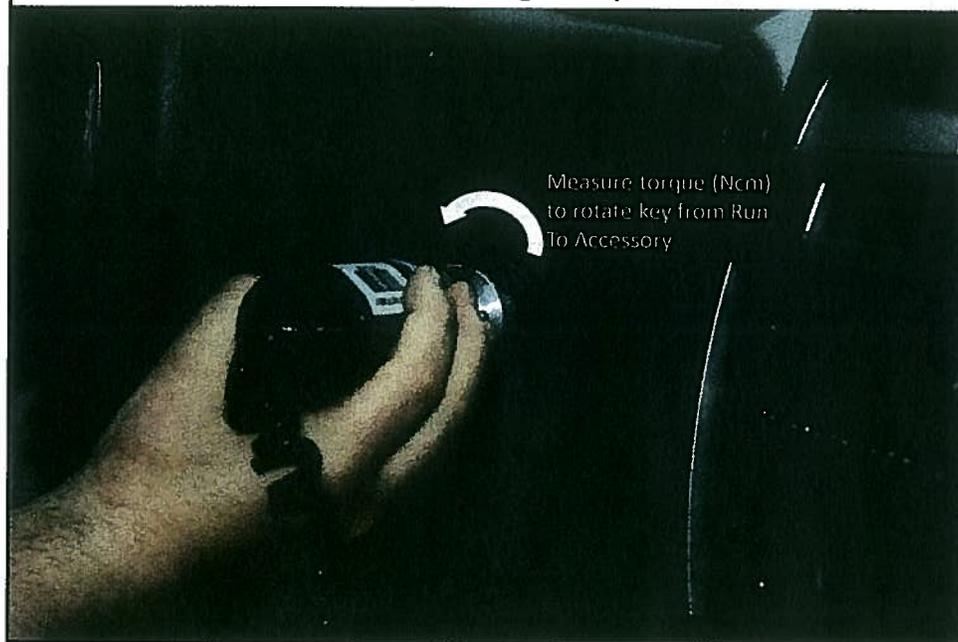
Test Set-up Using Torque Tool

- 5/22/12 44 vehicles in Davison salvage yard
 - Measured torque (Ncm) and force (N) to turn the ignition switch from Run to Accessory.
 - Five of the vehicles had a replacement key, or a key with a hole vs slot (force not measured)

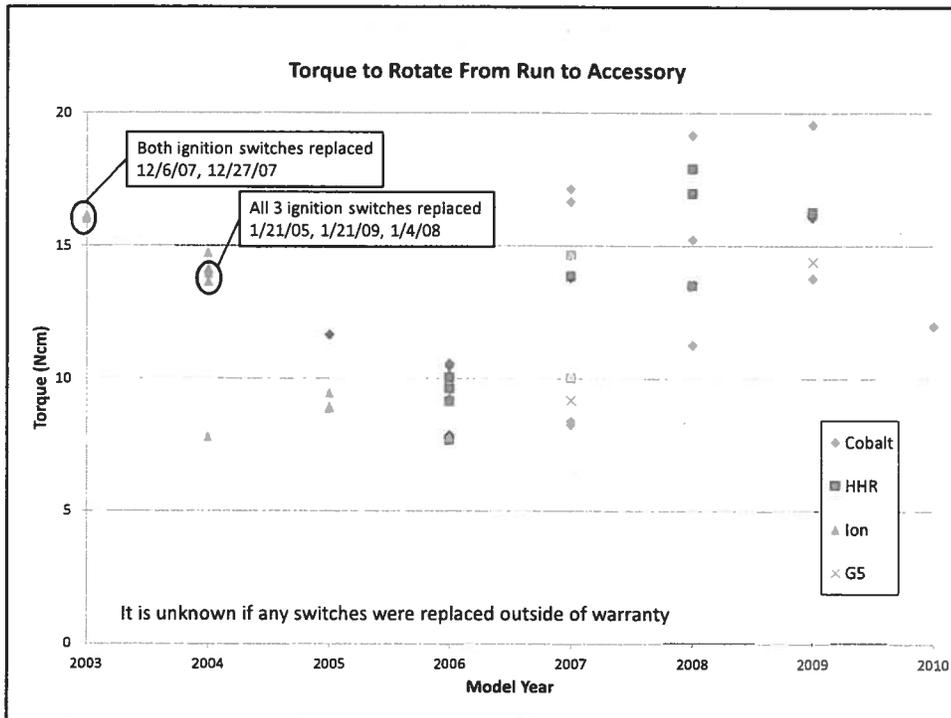
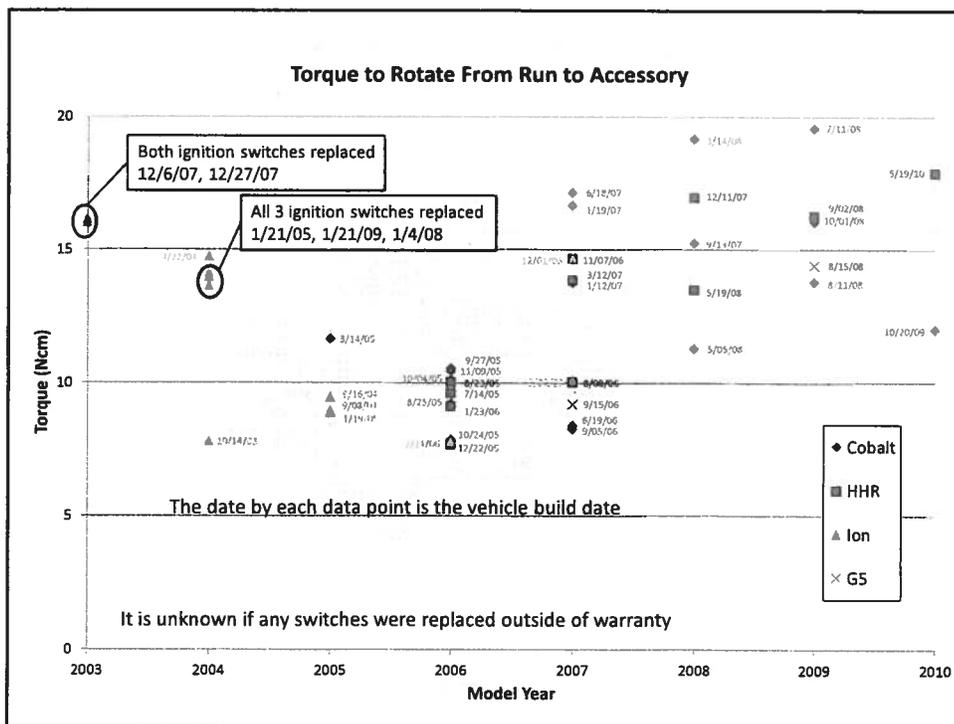
Measure torque (Ncm)
to rotate key from Run
To Accessory

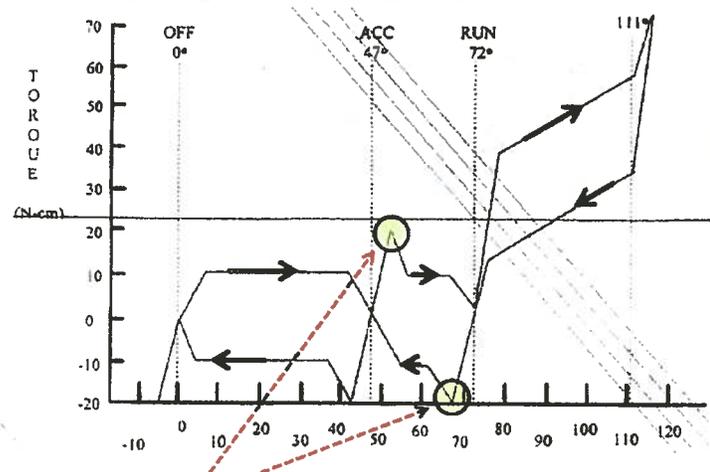
Switch Torque vs Rotation Specification

- 20 +/- 5 N-cm specification for
- Acc → Run
 - Run → Acc
