U.S. Department of Energy Office of Environmental Management

Accident Investigation Report

Underground Salt Haul Truck Fire at the Waste Isolation Pilot Plant February 5, 2014

March 2014

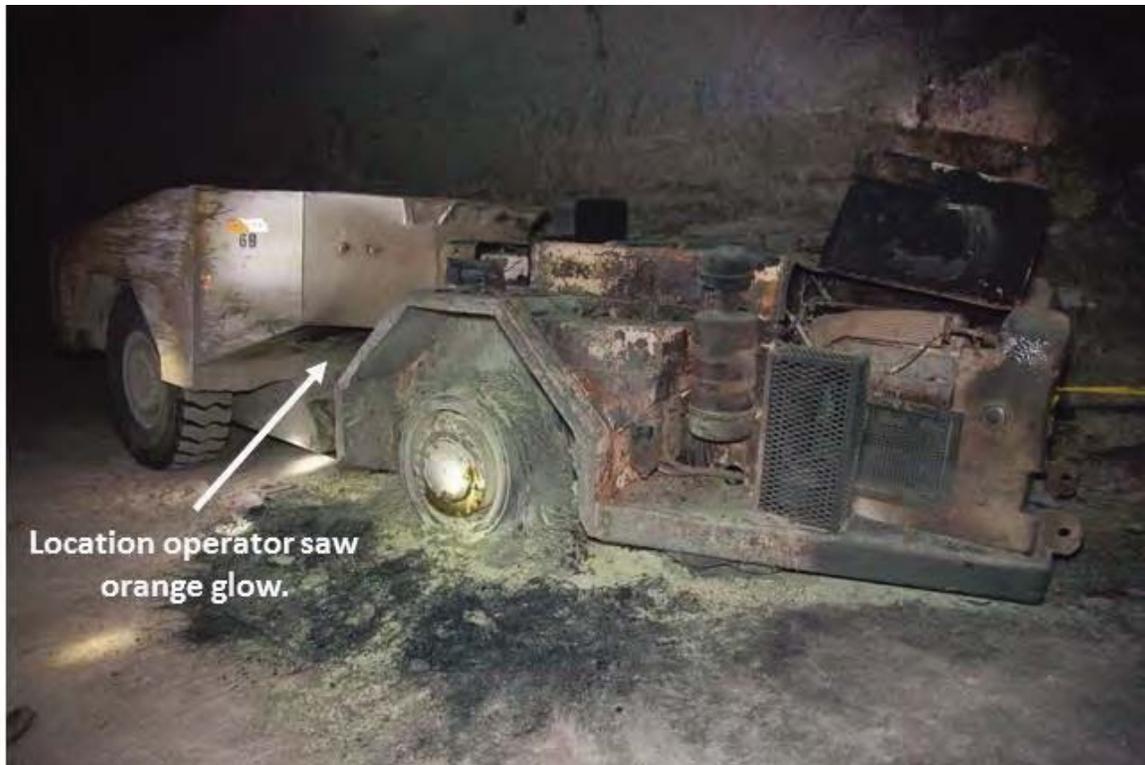
Figure ES-1: EIMCO Haul Truck 74-U-006B after Fire

The fire is believed to have originated in the truck's engine compartment and involved hydraulic fluid and/or diesel fuel which contacted hot surfaces on the truck, possibly the catalytic converter, and then ignited. The fire burned the engine compartment and consumed the front tires which contributed significantly to the amount of smoke and soot in the underground.

The Operator had just unloaded salt from the truck at approximately 1045 Mountain Standard Time (MST) when he noticed an orange glow and then flames between the engine and the dump sections of the truck (see Figure ES-1). The Operator attempted to extinguish the fire with a portable fire extinguisher stored on the truck and then by activating the salt haul truck's fire suppression system. Both attempts to extinguish the fire were unsuccessful. The Operator then used a mine phone to notify Maintenance of the fire, and his Supervisor overheard the conversation over a nearby mine phone, which can also be heard throughout the underground. Two nearby workers heard the discussion on the mine phone and, based on the urgency of the Operator's voice, went to the scene to see if they could assist. They began pushing a nearby 300-pound fire extinguisher to the fire when their carbon monoxide monitor alarmed and the smoke worsened. One of the workers called the Central Monitoring Room (CMR) to report the fire and smoke, and recommended evacuation of the underground.

The Board identified the direct cause of this accident to be contact between flammable fluids (either hydraulic fluid or diesel fuel) and hot surfaces (most likely the catalytic converter) on the salt haul truck, which resulted in a fire that consumed the engine compartment and two front tires.
