## Accident Investigation Report

## Phase 1

### Radiological Release Event at the Waste Isolation Pilot Plant on February 14, 2014

April 2014

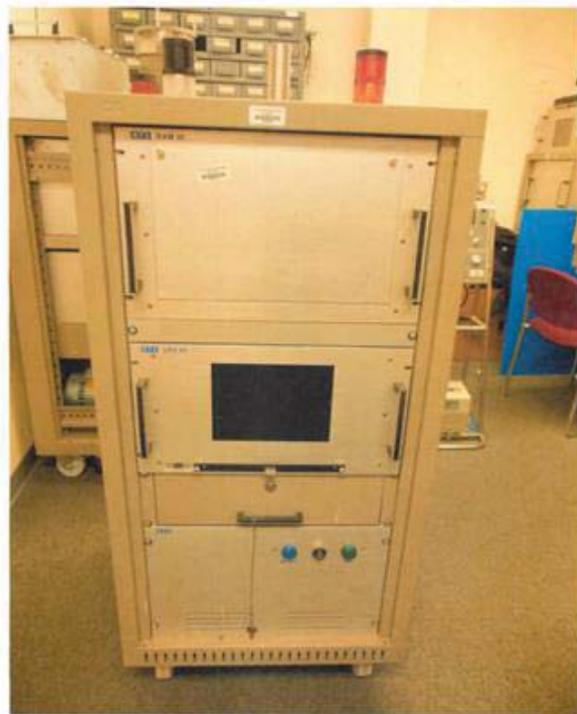
**Figure ES-1: RADOS Continuous Air Monitor**

The underground ventilation system (UVS) automatically switched to HEPA filtration mode when the airborne radiation alarmed the CAM and the 860 fan vortex damper was manually opened and adjusted to achieve designated airflow. This directed contaminated air from the U/G up through

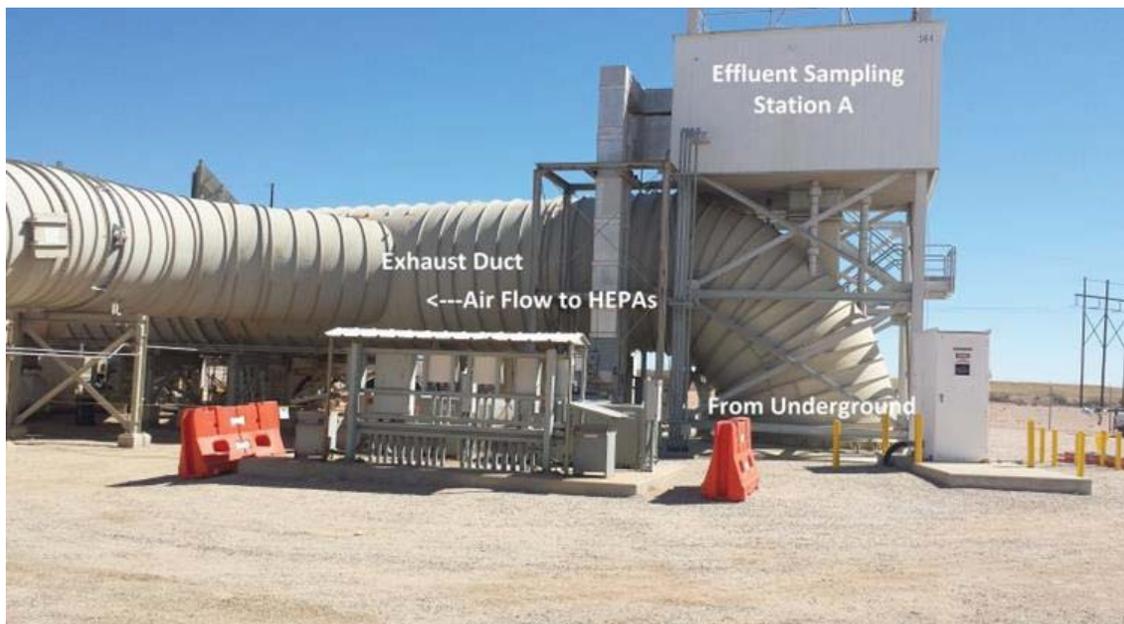
**Figure ES-2: Exhaust Air Shaft and Effluent Sample Station A**

On Saturday, February 15, 2014, the filters were counted at 0715; the RCM reported 4.4 million disintegrations per minute (dpm) alpha contamination on the filters from the effluent sample station upstream from the HEPA filters (Station A) (Figure ES-2). Preliminary data indicated the presence of TRU materials.

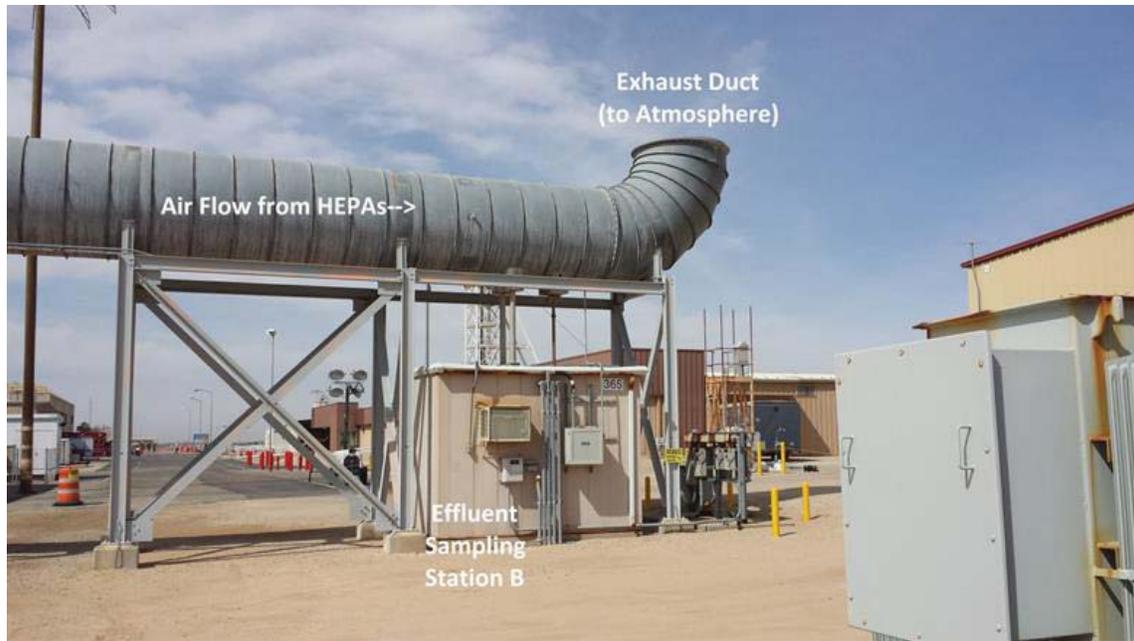
**Figure ES-3: Station B and Exhaust Duct**

Results from analysis of filters from the effluent sample station downstream of the HEPA filters (Station B) and at the discharge point to the atmosphere (Figure ES-3) were reported at 0915 and indicated 28,000 dpm alpha and 5,900 dpm beta contamination. This was the first indication that there was a release of contamination downstream of the HEPA filters to the environment.
