MITA[®]
MEDICAL IMAGING
& TECHNOLOGY ALLIANCE
A DIVISION OF **NEMA**[®]

STATEMENT

JOE ROBINSON

“Examining Improvements to the Regulation of Medical Technologies”

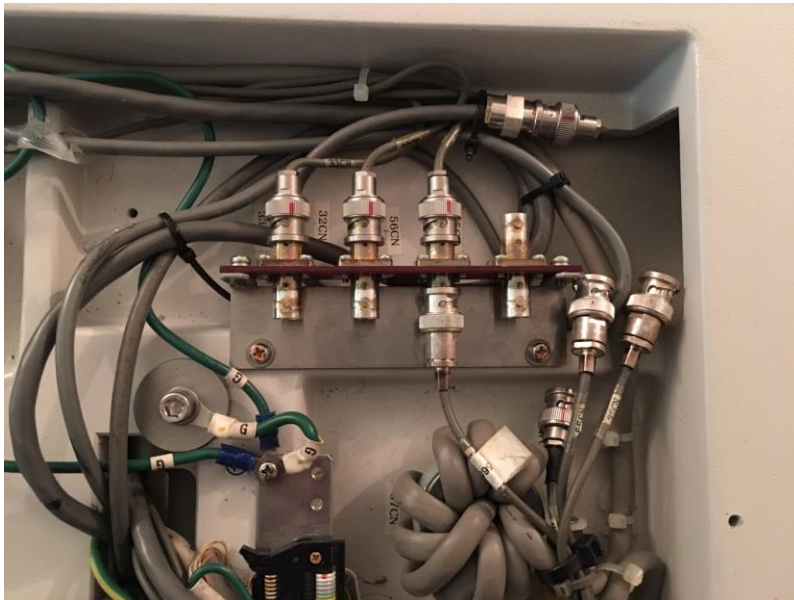
Receive Channels Disconnected

This MRI system includes four receive channels from the coils used to scan different portions of the anatomy. As shown in this photo, three of the four channels were disconnected because they were nonfunctional. Troubleshooting showed all three other were open and the fourth connected line was also compromised with readings that were outside of specification.

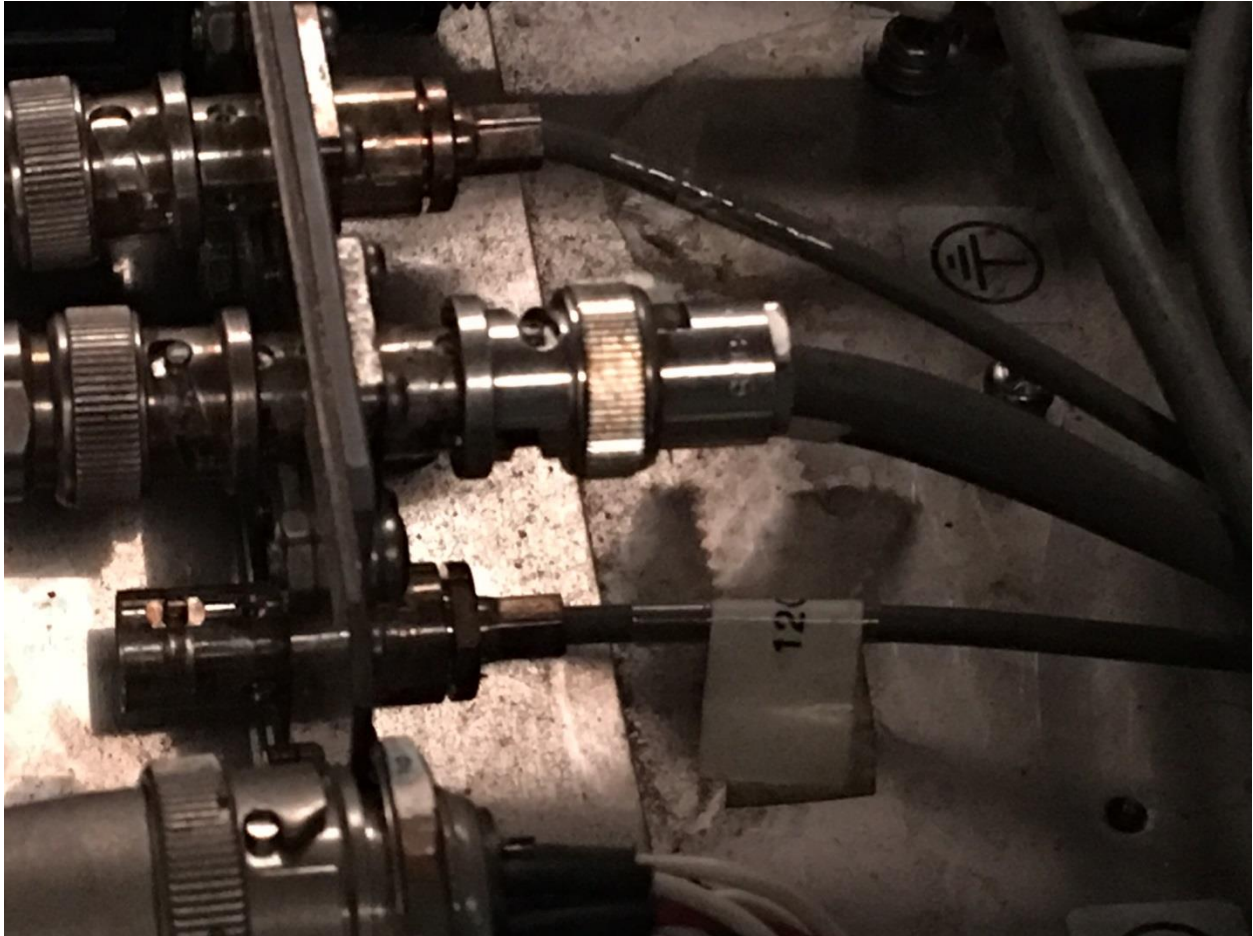
Incorrect Cable Replacement

At the foot of the patient table one of the 4 receive cables (the only remaining functional) was replaced with the incorrect cable. The incorrect cable is the larger diameter cable the center of the photo.

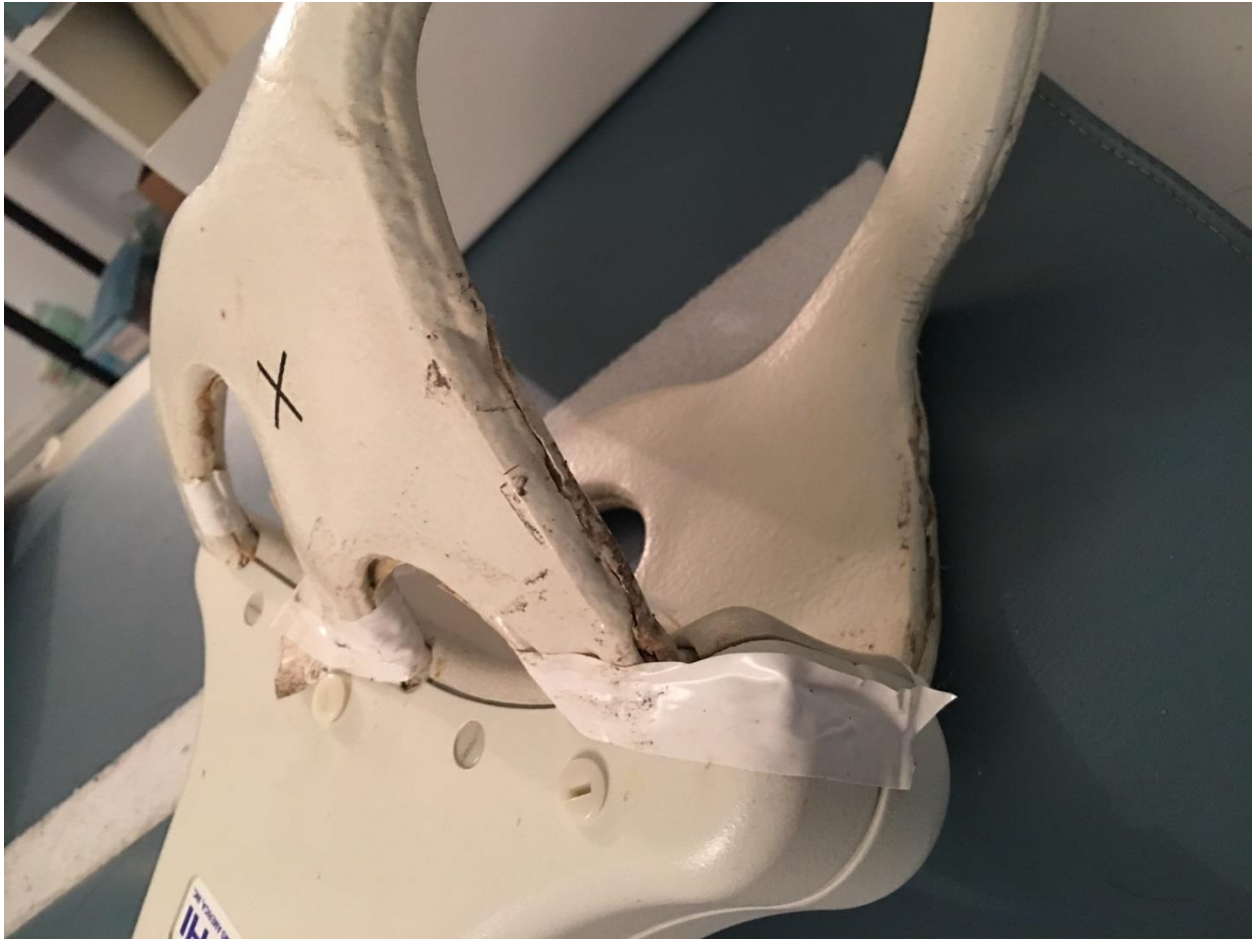
Shoulder Coil Serviced With Tape

The shoulder coil was found damaged with several attempted repairs using a white tape. The use of tape would prevent proper cleaning of the coil. The coil failed to meet specification when tested.

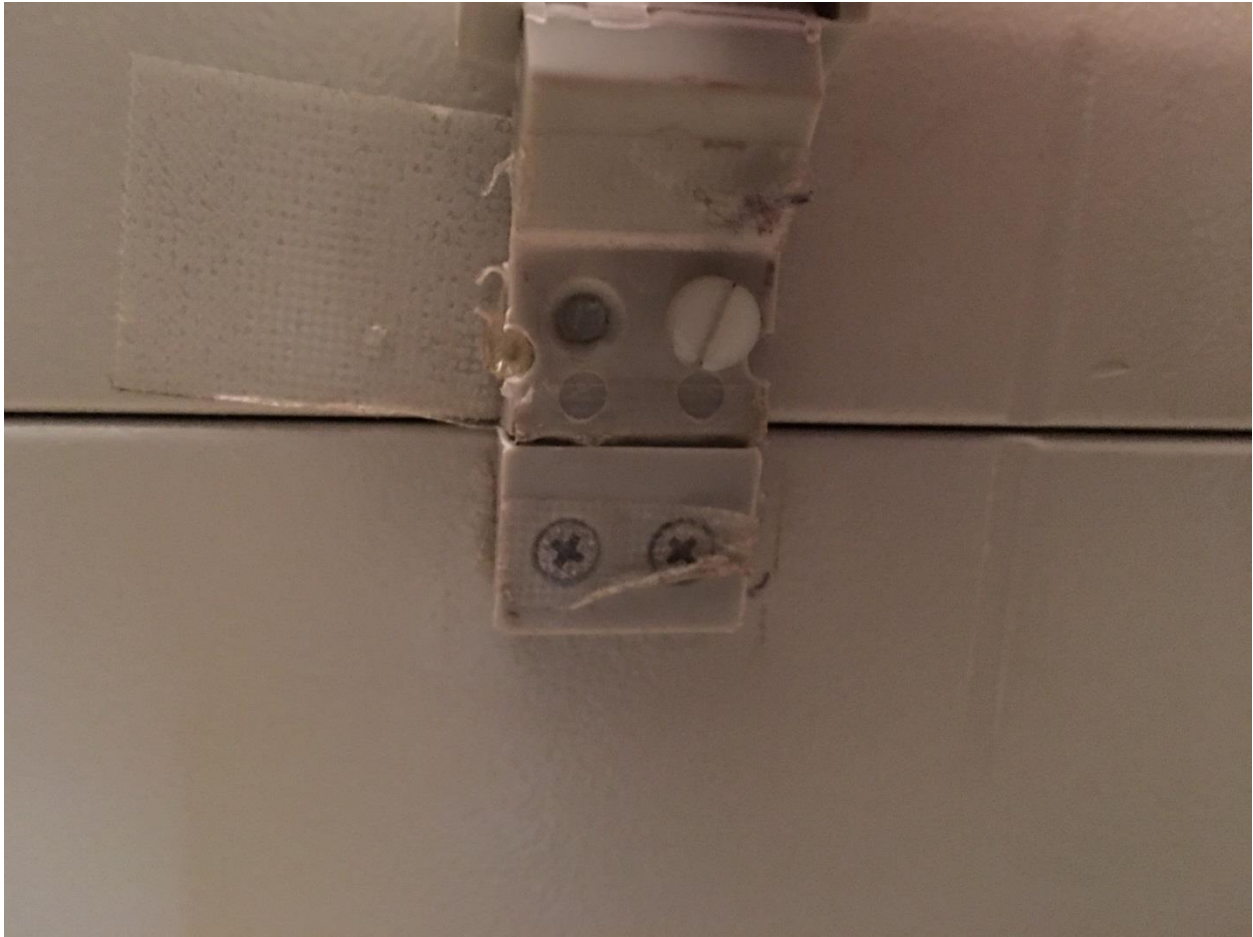
Head Coil Latch Damaged and Non Functional

The screw holes on both sides of the coil latch were stripped out. Repairs were attempted with incorrectly sized screws and tape. The top portion of the coil could not be properly secured to assure a good connection of the receive lines in the top portion of the coil.

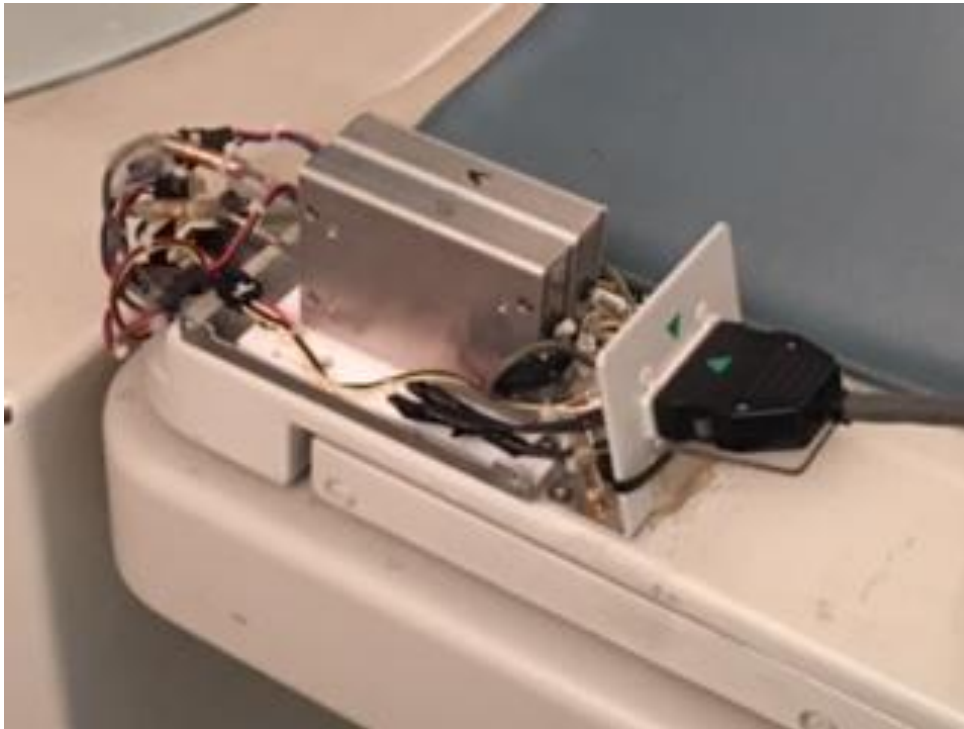
Missing Signal Amplifiers

The patient table is equipped with 4 pre-amps. The manufacturer found two of the pre-amps were missing from the system and had not been replaced.

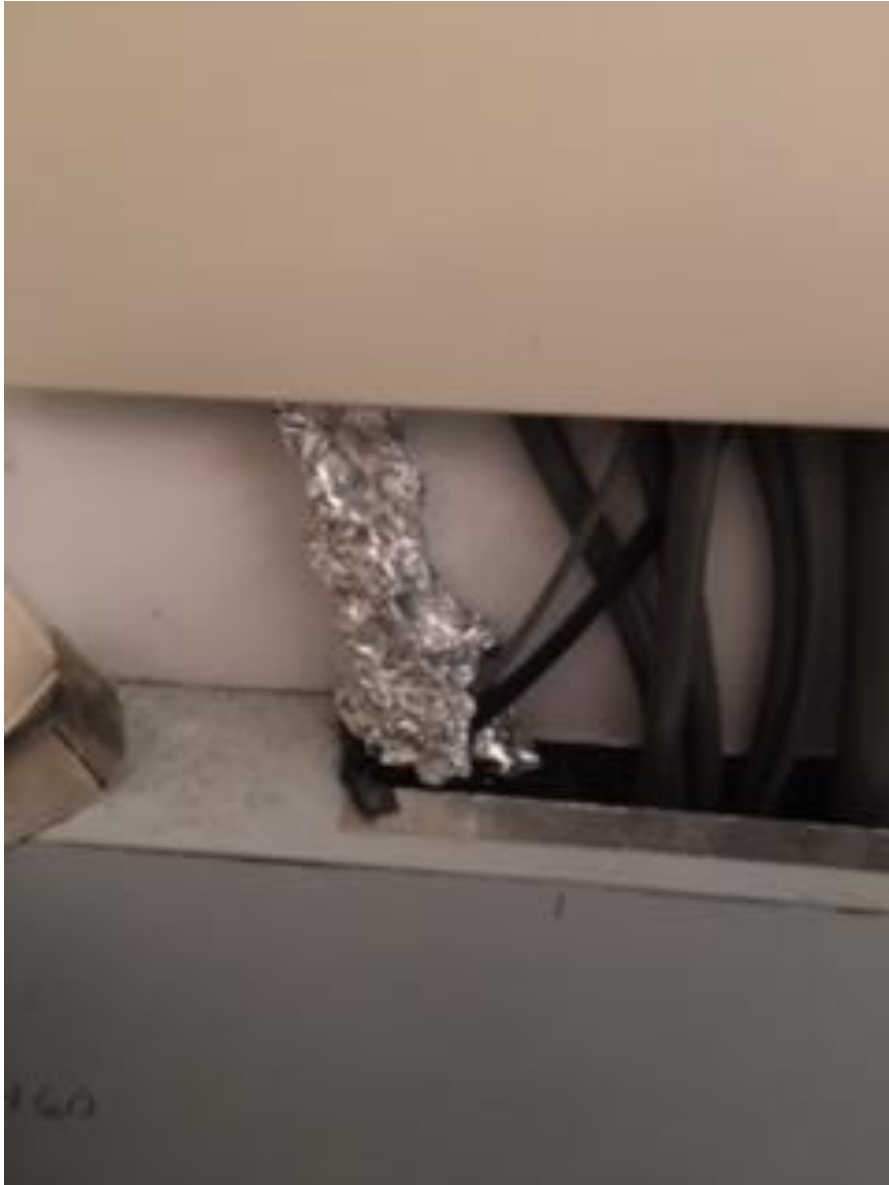
Aluminum Foil Used for Shielding

The manufacturer found aluminum foil used to shield some of the cables in the scan room. It is believed this was an effort to shield the receive cables to correct poor signal and artifacts in the images. This can present safety and electrical issues when used within the MRI filter panel that contains high voltage.

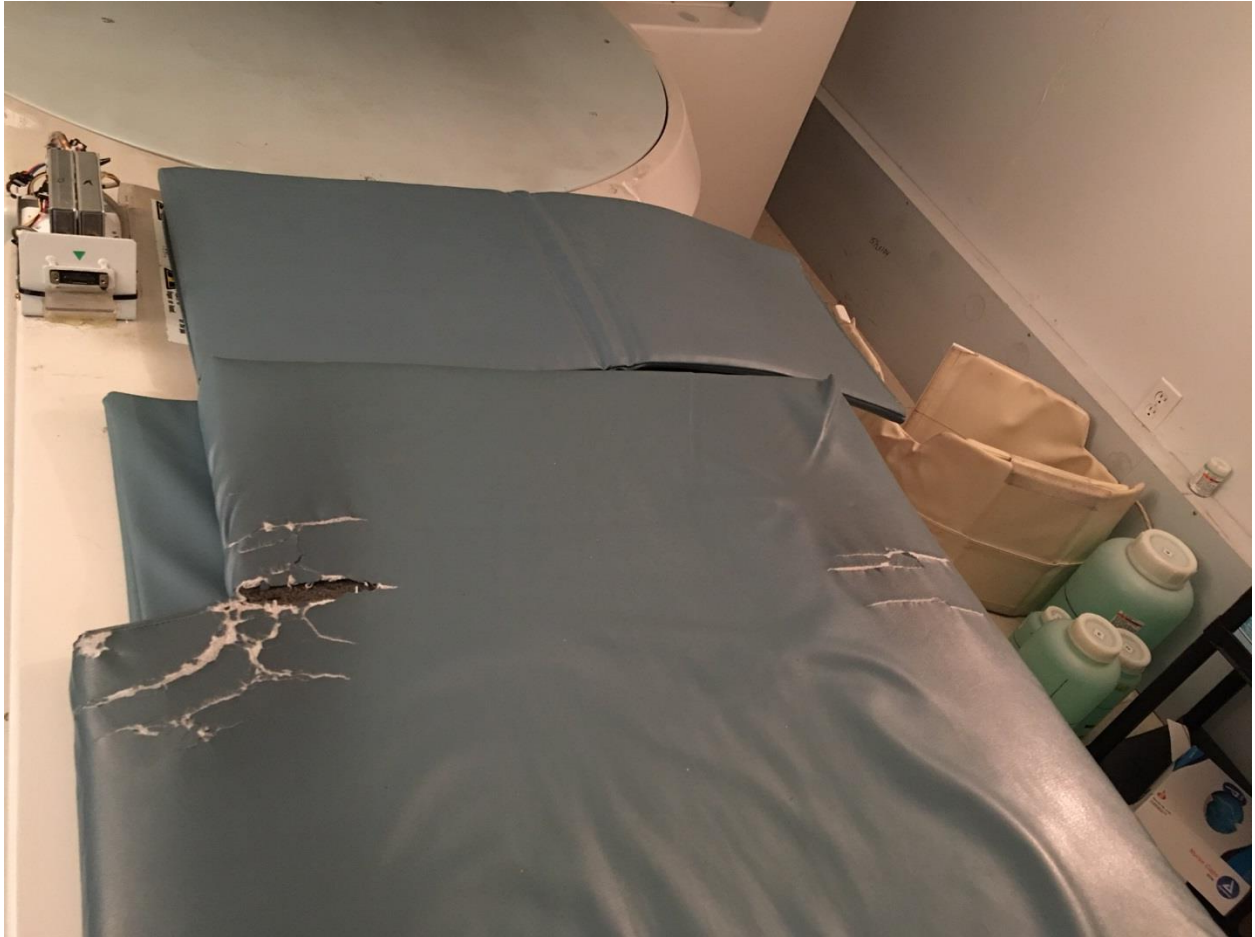
Patient Table Pads Damaged

The patient table pads were damaged and should be replaced to allow for proper cleaning.

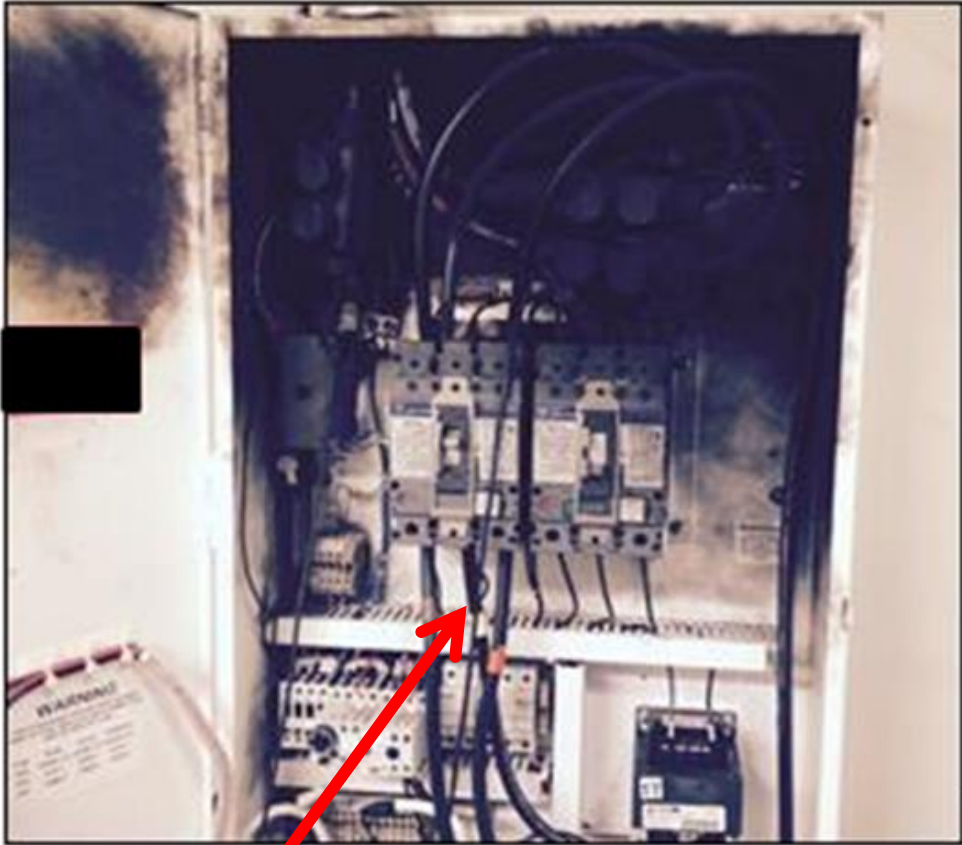
Panel where arc flash occurred

A third party service sub-contractor hired by an onsite contractor was working at a customer site troubleshooting an MRI system. The servicer was working in the service panel with the power on when an arc flash occurred resulting in burns to the contractor. The blast knocked him back and onto the floor. Other people working in the area said the event sounded like an explosion. The event also resulted in approximately half of the hospital losing power.

It is not known with total certainty what the servicer was doing at the time of the event or what caused the event to occur. He was going to be hooking up a power monitor to the system, but at what stage of that process he was at is unknown. He could have been checking the voltages prior to connecting the monitor or performing some other troubleshooting activity.

It is known, however, that he did not have on his Arc Flash Personal Protection Equipment (PPE) at the time of the event. The PPE itself would not have prevented the incident from occurring, but it would have prevented or lessened the severity of the injuries that occurred. This is potentially an example of inadequate training and non-compliance which resulted in bodily harm, equipment damage, and loss of power to the hospital.

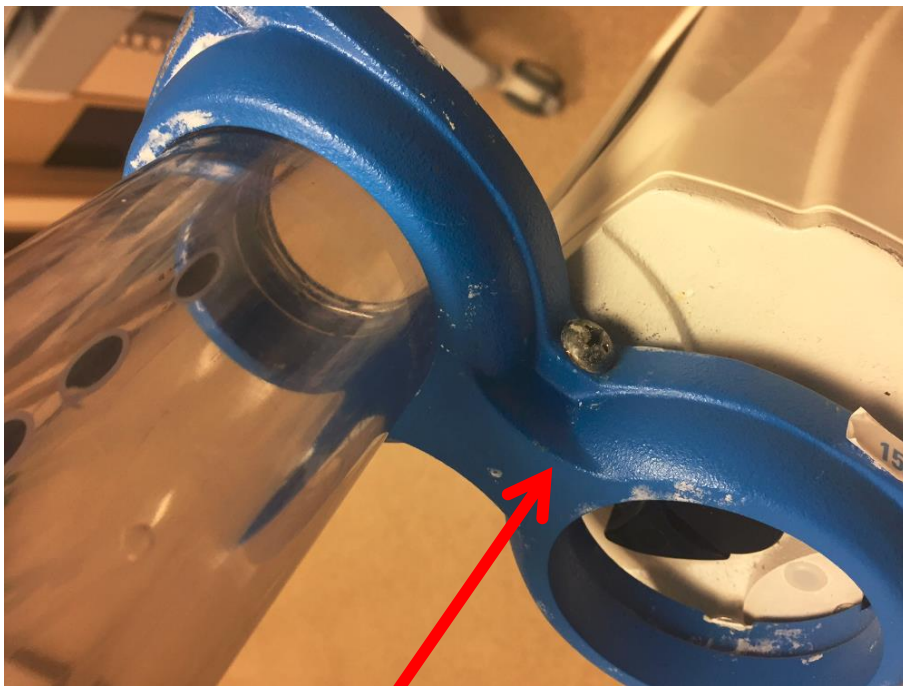
During a recent service call for an angiographic power injector, it was observed that a third-party service vendor inappropriately substituted an original equipment manufacturer's steel pin with a simple sheet metal screw to hold a syringe turret in place.

Angiographic power injectors of this class can inject fluid at pressures of up to 1200 psi. If this substituted sheet metal screw were to break or otherwise fail during a procedure, the turret could break free, potentially causing the turret and connected syringe to act as dangerous projectiles. Additionally, this improper part could cause vibrations during the injection, thereby leading to ancillary issues such as delay of procedure and eventual diagnosis due to unexpected equipment behavior.

Common sheet metal screw substituted for steel pin

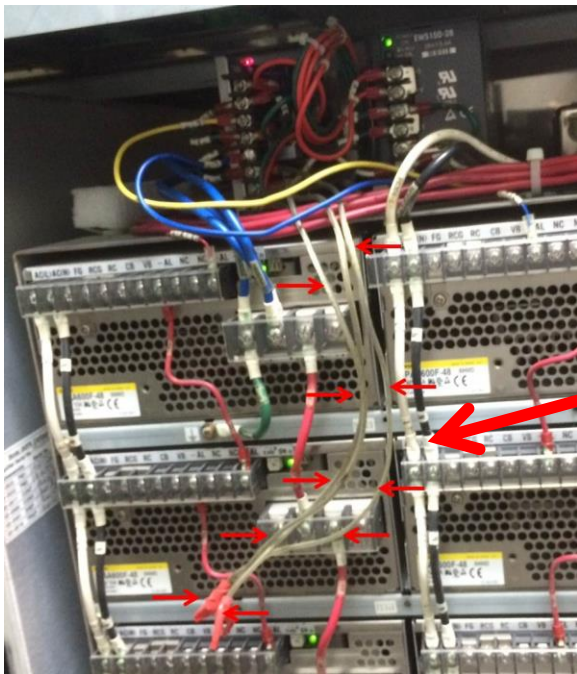
In this example a customer called the manufacturer and requested service on a 0.3T permanent magnet MRI due to ghosting on multiple images. The customer had been experiencing machine downtime due to the inability to properly scan patients. It is unknown for how long this problem existed. The manufacturer determined that the device had been improperly serviced, noting that additional wiring had been added to the electronics cabinet with no markings and terminations using hand-secured wire nuts. Further, the primary power supply cables lacked strain relief and protection from abrasions.

Speaker wire connecting power supply to unknown points and terminated with wire nuts

This improper servicing caused decreased equipment performance due to the resulting poor image quality as well as the electrical issues which may have caused an electrical short, fire, or electrocution.

The customer was advised to discontinue use of the system and was provided with a proposal to perform a full system installation review for repair and calibration.

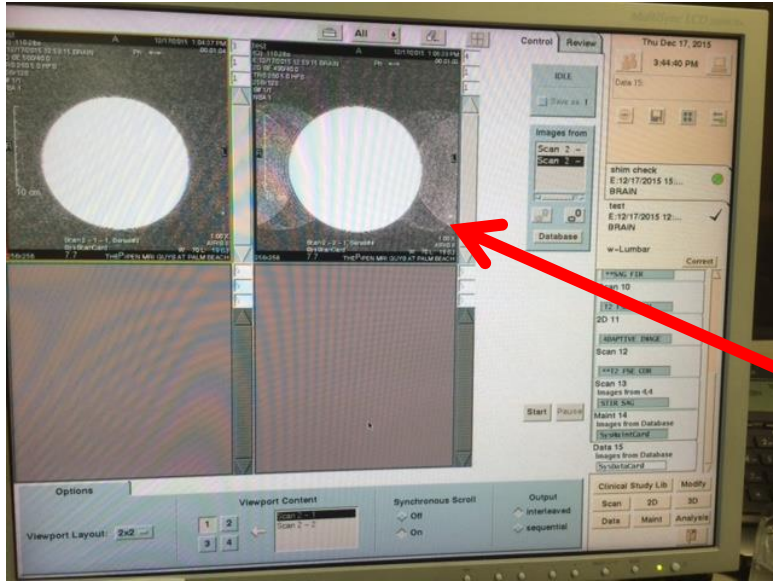
Example of ghosting on medical images

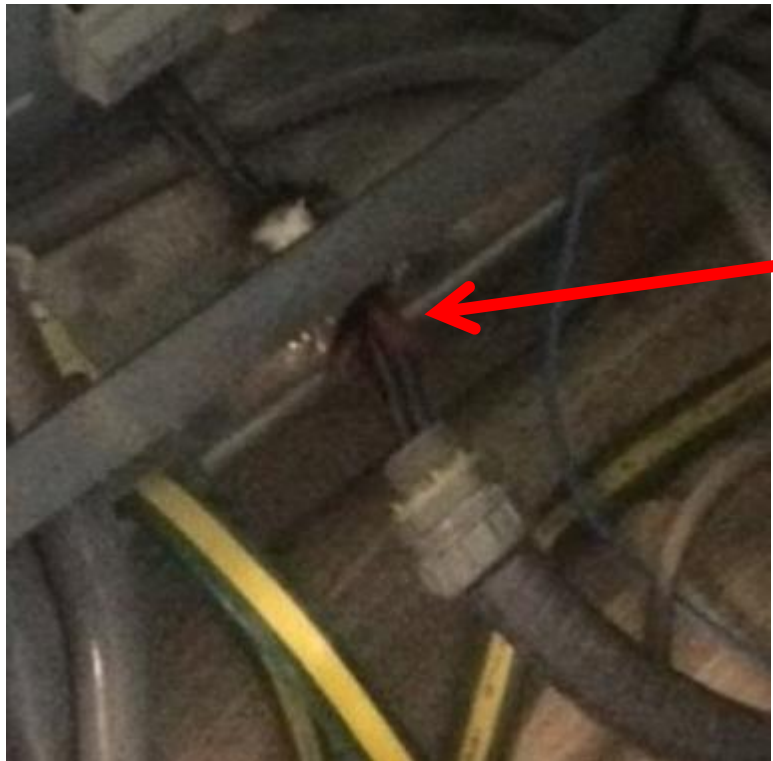
The primary power supply cables lacked strain relief and protection from abrasion

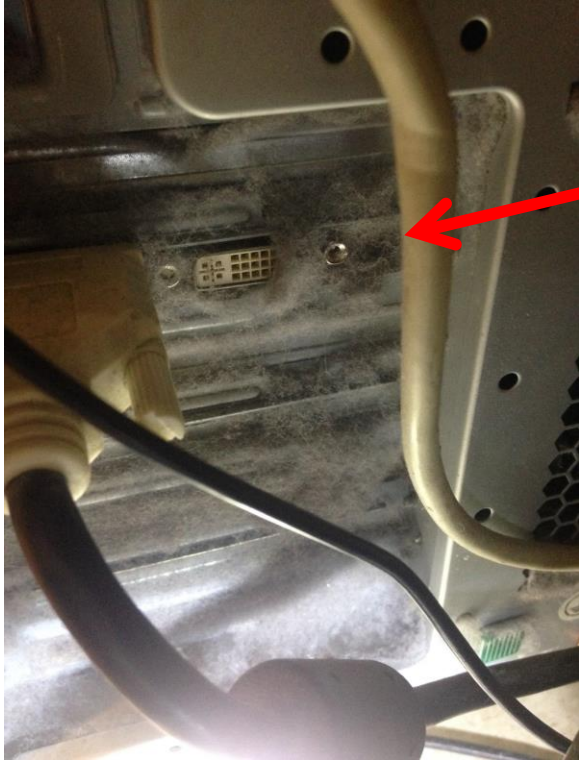
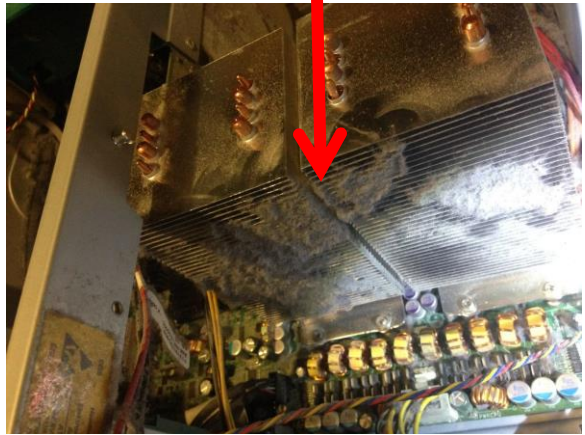
In a CT scanner it was discovered that the computer cooling ducts, image control system, and image reconstruction cabinet had clogged filters and ducts. Further, it was noted that:

Clogs resulting from improper servicing

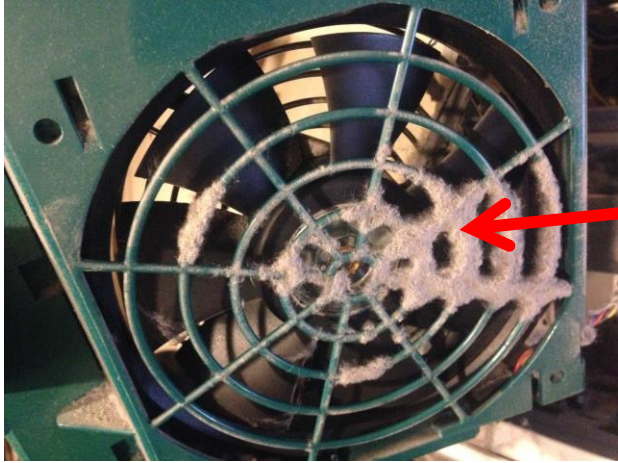
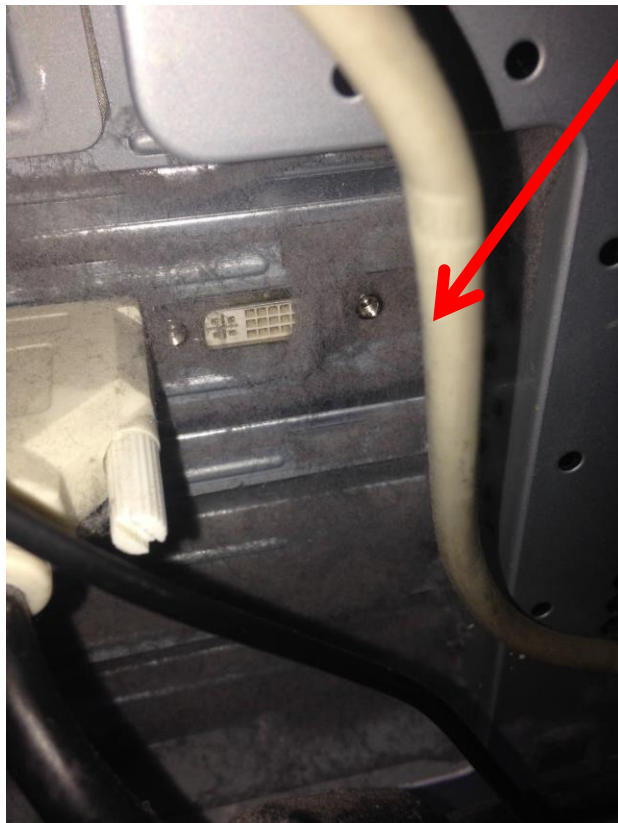
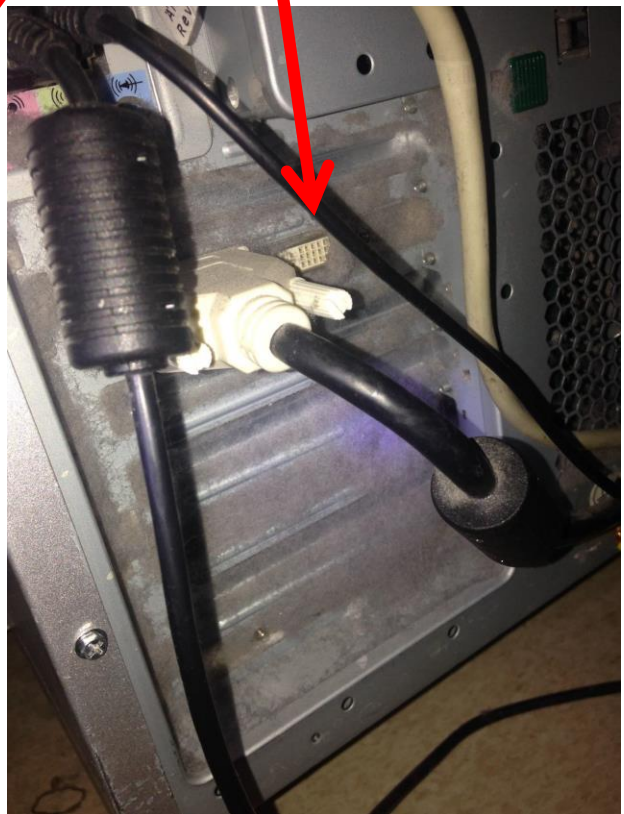
Clogs resulting from improper servicing

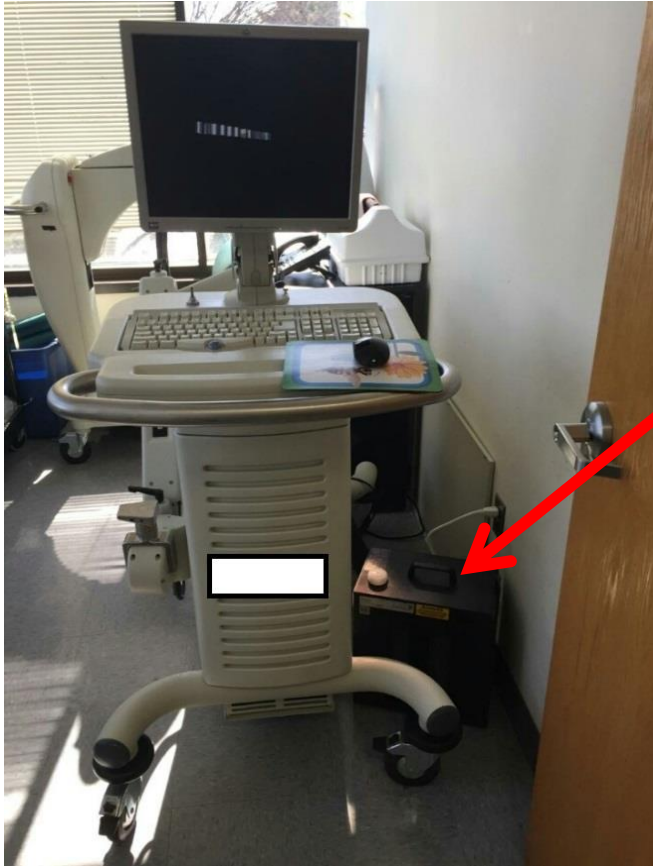
The device had numerous masked adjacent pixels in the detector image which could also mask any heart defects in the image. Further, the cooling unit was improperly connected to external power, bypassing the system's isolated power and grounding system potentially compromising patient safety and device performance.

With respect to the improper power connection of the cooling system, the way in which the system was connected violates the manufacturer's power and grounding isolation scheme, potentially compromising patient safety and device performance. Further, this issue could have led to the detector overheating and pixels failing. These modifications violate the Nationally Recognized Test Lab (NRTL) (e.g. UL/EL) listing of the device.

Remote chiller installed outside the unit on the floor with the cover of the unit off, exposing the camera internals

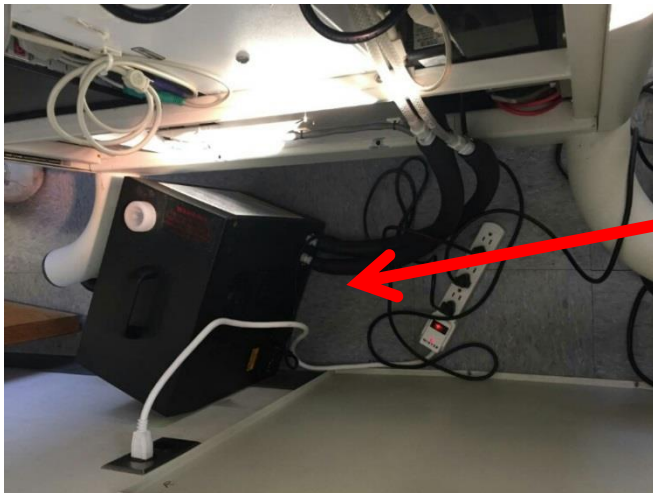
Remote chiller installed outside the unit on the floor with the cover of the unit off, exposing the camera internals

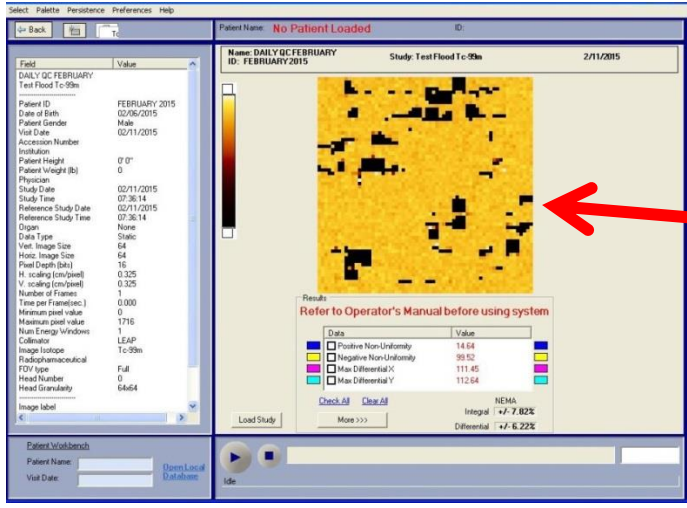
When adjacent pixels are removed, a portion of the imaging detector is lost, so portions of the heart would not be imaged, meaning a heart defect could go undetected by the reviewing physician. When one pixel fails, the system uses data from adjacent pixels surrounding the failed pixel to extrapolate. If two adjacent pixels are bad, then the system does not have a complete sampling of data surrounding the pixels to get a good image. The resulting image would have a blurred spot, resulting in lower diagnostic quality.

Masked pixels

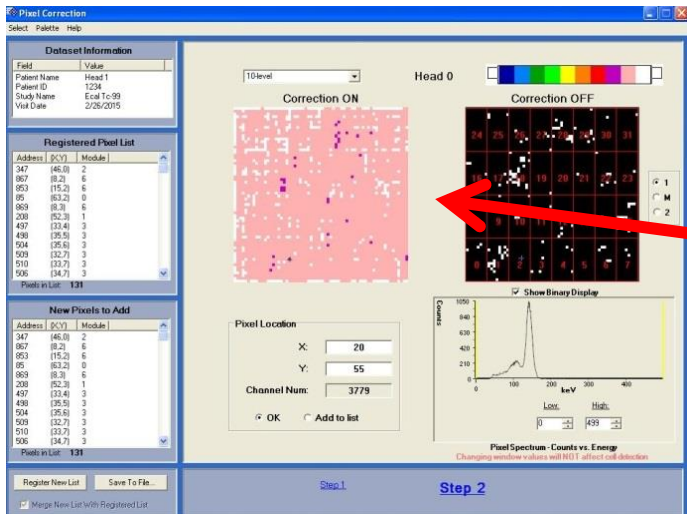
Masked pixels

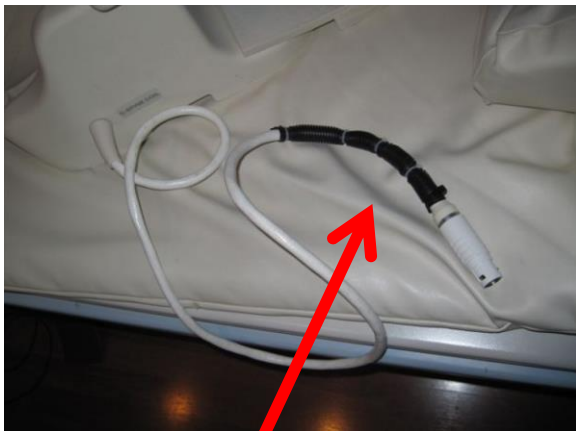
In a 0.3T permanent magnet MRI RF coil the signal cable had been pulled out of a connector housing and was repaired with zip ties and plastic tubing. It is unknown for how long the hazard was present.

Coil with plastic tubing and zip ties used to cover damaged cable

- Cable failure may result in:
 - Lost signal or image artifacts causing misdiagnosis or requiring additional scans
 - Electrical arcing causing electrocution or burns
- Zip tie edges are not smooth and may catch on patient skin or clothing;
- Zip ties and plastic tubing did not appear to be material tested and approved for patient contact;
- Zip ties and tubing did not provide proper strain relief for the cable and may have allowed further cable failure; and
- Plastic tubing may have further hidden additional cable failure

This improperly repaired coil did not meet manufacturer quality specifications and was removed from service and repaired.

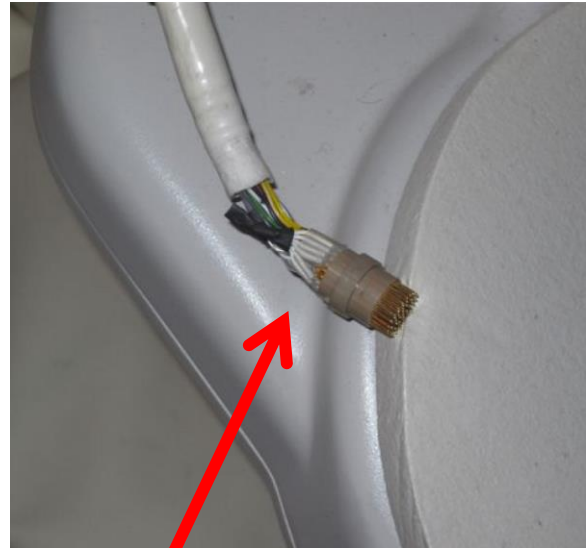
Example of failed coil that was hidden using zip ties and plastic tubing

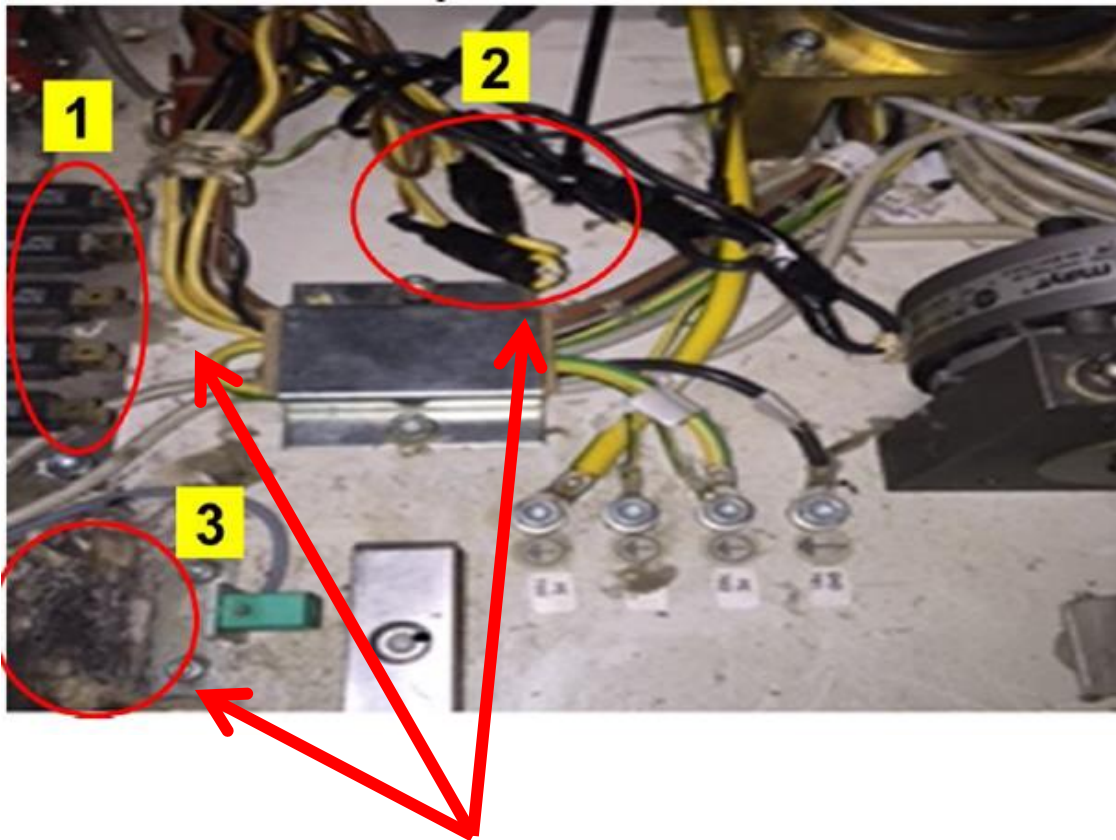
1. The bank of black fuses is not connected to cables, per original equipment manufacturer design and manufacturing specifications
2. Cables have been field repaired with fuses taped to the cable
3. Grease identified in cabling area

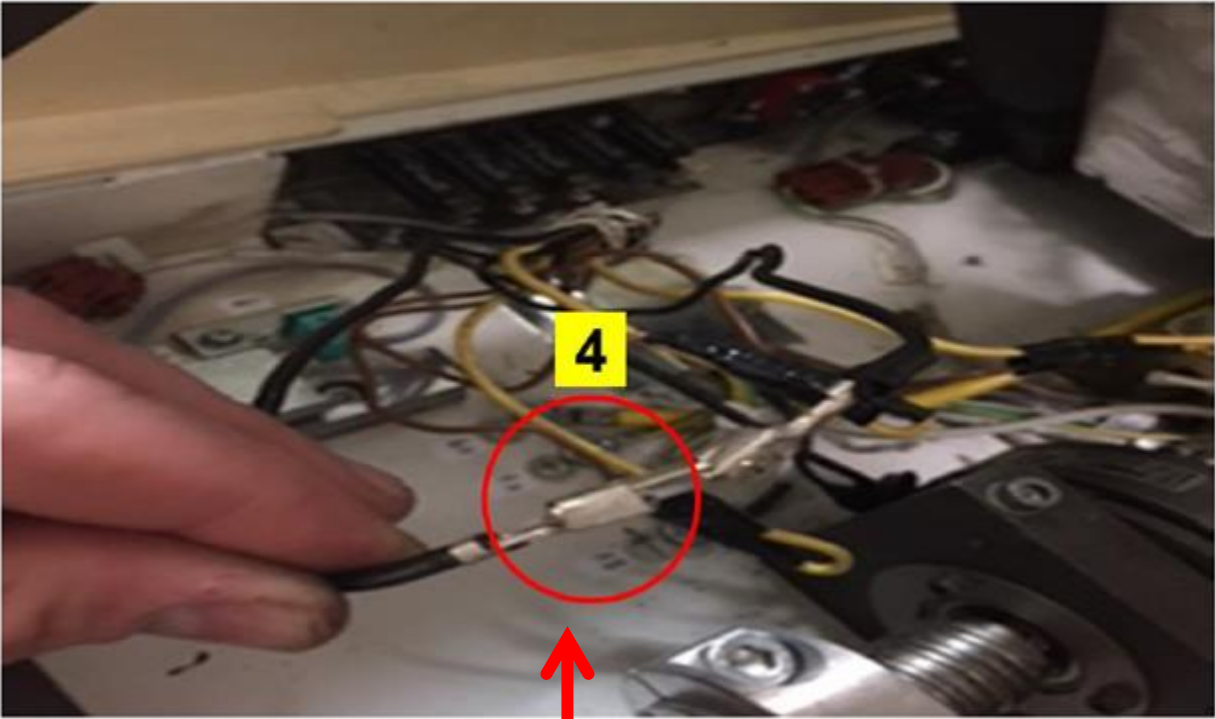
4. Non-qualified fuse, with field repair to reform connector to fit around non-qualified fuse

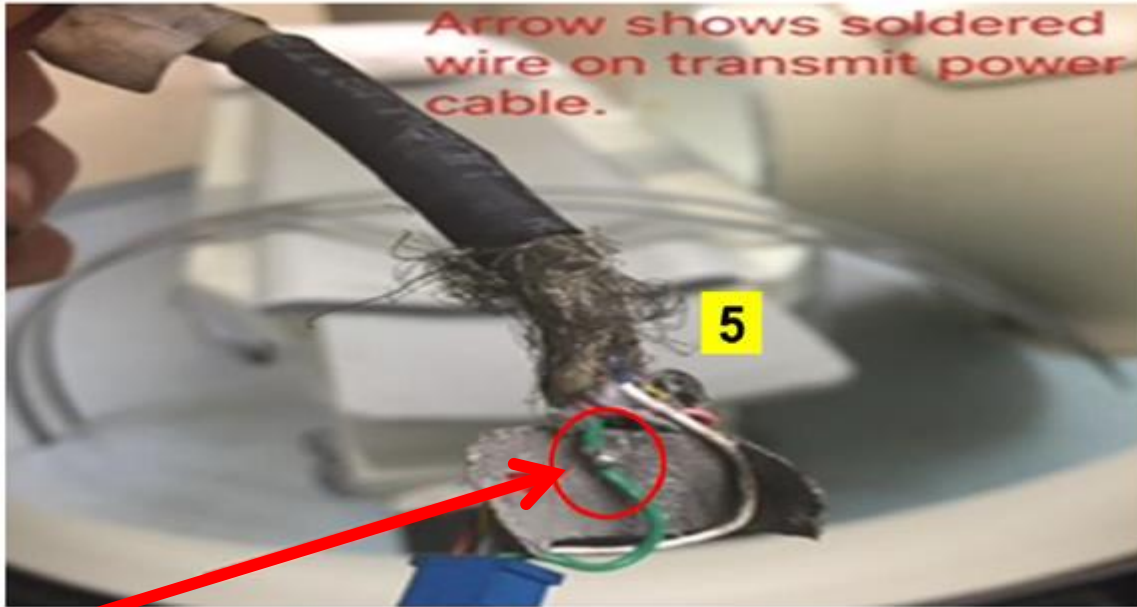
5. Transmit wire connection repaired previously and taped and visible and exposed at joint of green wire

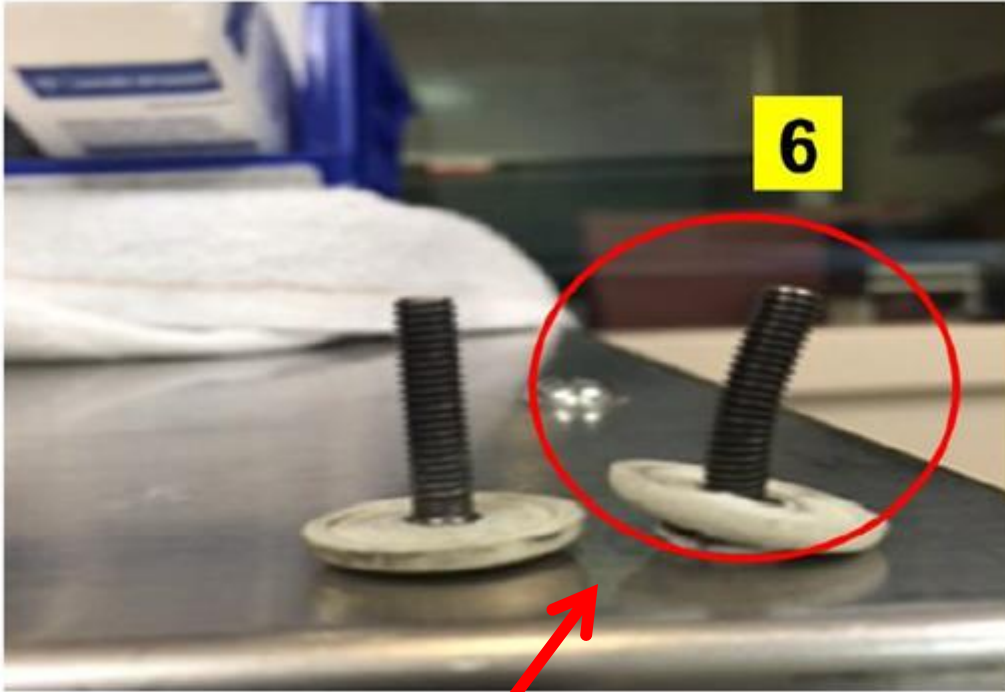
6. Bent screw found, preventing table from full range of horizontal motion

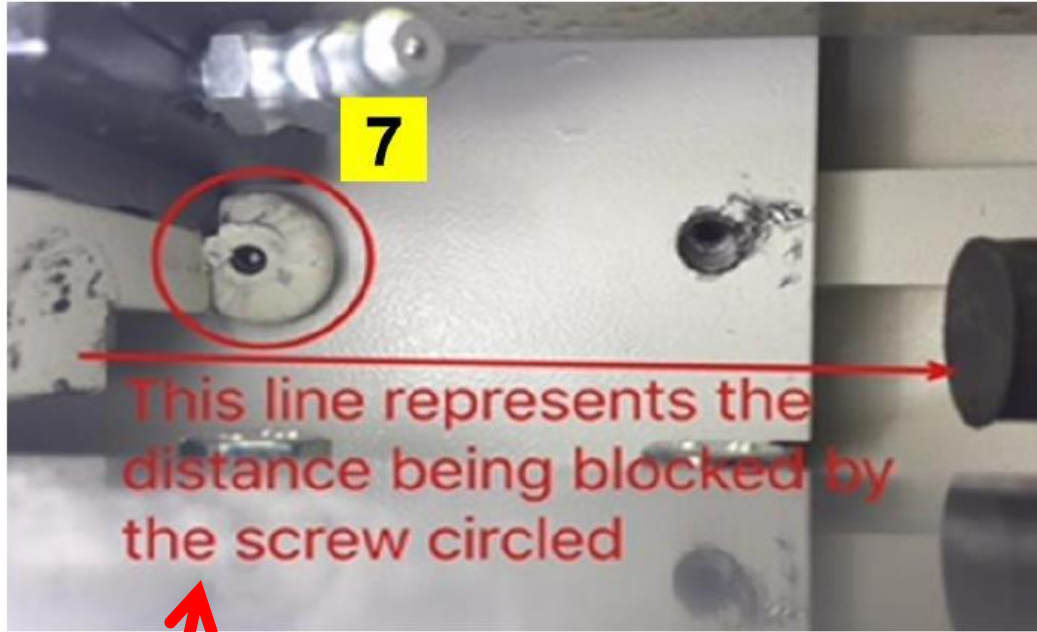
7. Manufacturer's service engineer identified horizontal travel distance blocked by bent screw

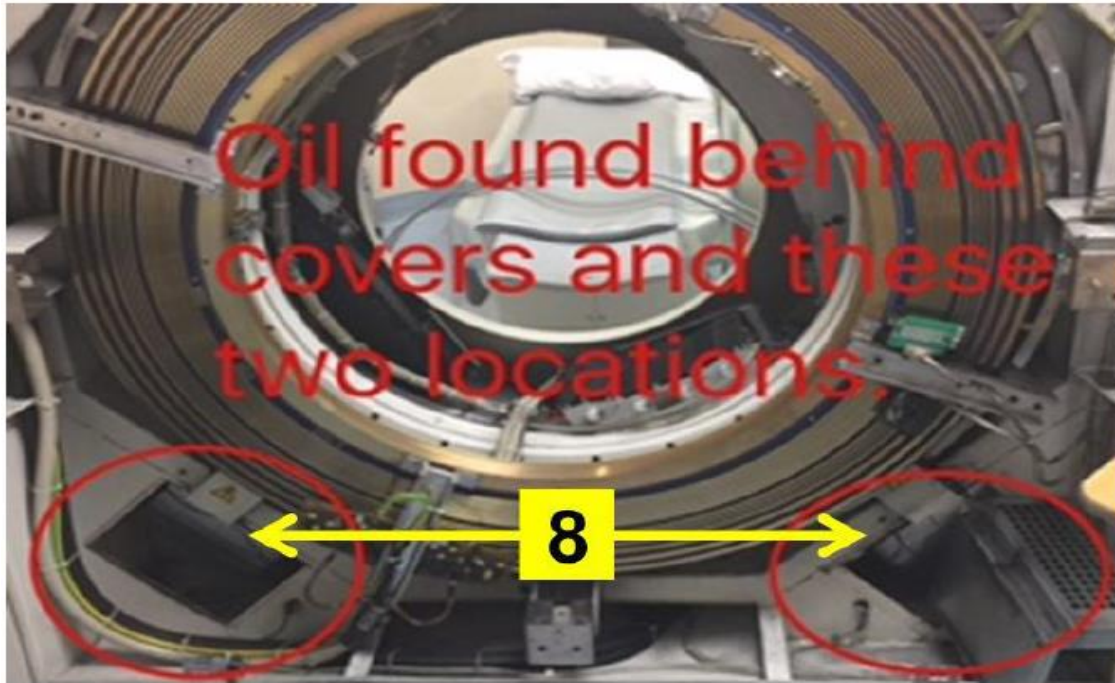
8. Excessive oil identified

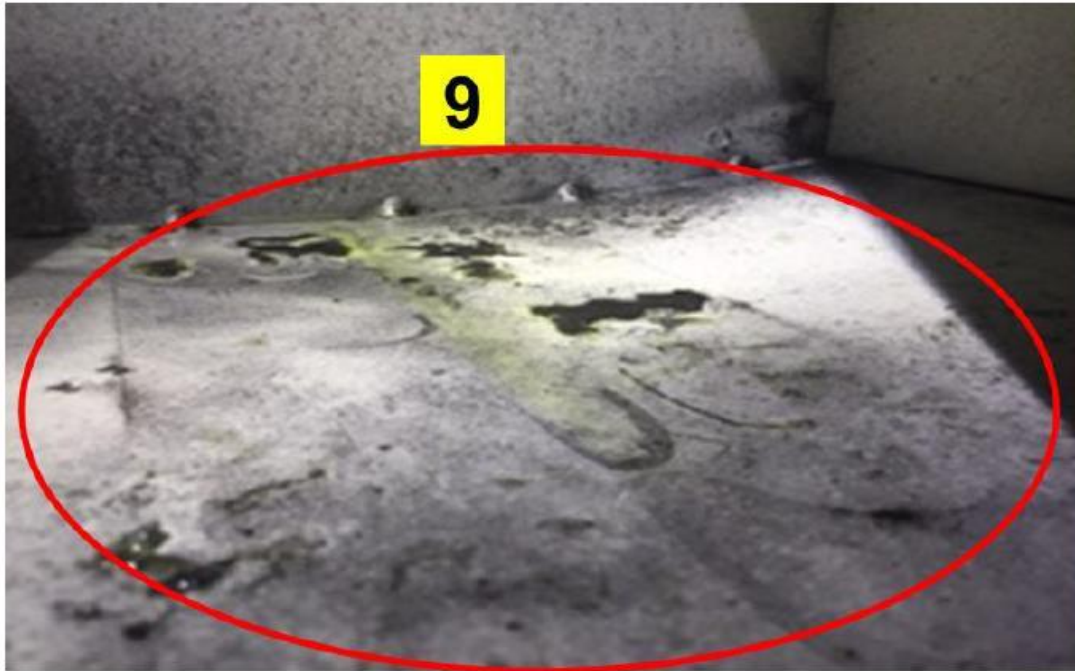
9. Oil and debris identified in back corners of gantry

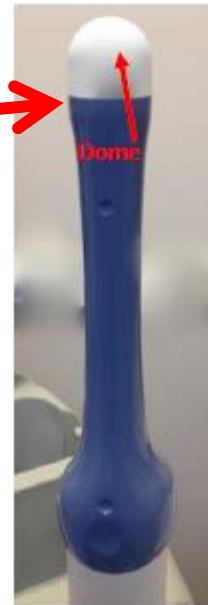
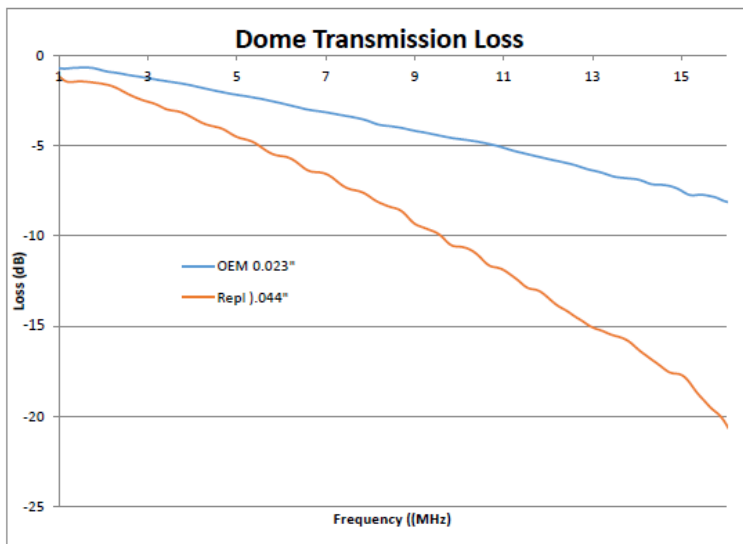
Improper ultrasound probe dome

This improper repair could have resulted in delayed diagnosis or misdiagnosis as well as health conditions associated with a non-biocompatible material.

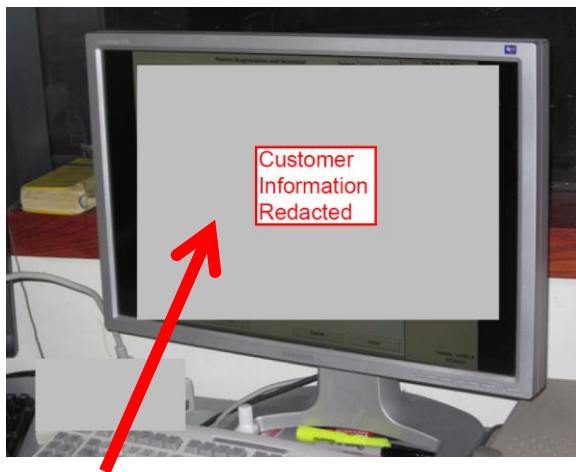
In a 0.3T permanent magnet MRI the system CPU and monitor were replaced with unknown aftermarket units that were not tested and validated to operate with the manufacturer's software. It is unknown for how long the hazard was present.

Aftermarket monitor installed on the MRI system

- Potential for improper operation or failure of the MRI software due to unknown or untested drivers for the computer components and monitor, and
- Since the monitor was not properly sourced, there is the potential for incorrect calibration or inadequate function for displaying patient images.
