MITA[®]
MEDICAL IMAGING
& TECHNOLOGY ALLIANCE
A DIVISION OF **NEMA**[®]

STATEMENT

JOE ROBINSON

“Examining Improvements to the Regulation of Medical Technologies”

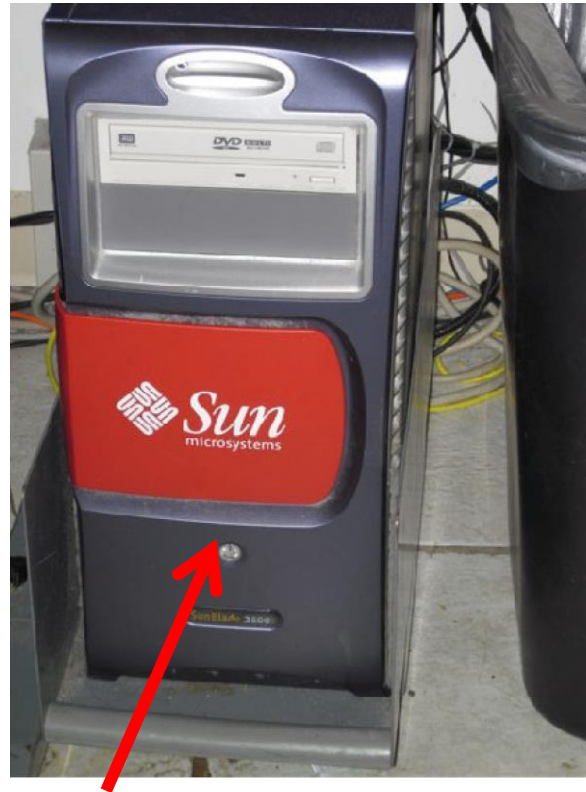
Aftermarket CPU installed on the MRI system

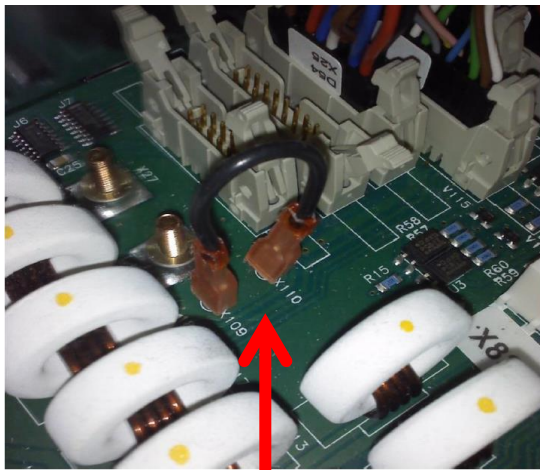
In this example, the detector on a fluoroscopy/radiography system had been replaced with a third party detector system which included the third party's user-console and radiation release button. Further, the third party had installed a jumper cable on circuitry to allow grid movement and sensing to be bypassed. This also allowed for multiple exposures to be taking on a single cassette without reseating/resetting the bucky. This, in effect, removed the manufacturer's double-exposure safety feature.

Third party installed a jumper cable on manufacturer circuitry to allow grid movement and sensing to be bypassed

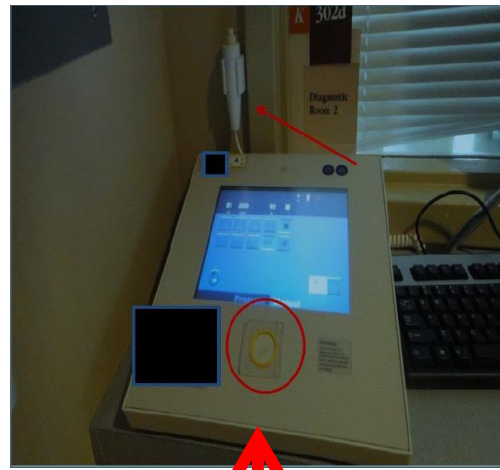
Manufacturer detector replaced with non-qualified detector system which included their user-console and radiation release button (manufacturer exposure button covered over w/Plexiglas plate to

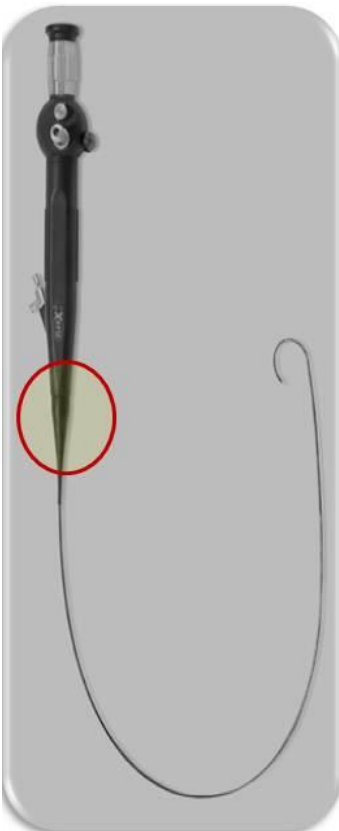
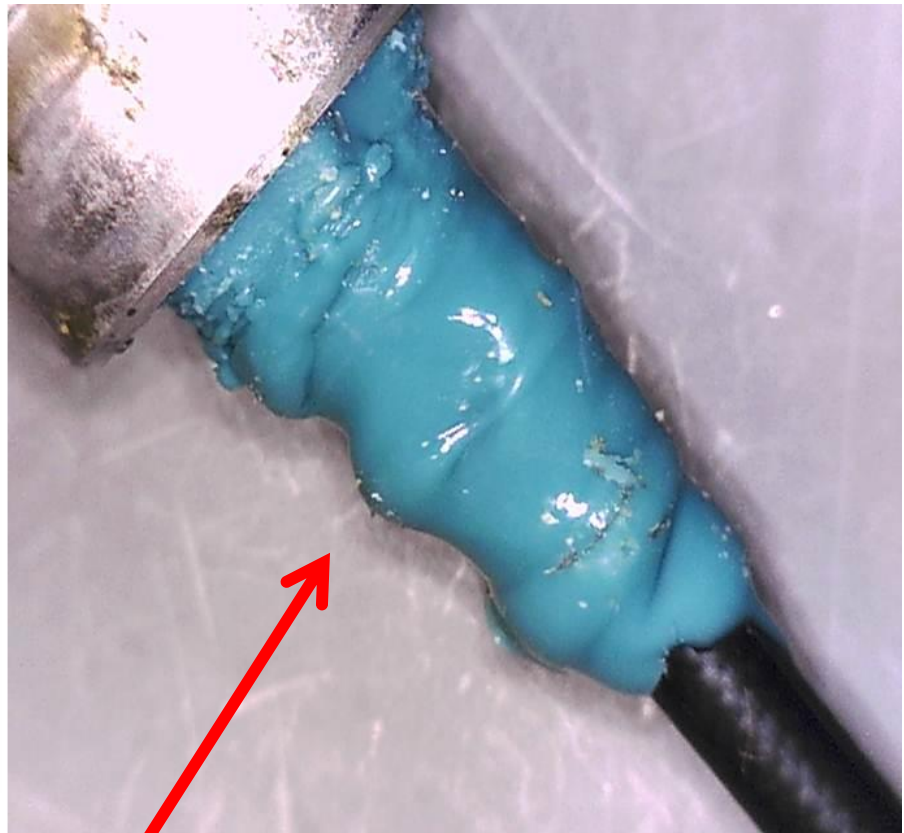
In this example, a porous unidentified material has been used by a non-manufacturer to seal the shaft from the handle of an endoscope. Being porous, there is a chance for bioburden to infiltrate the device and potentially cause cross contamination. Further, it is unclear whether this material will hold up to sterilization parameters. The scope could fail during use if the shaft were to disconnect from the handle.

Unidentified porous material used to seal the shaft of an endoscope.

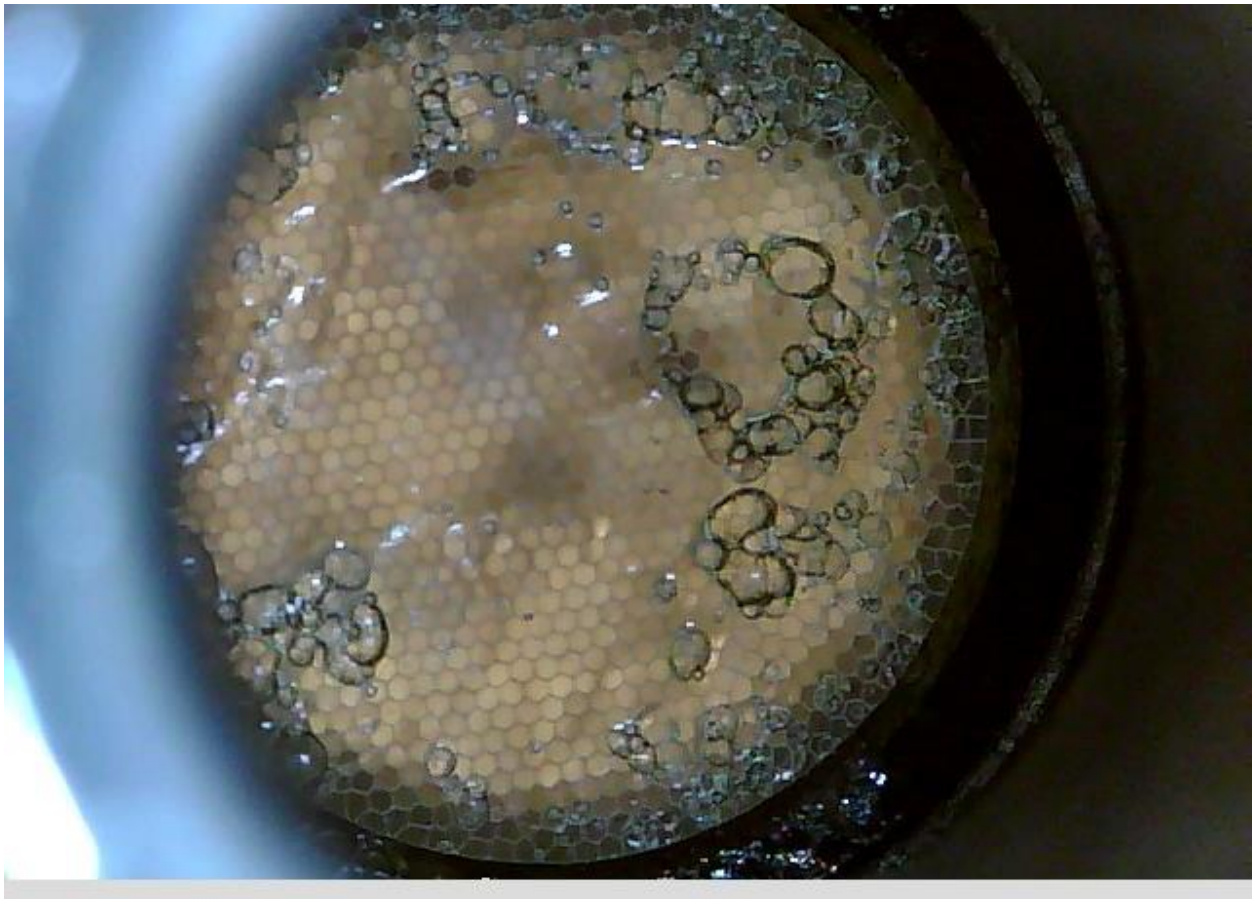
Improper Materials Used to Seal a Laparoscope

In this example, the light post of a laparoscope has been improperly sealed using non-manufacturer epoxy. The epoxy is failing and bubbling. This improper material will not hold up to sterilization parameters. Further, epoxy can harbor bioburden. Charring is also visible in this picture due to pyrogenic reaction. This could cause the light post to overheat and potentially ignite.

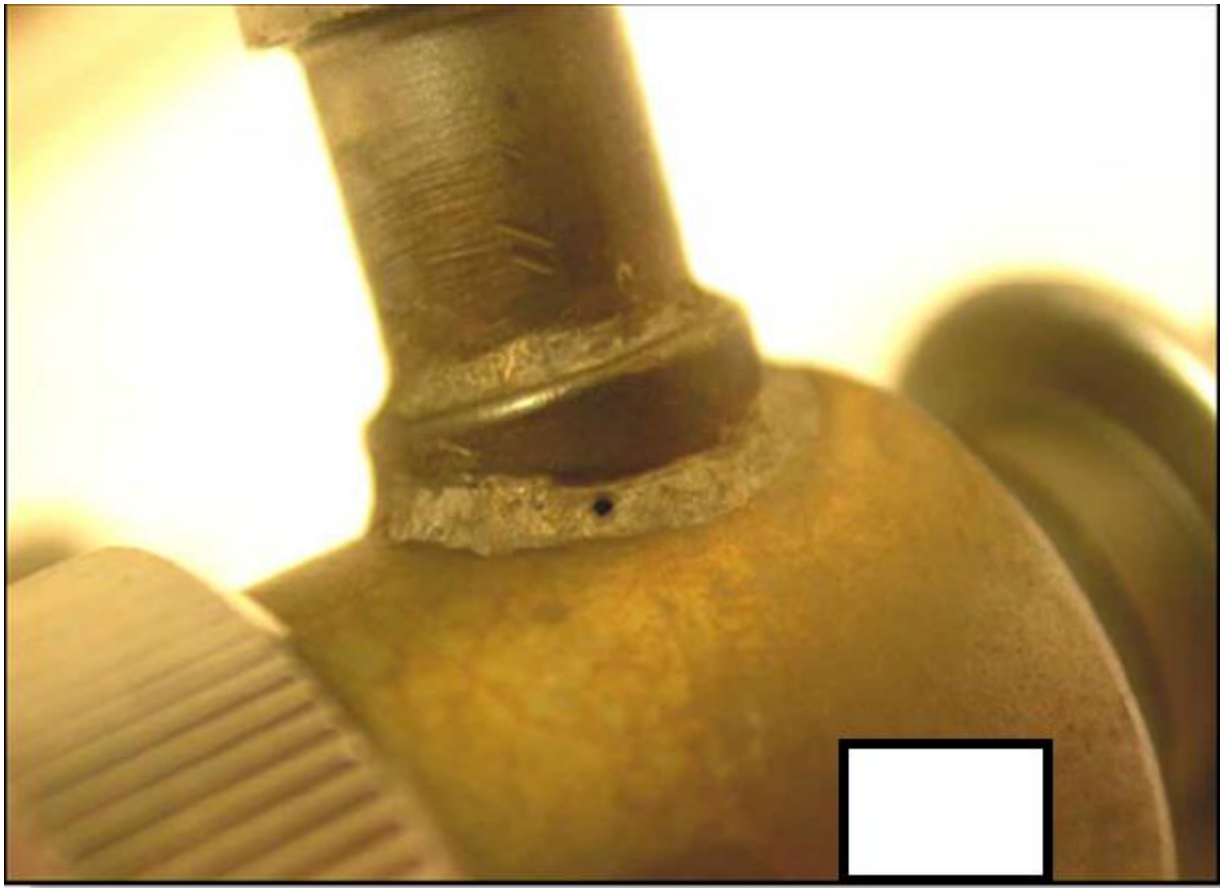
Improper Sealing on an Optical Forcep

In this example, non-manufacturer epoxy has been used on the flushing end of an optical forcep. This material would not hold up to reprocessing and sterilization. The material is pitting and the pitted areas can harbor bioburden. Further, a hole has formed in the material. The integrity of this material could fail and the port could break off during a surgical procedure.

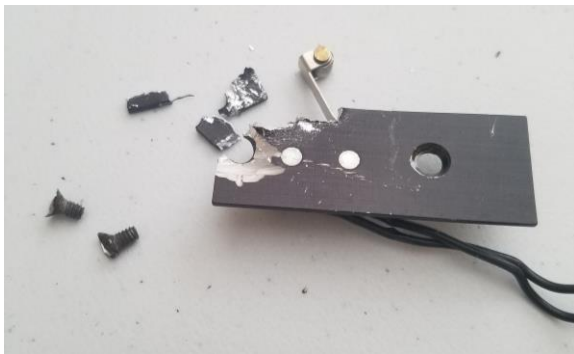
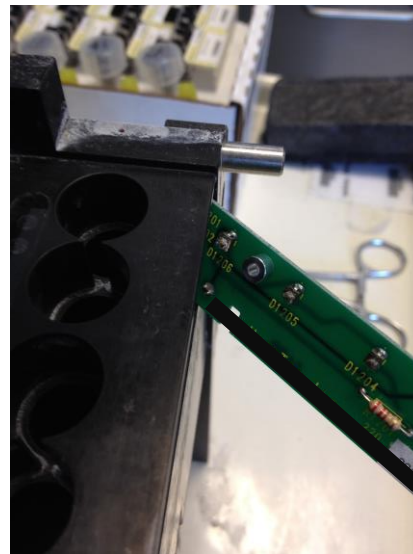
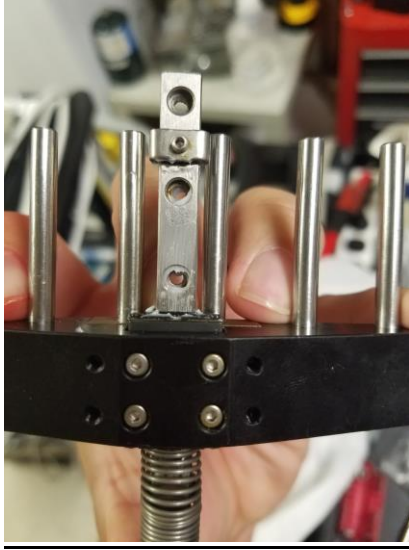
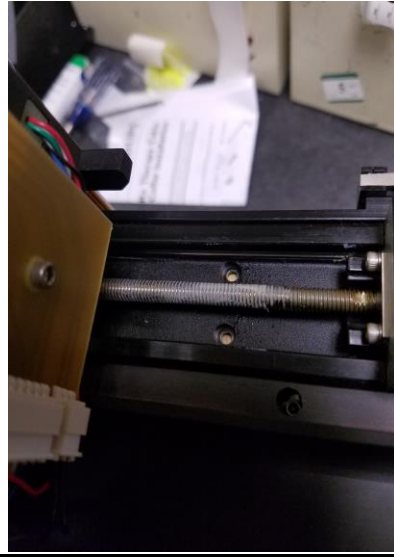
Improperly Serviced Hemostasis Management System

In this example, the field service technician was asked to service a Hemostasis Management System due to motor stalls. The unit was previously serviced by a 3rd- Party provider on June 17th, 2016. Upon inspection of the unit, the field service technician found the x – motor slide assembly completely inoperable, due to dried grease on the gear. While repairing the unit, the field service technician found multiple other errors, such as a bad ADU board, xy interface board, spring sensor, stripped out hardware, resulting in a \$13,000 repair of the unit.

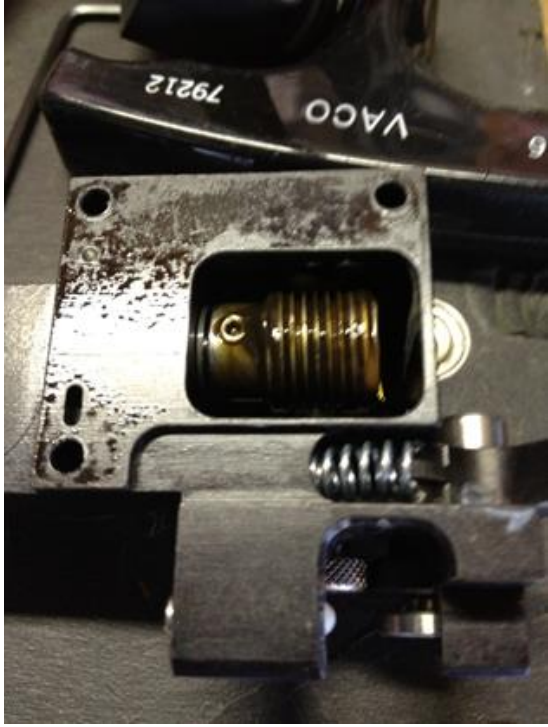
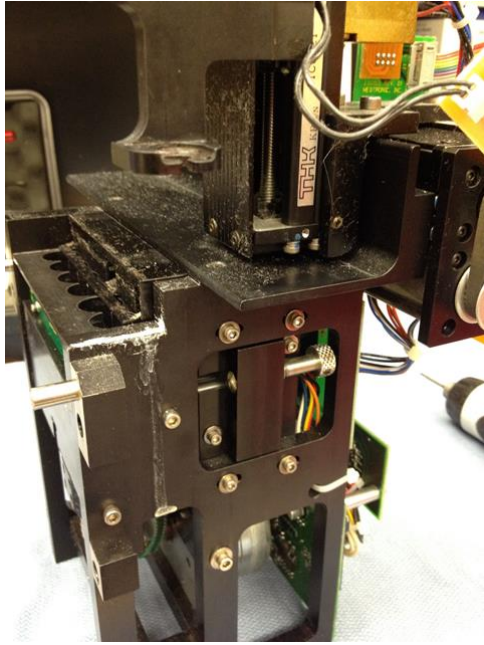
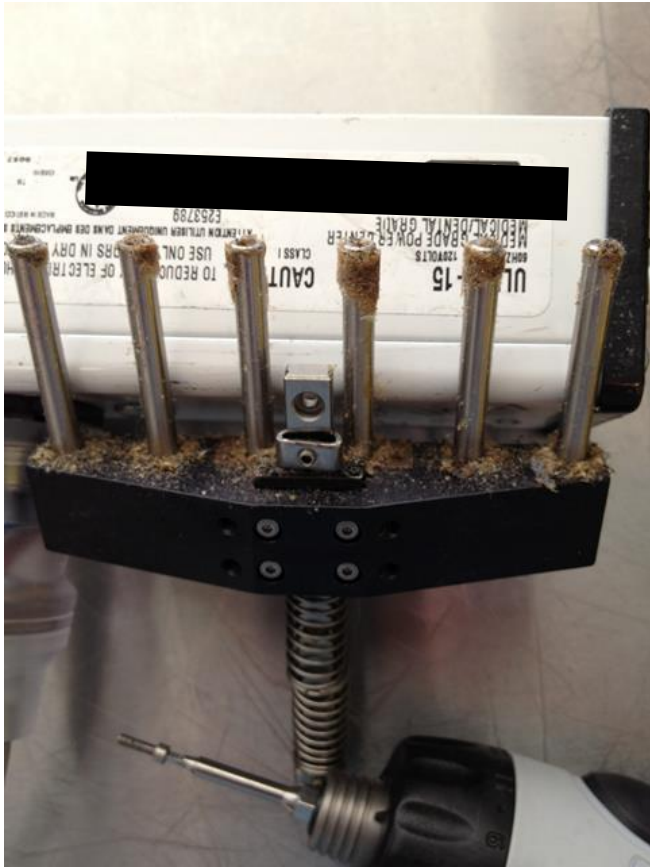
Improperly Serviced Hemostasis Management System

In this example, the field service technician was asked to service a hemostasis management system due to motor stalls. Upon arrive the field service technician noted that the unit has a PM sticker from a 3rd party service provider indicating a preventive maintenance (PM) was completed a few weeks prior on the unit.

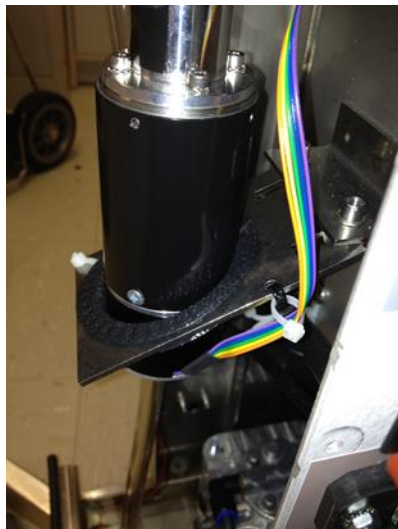
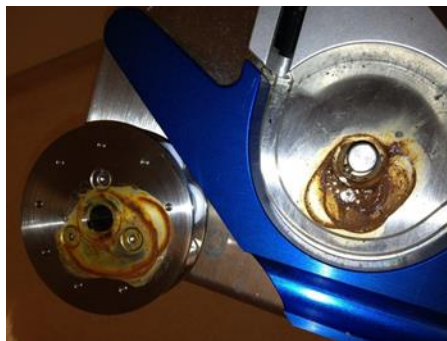
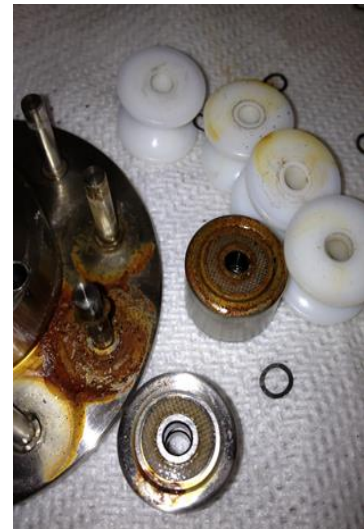
Improperly Serviced Blood Transfusion System

In this example, the field service technician was contacted by the hospital to service their autologous blood transfusion system due to noise coming from the centrifuge bowl. The unit was serviced by a 3rd party provider. Based on the field service technician's assessment he determined that:

This would cause improper function of the roller head for processing blood, additional wear and tear to the disposable tubing, improper volume calculations, and potential motor stalls to the point of not being usable during a case.

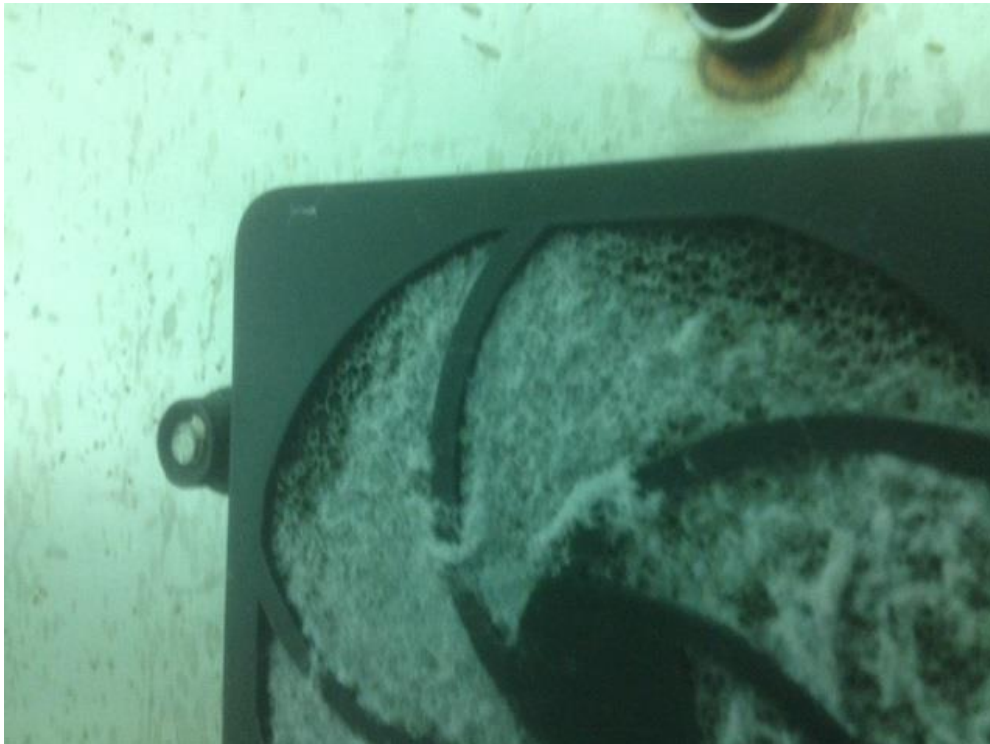
Improperly Serviced Cardiopulmonary Bypass Unit

In this example, the field service technician was at the facility to complete service on a cardiopulmonary bypass unit. The technician noted autologous blood transfusion system unit with a calibration tag dating back to January of 2015. The technician informed the hospital biomedical engineer that the unit was overdue for service. The hospital biomedical engineer informed the field service technician that the unit was recently serviced by a third-party provider.

The field service technician showed the attached image to the hospital biomedical engineer and informed her that the autologous transfusion system contains internal filters, and if these filters become obstructed, such as in this case can lead to equipment malfunctions of improper operation inadequate vacuum and overheating.

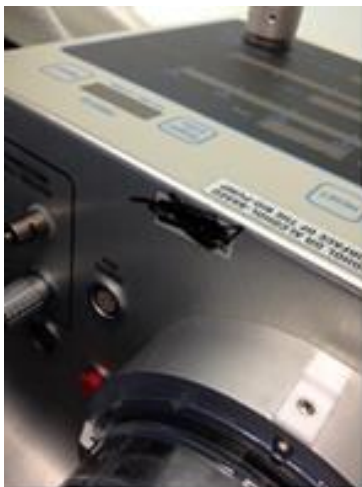
Improperly Serviced Cardiopulmonary Bypass Unit

In this example, the field service technician noticed an issue with a cardiopulmonary bypass procedures. As a good faith gesture, the field service technician powered on the equipment to confirm the unit was functioning. The field service technician noticed a third-party service card that indicated the unit was just serviced.

The image is the manufacturer's 'tamper' sticker that remained intact after the unit was serviced by the third-party. Verifying that the unit's cover was not removed by the third-party service provider to conduct proper servicing, which is also necessary to test or replace the unit's batteries.

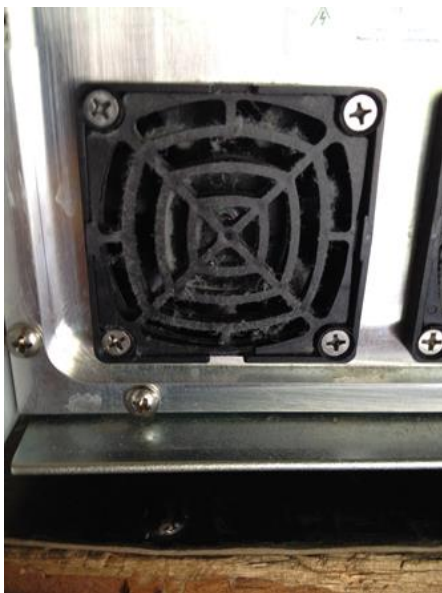
Improperly Serviced Speed Controller System

In this example, the field service technician was called to service a Speed Controller System. The unit was just serviced by a 3rd- party provider, however, when they turned the unit to battery (back- up for power failure or unavailability of power), the unit stopped functioning. If the battery fails during patient support, the perfusionist must operate in manual mode and hand crank the blood through the system until an alternate power source can be identified.

Along with debris getting inside the unit with the potential to over-heat the equipment, if the operator needed to use this unit in the battery mode, it would increase patient and operator risk. The operator would have to change to the hand crank operations to maintain proper flow for the patient until AC power was available.

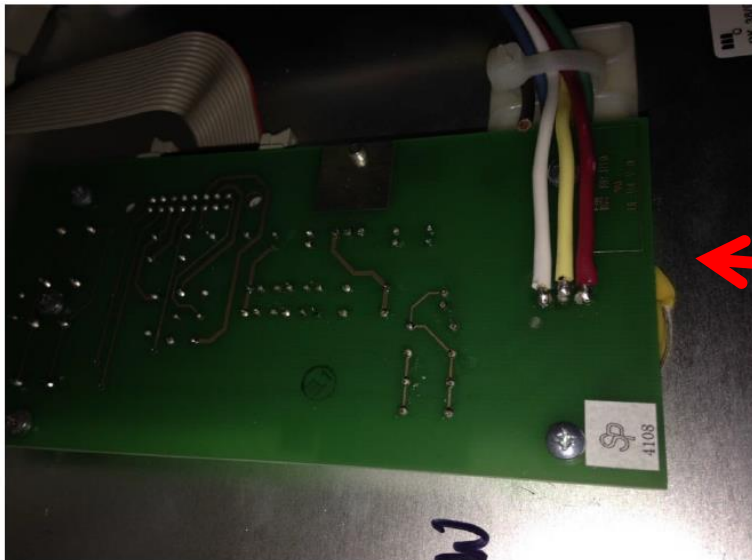
Wires soldered to exposure switch circuit board by third party vendor (it is unknown what these wires do)

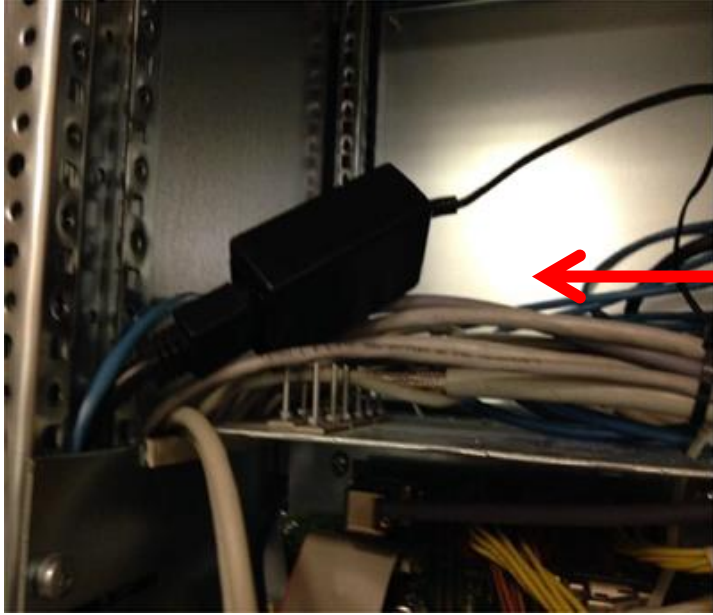
Third party vendor power supply and other cables inside control box

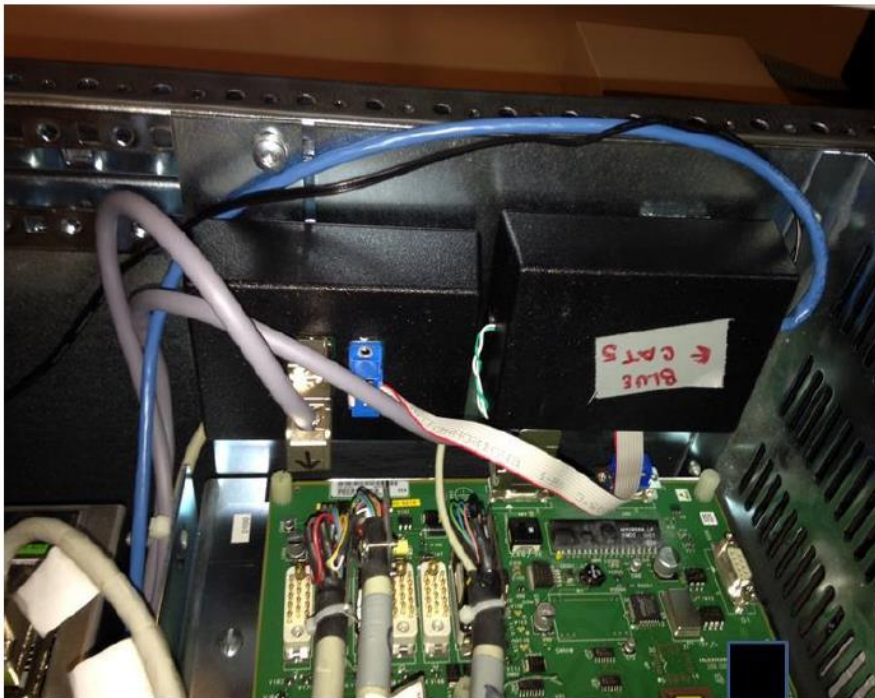
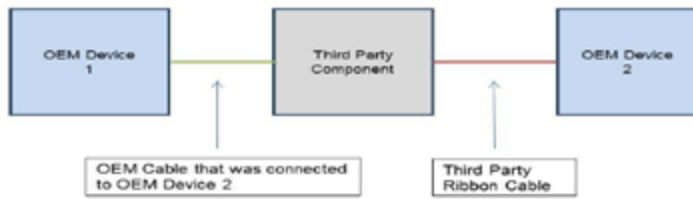
A third party component and cable were inserted on the cable that was connecting Device 1 to Device 2 as seen in the diagram and picture
