VI Damage Assessments

Summary of Preliminary Damage Assessments
For Task Orders 001 thru 004
November 13, 2017

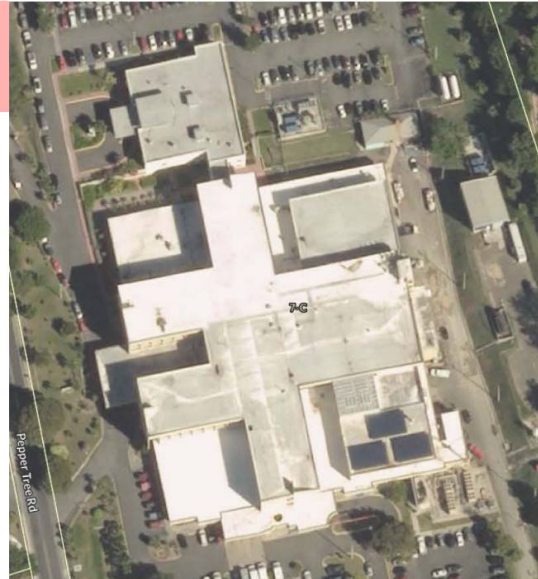
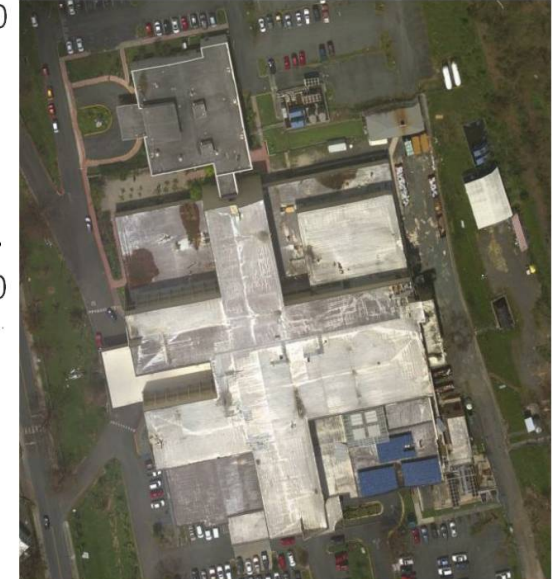
**Non-Flood: Wind Driven Rain,
Roof Damage, Water Intrusion**

Facility Name	Architecture	Structure	Site_1	Mechanical/Plumbing	Electrical / Comm/ Security	Fire Protection	Overall Narrative Rating
Juan F. Luis Hospital	Catastrophic Damage to roofing and roof insulation causing mold remediation in ceiling plenums and replacement of spray-on fireproofing. -Minor damage to EIFS siding and louvers. -Minor to moderate damage to ceilings, walls and floors from water damage.	Moderate Damage, only limited structural systems damaged. - Multiple large openings, especially louvers, which failed now require reinforcing around the rough openings. - Some long span steel stud walls which failed require intermediate members to support the walls	Minor to Moderate Damage. Majority of site infrastructure is in useable condition, some debris is present from elements of the building, Majority of exterior lighting damaged.	Moderate to significant damage, multiple exterior equipment including pumps, fans, condensing units, and exterior piping and duct insulation has sustained significant to major damage on the roof and exterior locations. Variable refrigerant system serving the OR area has been destroyed. Insulation within the building on duct and piping that has water damage has to be removed and replaced.	Moderate to significant damage, Main electrical concerns are automatic transfer switches not automatic but operating manually and almost half of the interior lighting is nonoperational. Main communications damage is public address system has very poor sound quality	Significant damage- FA devices on level 3 damaged, moderate FA device issues on level 2, and on level 1.	Catastrophic- Remediation efforts that will be necessary as a result of roof damage will require replacement of a significant portion of all partitions and building systems within the building.

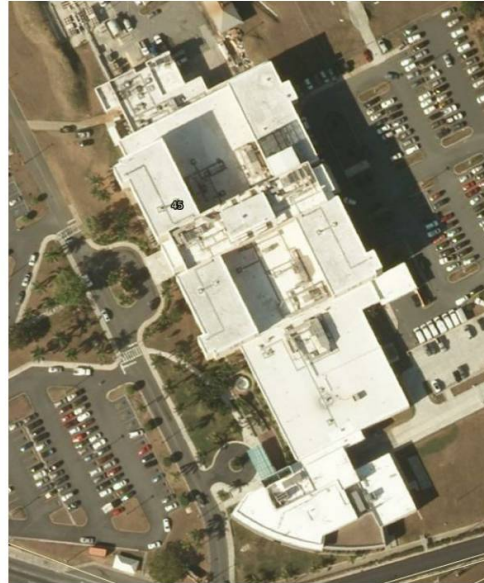
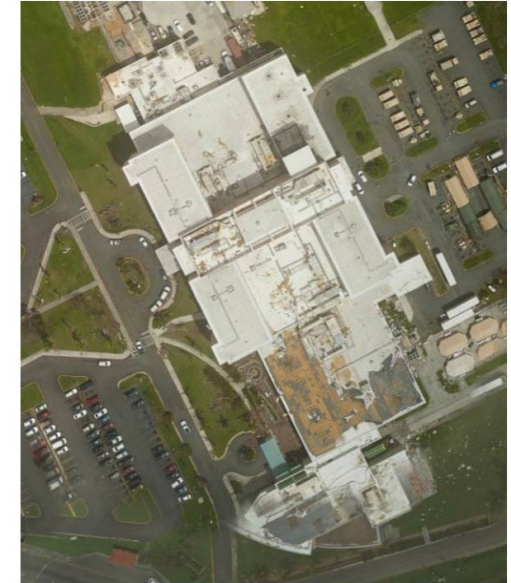
Non-Flood: Wind Driven Rain,
Roof Damage, Water Intrusion

Facility Name	Architecture	Structure	Site_1	Mechanical/Plumbing	Electrical / Comm/ Security	Fire Protection	Overall Narrative Rating
Schneider Regional Medical Center	Catastrophic Damage to roofing an roof insulation causing mold remediation in ceiling plenums and replacement of spray-on fireproofing. -Minor damage to EIFS siding and louvers. -Moderate damage to ceilings, walls and floors from water damage.	Moderate Damage, only limited structural systems damaged. - Multiple large openings, especially louvers, which failed now require reinforcing around the rough openings. - Some long span steel stud walls which failed require intermediate members to support the walls	Minor to Moderate Damage, Majority of site infrastructure is in useable condition, some debris is present from elements of the building, all exterior lighting damaged.	Catastrophic damage to the HVAC roof top equipment is missing or dislodged from roof curbs or original locations. Roof experiencing ponding and leaking into lower levels. Insulation and equipment on upper levels has been compromised with water from leaking. Cancer Center - HVAC moderate damage throughout, domestic water shutdown due to leaks in the system.	Catastrophic damage. The interior lighting and branch wiring suffered moderate to significant damage estimated at approximately half.	Moderate damage. FA Devices appear to be damaged by water infiltration. Sprinkler System does not appear to show any damage.	Catastrophic- Remediation efforts that will be necessary as a result of roof damage will require replacement of a significant portion of all partitions and building systems within the building.

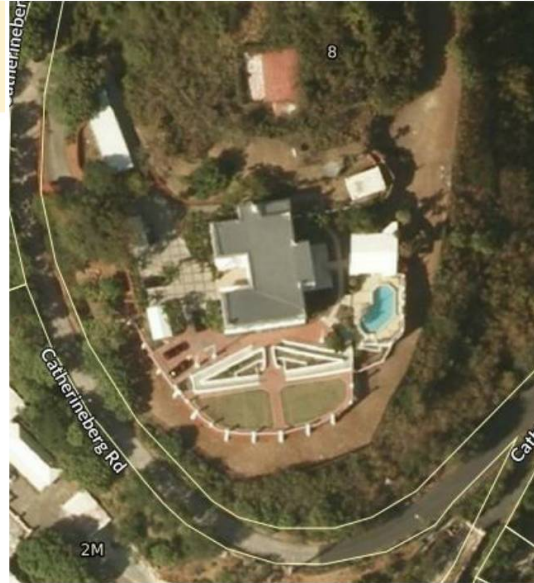
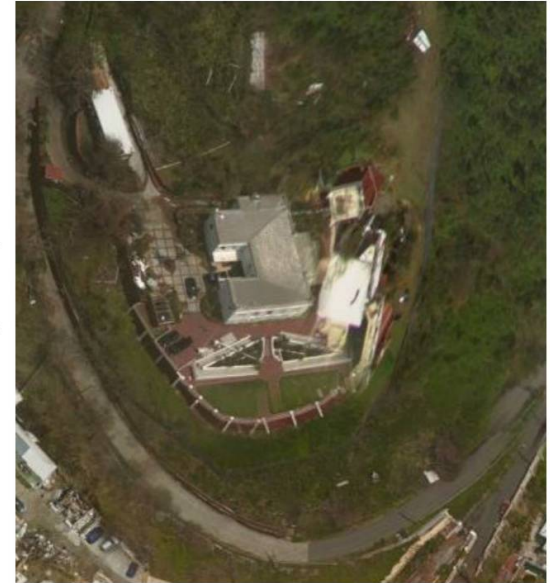
Non-Flood: Wind Driven, Water Intrusion.
Disaster Damage

Facility Name	Architecture	Structure	Mechanical/Plumbing	Electrical / Comm/ Security	Overall Narrative Rating
Estate Catherineberg	Significant damages. The storm breached/blew out several exterior shutters/windows. Wind and rain damage to interiors. Damage to historic plasterwork and floors, and damage to wood tray ceiling in the parlor. The building also exhibits widespread mold growth.	Significant Damage. - Exterior two flag poles yielded at base. - All windows and shutter broken. - Ceiling Damage due to water intrusion. - Significant damage to building exterior and gazebo.	Mechanical equipment has moderate to catastrophic damage. Outdoor condensing units were dislodged and destroyed. Some indoor units sustained water damage as well.	Electrical conduits and wiring of branch have been affected. The generator is operational but further inspection and maintenance is required. Almost half of Exterior lighting fixtures have been affected, further inspection is required. Some interior lighting fixtures have been affected. Some Comm/Security and public address devices have been affected.	Severe but repairable - Remediation efforts that will be necessary as a result of water intrusion will require replacement of a significant portion of all partitions and building systems within the building.

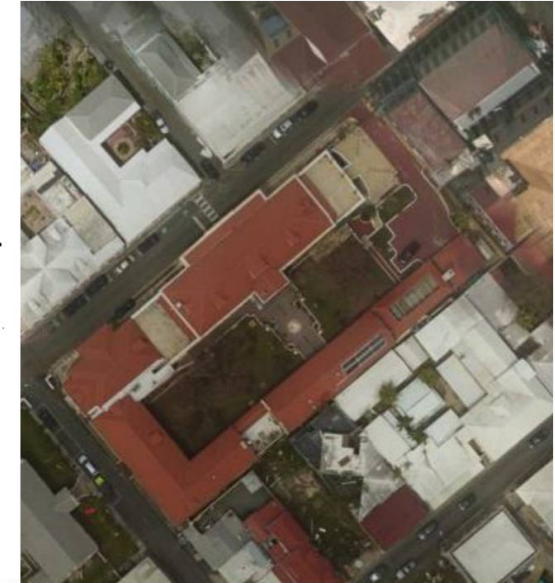
Non-Flood: Wind Driven, Water Intrusion.
Disaster Damage

Facility Name	Architecture	Structure	Mechanical/Plumbing	Electrical / Comm/ Security	Fire Protection	Overall Narrative Rating
Government House, St. Croix, Christiansted	Exterior: Overall minor damage. Roofing-Portion of gutter and downspout drainage system. Resealing of all roof corrugated metal deck laps joints. HAZMAT materials verification recommended prior to any scope of work performance. Wall(s)-Damage requires crack and stucco repairs (chimney and walls). Repainting of exterior facade/ walls areas required. Interior moderate damages. Plaster, wood trim and paint damaged by water penetration, some mold is present.	Moderate Damage. Exterior cracks to column capitals, Exterior walkway slab cracks due to possible foundation settlements, ceiling damage, and minor wall cracking at third floor kitchen wall.	Mechanical equipment has minor to significant damage. exterior louvers sustained a majority of the damage ranging from blockage and screen damage to bent louver blades. Exterior condensing units had moderate coil damage. Plumbing equipment suffered moderate to catastrophic damage. Roof drains and gutter systems were significantly impacted causing leaks and other damage. Corrosion on plumbing fixtures was also noted in a few areas.	Electrical conduits and wiring of branch circuits have been affected due to roof leaking. One of two generator is not operational. The elevator is not working. Almost half of all exterior lighting fixtures have been affected.	Fire alarm system damaged. Fire alarm devices suffered moderate to catastrophic damage in the Inner Courtyard.	Severe but repairable - Remediation efforts that will be necessary as a result of roof damage will require replacement of a significant portion of all partitions and building systems within the building.

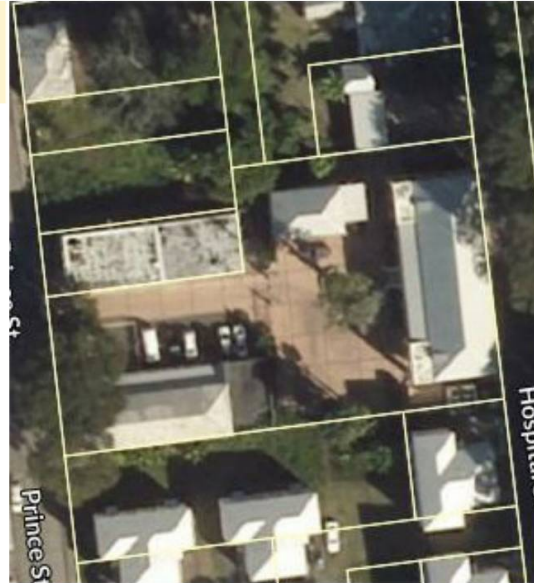
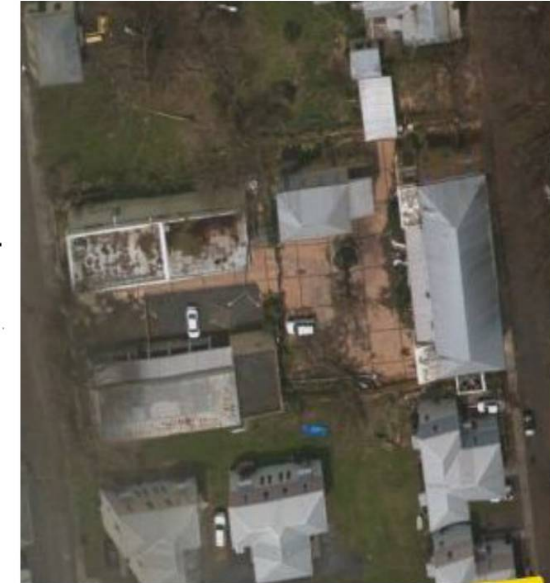
Non-Flood: Wind Driven, Roof Damage, Water Intrusion.
Disaster Damage

Facility Name	Architecture	Structure	Mechanical/Plumbing	Electrical / Comm/ Security	Fire Protection	Overall Narrative Rating
Government House, St. Croix, Fredricksted	Exterior: Overall significant damage. Roofing- majority of gutter and downspout drainage system have been damaged or blown-off due to high wind event. Resealing of all existing roof corrugated metal deck laps joints and flashings required. HAZMAT materials verification recommended prior to any scope of work performance. Wall(s)-portion of existing stucco has been damaged or blown-off due to high wind event Repainting of exterior facade/ walls areas required. Recommendation for crack/stucco/ waterproofing/ paint for exterior building envelope walls. Replacement of existing broken window/glazing required. Interior minor damages. Plaster, wood trim and paint damaged by water penetration, some mold is present.	Minor Damage. Minor wall cracks in second floor and meeting house. Some minor water damage to architectural finishes due to roof leaks.	Plumbing systems have moderate to catastrophic damage. Plumbing fixtures require moderate repairs or replacement but roof gutter system has substantial damage and leaks. Mechanical has moderate damage to generator exhaust.	Electrical conduits and wiring of branch circuits have been affected. Exterior lighting fixtures have been affected. Exterior disconnect Switches have been affected, all need complete replacement.	Some damaged, require further inspection.	Severe but repairable Remediation efforts that will be necessary as a result of roof damage will required replacement of a significant portion of all partitions and building systems within the building.

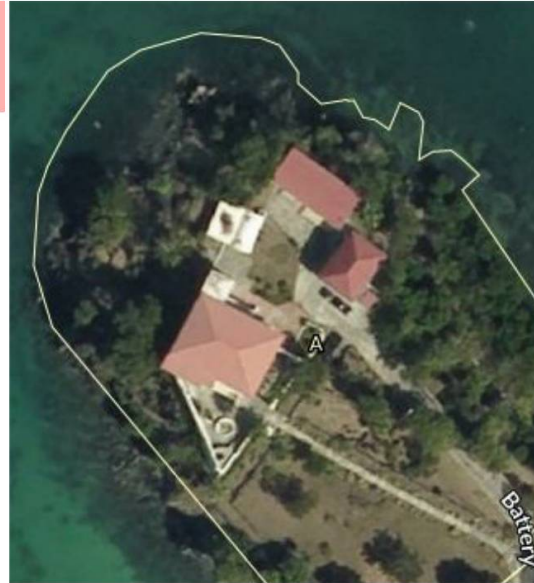
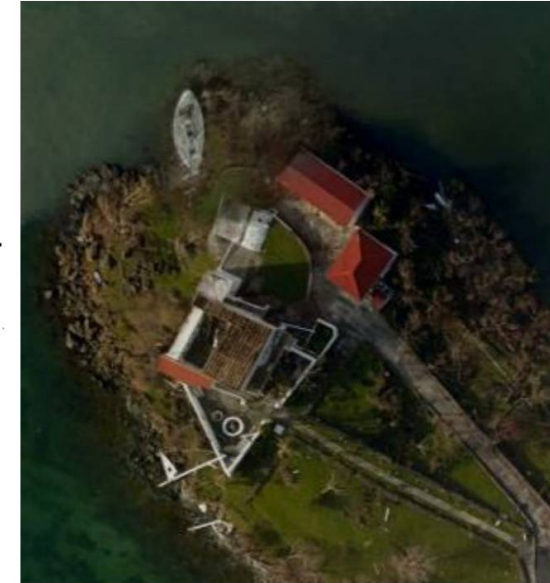
**Non-Flood: Wind Driven, Roof
Damage, Water Intrusion.**

Facility Name	Architecture	Structure	Mechanical/Plumbing	Electrical / Comm/ Security	Fire Protection	Overall Narrative Rating
Government House, St. John	Exterior: Overall catastrophic damage. Roofing-Entire roof system at Main Bldg. including gutter and downspouts and structural wood T & G/ beam assembly failure in high wind event. Wall(s)-portion of existing stucco has been damaged or blown-off. Repainting of exterior facade/ walls areas required. Recommendation for crack/stucco/ waterproofing/ paint for exterior building envelope walls and concrete spalling conditions. Replacement of existing broken window/glazing required. Extensive water damage to all exterior finishes. Overall minor damage. At Secondary Bldg. portion of gutter and downspout drainage system. Resealing of all roof corrugated metal deck laps joints. HAZMAT materials verification recommended prior to any scope of work performance. Wall(s)-Damage requires crack and stucco repairs (chimney and walls).	Significant damage to catastrophic damage in some items. - Complete roof was blown away - Cracked balcony beams - Pool ornaments broken - Boat mast broken and damaged support retaining wall - 2nd floor ceilings and slab damage - Licensing building gutter blown away on one side	Mechanical systems suffered significant to catastrophic damage, most split systems were destroyed or damaged. Some ductwork damage was also documented. Plumbing systems experienced significant to catastrophic damage. Roof gutter system was completely destroyed on the main building and the sewage system is rusted and broken in	Electrical conduits and wiring of branch circuits have been severely damaged. Half of interior lighting has been severely damaged. The exterior lighting is a total loss. All low voltage systems are down, we recommend the entire electrical system to be replaced.	Almost all of the fire alarm system damaged.	Severe to catastrophic Remediation efforts that will be necessary as a result of roof damage will required replacement of a significant portion of all partitions and building systems within the building.

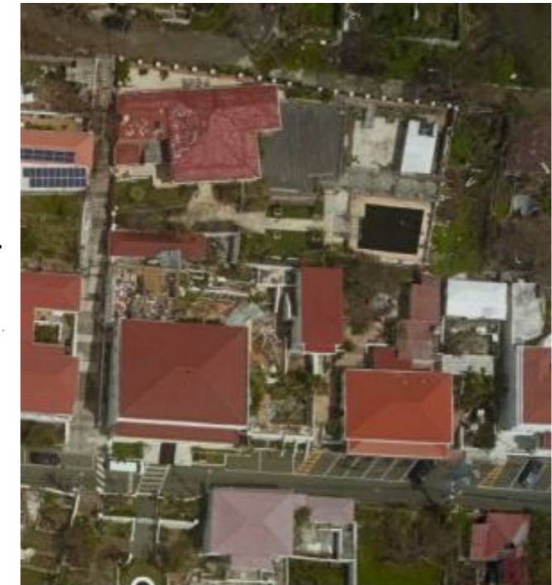
Non-Flood: Wind Driven, Roof Damage, Water Intrusion.

Facility Name	Architecture	Structure	Mechanical/Plumbing	Electrical / Comm/ Security	Fire Protection	Overall Narrative Rating
Government House, St. Thomas	Exterior: Overall catastrophic damage. Roofing-Main Bldg. roof and accessories damaged during high wind event. watertight intergity compromised roof assembly system recommendation for replacement. Wall(s)-Repainting of exterior facade/ walls areas required. Recommendation for crack/stucco/ waterproofing/ paint for exterior building envelope walls and concrete spalling condions. Replacement of existing broken window/glazing / shutters required. Extensive water damage to all exterior finishes. HAZMAT materials verification recommended prior to any scope of work performance. Wall(s)-Damage requires crack and stucco repairs. Plaster damaged or fallen off, wood trim and paint damaged by water penetration, mold in ballroom, water damage to wood floors, water damage to ceiling, ceiling tiles are water stained, ceiling tiles are damaged.	Moderate Damage. - Roof over addition portion collapsed. Entire roof structure to be replaced there. - Water damage to ceilings. No floor slab structural damage noticed. - Significant cracking in stair brick wall. Needs repair. - Guard booth completely damage. - site retaining wall to be replaced.	Mechanical equipment suffered minor to catastrophic damage. Minor damage was an electrical connection at a unit and a number of units were completely destroyed and must be replaced. Plumbing systems had no obvious damage.	Almost half of interior lighting has been severely damaged, so for this resport it must be considered catastrophic damage. The exterior lighting is a total loss, catastrophic damage. Comm/Security systems remain funtional, but have been affected by water filtration. Even all electrical systems remain funtional, it seems to be exceeded its useful life, so we recommend the entire electrical system to be replaced.	The Fire alarm System is operational but has been partially affected by watter filtration.	Catastrophic Remediation efforts that will be necessary as a result of roof damage will required replacement of a significant portion of all partitions and building systems within the building.

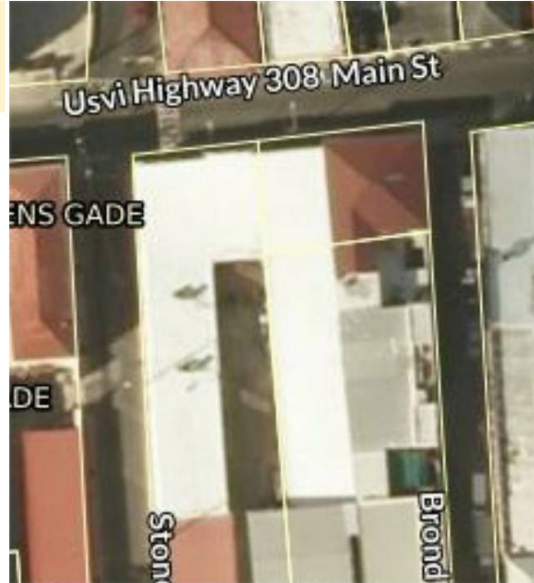
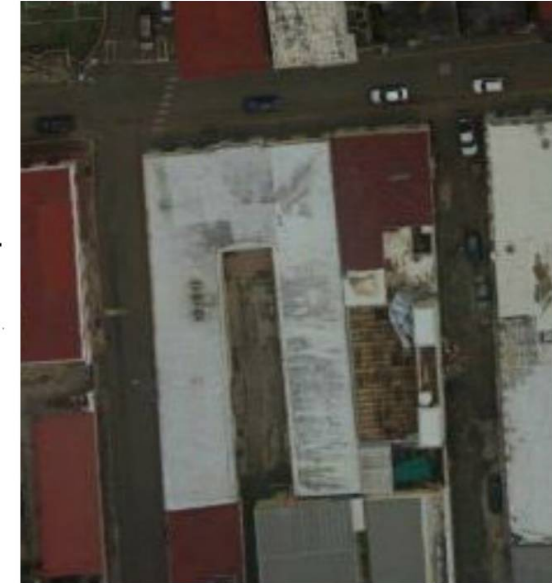
Non-Flood: Wind Driven, Water Intrusion.

Facility Name	Architecture	Structure	Mechanical/Plumbing	Electrical / Comm/ Security	Fire Protection	Overall Narrative Rating
Office of the Governor's Finance and Communication Building	Exterior: Overall Moderate damage. Roofing - Resealing of all existing roof systems including corrugated metal deck laps joints and flashings required. HAZMAT materials verification recommended prior to any scope of work performance. Wall(s) - Repainting of exterior facade/ walls areas required. Recommendation for crack/stucco/ waterproofing/ paint for exterior building envelope walls. Interior-Plaster, wood trim and paint damaged by water penetration, some mold is present.	Moderate Damage. - Warped wood flooring due to water infiltration. - Ceiling Damage. - 1st floor room exterior door and shutters do not open due to possible water damage. - Stair from 1st to 2nd floor have cracked stringer due to possible settlement of supporting slab/foundation. - portion of retaining wall damaged by	Mechanical equipment suffered catastrophic damage, many outdoor condensing units are severely damaged with a few still operating but not full capacity. Mold has been noticed due to the AC systems not working properly or at all. Plumbing at main building appears intact but plumbing to adjacent structures have moderate deficiencies, lack of cold water at sinks and leaks.	Electrical conduits and wiring of branch circuits have been affected, requires further inspection. Almost half or more of exterior lighting fixtures have been affected. Some interior lighting is affected. Comm/Security and public address systems are not	Some of the Fire alarm System has been affected.	Severe but repairable - Remediation efforts that will be necessary as a result of water intrusion will required replacement of a significant portion of all partitions and building systems and equipments within the building.

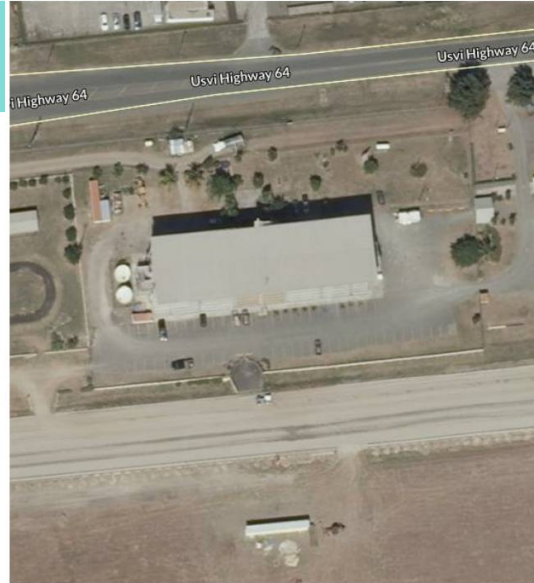
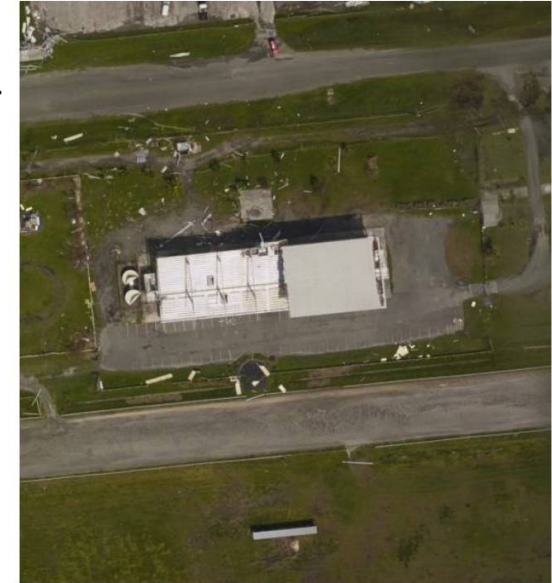
Facility Name	Architecture	Structure	Site_1	Mechanical/Plumbing	Electrical / Comm/ Security	Fire Protection	Overall Narrative Rating
Randall Doc James Racetrack	Minor to to Moderate Damage. Damage found at Horse Stable, Gate, Bleachers, and Press box.	Moderate Damage- Portions of the roof is missing.	Minor Damage, Some debris is present. Chain link fencing needs to be replaced in several areas.	Not Applicable	Minor Damage, Satellite dish has been destroyed.	Not Applicable	Minor Damage to Canopy, Horse Stable, Gate, Bleachers, and Press box.
