Issue Number: **N172404**

Part - Location: **Ignition Key Cylinder Assembly - Column - Steering**

Complaint: **vehicle can be keyed off with knee while driving**

Primary Project No:	Cobalt	Model Year:	2005
Other Project No(s):	05X001	Model Year Qtr:	
Vehicle/Prop. #:		Model Code:	
Marketing Division:	Chevrolet, Pontiac	Hardware Stage:	
Marketing Region(s):		(VIN) Vehicle ID #:	
Engine(s):		Transmission(s):	
Engine Serial #:		Transmission Serial #:	
Drive Type(s):		Option(s):	
Steering:		PIMREP No:

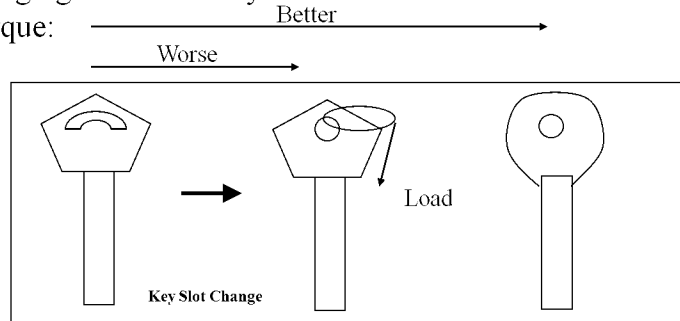
➤ Changing slot in the key in order to reduce lever arm and thus the torque:

✓ It was determined that the lever arm is still present due to fob ring. This may even cause a higher pulling load if fob ring is wedged between the slot and the sharp corner of key.

✓ Can be considered as a containment if the shape of key is changed to round corners

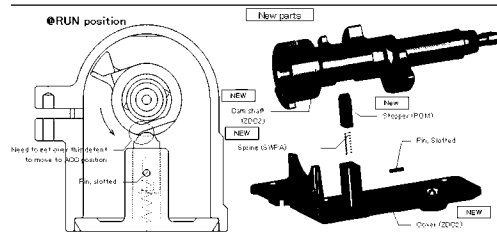
➤ Detent between lock cover and cam shaft:

- ✓ Partial solution based on engineering judgment. No experimental verification that detent is sufficient.
- ✓ If chosen, will drive changes and tuning efforts in ignition switch in order to avoid double detent feel.
- ✓ Design has to become common between Delta, Theta and Kappa
- ✓ Can be combined with the new ignition switch presently sourced for GMT191/2/3 for better detent
