**CALSPAN ON-SITE AIR BAG NON-DEPLOYMENT INVESTIGATION**

**CASE NO: CA05-049**

**VEHICLE: 2005 CHEVROLET COBALT**

**CRASH DATE: JULY 2005**

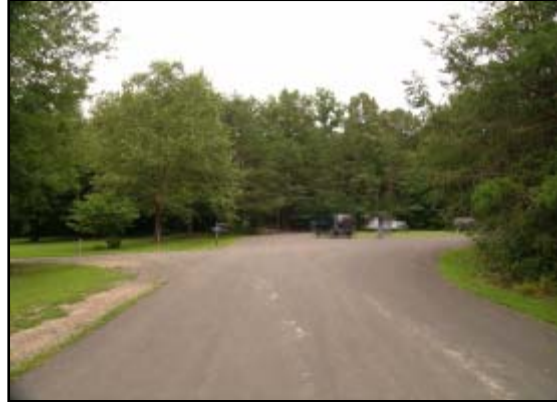
The 16-year old female driver was attending a house party at a residence located at the mouth of the cul-de-sac. She was under the influence of alcohol with a toxicology reported BAC of .17. The driver was not restrained by the manual 3-point lap and shoulder belt safety system. The lack of belt usage was determined from the vehicle inspection and EDR data. She left the party alone during the nighttime hours and attempted to exit the rural subdivision. For an unknown reason, the driver returned toward the cul-de-sac, traveling in a southerly direction on the left side of the two lane non-delineated roadway (**Figure 2**).

**Figure 2. Pre-crash travel direction and overall view of the crash site.**

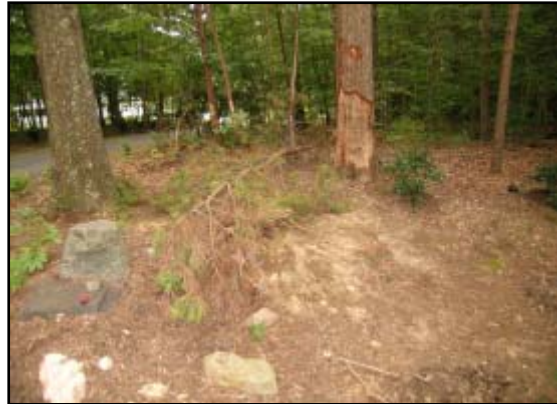
As the Cobalt traversed the mouth of the driveway, the undercarriage overrode the landscaping, which consisted of flush mounted rocks within the dirt and mulch. The front left area of the vehicle narrowly missed a large rock that was positioned vertically within the landscaped area. The Cobalt continued forward in a tracking mode and impacted a 13 cm (5") diameter pine tree with the front left area of the vehicle. The resultant direction of force for this impact event was 12 o'clock. The impact uprooted the tree, but did not fracture the 13 cm (5") trunk. The Cobalt carried the tree forward as this impact produced a minimal velocity change to the vehicle. (The delta V could not be calculated due to the masking of damage by the subsequent impact). **Figure 3** is an overall view of the crash site.

**Figure 3. Overall view of the crash site.**

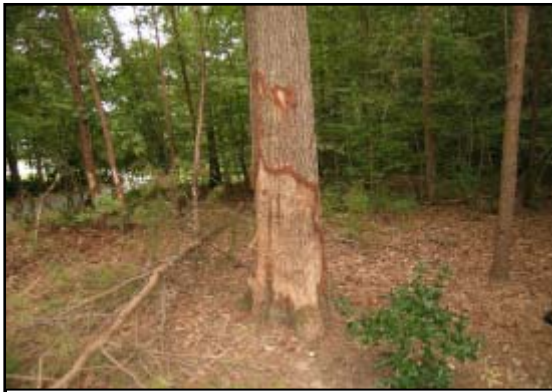
The Cobalt continued forward an additional 2.3 m where it struck a 51 cm (20") diameter hardwood tree with the front right area (**Figure 4**). At impact, the vehicle was in a near tracking attitude, and may have rotated slightly counterclockwise as a result of the initial

As the front bumper beam crushed to a depth of 110 cm (43.4"), the right front tire and wheel engaged the tree. The engagement fractured the alloy wheel and axle, and front suspension components, separating the wheel and brake assembly. The crush extended onto the right side plane of the Cobalt, engaging the right A-pillar and leading edge of the right door. The damage algorithm of the WinSMASH program computed a total velocity change of 61 km/h (37.9 mph) with longitudinal and lateral components of -60 km/h (-37.3 mph) and -11 km/h (-6.8 mph) respectively. The EDR recorded a maximum velocity change of 80 km/h (49.99 mph) at 300 msec of Algorithm Enable (AE). The frontal air bag system did not deploy. Due to the offset right crash, the Cobalt began to rotate in a clockwise (CW) direction as it separated from the tree.

**Figure 4. Impact with the 51 cm (20'') diameter hardwood tree.**

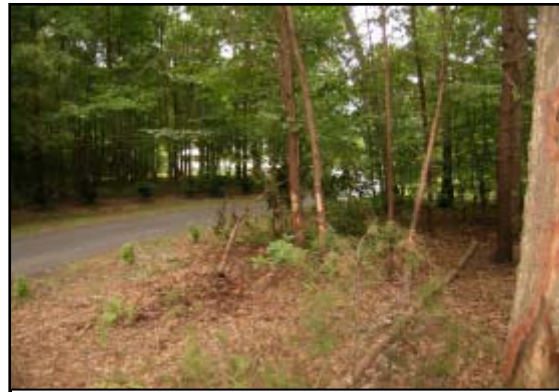
**Figure 5. Area of impact with the four small diameter trees and final rest.**

As the Cobalt rotated CW, the left side area impacted four small diameter trees that were located 2.8-4.6 m (9-15') south of the 51 cm (20'') diameter tree (**Figure 5**). The lateral impact deflected the trees, which resulted in a ramping effect as the undercarriage of the Cobalt rode up the trees. This ramping effect resulted in an overturn (flip-over) of the Cobalt as it rolled one-quarter turn onto its right side. The Cobalt continued to rotate approximately 40 degrees about its longitudinal axis prior to coming to rest on its side.

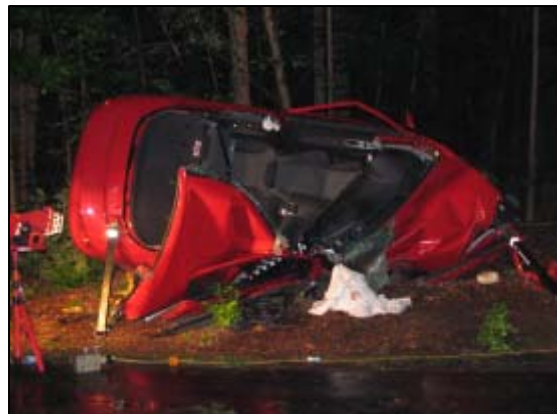
The Cobalt came to rest on its right side, facing in a northeasterly direction (**Figure 6**). At rest, the vehicle was facing in a direction that was nearly opposite of its initial travel direction. Volunteer fire

**Figure 6. On-scene image of the Cobalt at final rest.**
