INDIANA UNIVERSITY

TRANSPORTATION RESEARCH CENTER

ON-SITE AIR BAG NON-DEPLOYMENT INVESTIGATION

CASE NUMBER - IN-06-033
LOCATION - WISCONSIN
VEHICLE - 2005 CHEVROLET COBALT
CRASH DATE - October 2006

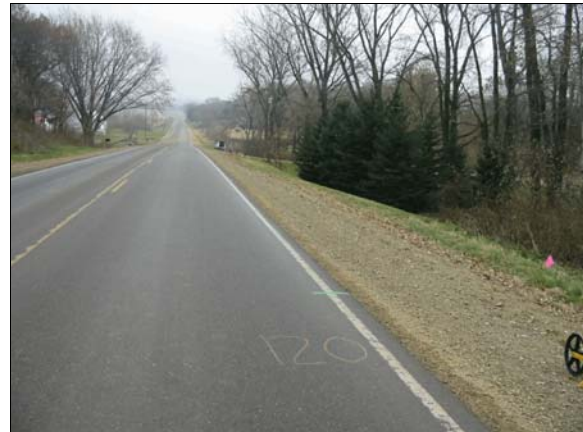
Figure 1: Approach of case vehicle eastbound to roadway departure, number on roadway indicates meters to impact

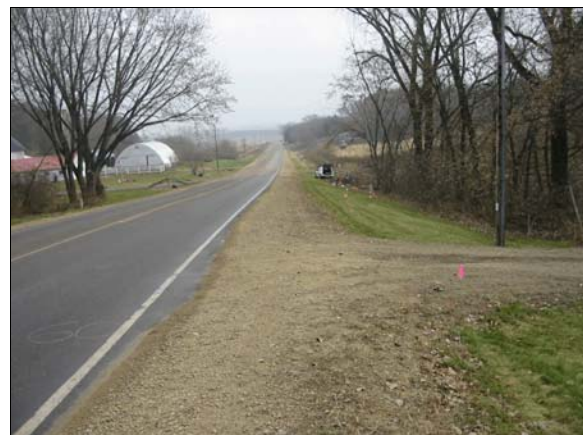
Figure 2: Overview of path of case vehicle, flag at edge of driveway shows track of case vehicle’s left side tires

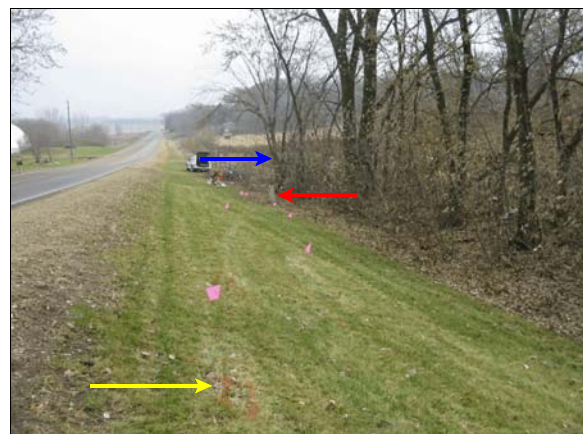
Figure 3: Vehicle touchdown location (yellow arrow) from vault and approach to telephone utility box impact (red arrow) and impact with clump of trees (blue arrow)

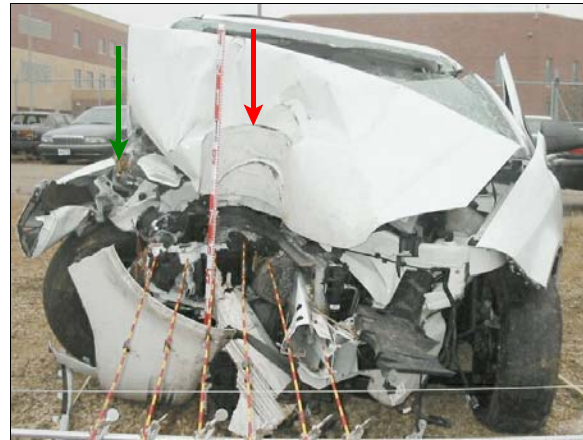
The center right of the case vehicle initially engaged the leading tree in the clump and then the front right engaged a tree immediately behind and to the right of the first tree (Figures 4 and 5). The first tree was displaced in the ground and broken off at the root. It appeared that a branch from this tree also broke off and impacted the top of the case vehicle and broke out the backlight (event 3). The case vehicle's driver and front right air bags did not deploy as a result of the impact with the clump of trees, possibly due to the yielding nature of the impact with the first tree or power loss due to movement of the ignition switch just prior to the impact. See the discussion below under the "Case Vehicle" and "Crash Data Recording" sections for further information regarding the ignition switch problem and air bag non-deployment.

Figure 4: Damage to case vehicle from impact with clump of trees, red arrow shows impact location of tree that broke off, green arrow shows impact location of second tree, vertical scale in tenths of meter

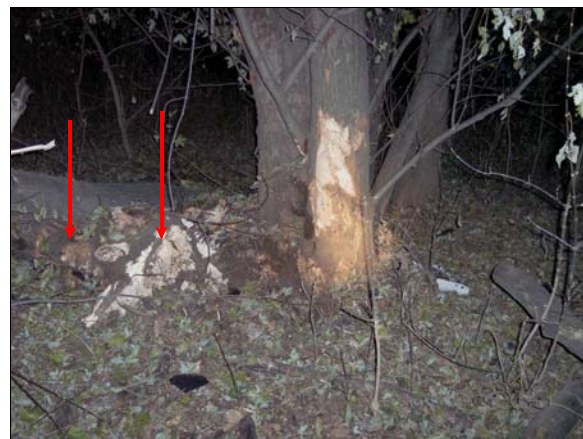
Figure 5: Police on-scene photo of impacted clump of trees, arrows shows broken/uprooted tree

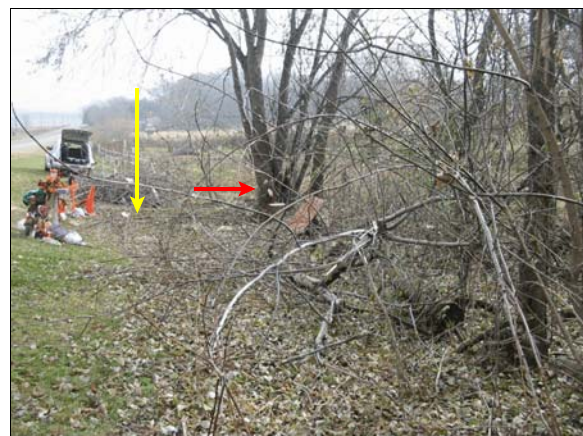
Post-Crash: As a result of the tree impact, the case vehicle rotated clockwise approximately 90 degrees and came to rest heading southwest (Figure 6). At final rest the case vehicle was approximately 3 meters (10 feet) north of the impacted clump of trees.

Figure 6: Red arrow shows impacted clump of trees, yellow arrow shows area of case vehicle's final rest

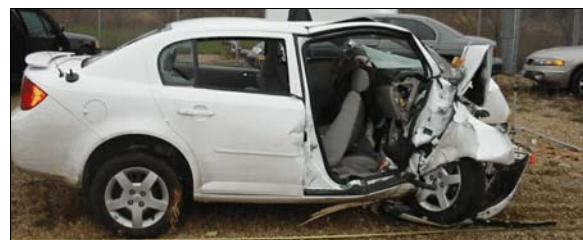
Exterior Damage: The case vehicle’s initial impact with the telephone utility box involved the center portion of the front bumper. The precise location of the damage on the front bumper from the telephone utility box could not be determined due to the overlapping damage from the subsequent tree impact and missing portions of the front bumper fascia. The case vehicle’s impact with the tree involved the front right portion of the case vehicle. The front bumper, grille, hood, and right fender were directly contacted and crushed rearward. The direct damage began at the front right bumper corner and extended approximately 45 centimeters (17.7 inches) along the front of the of the vehicle. The front crush profile was taken at the bumper level. The maximum residual crush was determined to be 121 centimeters (47.6 inches) occurring at C₃ (**Figures 7 and 8**). The direct damage from the tree branch impact involved the roof and the backlight. There was a dent located near the right “C”-pillar and the backlight was broken out. The table below shows the case vehicle’s front crush profile.

Figure 7: Right side view of crush to front of case vehicle from impact with clump of trees

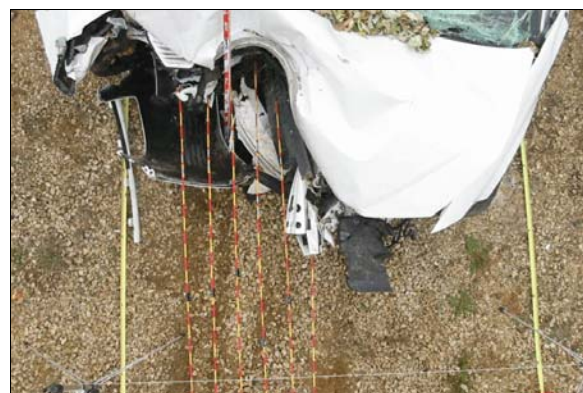
Figure 8: Top view of crush to front of case vehicle from impact with clump of trees, each increment on rods is 5 cm (2 in)

The case vehicle’s right side wheelbase was reduced 58 centimeters (22.8 inches). The left side wheelbase was extended 5 centimeters. Induced damage involved the left fender, hood, roof, right front door, right “A”-pillar and right roof side rail. The rescue crew cut the right “A”-pillar and removed the right front door.

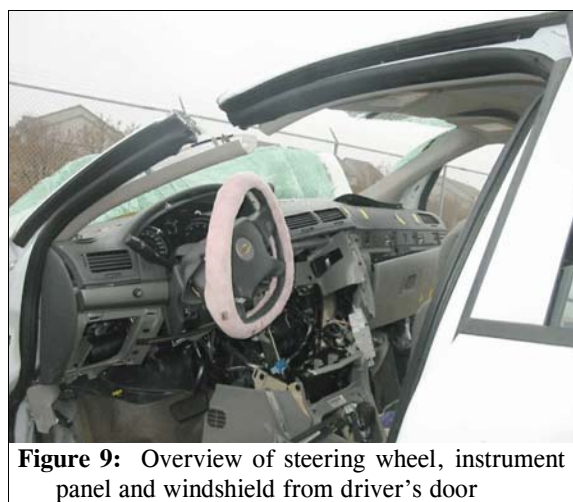
Vehicle Interior: Inspection of the case vehicle’s interior (**Figure 9** and **Figures 10** and **11** below) revealed that primarily the right half of the steering wheel was severely bent forward and the steering column was crushed forward and upward (**Figure 12** below) due to driver loading. The driver’s knee bolsters had been heavily contacted by the driver’s knees and broken out. There were scuff marks on the right instrument panel and the glove box door due to loading by the front right passenger. The front right passenger’s seat back was also intruded forward nearly to the instrument panel (**Figure 10** below) due to loading by the unrestrained back right passenger. Passenger compartment intrusion involved the driver’s and front right passenger’s toe pans, which intruded longitudinally 18 centimeters (7.1 inches) and 23

Figure 9: Overview of steering wheel, instrument panel and windshield from driver’s door

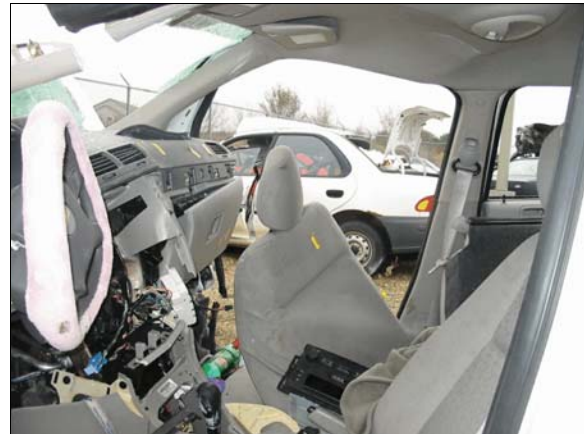
centimeters (9 inches) respectively. The brake pedal also intruded longitudinally 18 centimeters (7.1 inches), and the right instrument panel intruded 18 centimeters (7.1 inches) longitudinally into the front right passenger's occupant space.

Figure 10: Left side view of steering wheel, instrument panel and displacement of front right seat back and head restraint due to the back right passenger loading the seat back into the front right passenger

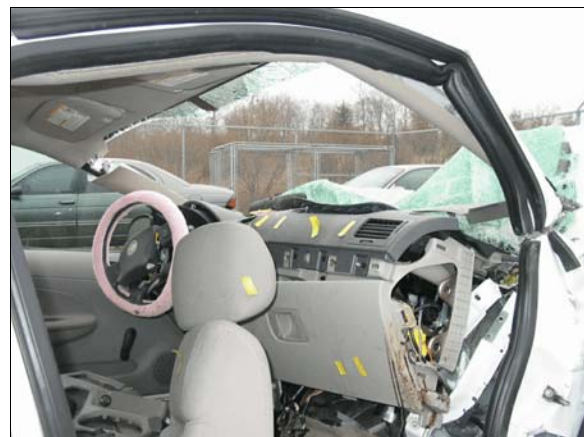
Figure 11: Right side view of case vehicle's front seating row, instrument panel, steering wheel and windshield

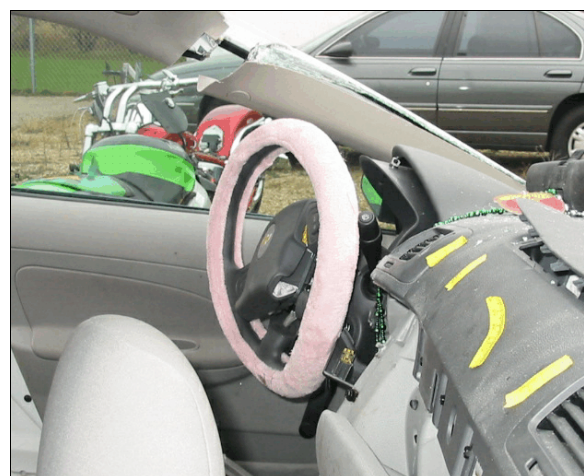
Figure 12: Right side view of deformation to steering wheel and steering column

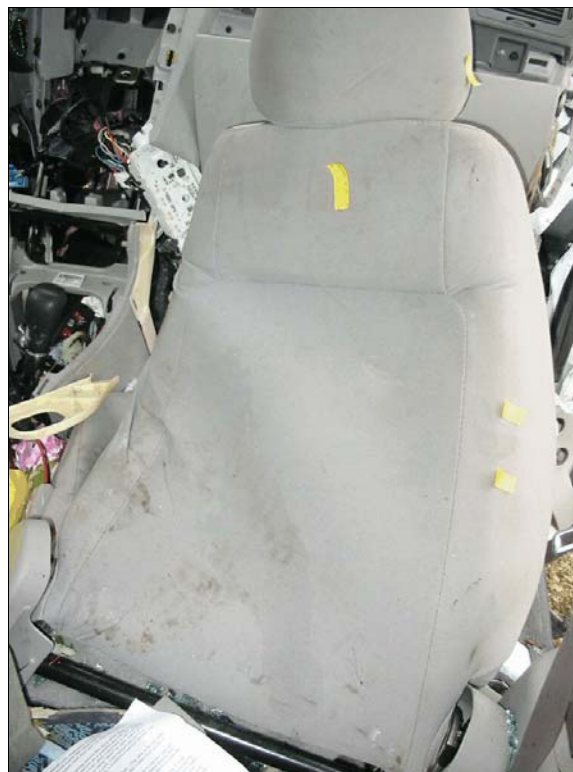
seat back extensively forward (Figure 13). The back right passenger most likely ramped over the seat back and impacted her head on the windshield header causing facial fractures and a traumatic brain injury. The back right passenger rebounded and as the case vehicle rotated clockwise, she most likely contacted the right rear door. She was found lying face up across the back seat with her feet in the floor pan behind the driver’s seat. She was removed from the case vehicle by rescue personnel.

Figure 13: Damage to front right passenger’s seat back due to loading by unrestrained back right passenger

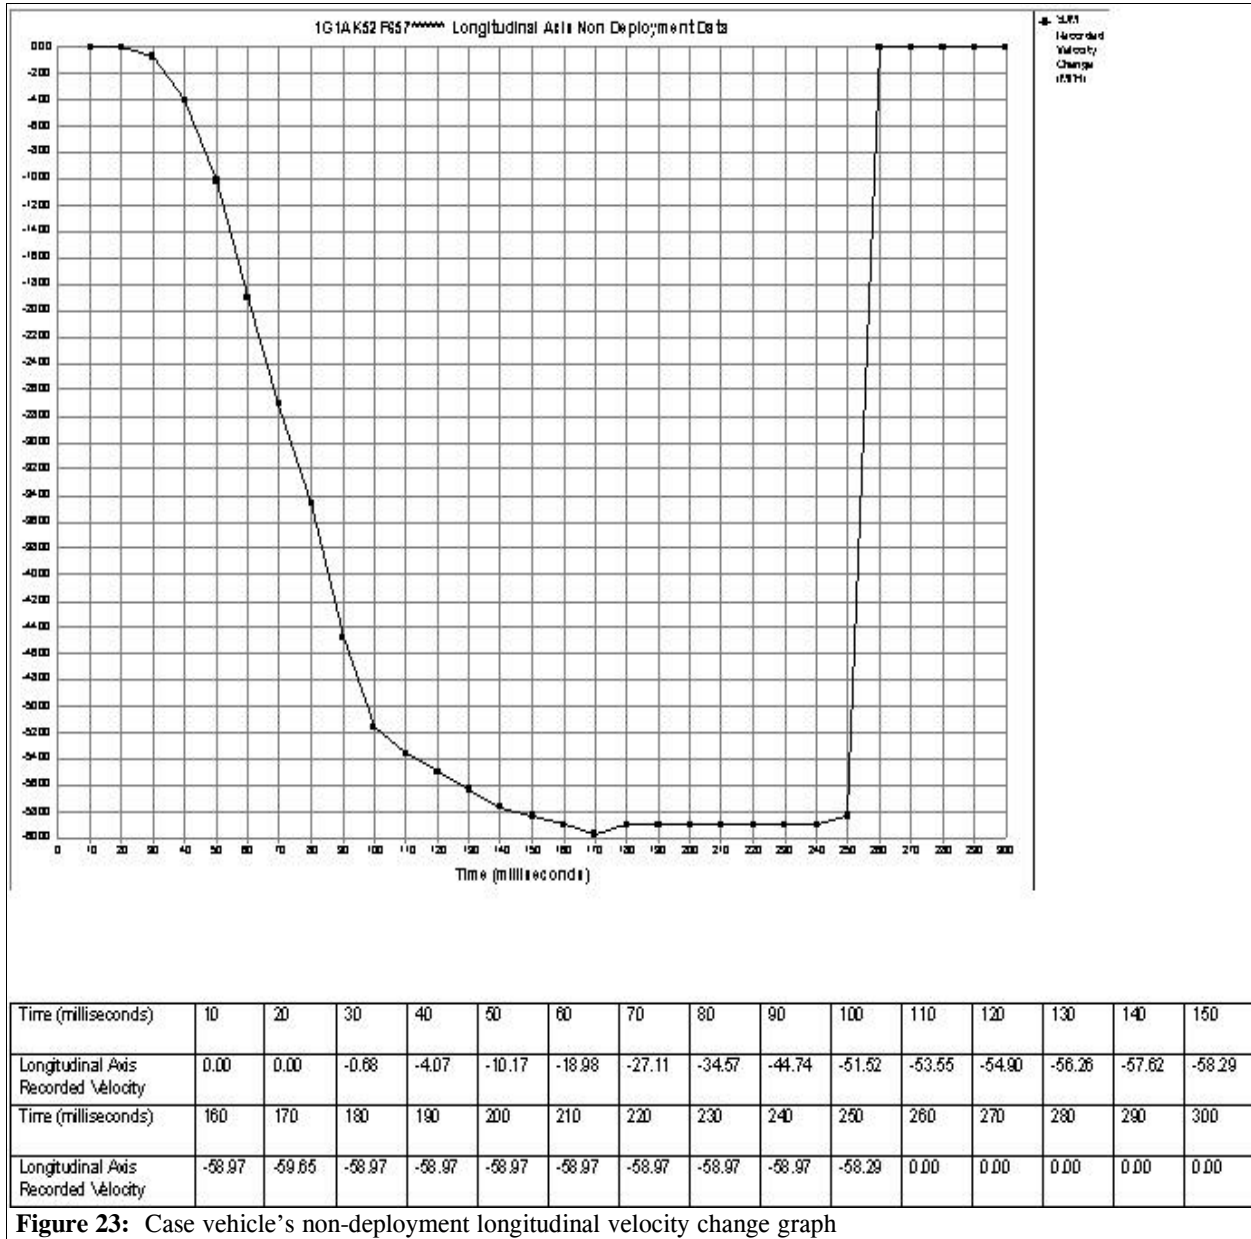
Analysis of the case vehicle’s EDR data in light of the yielding of the first tree contacted during the impact with the clump of trees suggest another possible reason for the non-deployment of the driver and front right passenger air bags in this crash. The slope of the case vehicle’s initial longitudinal crash pulse was compared to the slope of the initial longitudinal crash pulse from two

Chevrolet Cobalt deployment files from prior cases. The data indicated that the slope of the case vehicle's initial crash pulse was not nearly as steep as that of the comparison deployment files. It is possible that due to the yielding nature of the initial impact with the clump of trees, the case vehicle's crash sensing algorithm, which must make its deployment decision within the approximate first 50 milliseconds following algorithm enable, predicted that the crash would not be severe enough to require air bag deployment and did not issue a deployment command.

Figure 23: Case vehicle's non-deployment longitudinal velocity change graph

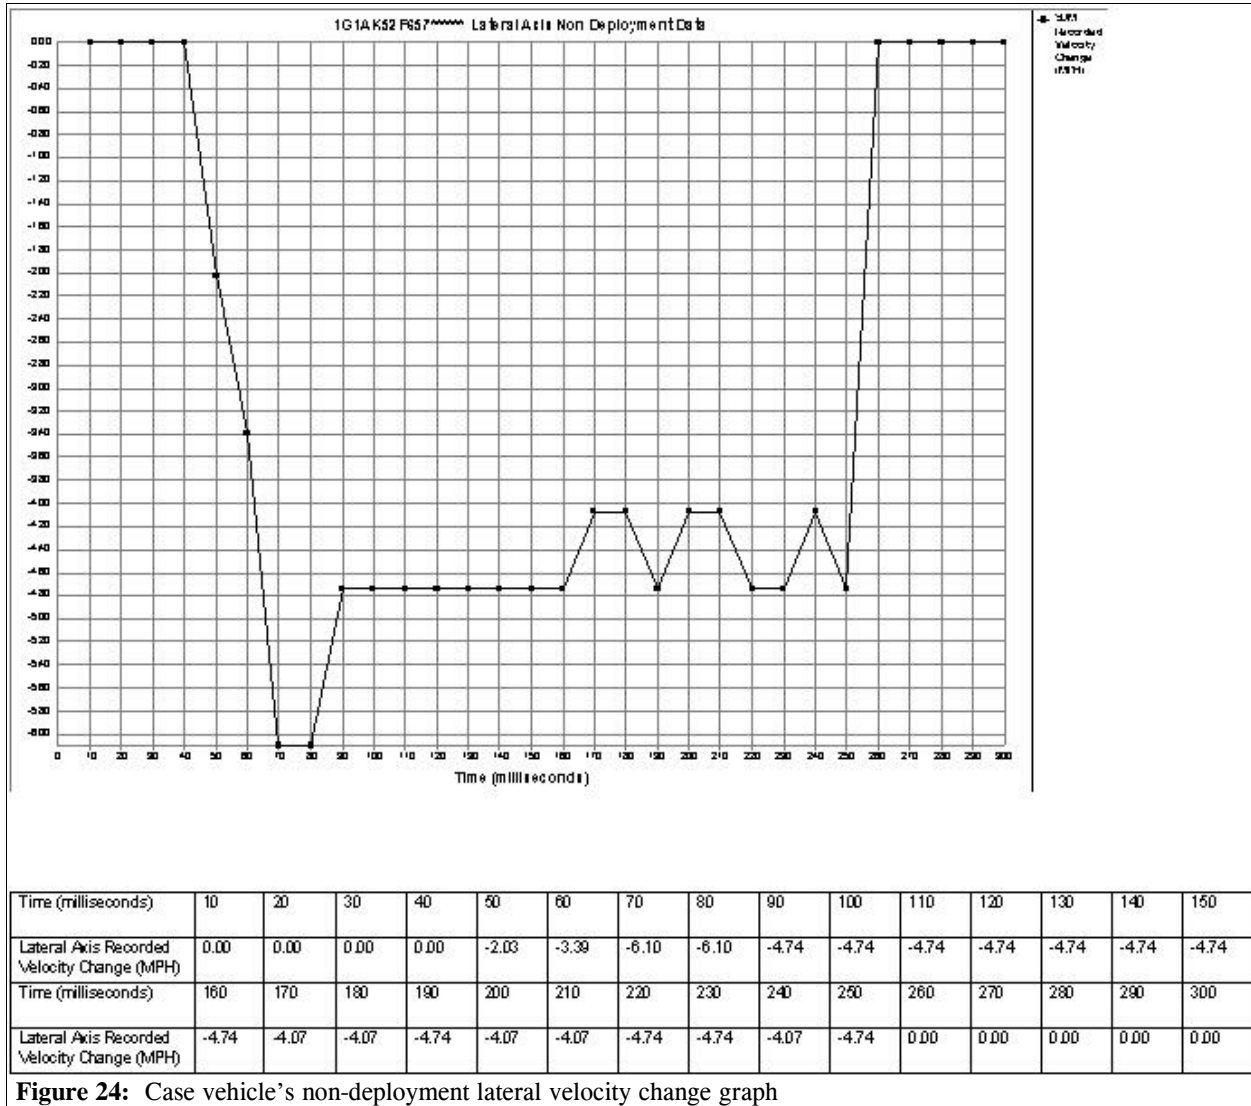
Figure 24: Case vehicle's non-deployment lateral velocity change graph
