**2005-2007 Cobalt/Pursuit/G5**  
**Front Airbag Non-Deployment**  
**709,741 Vehicles**  
**Cost Estimate: \$14.2M-\$37.7M**

ETQ N-130454

**Condition:**

Front airbag non-deployment has been identified in certain crash events. In those events the ignition switch was in ACCESSORY or OFF.

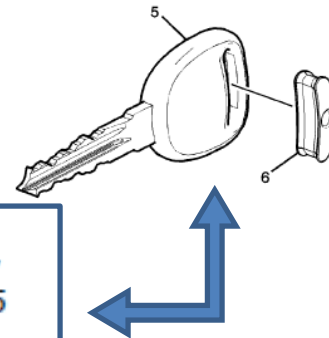
Engineering has come up with an insert for the key ring so that it goes from a "slot" design to a hole design. As a result, the key ring cannot move up and down in the slot any longer – it can only rotate on the hole. In addition, the previous key ring has been replaced with a smaller, 13 mm (0.5 in) design. This will result in the keys not hanging as low as in the past.

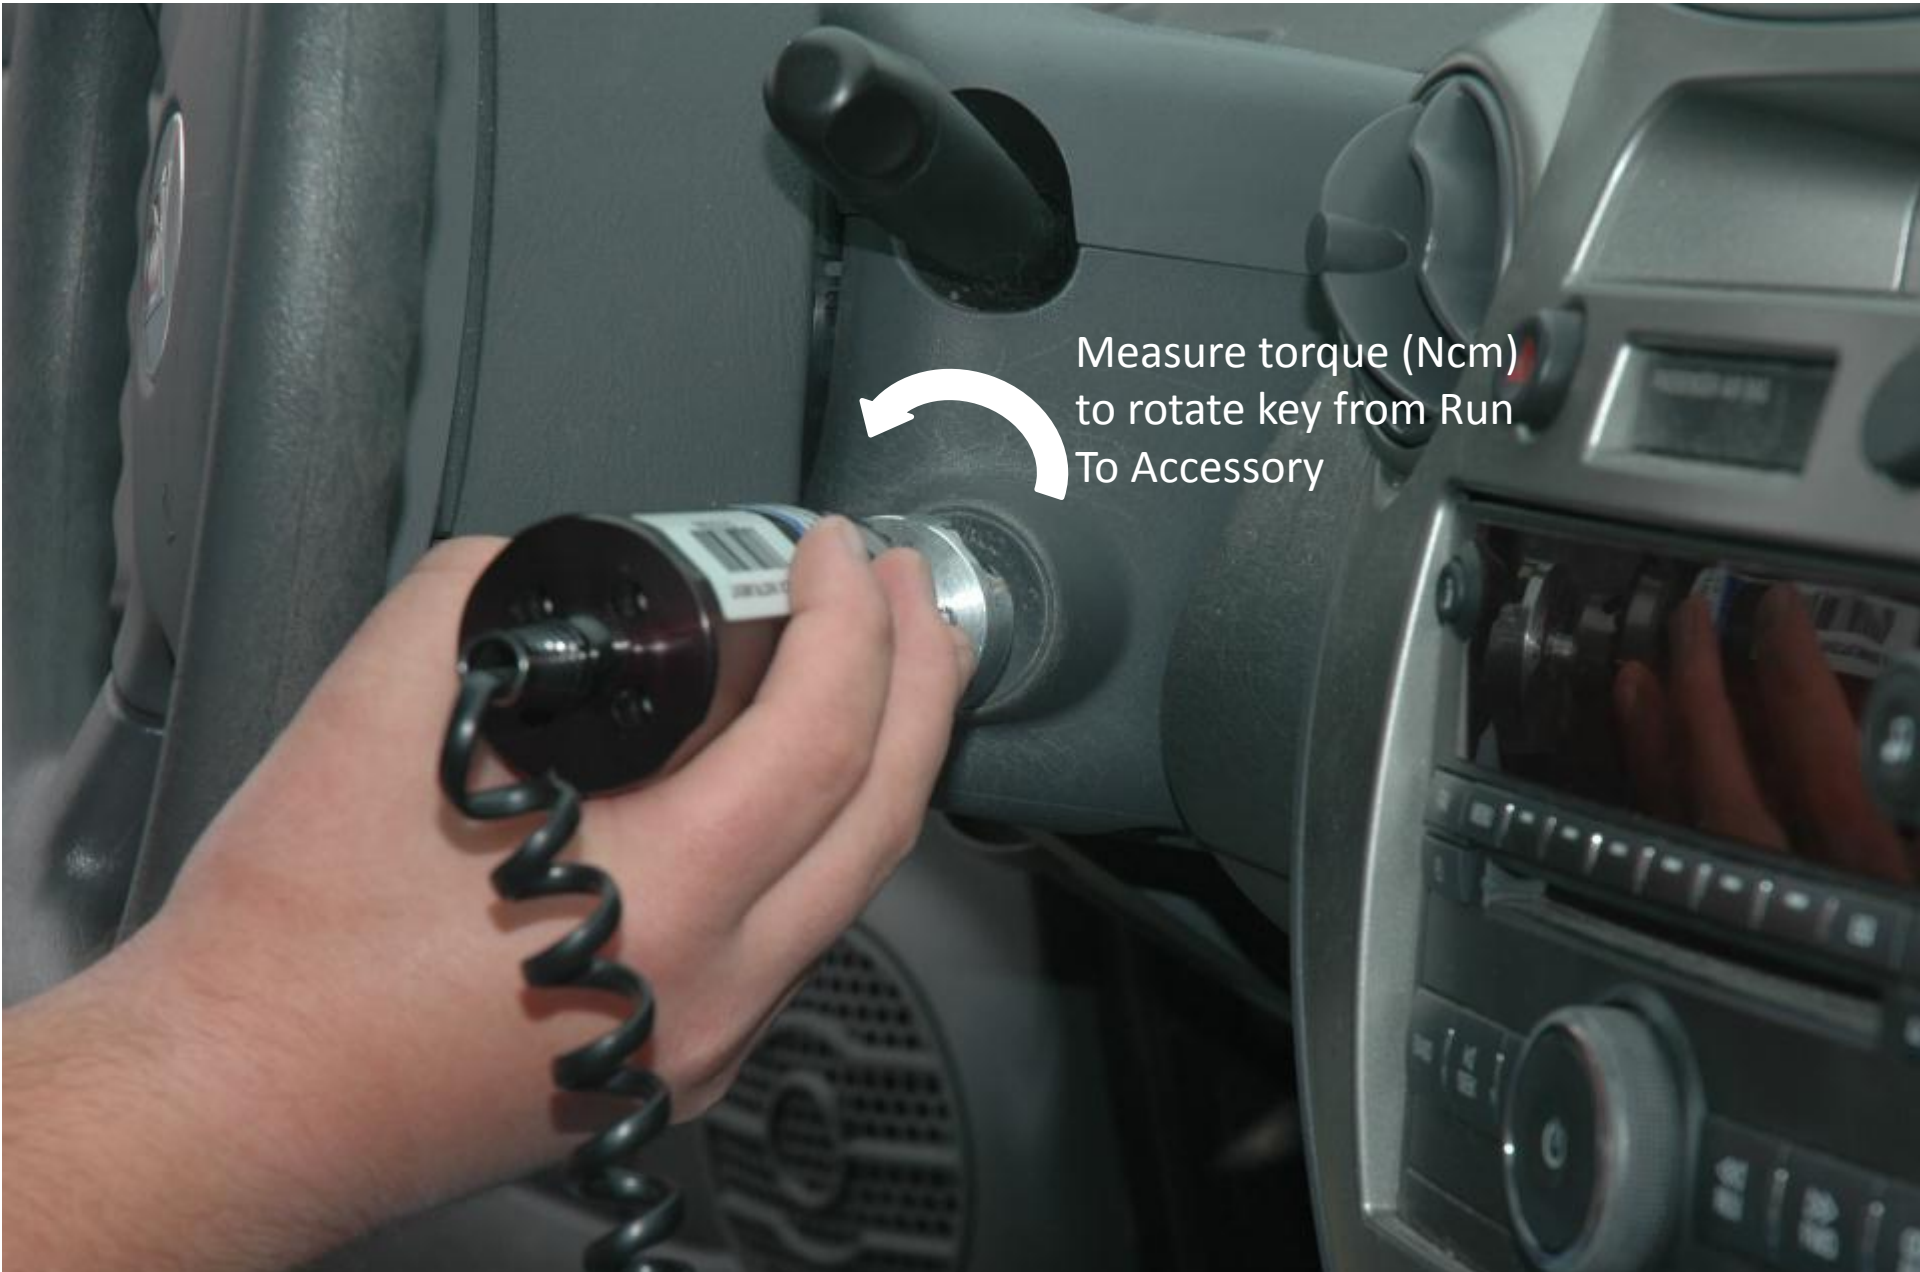
# Test Set-up Using Torque Tool

Measure torque (Ncm)  
to rotate key from Run  
To Accessory

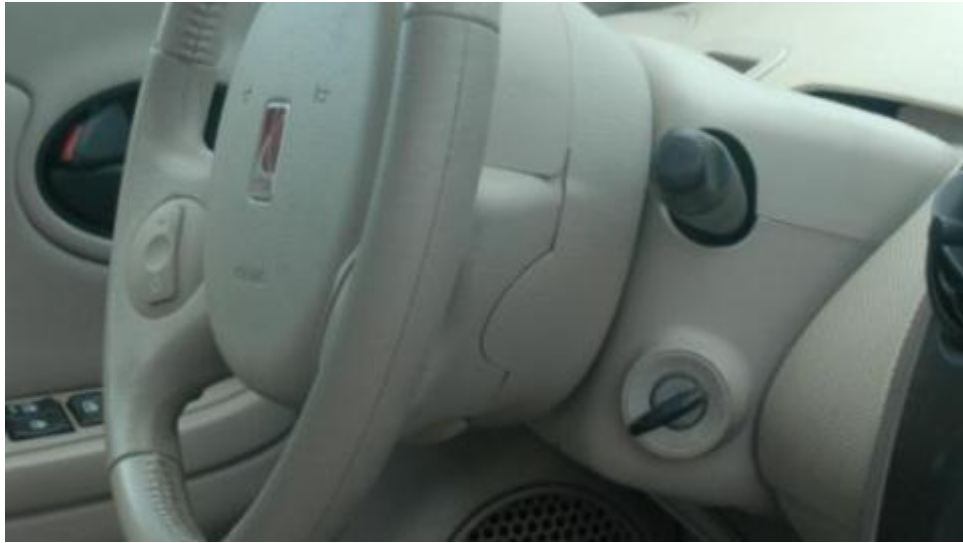
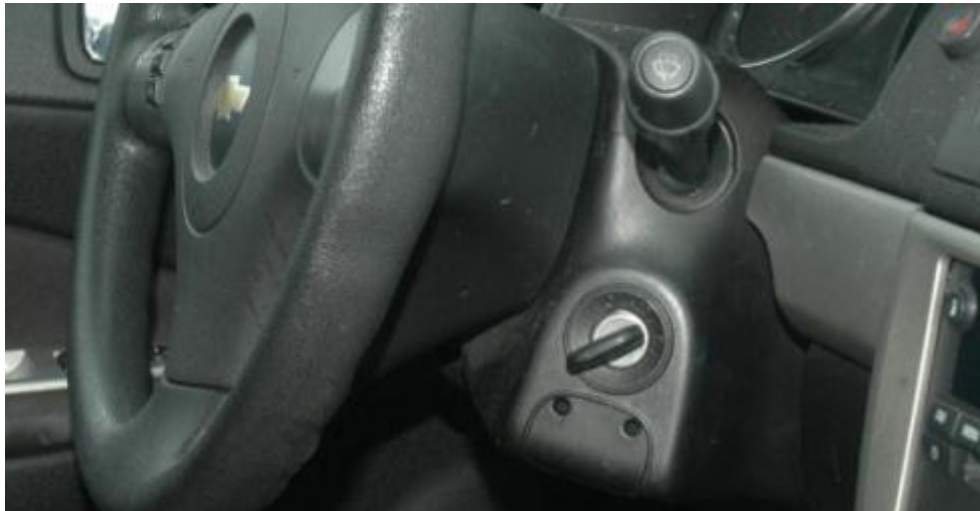
# 2003 Ion vs 2007 Cobalt

- Review indicates 2 potential non-deploys for Ion, but are not confirmed to be the same cause.
- Ion has different column shroud which could affect potential for key interaction
- HHR has more clearance to the driver's knee
