2005-2007 Cobalt/Pursuit/G5

ETQ N-130454

Ignition Switch

778,563 Vehicles

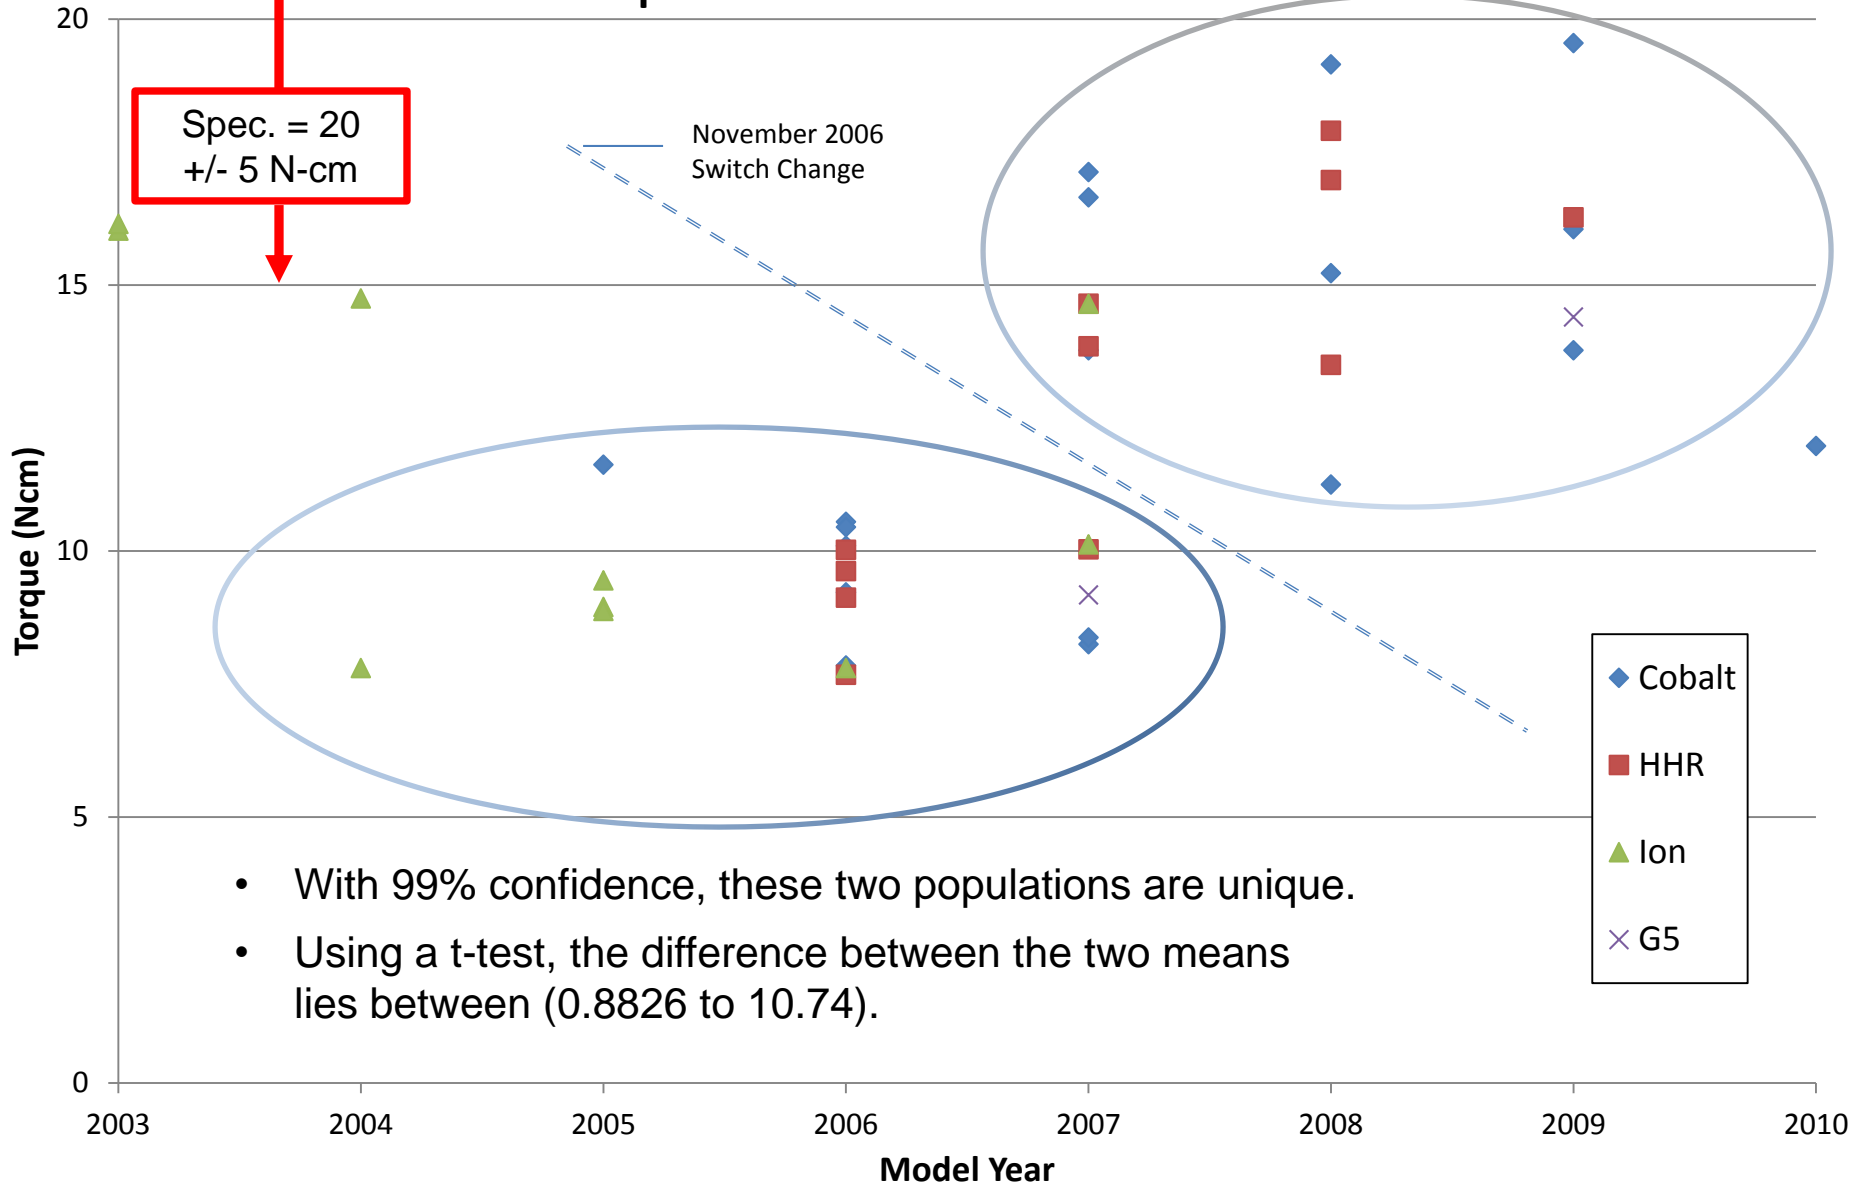
Salvage Yard Vehicle Measurements

Torque to Rotate From Run Position

Original Switches only.

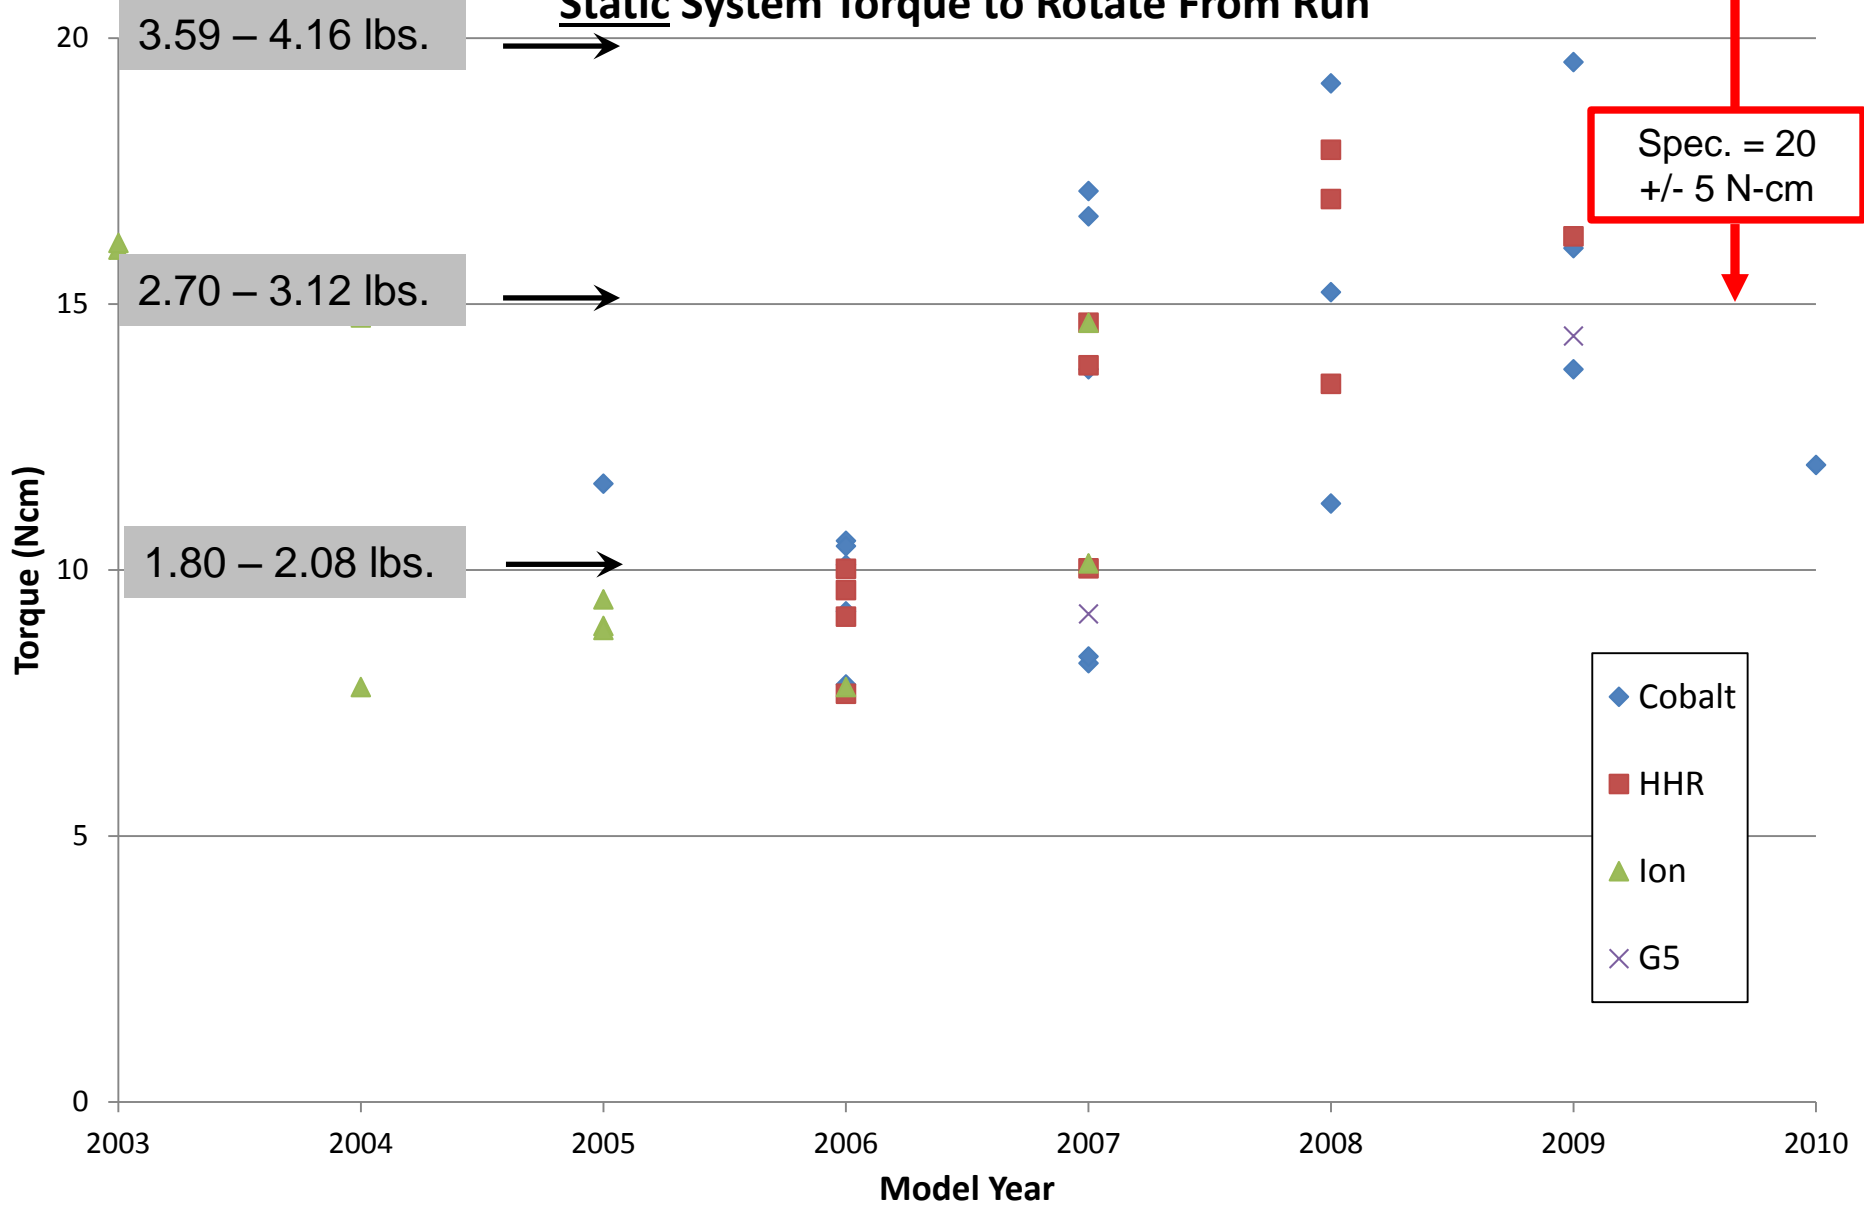
Salvage Yard Vehicle Measurements

Static System Torque to Rotate From Run

Spec. = 20
+/- 5 N-cm

Original Switches only.

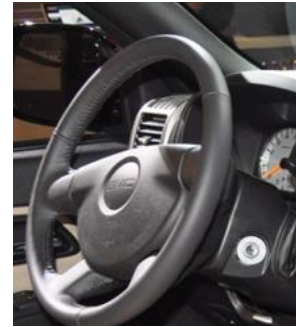
Colorado/Canyon – low mount and awkward key insertion

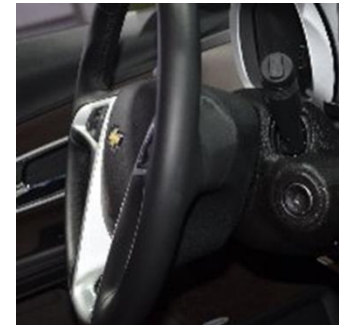
Equinox - mid mount – increases shroud width

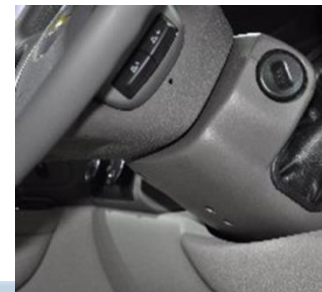
Tahoe - high mount – eliminates ability to have RH wiper stalk

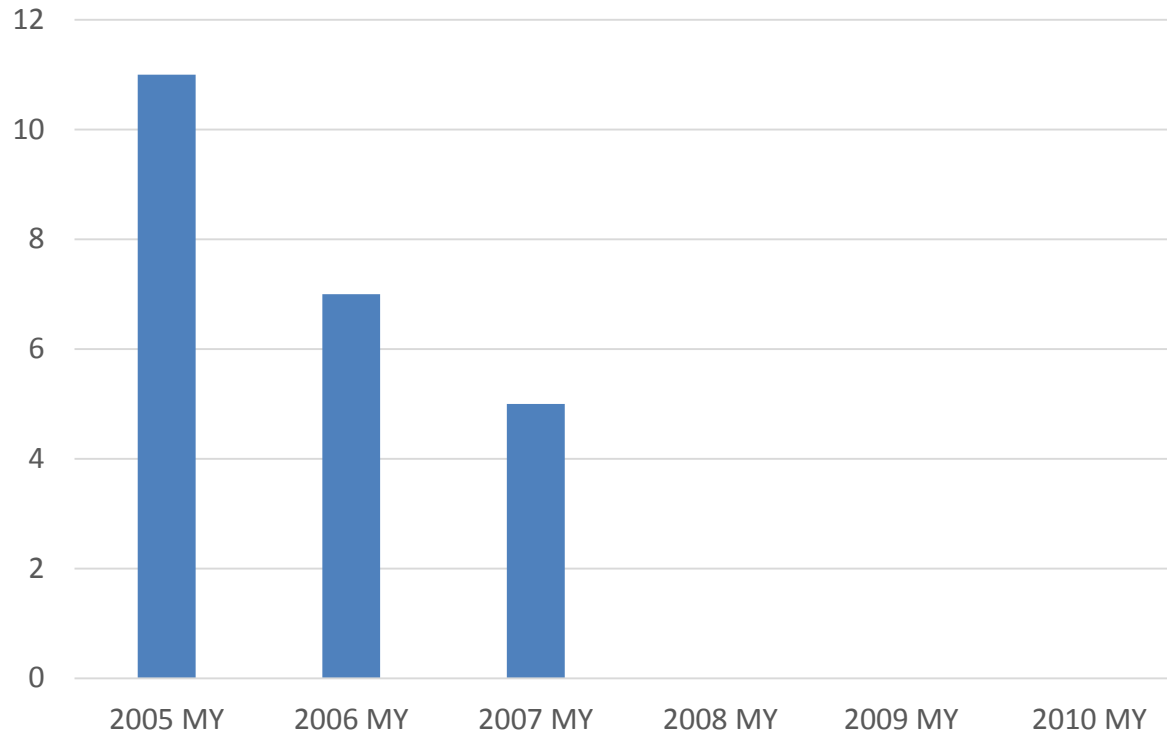
Non-Deployment Allegations by Model Year Cobalt (22), G5 (1)

A revision to the switch occurred during the 2007 MY to increase the torque to rotate.

- The part number was not changed and the breakpoint is unconfirmed, but is believed to be in early November 2006.
- 4 of the allegations within the 2007 MY are after November 2006.

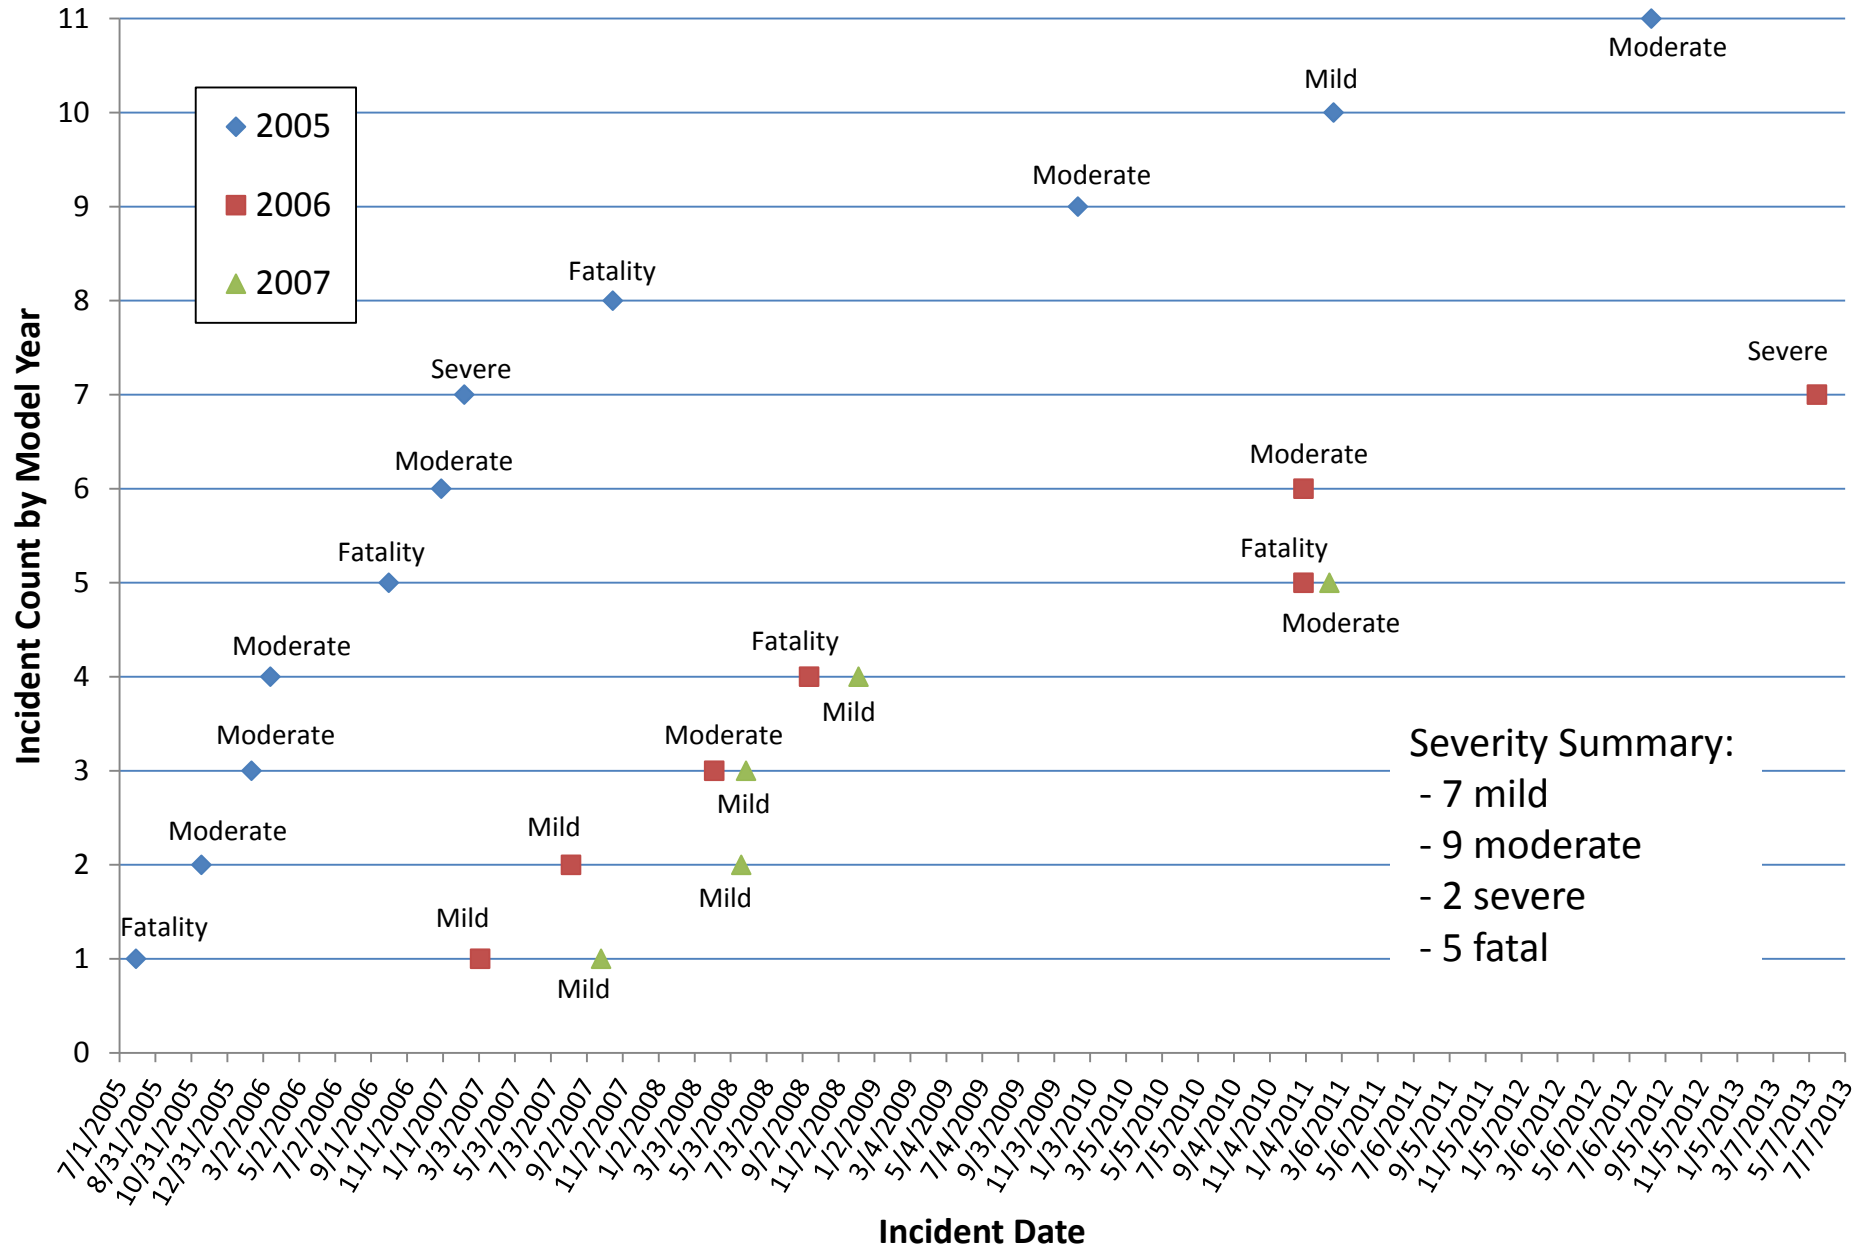
Severity of Injuries: 2005-7 Cobalt / G5 Reports of Airbag Non-Deploy

Severity Summary:

- 7 mild
- 9 moderate
- 2 severe
- 5 fatal

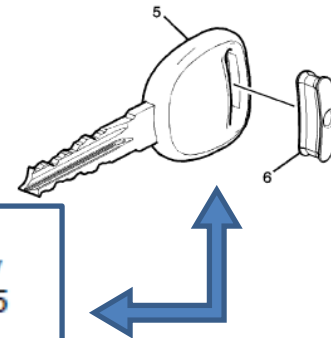
There is potential for the driver to inadvertently turn off the ignition due to low ignition key cylinder torque/effort.

The concern is more likely to occur if the driver is short and has a large and/or heavy key chain. In these cases, this condition was documented and the driver's knee would contact the key chain while the vehicle was turning and the steering column was adjusted all the way down. This is more likely to happen to a person who is short, as they will have the seat positioned closer to the steering column.

In cases that fit this profile, question the customer thoroughly to determine if this may be the cause. The customer should be advised of this potential and should take steps to prevent it – such as removing unessential items from their key chain.

Engineering has come up with an insert for the key ring so that it goes from a "slot" design to a hole design. As a result, the key ring cannot move up and down in the slot any longer – it can only rotate on the hole. In addition, the previous key ring has been replaced with a smaller, 13 mm (0.5 in) design. This will result in the keys not hanging as low as in the past.

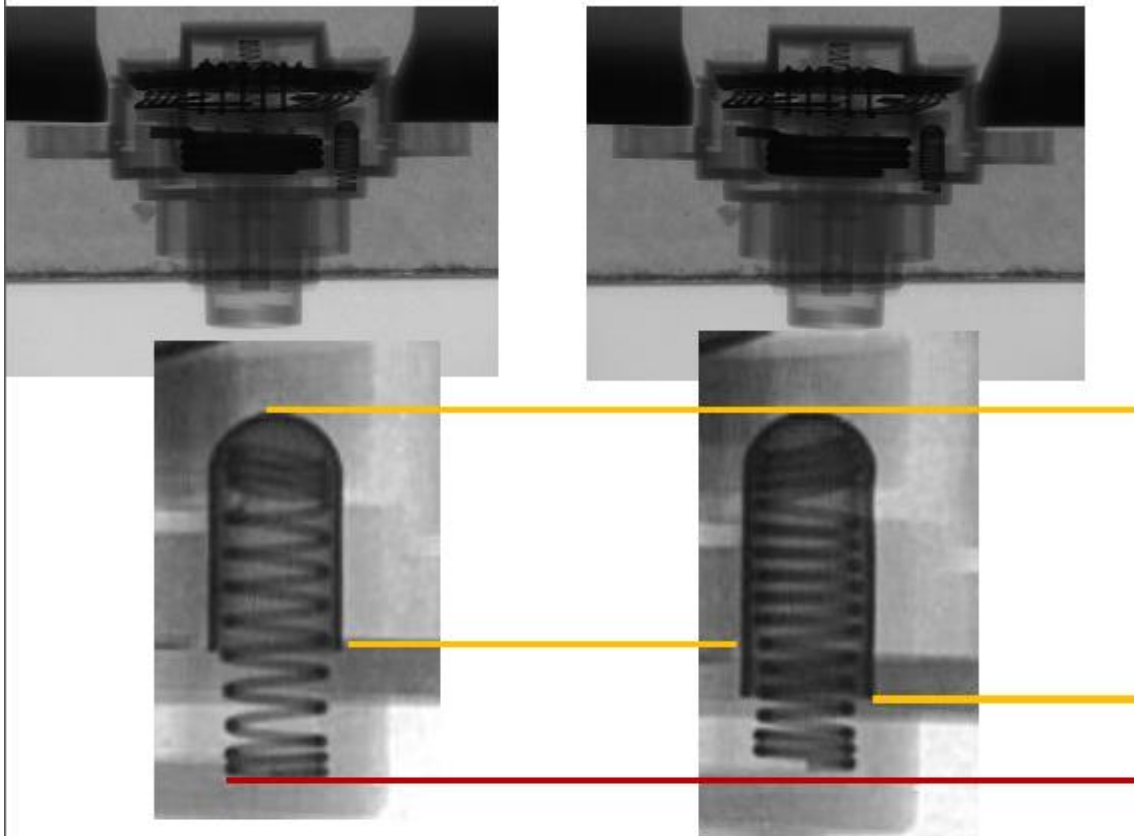
2008 Salvage Yard Cobalt

- Ignition switch with increased effort passed validation 4/26/06.
- Part number not changed.
- Implementation date is unknown.

- 15 spring coils
- Run to Acc: -22.6 N-cm
