Issue Number: **N202832**

Part - Location: **Ignition Switch -Steering Column**

Complaint: **Engine will not start, sometimes sets DTCs B2960 and/or B3033**

Vehicle/Product Line: **ZAcad**

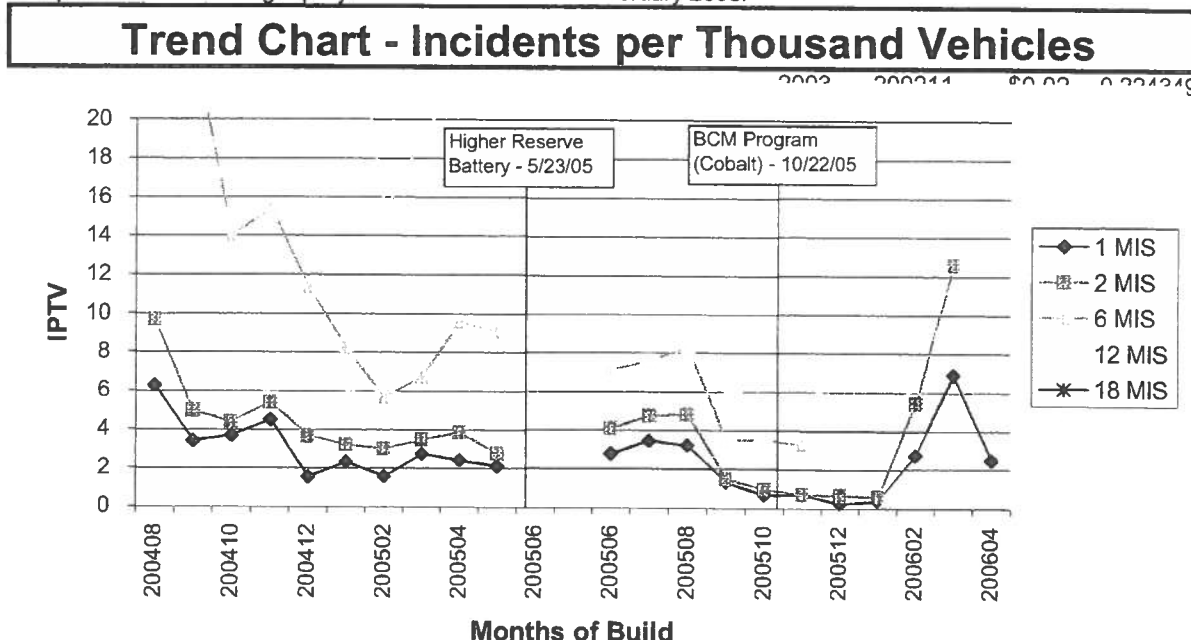
Some indicate car will start by manipulating the ignition switch. Others indicate Passlock codes B2960 and/or B3033 are stored in history.
Tech Repair: Replace ignition switch.

Complaints are increasing rapidly with vehicles built after February 2006:
