COLLISION ANALYSIS & RECONSTRUCTION REPORT

COLLISION DATE: 10-24-2006

**LOCATION: CTH N East of North Skyline Drive
ST CROIX COUNTY, WI**

REPORT DATE: February 14, 2007

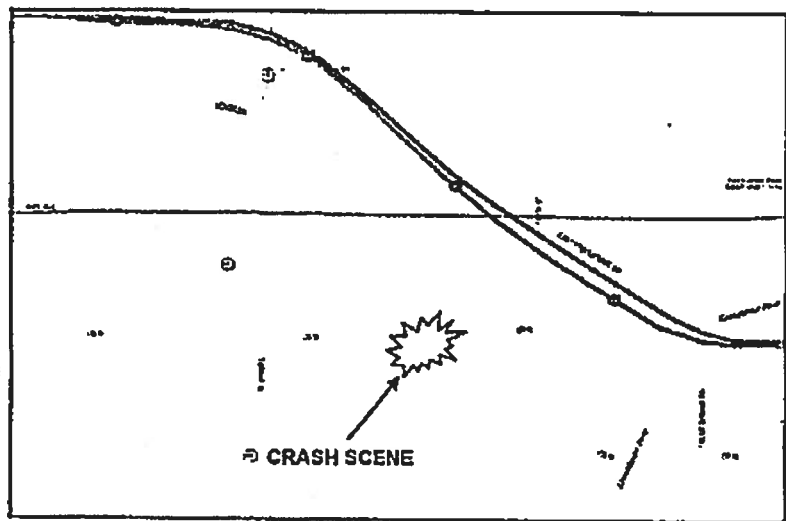
Upon my arrival on scene I viewed the scene with Deputy Mark Sommers and Trooper William Traynor. The roadway leading up to the crash scene was inspected for any indication as to why the [REDACTED] vehicle left the road. The first evidence that could be observed was gravel from the shoulder scattered onto the eastbound lane approximately 195 feet west of the driveway at 1237 CTH N. This was most likely caused by the tires of the [REDACTED] vehicle as they left the roadway. There were rolling tire marks in the south ditch that lead up to the edge of the driveway. The vehicle then struck the sloped driveway embankment and vaulted approximately 59 feet through the air. The vehicle landed and traveled another 82 feet before striking a telephone junction box. The vehicle then traveled an additional 46 feet before striking a grouping of two trees, and rotating approximately 94 degrees. The vehicle came to rest just north of the trees, facing south in the south ditch.

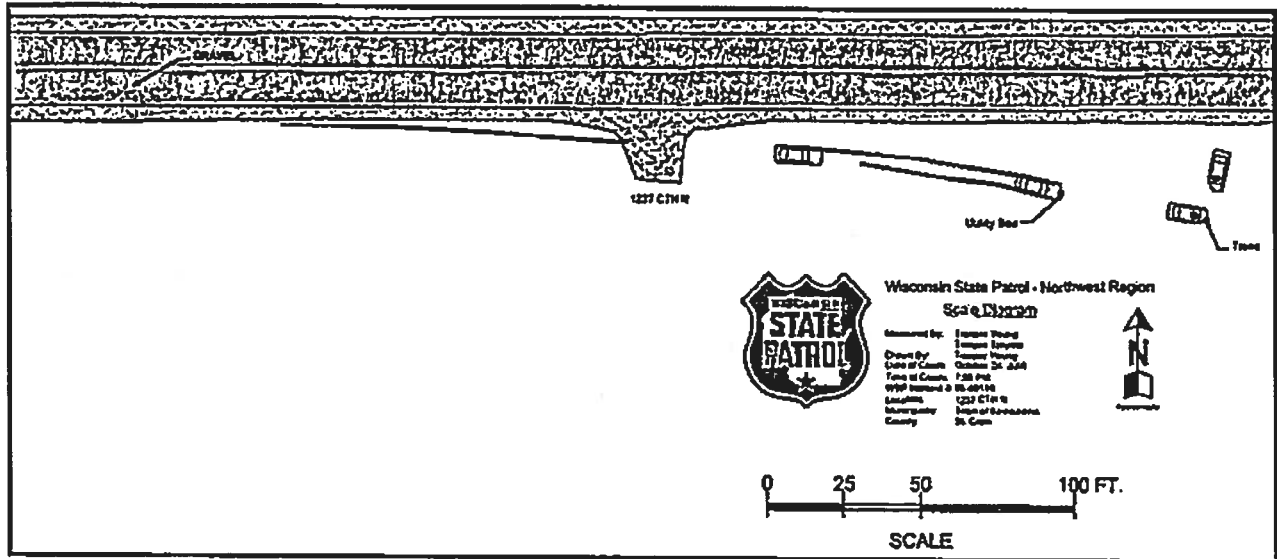
As the [REDACTED] vehicle traveled down a slight grade her vehicle went onto the south shoulder and into the south ditch. When the vehicle approached the driveway at house number 1237 it launched off of the west edge of the driveway and was airborne for approximately 59 feet. The vehicle landed and traveled approximately 82 feet before striking a telephone junction box and knocking it down. The vehicle then traveled another 46 feet through some brush before striking two larger trees. The vehicle then rotated clockwise approximately 94 degrees while traveling another 14 feet before coming to rest.

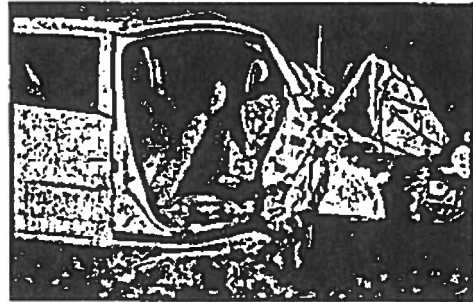
There was heavy frontal contact damage concentrated on the right side and induced damage to the roof and passenger side. Emergency medical services (EMS) had removed the right front passenger door and cut both A-pillars to extricate the front seat occupants.

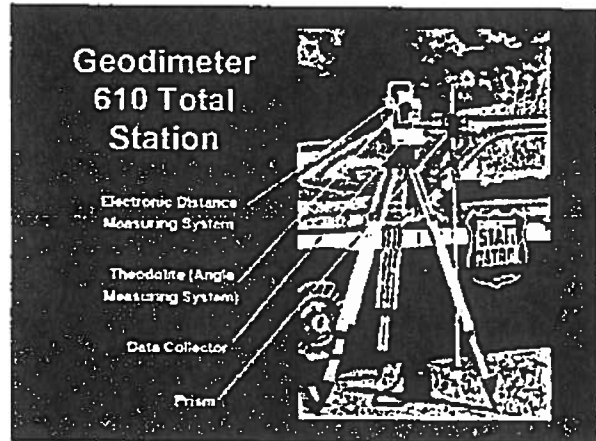
On October 24, 2006, with the assistance of Trooper William Traynor the crash scene was mapped with the State Patrol's Geodimeter 610 Total Station. Detailed measurements of the scene were taken locating roadway and lane edges, tire marks, a utility box and tree as well as the final rest position of the vehicle involved in the crash. The measurements obtained using the total station were then used in *Crash Zone*, a *Computer Aided Drawing* (CAD) program to produce a forensic map of the crash scene.

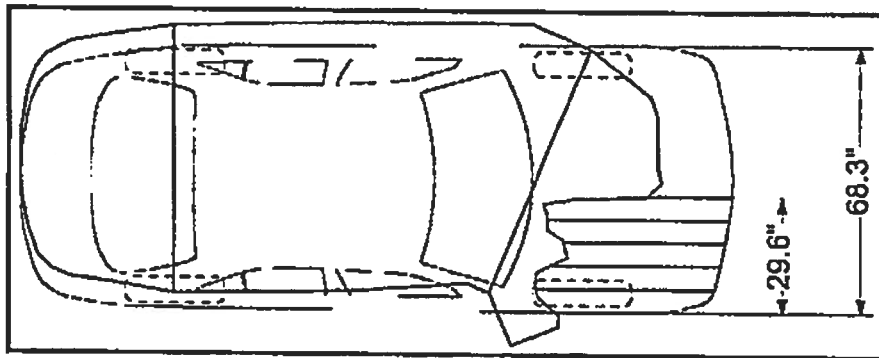
On November 6, 2006, Trooper Traynor and myself went to the St. Croix County Impound Lot to measure the damage profile of the [REDACTED] vehicle. Using the State Patrol's Geodimeter 610 Total Station, measurements of the [REDACTED] vehicle were taken to determine the amount of deformation that was caused by the collision with the trees.

The ***Vault Formula*** was used to determine the speed of the vehicle when it vaulted off of the driveway. The vault speed was calculated to be approximately **48 mph**. A crush analysis was also performed to determine the speed lost impacting the grouping of two trees and damaging the front of the vehicle. The crush calculations indicated a speed of approximately **38 mph** at the trees.
