ON-SITE AIR BAG NON-DEPLOYMENT INVESTIGATION

CASE NUMBER - IN-06-033

VEHICLE - 2005 CHEVROLET COBALT

CRASH DATE - October 2006

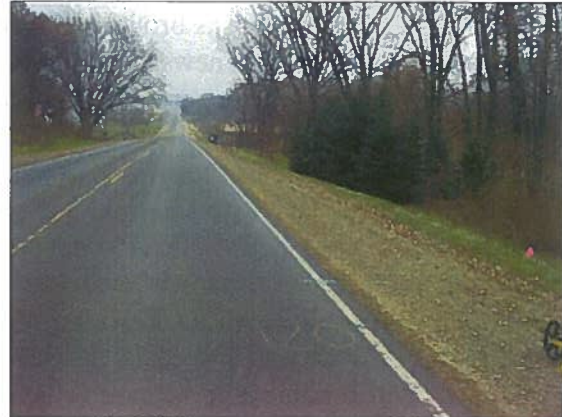
Figure 1: Approach of case vehicle eastbound to roadway departure, number on roadway indicates meters to impact

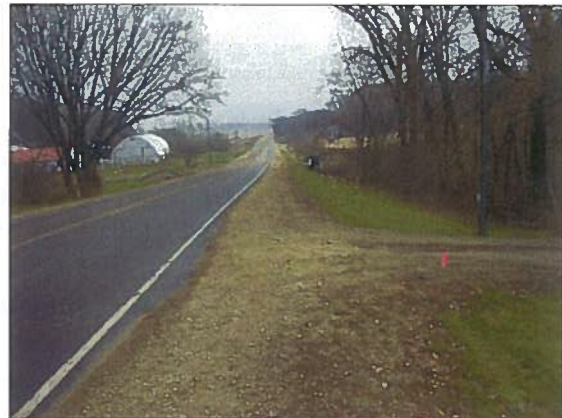
Figure 2: Overview of path of case vehicle, flag at edge of driveway shows track of case vehicle's left side tires

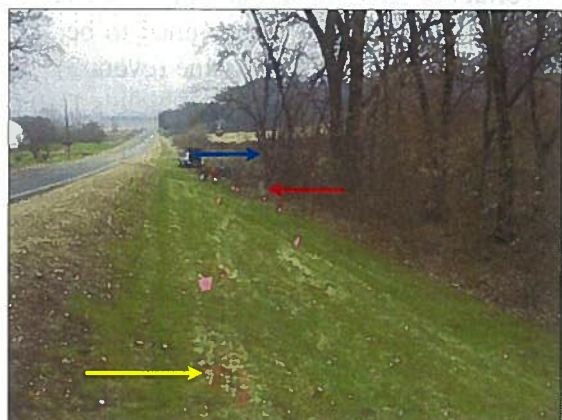
Figure 3: Vehicle touchdown location (yellow arrow) from vault and approach to telephone utility box impact (red arrow) and impact with clump of trees (blue arrow)

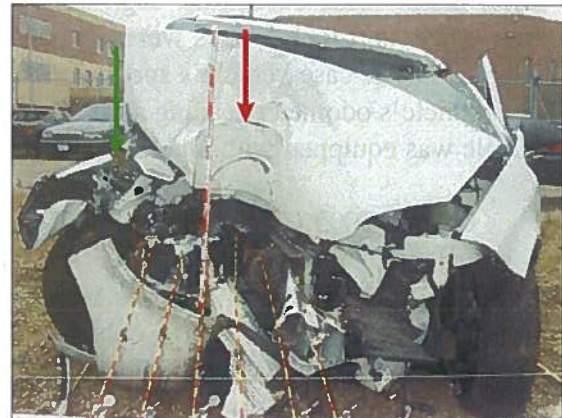
The center right of the case vehicle initially engaged the leading tree in the clump and then the front right engaged a tree immediately behind and to the right of the first tree (**Figures 4 and 5**). The first tree was displaced in the ground and broken off at the root. It appeared that a branch from this tree also broke off and impacted the top of the case vehicle and broke out the backlight (event 3). The case vehicle's driver and front right air bags did not deploy as a result of the impact with the clump of trees, possibly due to the yielding nature of the impact with the first tree or power loss due to movement of the ignition switch just prior to the impact. See the discussion below under the "**Case Vehicle**" and "**Crash Data Recording**" sections for further information regarding the ignition switch problem and air bag non-deployment.

Figure 4: Damage to case vehicle from impact with clump of trees, red arrow shows impact location of tree that broke off, green arrow shows impact location of second tree, vertical scale in tenths of meter

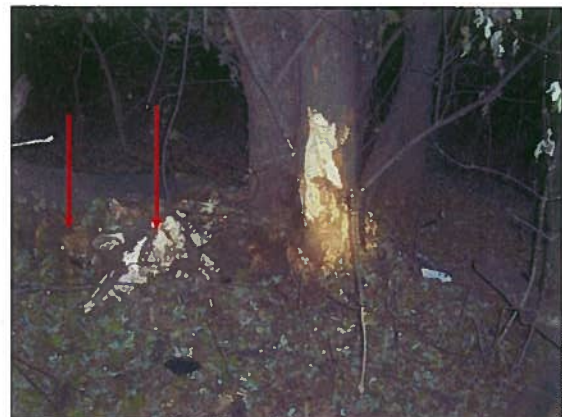
Figure 5: Police on-scene photo of impacted clump of trees, arrows shows broken/uprooted tree

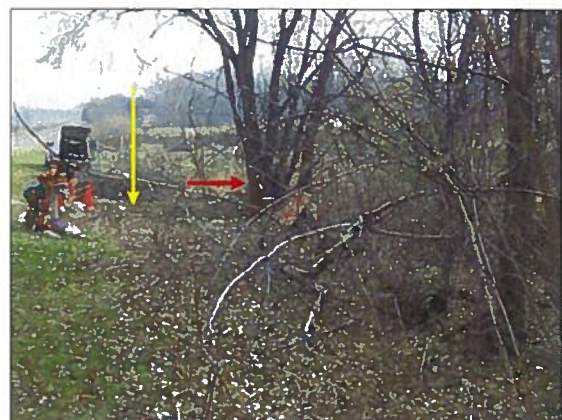
Post-Crash: As a result of the tree impact, the case vehicle rotated clockwise approximately 90 degrees and came to rest heading southwest (**Figure 6**). At final rest the case vehicle was approximately 3 meters (10 feet) north of the impacted clump of trees.

Figure 6: Red arrow shows impacted clump of trees, yellow arrow shows area of case vehicle's final rest

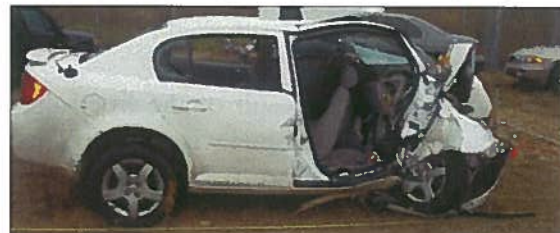
Figure 7: Right side view of crush to front of case vehicle from impact with clump of trees

The case vehicle's right side wheelbase was reduced 58 centimeters (22.8 inches). The left side wheelbase was extended 5 centimeters. Induced damage involved the left fender, hood, roof, right front door, right "A"-pillar and right roof side rail. The rescue crew cut the right "A"-pillar and removed the right front door.

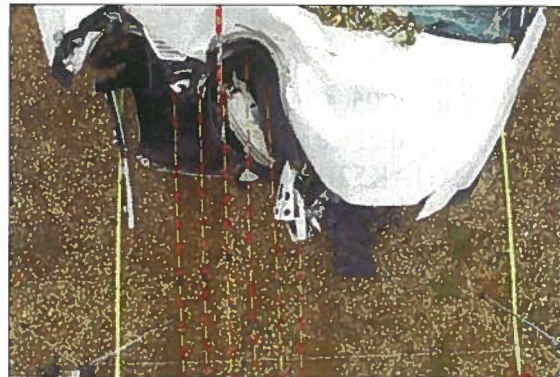
Figure 8: Top view of crush to front of case vehicle from impact with clump of trees, each increment on rods is 5 cm (2 in)

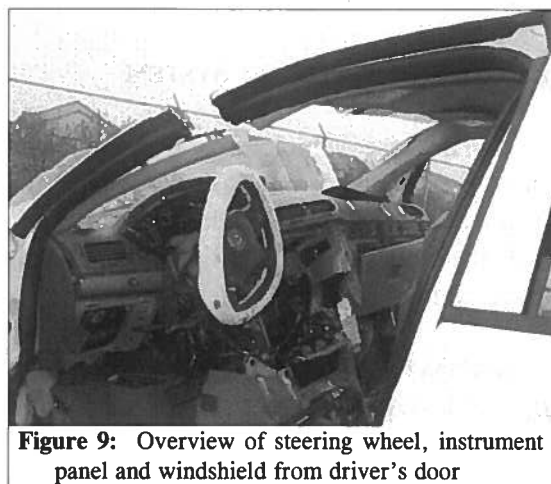
Vehicle Interior: Inspection of the case vehicle's interior (**Figure 9** and **Figures 10** and **11** below) revealed that primarily the right half of the steering wheel was severely bent forward and the steering column was crushed forward and upward (**Figure 12** below) due to driver loading. The driver's knee bolsters had been heavily contacted by the driver's knees and broken out. There were scuff marks on the right instrument panel and the glove box door due to loading by the front right passenger. The front right passenger's seat back was also intruded forward nearly to the instrument panel (**Figure 10** below) due to loading by the unrestrained back right passenger. Passenger compartment intrusion involved the driver's and front right passenger's toe pans, which intruded longitudinally 18 centimeters (7.1 inches) and 23

Figure 9: Overview of steering wheel, instrument panel and windshield from driver's door

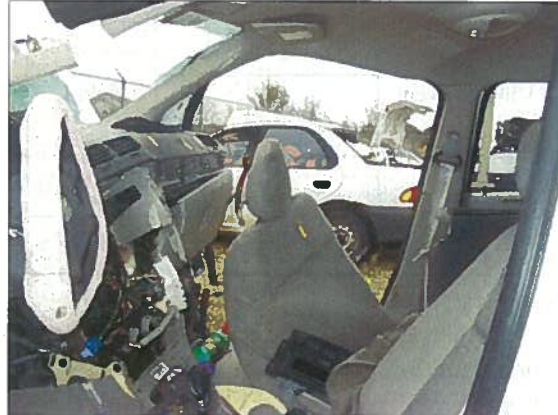
Figure 10: Left side view of steering wheel, instrument panel and displacement of front right seat back and head restraint due to the back right passenger loading the seat back into the front right passenger

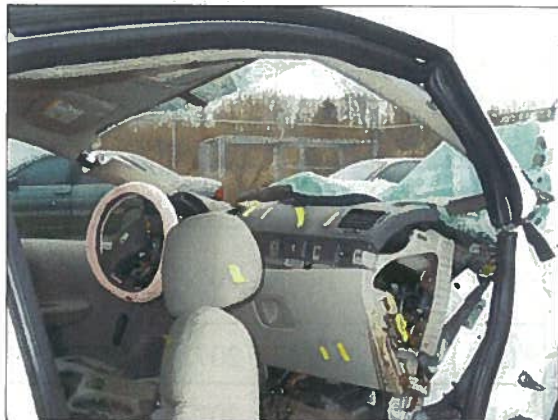
Figure 11: Right side view of case vehicle's front seating row, instrument panel, steering wheel and windshield

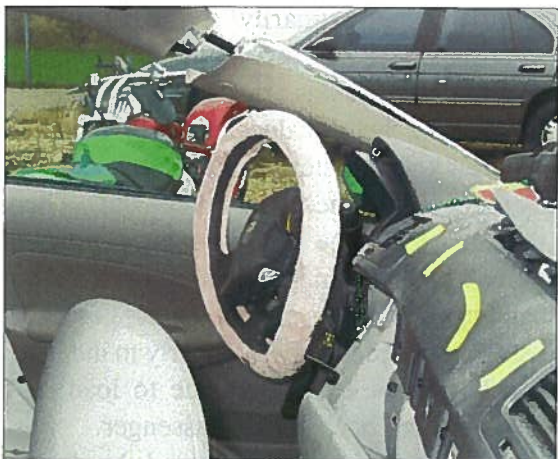
Figure 12: Right side view of deformation to steering wheel and steering column

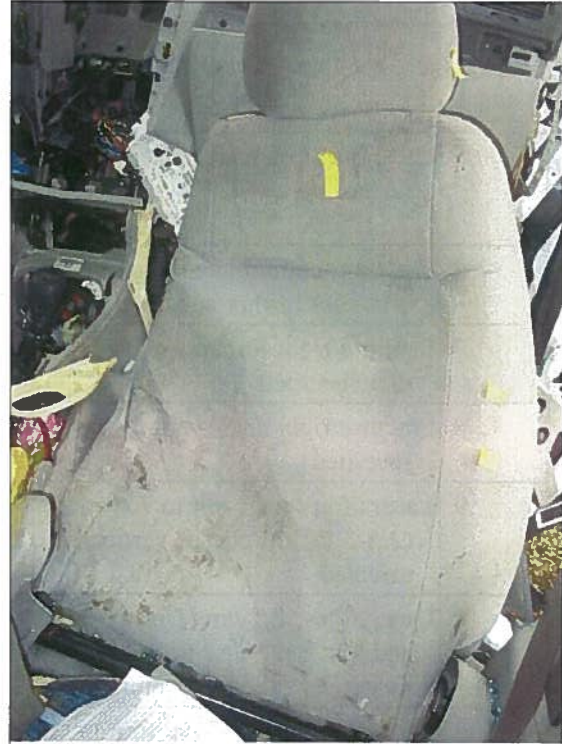
seat back extensively forward (Figure 13). The back right passenger most likely ramped over the seat back and impacted her head on the windshield header causing facial fractures and a traumatic brain injury. The back right passenger rebounded and as the case vehicle rotated clockwise, she most likely contacted the right rear door. She was found lying face up across the back seat with her feet in the floor pan behind the driver's seat. She was removed from the case vehicle by rescue personnel.

Figure 13: Damage to front right passenger's seat back due to loading by unrestrained back right passenger
