Subject Cobalt PQSR Jan. 29

X001 Program Quality Sufficiency Review

Gary Altman – Senior Program Engineering Manager

January 29, 2009

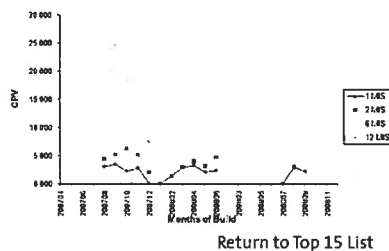
#1 K2720 Manual Transmission Replacement

- Cracked transmission/clutch housings due to high torque loading at a hard launch

The new torque limiter is 10mm longer than the current part

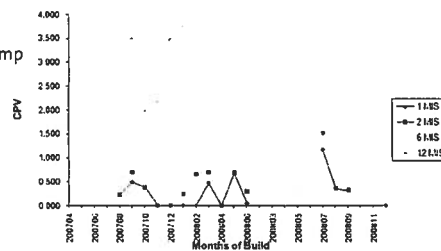
#2 J1840 Engine Replacement

Issue: 1028617 - Upper Radiator Hose Clamp - Coolant loss - Engine failure

- Upper Radiator Hose Clamp leaking due to clamp mis-positioning and blowing off. The engine overheats and fails.

- Change the current clamp to a grenade style pin clamp so the installation process can be error proofed to stop the line if the pin is not pulled.
- This is the last of four clamps to be changed. Packaging caused delay of implementation

Error proofing

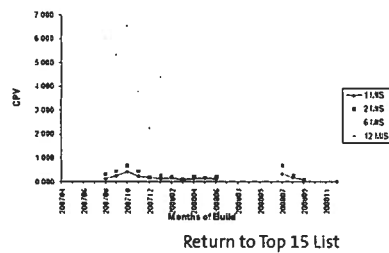
#7/10 E7200 Ignition Lock Cylinder Replacement

IPTV 10.38 CPV \$2.08 Cost per Incident \$188.81 # of Incidents 85

Production Fix: 4/22/09

Field Fix: Use Lambda style service kit 2009 SORP
AT only

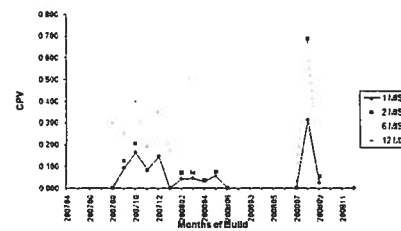
#8 D2460 HVAC Assembly - Upper Replace

- Delphi 5-phase - Water leaking into the interior of the vehicle from the HVAC module

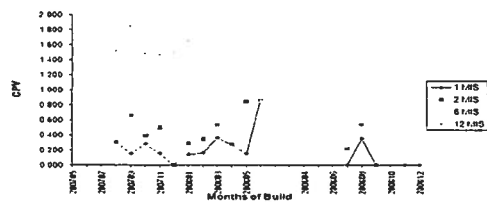
#9 K7000 Automatic Transmission Replacement

- Bearing damaged from excess material lodged in the bearing pocket of the Driven Sprocket Support part

- Material build up caused by a guide on the robot load at the debur operation that was steel. Proper guide material is nylon (changed from steel to nylon in 1997).

Containment: Visual Inspection

Production Fix: 7/14/08 at Windsor Transmission

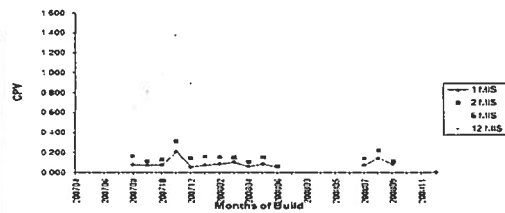
#15 N0110 Battery Replacement

- Main Body Harness Trunk Branch Complaint: Damaged wire - broken or cut wires

- These 3 wires are pulled through the passenger compartment to the trunk during assembly.
- The battery current sensor plug and/or wire is prone to catch on the sheet metal as it is routed.
- The connector can also become trapped under spare tire or battery if not in the correct place before connections are made.
- Broken or cut wires occur (effects charging). Collateral damage due to ignition lock cylinder and On Star

Containment: 11/3/08

Production Fix: Same

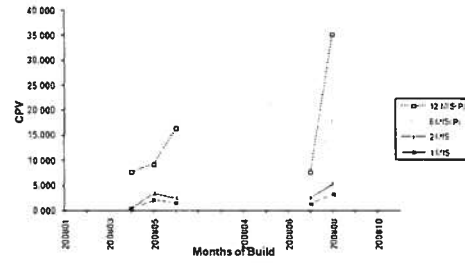
#1 K2720 Manual Transmission Replacement/#2 K1200/K1120 Manual Trans Shift Cable Replace/ Trans Control Replace - Turbo

- Because of the short directional throws inherent in this shifter, the sensitivity to adjustment becomes critical.
- It was found that as little as 2.0mm at the shift knob would be enough to throw the entire system out of adjustment
- Because of shifter ratios of approximately 3:1, this translates into a movement of less than 0.7mm at the cable connection
