From: John R Dolan
To: David Carey; John Capp
CC: Lisa D. Weber; Vipul Modi
BCC:
Sent Date: 2012-05-15 13:50:22:000
Received Date:
Subject: Slides for Cobalt Issue
Attachments: cobalt key.pptx *Attached*

Cobalt Issue Activities

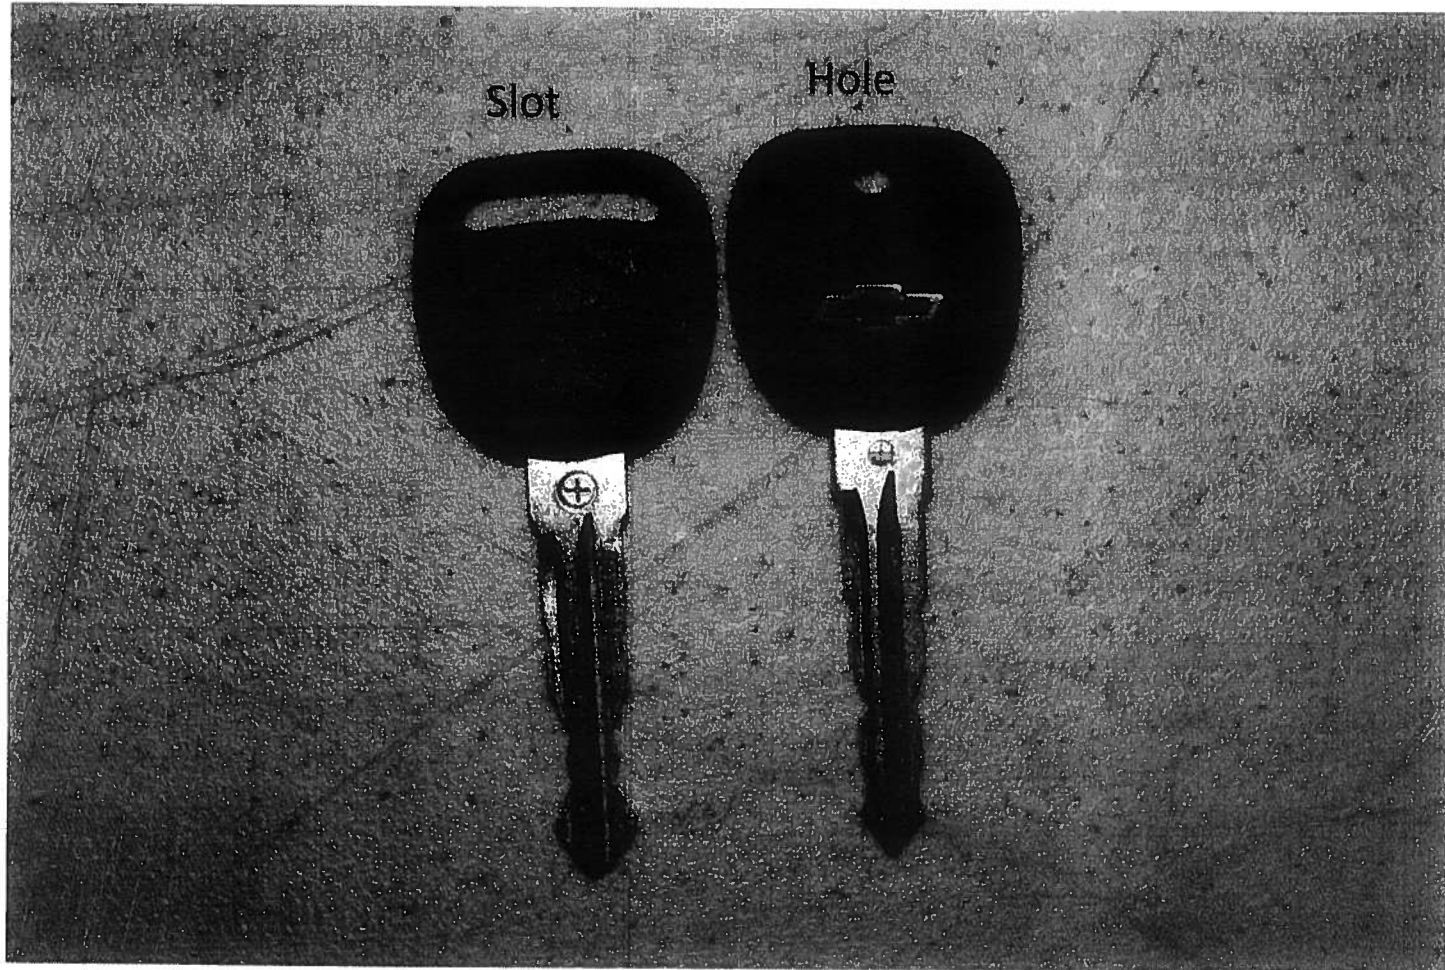
Fig 1. Key Styles

- The force was measured by pulling on a ring attached to the key ring slot of the key (Fig 1)
 - Rotational force measured in 8 2005 - 2006 at the Davison Salvage Yard indicate some vehicle require low force to rotate the key (Table 1).

- On one of the 8 Cobalts, the force required to rotate the key was greater than 25lbs (limit of the available force meter), this was the only vehicle that had a hole style key ring slot.

- A salvage yard HHR, which has a similar key cylinder and a key with a hole was also beyond the limit of the available measurement tool

Only 1 of the 8 Cobalts inspected had a circular key ring hole; the cylinder would not rotate with the application of more than 25lbs force

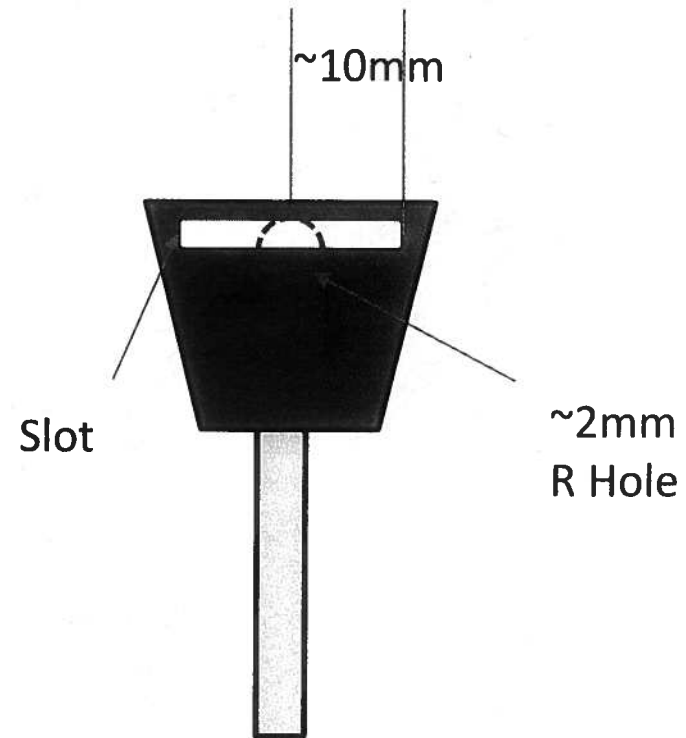
θ for Cobalt > 60

θ for Lambda < 20

The moment arm
on the slotted part
is $\sim 5\text{x}$ bigger
