2005-7 Cobalt/G5 Frontal Airbags

Requests from 6/21/12 mtg to understand why only 2005-7

ON-SITE AIR BAG NON-DEPLOYMENT INVESTIGATION

CASE NUMBER - IN-06-083
LOCATION - WISCONSIN
VEHICLE - 2006 CHEVROLET COBALT
CRASH DATE - October 2006

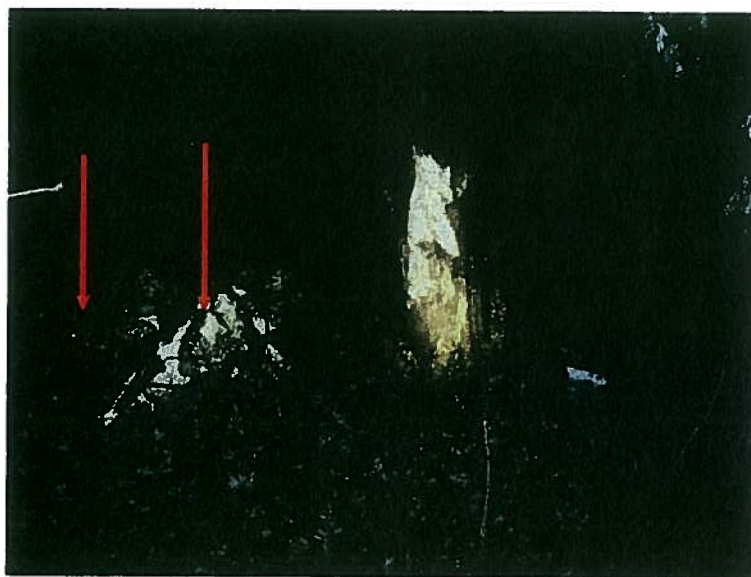
Figure 5: Police on-scene photo of impacted clump of trees, arrows shows broken/uprooted tree

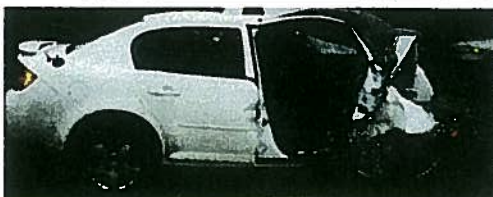
Figure 7: Right side view of crush to front of case vehicle from impact with clump of trees

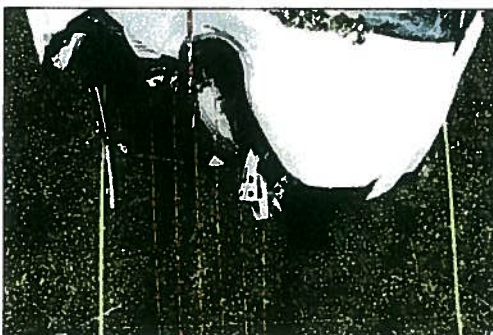
Figure 8: Top view of crush to front of case vehicle from impact with clump of trees, each increment on rods is 5 cm (2 in)

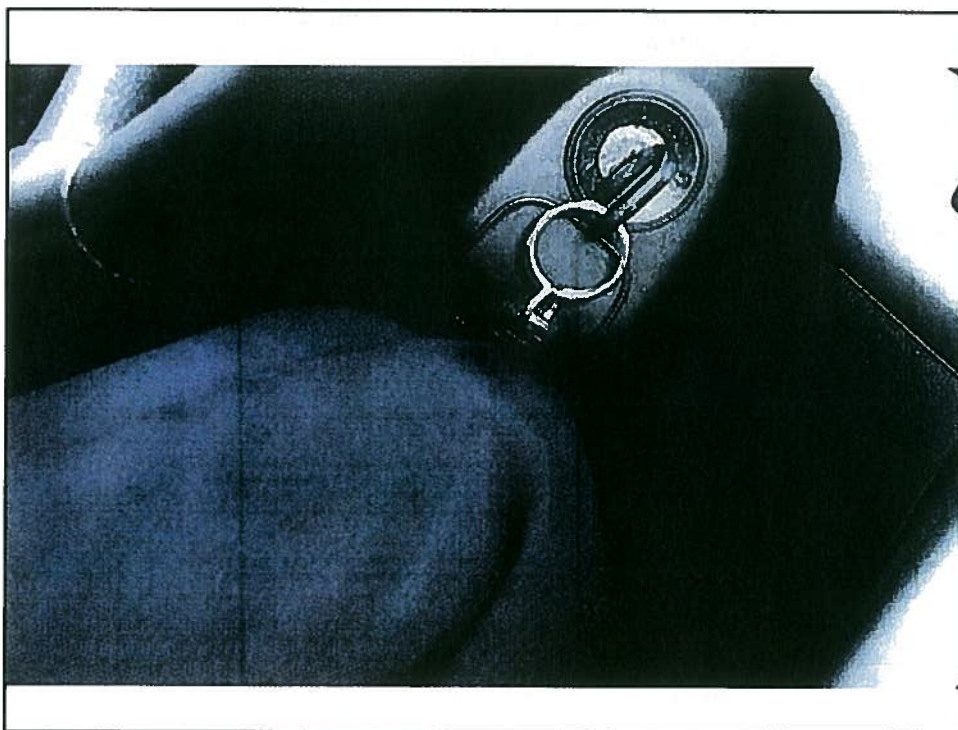
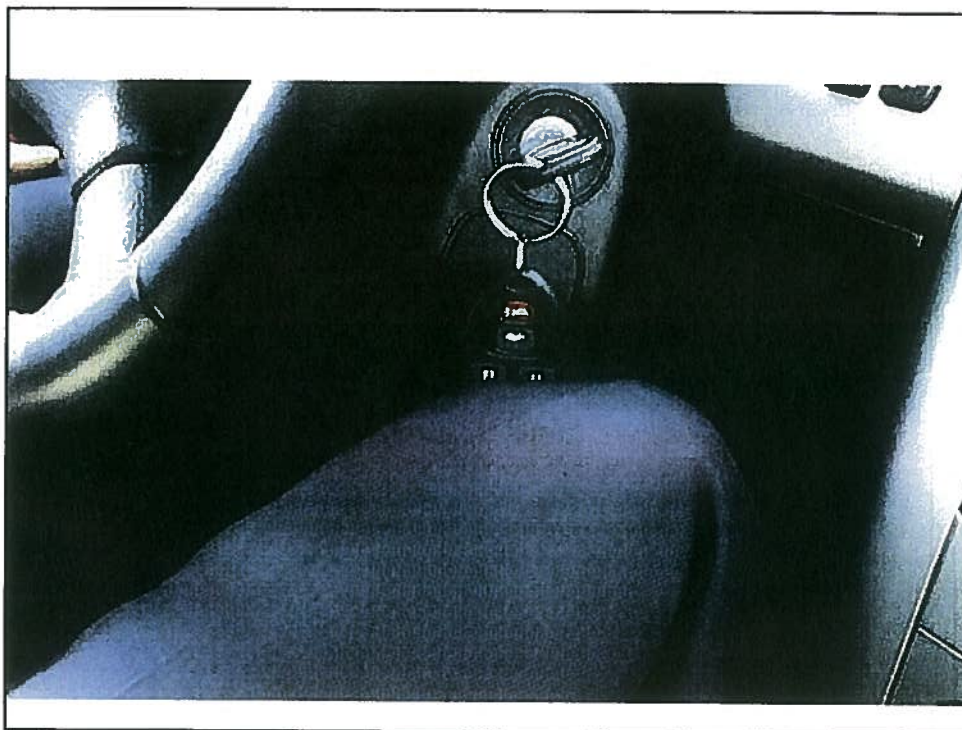
Cobalt SS – Driver Knee Hits Key During Heel/Toe

It has been reported that the driver's knee can hit the key and fob in the ignition switch and turn off the engine during heel/toe - brake/throttle actuation used for spirited driving maneuvers. This condition occurs on the Chevrolet Cobalt SS with manual transmission. It was also established that the turn off condition *did not* occur when the fob was removed from the key.

Using RAMSIS on the Cobalt SS data, the operator was able to show a condition where the knee was within less than 10mm from the key in the ignition switch (without a fob).
