2005-2007 Cobalt/Pursuit/G5
Front Airbag Non-Deployment
709,741 Vehicles
Cost Estimate: \$14.2M-\$37.7M

ETQ N-130454

Root Cause:

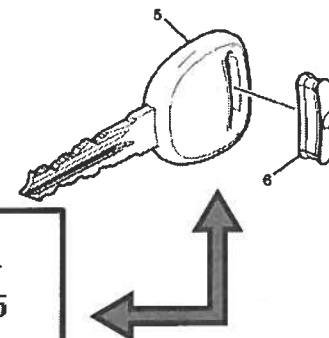
Engineering has come up with an insert for the key ring so that it goes from a "slot" design to a hole design. As a result, the key ring cannot move up and down in the slot any longer – it can only rotate on the hole. In addition, the previous key ring has been replaced with a smaller, 13 mm (0.5 in) design. This will result in the keys not hanging as low as in the past.

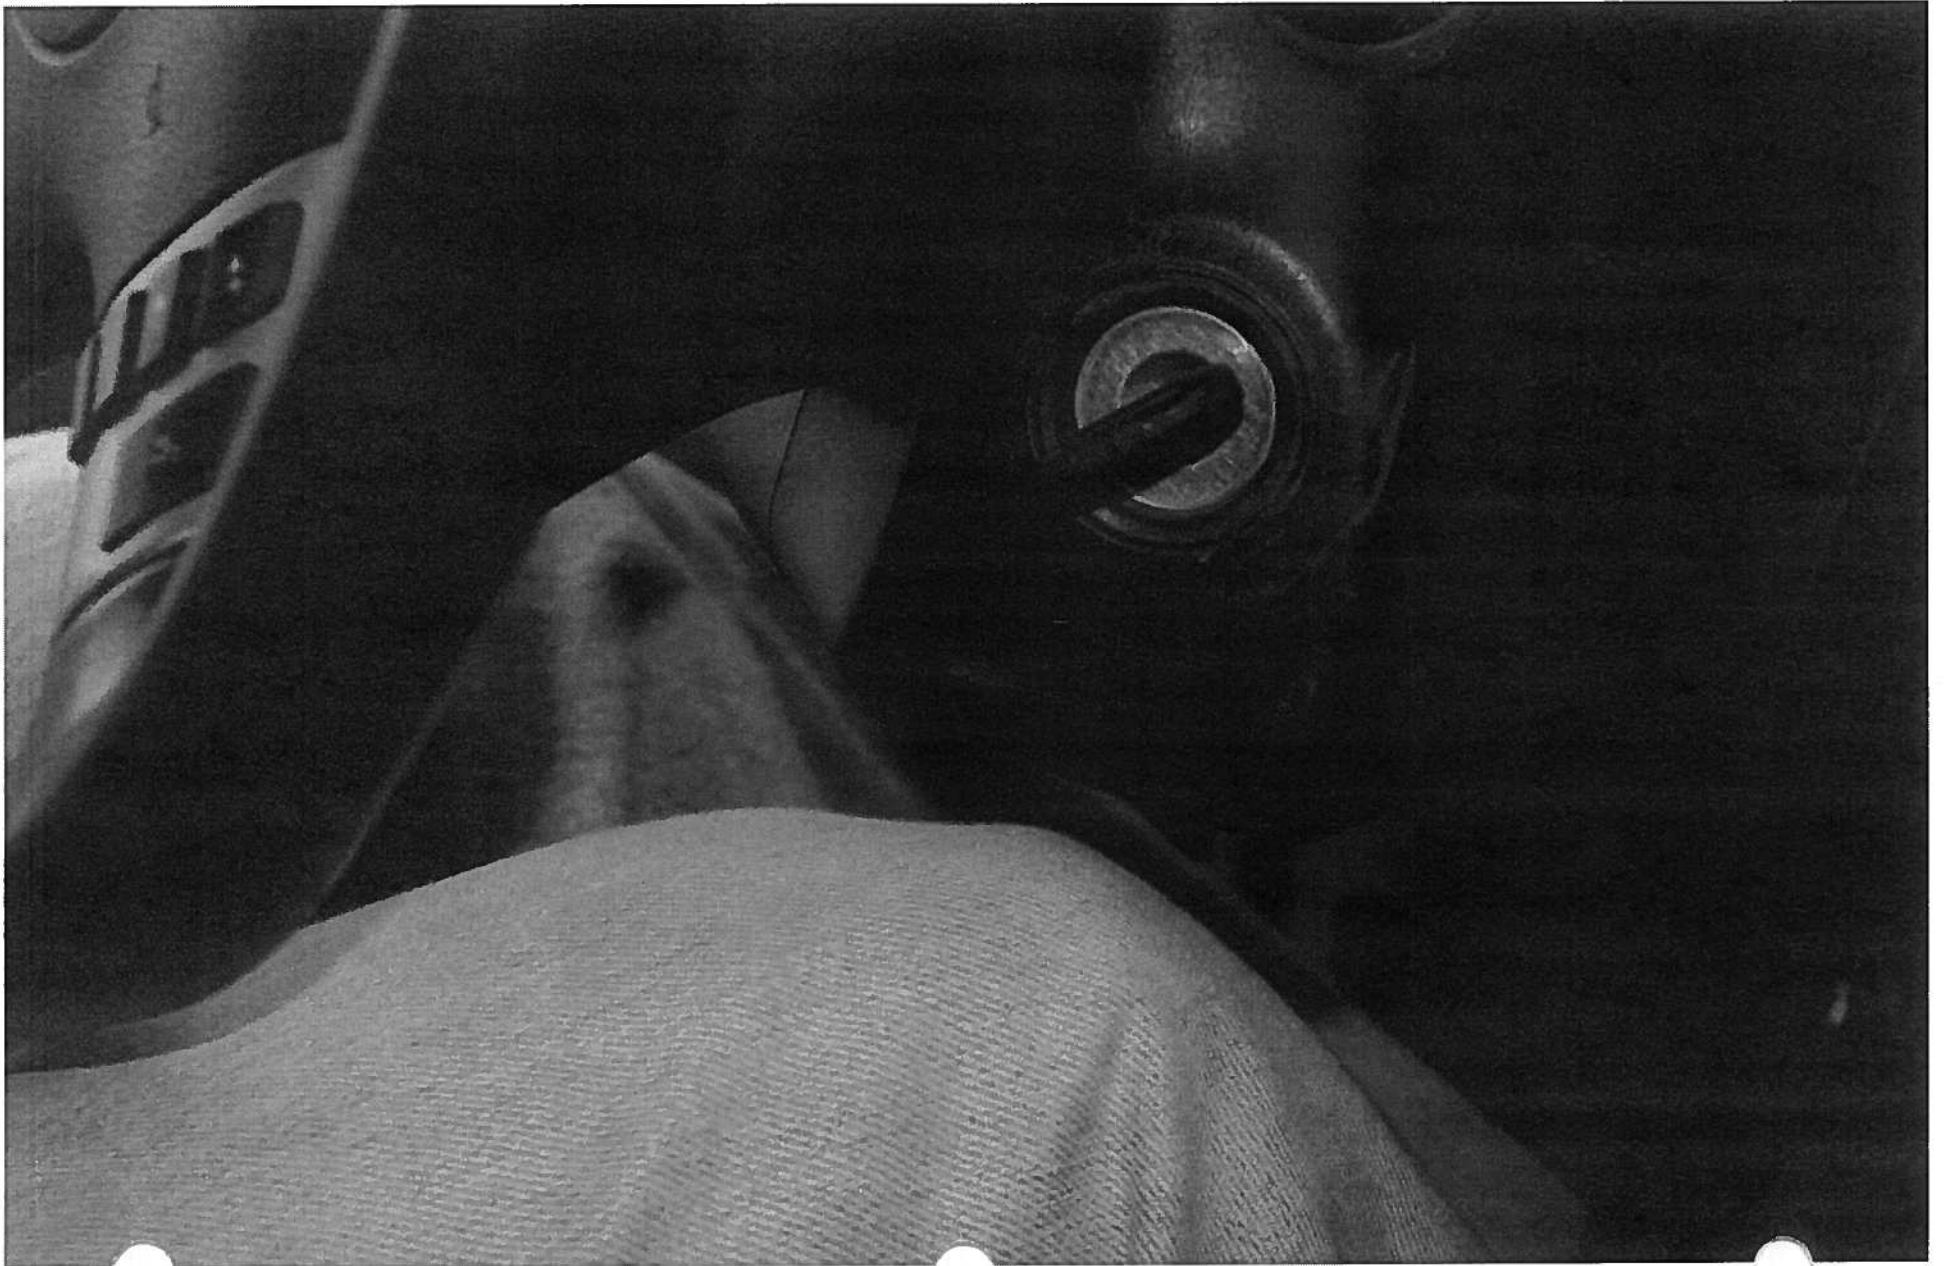
HHR Knee Clearance to Ignition (6'1" driver)

- Review indicates 2 potential non-deploys for Ion, but are not confirmed to be the same cause.
- Ion has different column shroud which could affect potential for key interaction
- HHR has more clearance to the driver's knee
