**From:** David M. Trush  
**To:** Ron Arnesen  
**CC:**  
**BCC:**  
**Sent Date:** 2008-01-30 11:29:44:000  
**Received Date:**  
**Subject:** Re: 2008 X001 Cost Save To Go With Strattec Steering Column Ignition Cylinders  
**Attachments:**

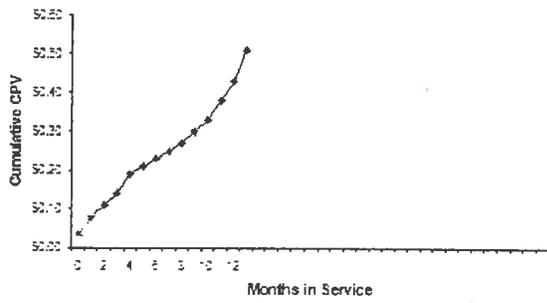
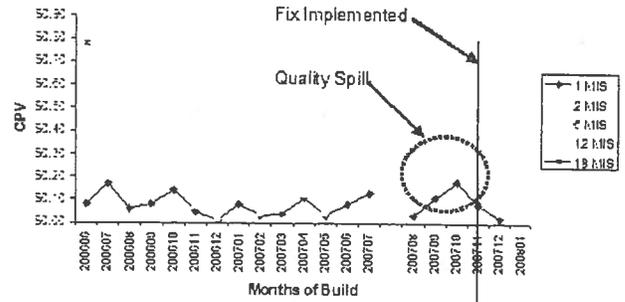
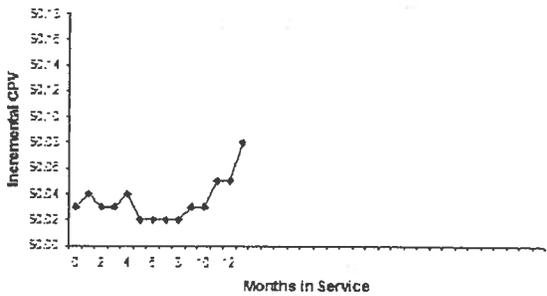
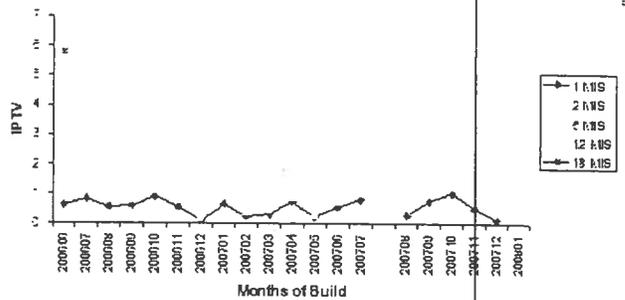
Ron,  
the component with the issue is called a trigger and what happens is it fractures. The result is that the ignition cylinder is unable to be rotated to start the vehicle.

Al,  
Major reason for switching suppliers, from Ortech to Strattec, was that Ortech decided to exit the lockset business at General Motors. The cost saving that occurred was a side benefit.  
The increased effort to rotate the cylinder never occurred, the program did not want to pay ~\$2.00/car and ~\$300,000 in tooling for a new ignition switch. These costs are what I remember, Ray DeGiorgio should have better numbers. We do have a plug that fits in the keyslot that is available through service. This fixes the issue where the key rotated from run to acc. position.  
The higher warranty issue is related to a supplier quality spill with a component that is in the ignition cylinder. A fix was put in place mid October 2007. Below is the warranty data for the Cobalt E7200 2MIS ignition cylinder. This also affects the HHR.
