# **Natural Gas Pipeline Pictures**

**Presented by Maya K. van Rossum,  
the Delaware Riverkeeper  
to the Committee on Energy and  
Commerce**

**July 9, 2013**

**Delaware Riverkeeper Network Documents Pipeline Construction Activity in the Delaware River Basin**

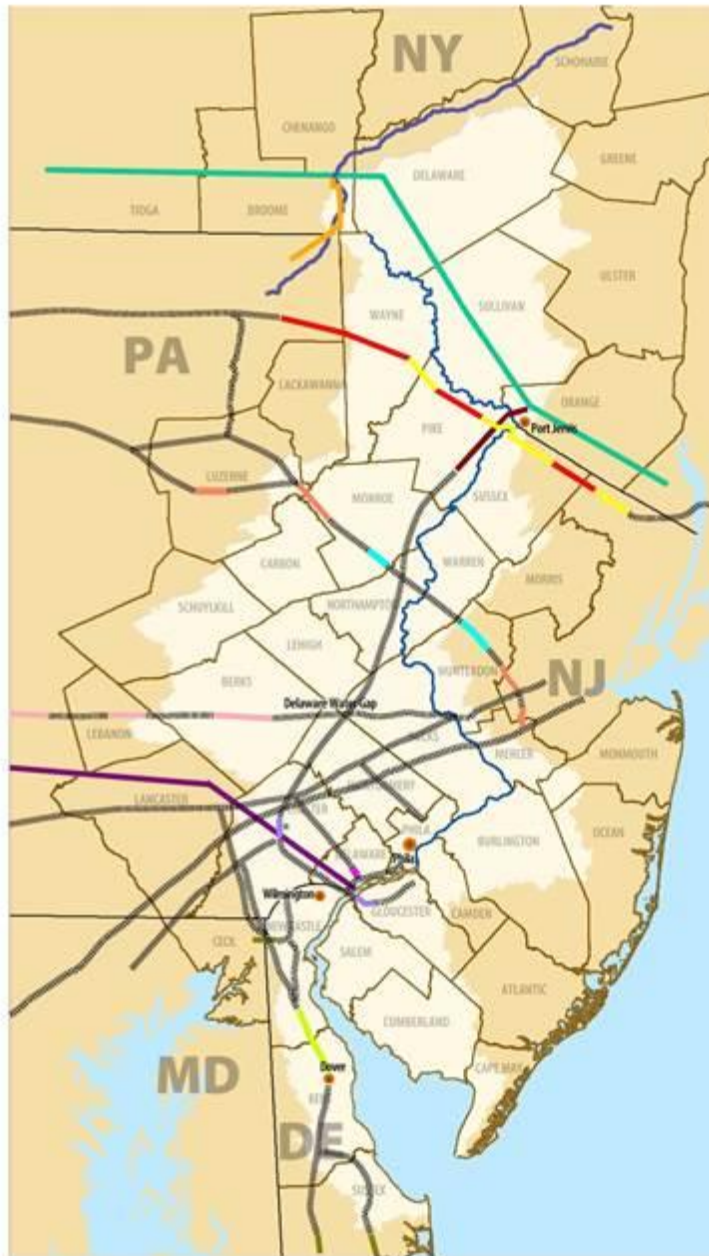
**Pipeline Projects Currently Planned To Go Through the Delaware River Basin**

- Existing Pipelines  
 DTE Bluestone Pipeline  
 TGP Northeast Upgrade Project  
 ESG Greenspring Project  
 Constitution Pipeline  
 Transco Leidy Southeast Expansion  
 Transco Northeast Supply Link  
 Transco Philadelphia Lateral  
 Transco Mainline "A" Replacement  
 Texas Eastern TEAM 2014 Project  
 Columbia East Side Expansion Project  
 Sunoco Mariner East Project

**Pipeline Projects That Will Potentially Cross the Delaware River Basin**

- Transco Northeast Connector (Not Pictured)

**Pipeline Projects Constructed Through the Delaware River Basin Since 2011**

- Millennium Pipeline  
 TGP 300 Line Upgrade Project  
 Columbia 1278 K Replacement  
 ESG System Expansion

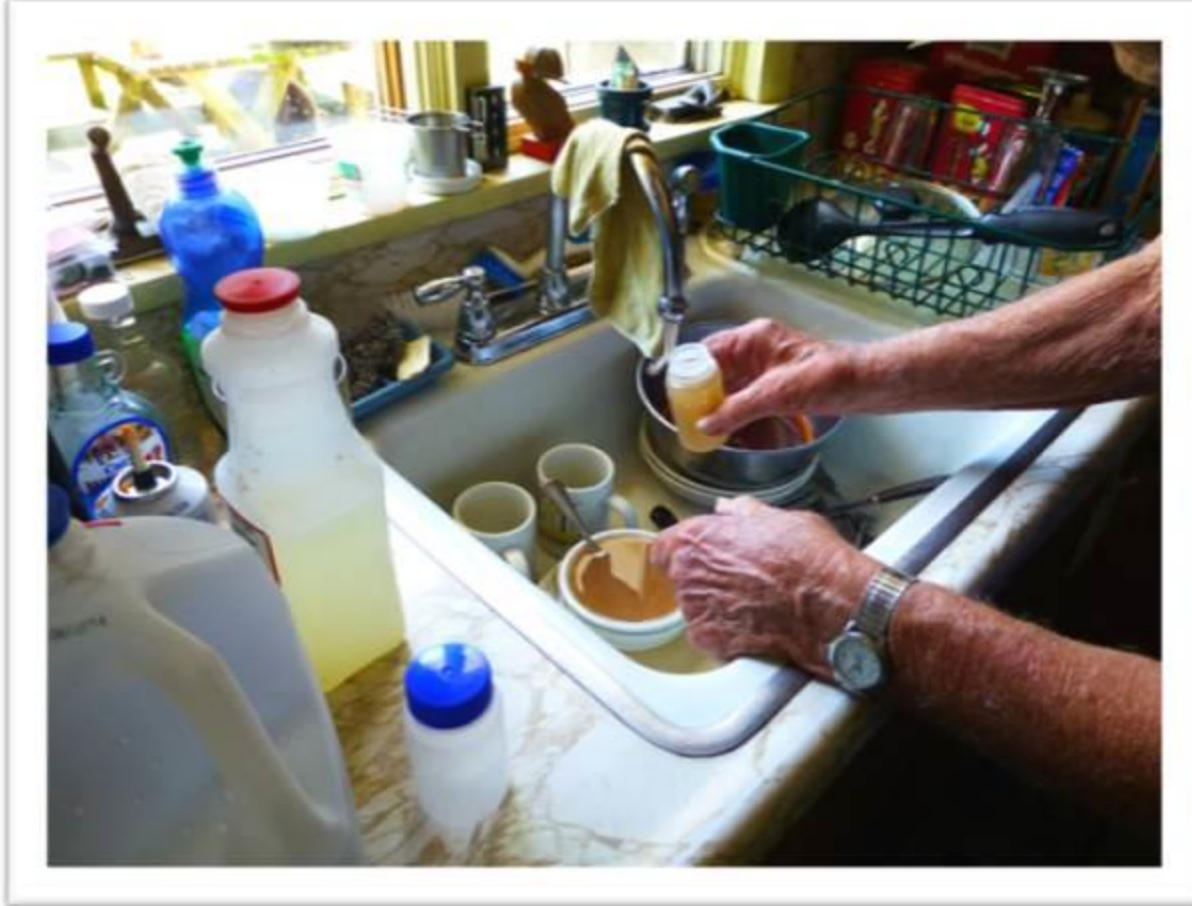
## **Contaminated Well Due to Pipeline Construction**

Pipelines nearby homes can impact well water like in this case that occurred in New Jersey during pipeline construction. June 2013.

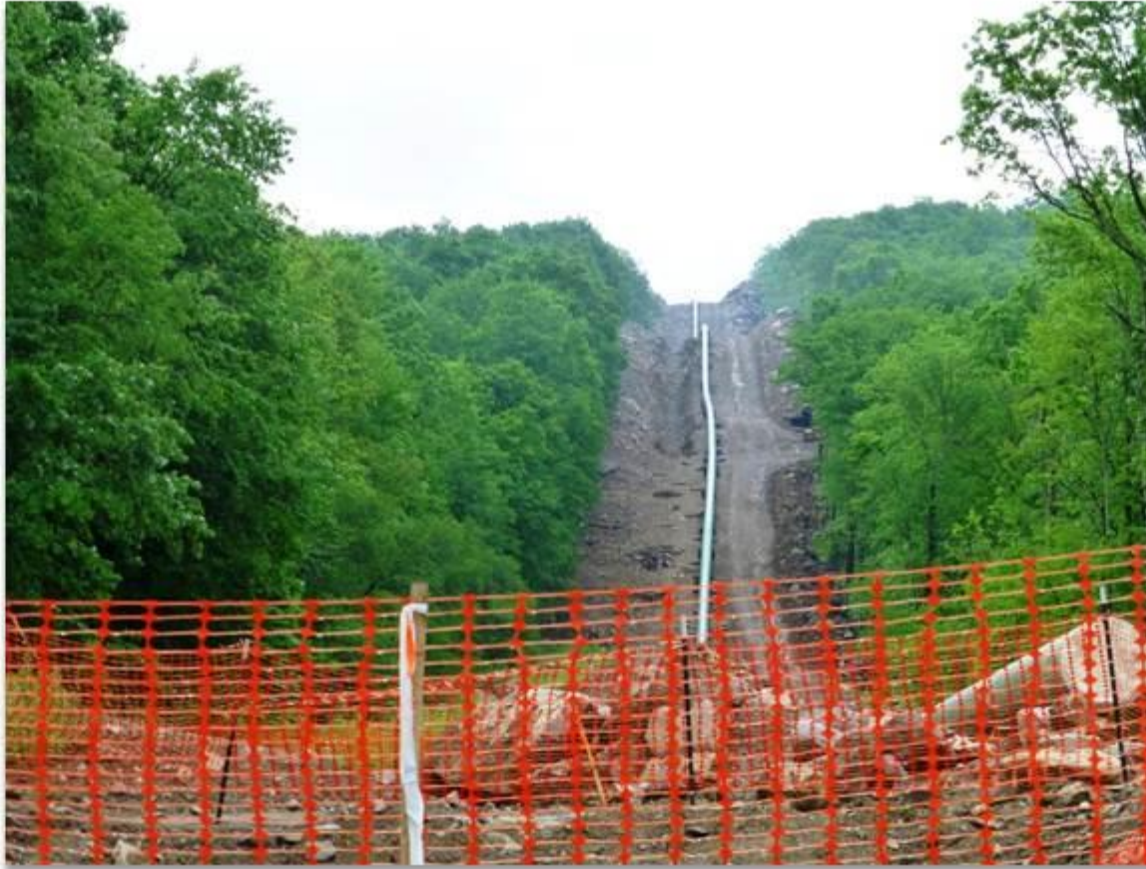
## **Pipeline Cut Through Public Lands**

This pipeline path currently under construction passes through High Point State Park in New Jersey. Often public lands had intact and healthy habitat and mature forests before pipeline cuts occur. June, 2013.

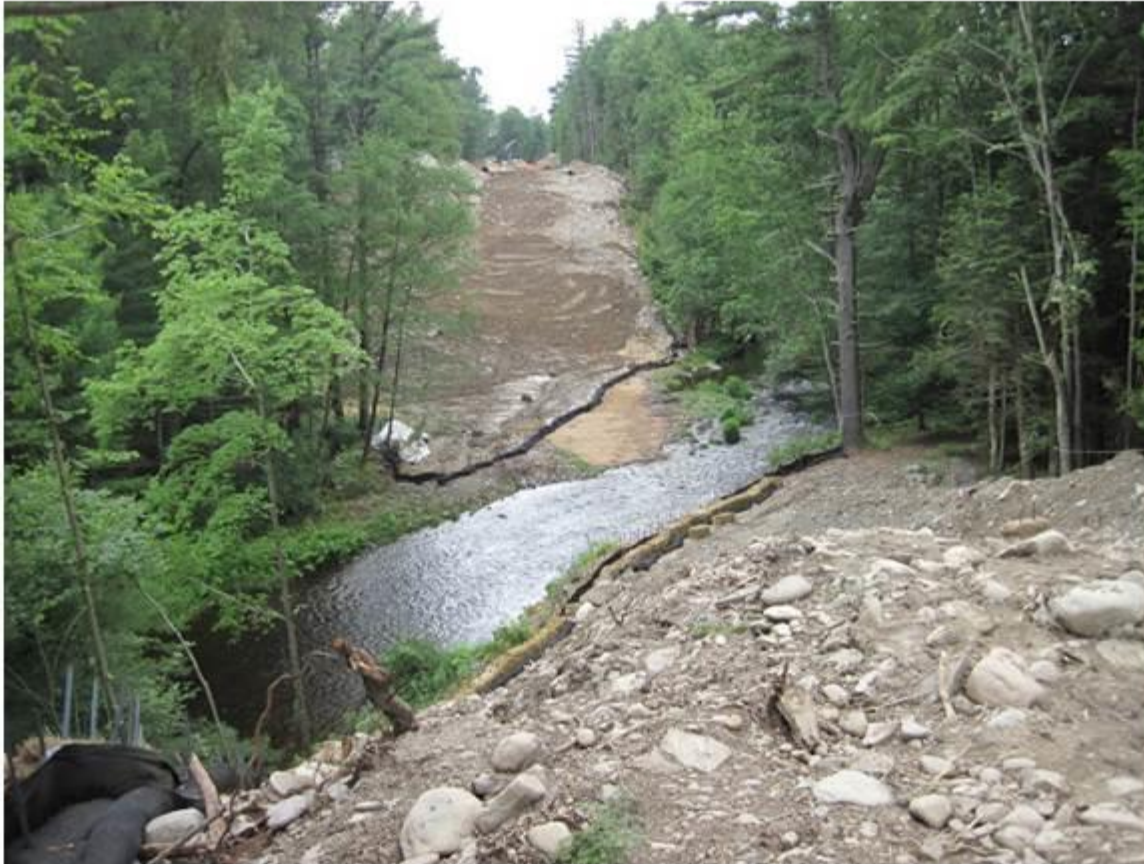
## **Conversion of Forested Landscapes to ROW**

Pipelines often cut through forests and steep slopes which require much technical oversight to ensure measures are used to limit impacts. This pipeline cut through Pike County, PA across the Sawkill Creek. June 2011.

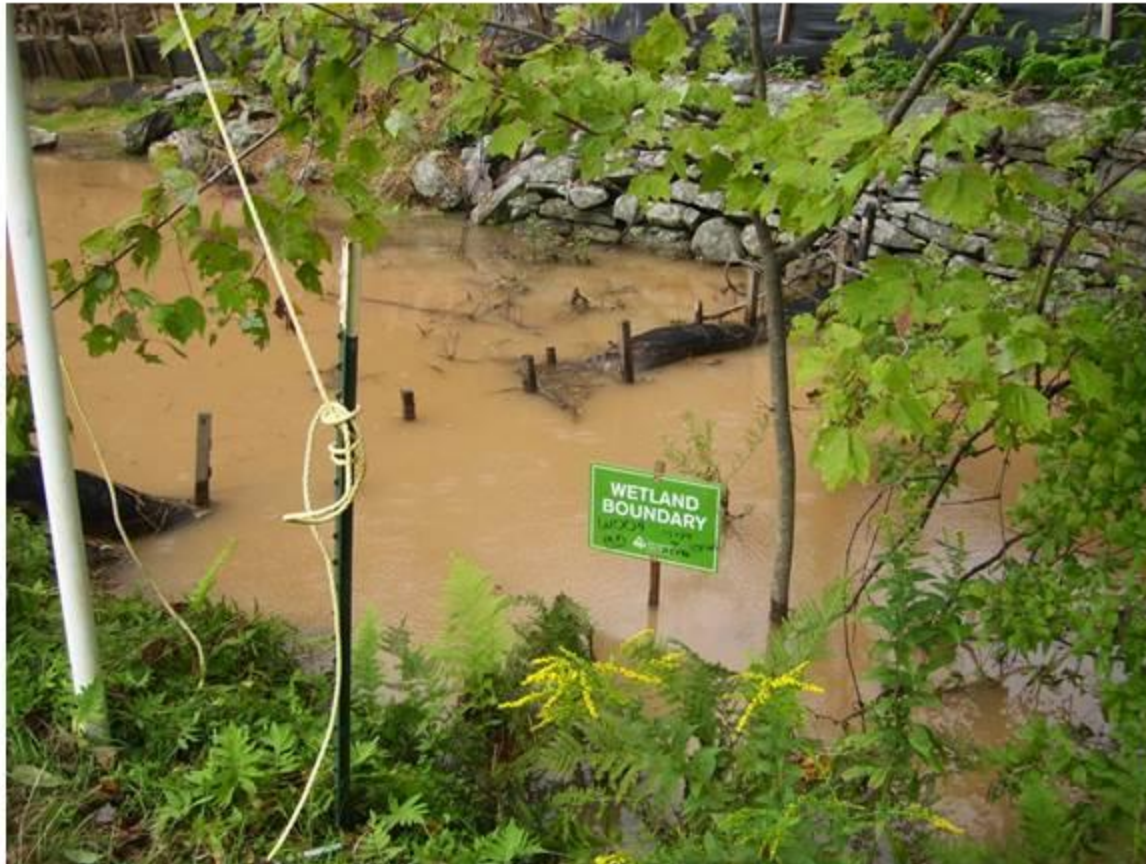
## **Sediment Discharged to Wetlands**

Compost filter socks are topped by sediment-laden water causing large discharge of sediment to the adjacent high quality wetland outside the pipeline ROW.

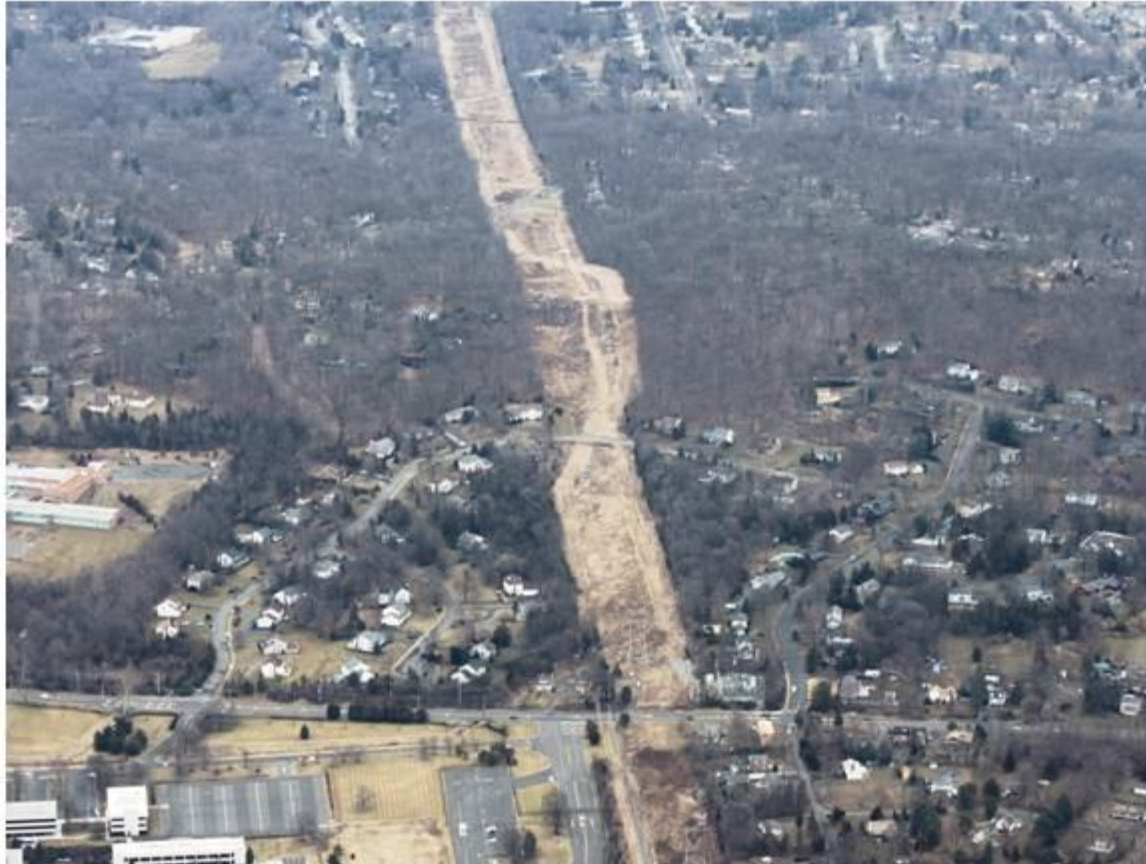
### **Pipeline ROWs Are Wide and Cut Through All Land Uses**

Aerial flyover of a pipeline crossing through multiple counties in Pennsylvania, February 25, 2013.

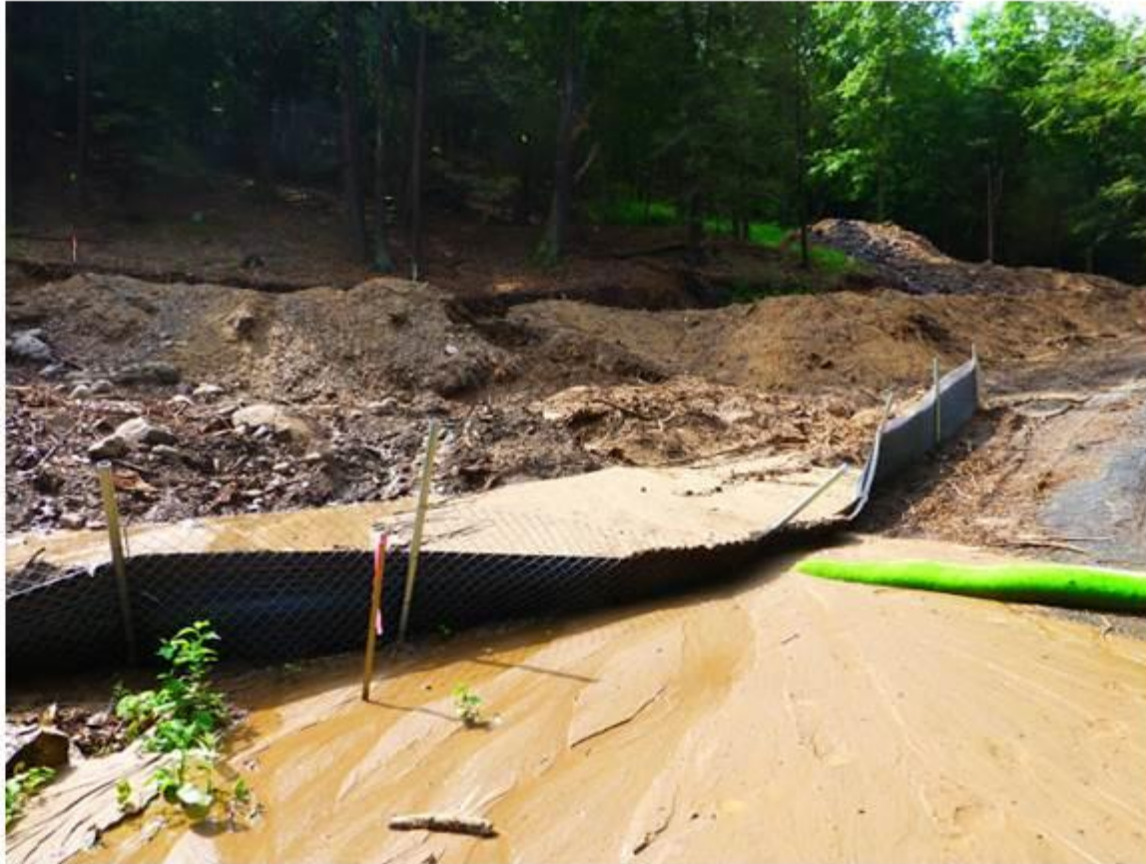
## **Overwhelmed and Failing Erosion & Sedimentation Controls**

This once forested slope dominated by underground springs and wetlands is a challenging location for a pipeline path with continual issues with stabilization of soils and control of water.

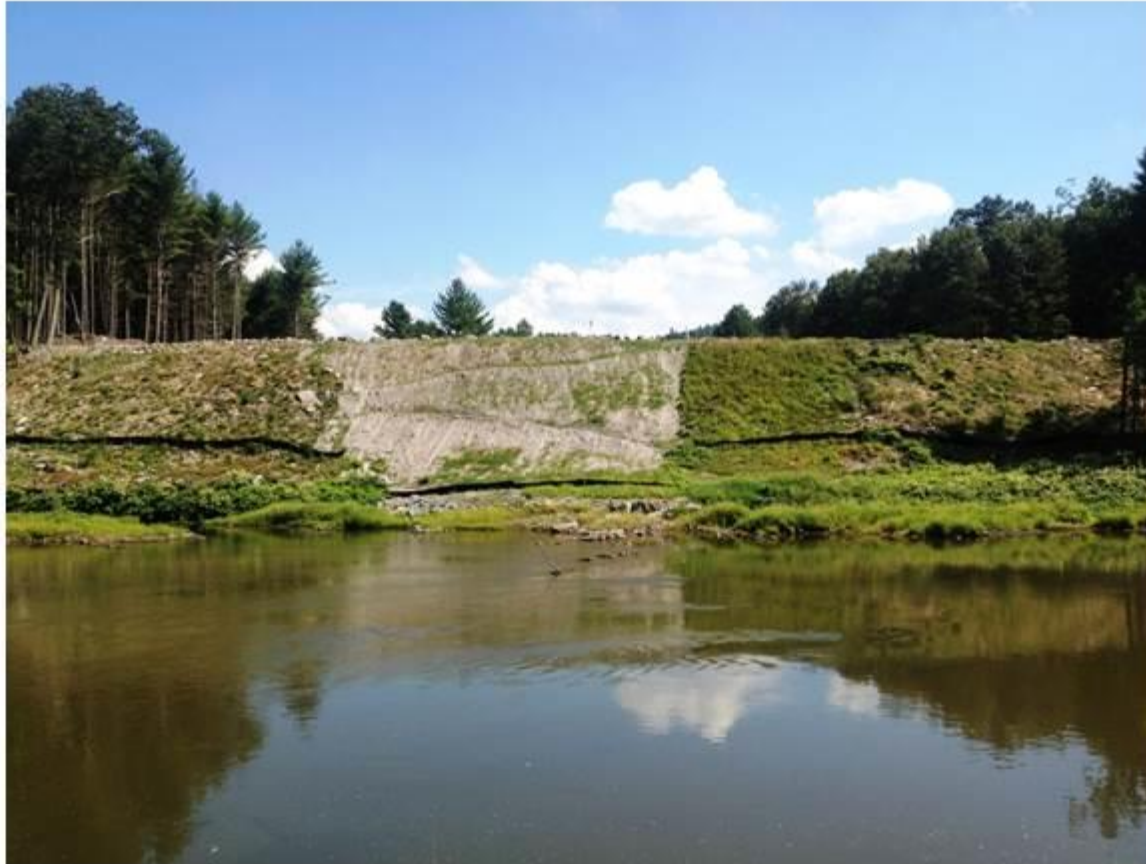
## **Lagging Recovery**

Nine months after this new pipeline began carrying gas, land surface impacts adjacent a high quality tributary to the Delaware River including soil compaction and lack of vegetation growth keep this site in temporary restoration phase. August, 2012

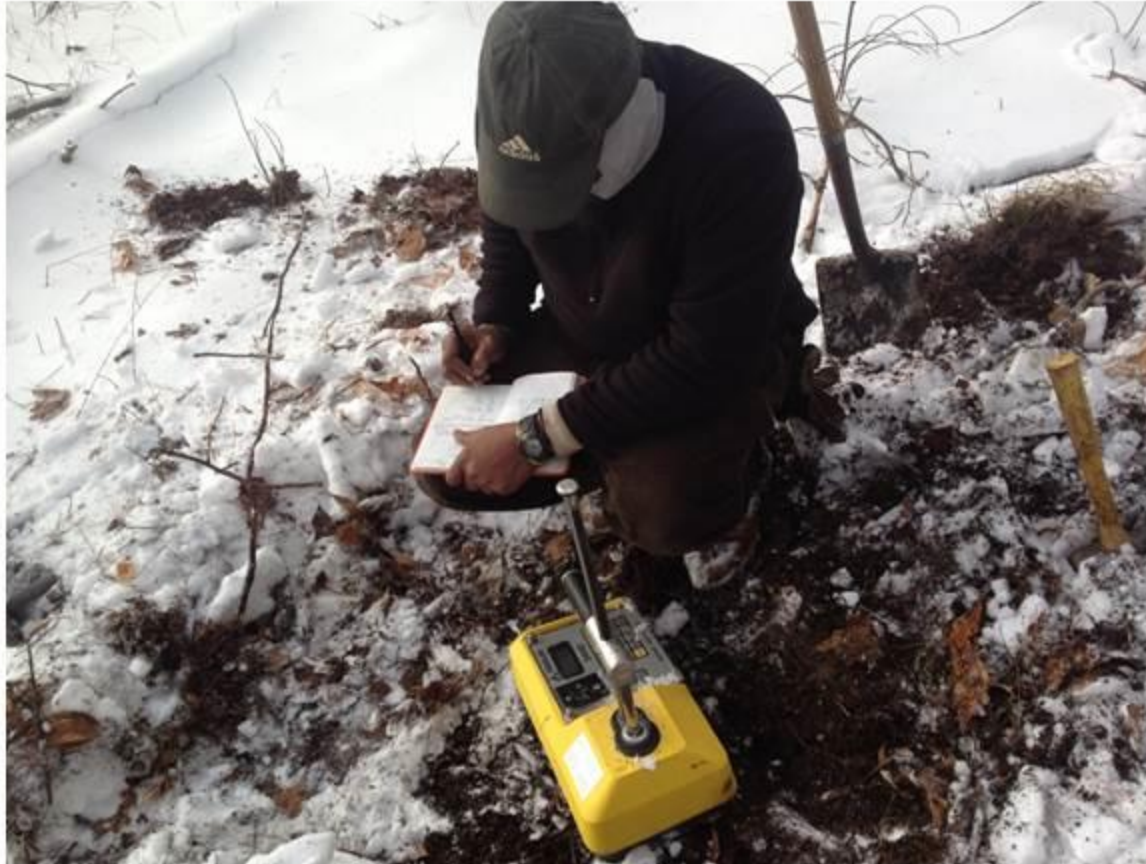
## **Soil Compaction on ROW**

A soil compaction study commissioned by Delaware Riverkeeper Network along a pipeline in Pike County, PA indicated extreme soil compaction along the pipeline ROW in temporary workspace areas which leads to increased stormwater runoff, challenging regrowth conditions, and a likely permanent change to the soil profile.

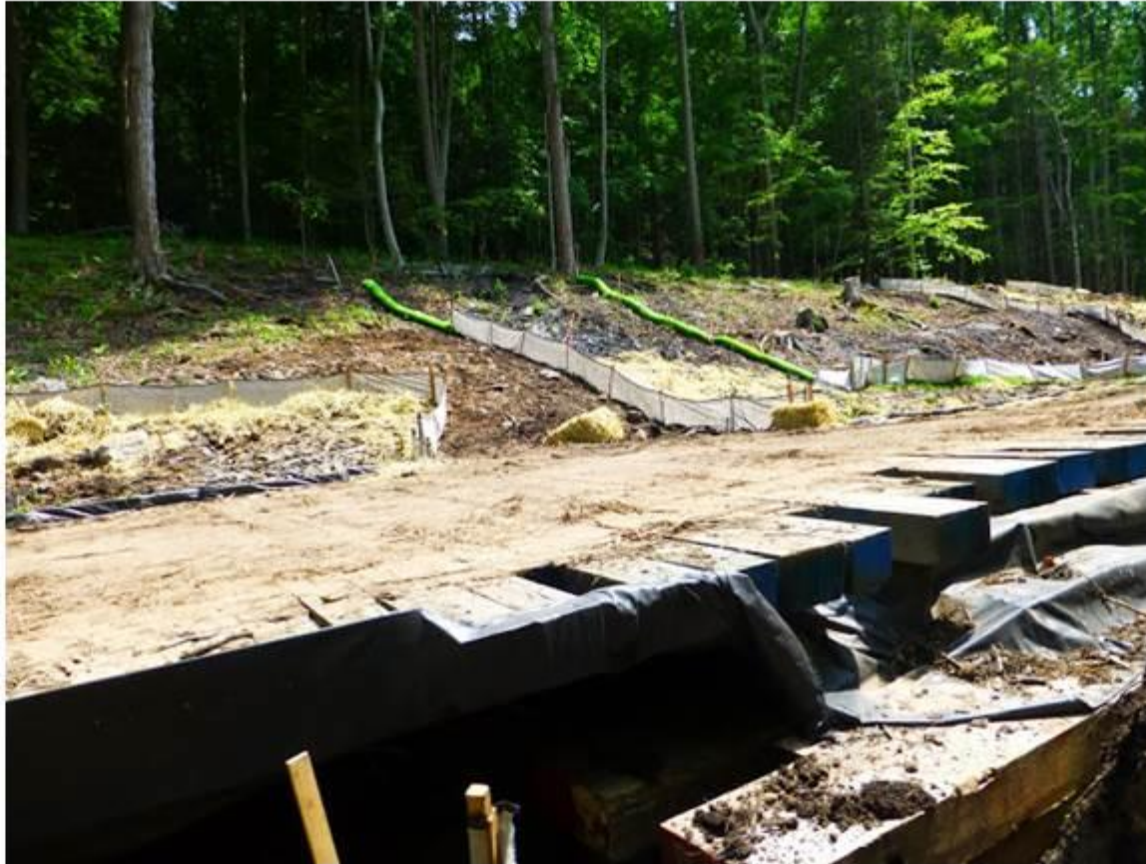
## **Waterbody Crossings Are Challenging**

Wetlands, streams, and spring crossings are sensitive areas that are challenging places to site pipelines. June, 2013
