Committee on Transportation and Infrastructure
U.S. House of Representatives
Washington, DC 20515

SUMMARY OF SUBJECT MATTER

TO: Members, Subcommittee on Aviation
FROM: Staff, Subcommittee on Aviation
RE: Subcommittee Hearing on "Lessons Learned from the Boeing 787 Incidents"

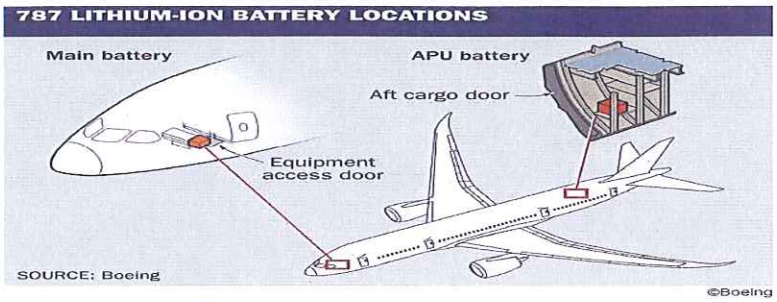
FIGURE 1:

On January 15, 2013, an All Nippon Airways 787, during a domestic flight in Japan, experienced a problem with its main battery (*Figure 1*).[5] According to the carrier, the main battery in the forward cargo hold triggered an emergency warning to the pilot. This warning was followed by a second warning light in the cockpit that indicated smoke. According to passengers and crew, there was an odd smell in the cockpit and cabin. The pilot decided to make an emergency landing and evacuate all passengers and crew via inflated chutes. While there was no fire when the plane landed, there was discoloration and signs of leakage in the main battery.
