Robert Squires - Squires Consulting LLC
Landowner Advocate

Opening Statement for May 5, 2021 Subcommittee on Civil Rights and Civil Liberties Hearing:
“Pipelines Over People (Part II): Midship Pipeline’s Disregard for Landowners in Its Pathway”

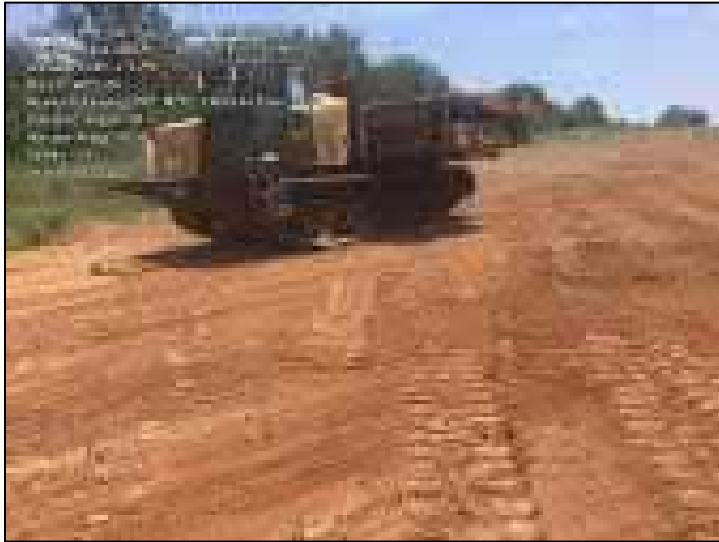
Maintenance work near MP VE8.1 on 08/04/20.

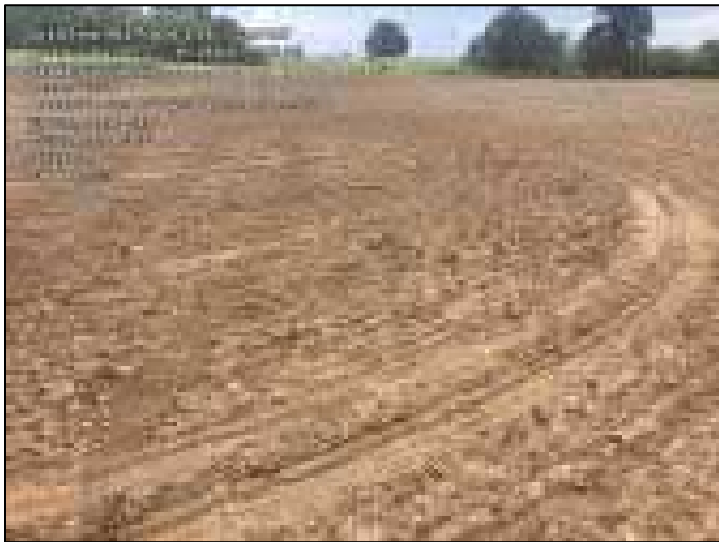
Maintenance work near MP 116.3 on 08/05/20.

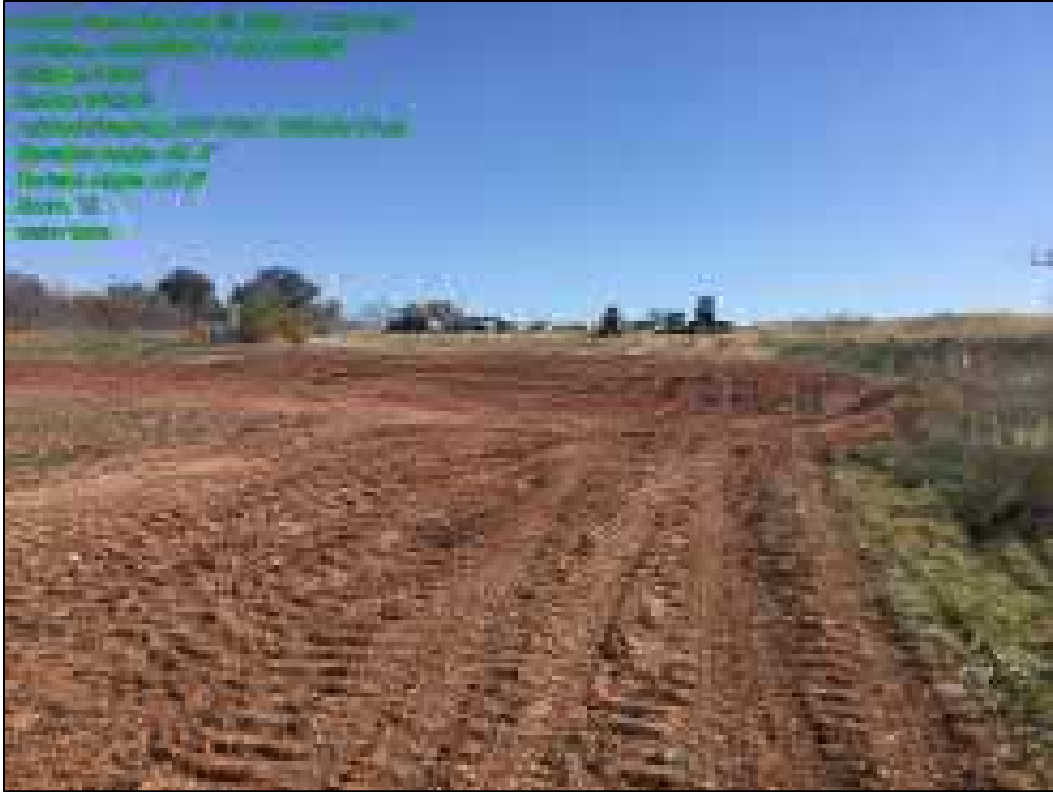
Maintenance work on Sandy Creek Farms property near MP 72.1 on 11/05/20.

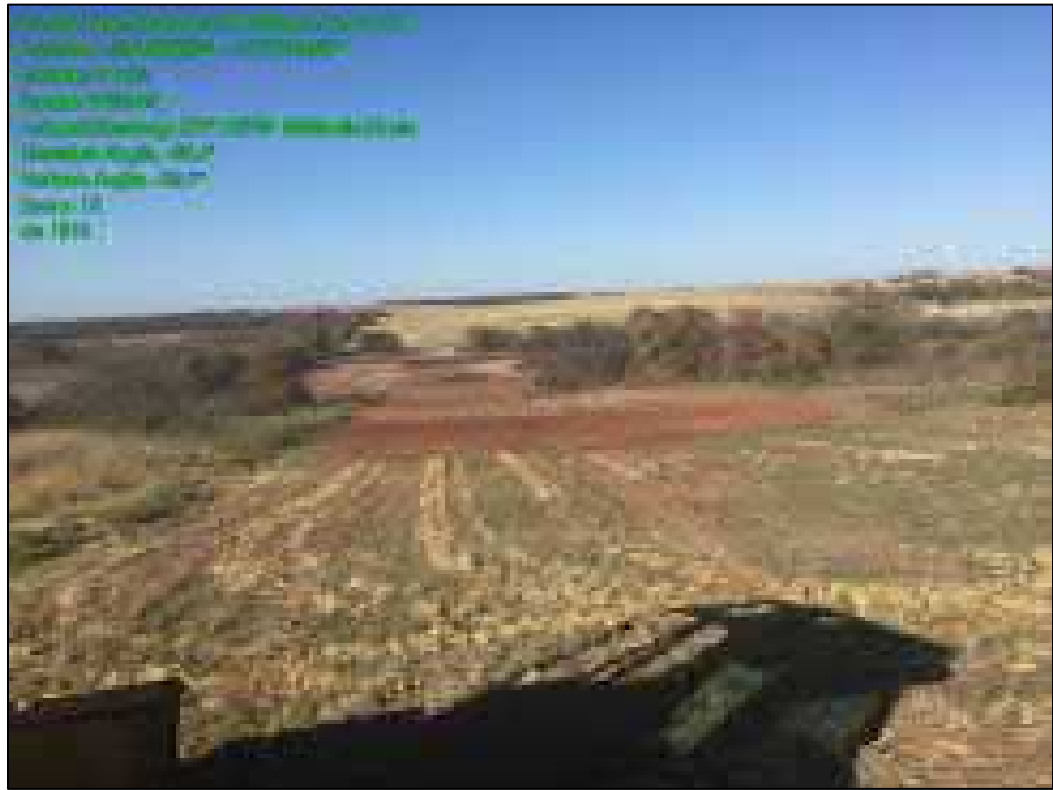
Maintenance work on Sandy Creek Farms property near MP 72.2 on 11/05/20.

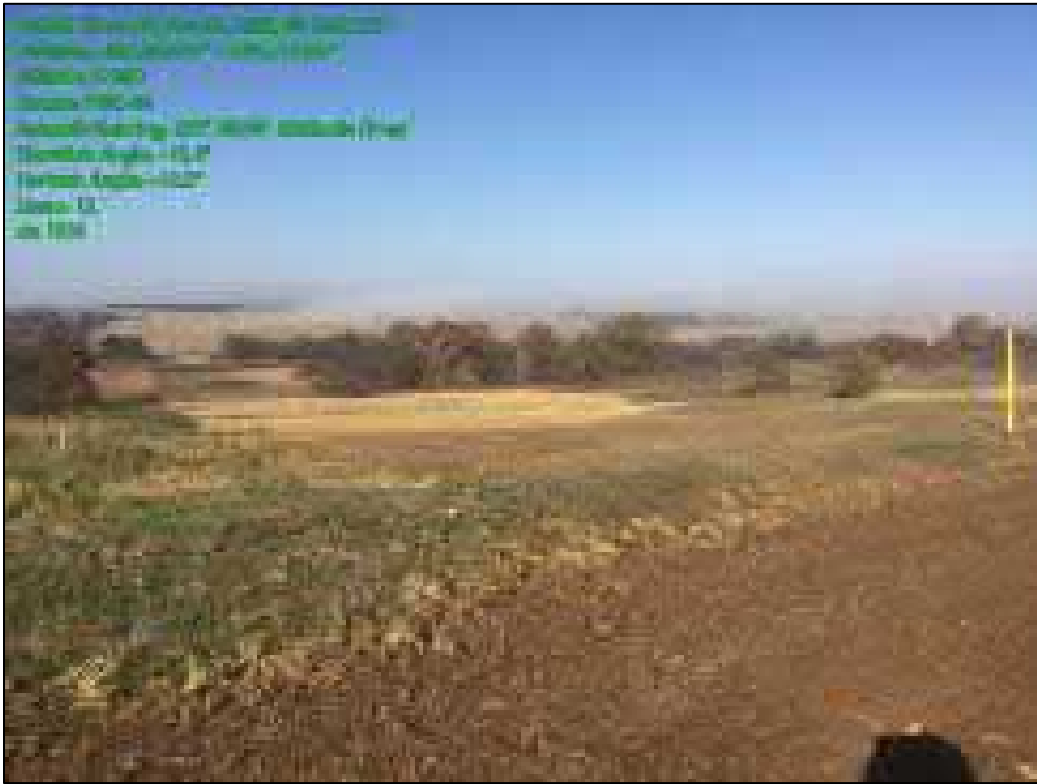
Maintenance work on Sandy Creek Farms property near MP 72.2 on 11/06/20.

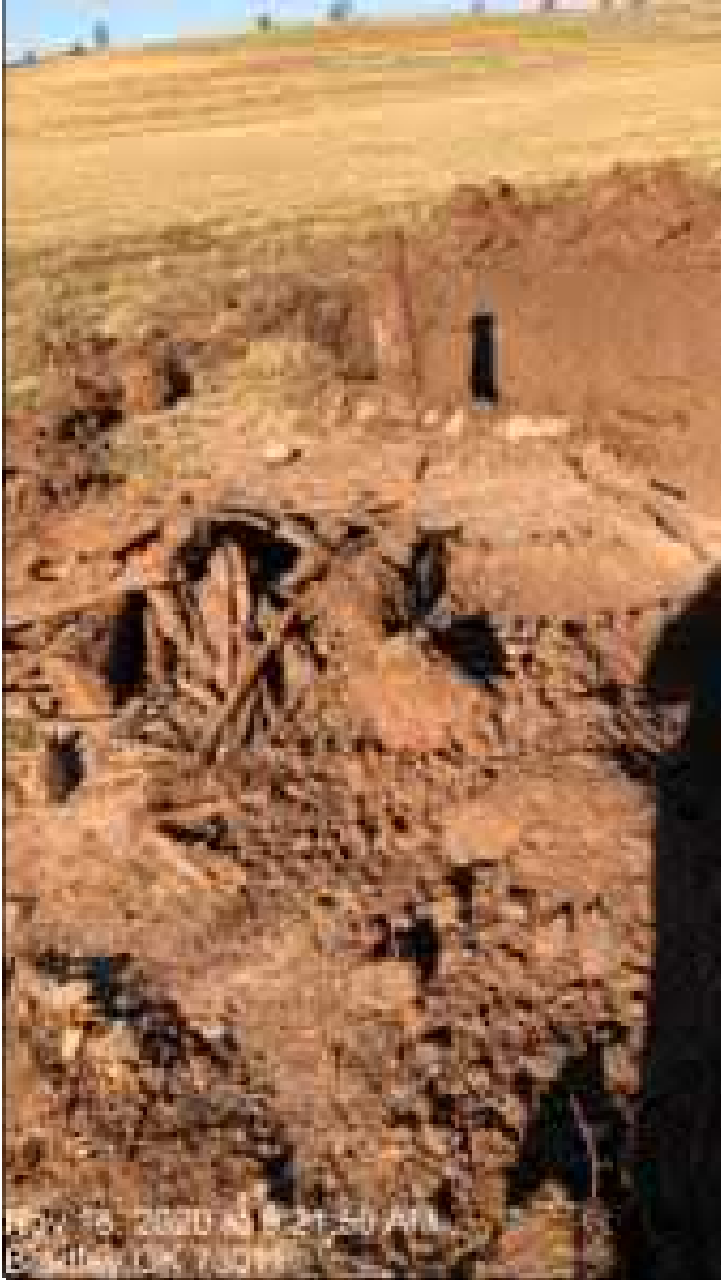
Excavations by landowner on Nov 18, 2020, construction debris located 4 – 6 feet below surface

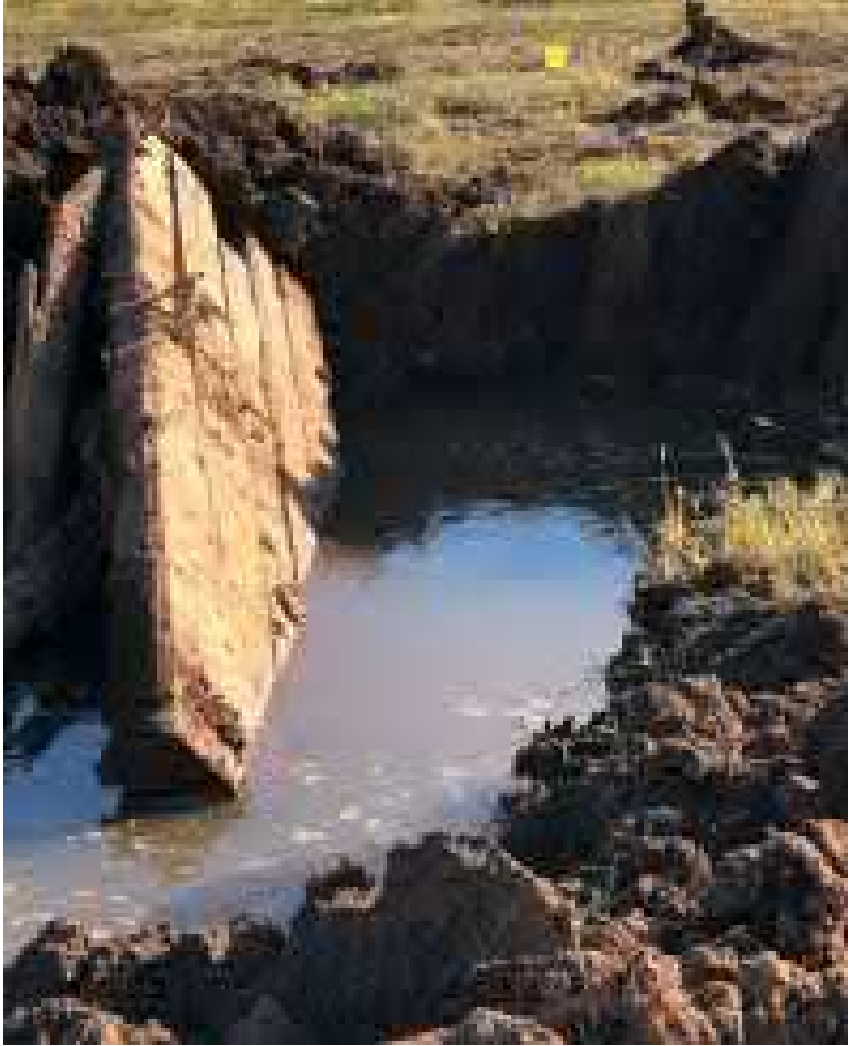
Excavations by landowner on Nov 18, 2020, mats located 4 – 4 feet below surface.

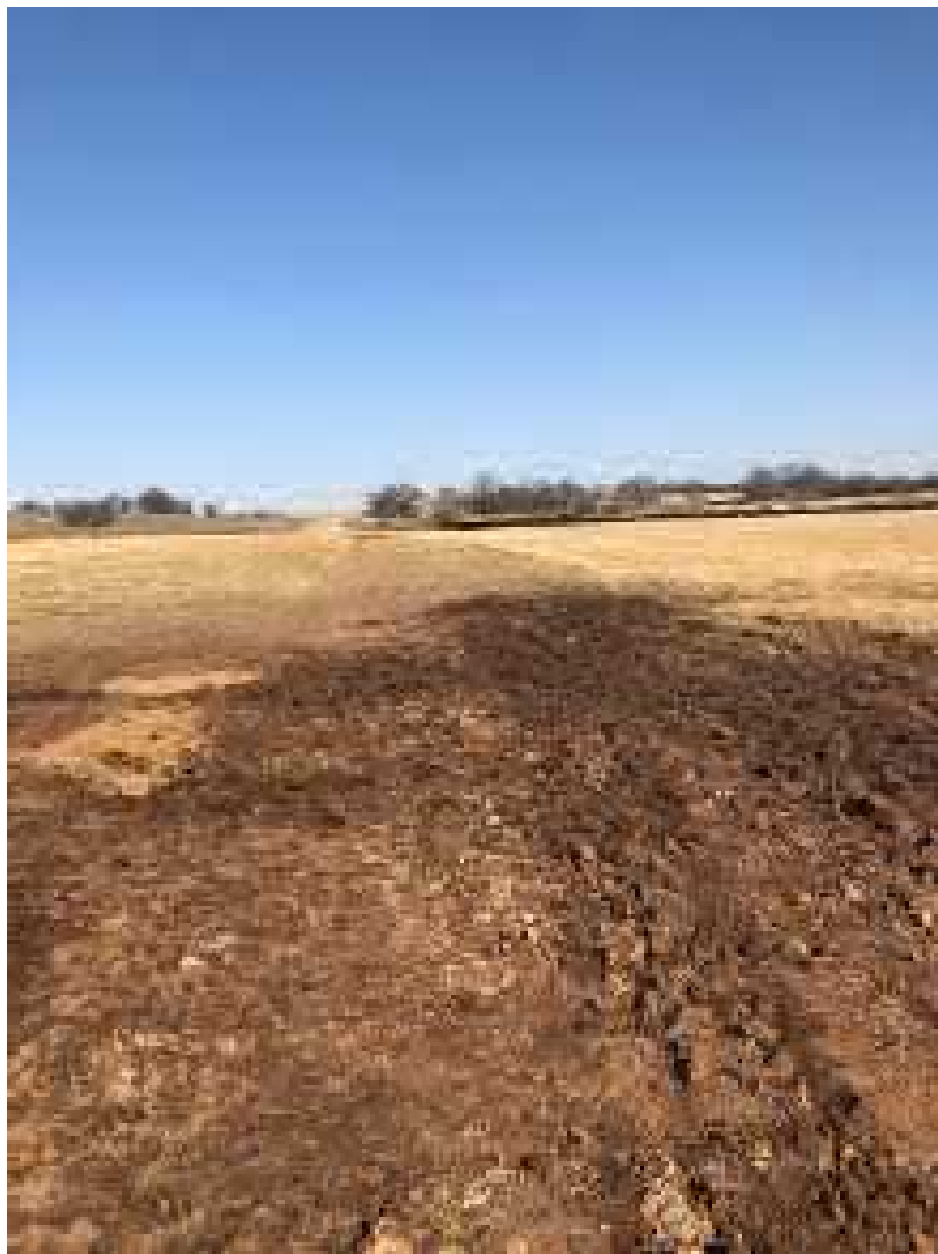
Midship Operations completed backfilling over Midship Pipeline on Nov 19, 2020
