**OFFICE OF DEFECTS INVESTIGATION  
CALSPAN ON-SITE AIR BAG NON-DEPLOYMENT FATAL CRASH INVESTIGATION  
SCI CASE NO: CA09022**

**VEHICLE: 2005 CHEVROLET COBALT  
LOCATION: PENNSYLVANIA  
CRASH DATE: APRIL, 2009**

<i>16. Abstract</i> <p>This on-site investigation focused on the fatal air bag non-deployment crash of a 2005 Chevrolet Cobalt. The Chevrolet was involved in a severe head-on collision with a 2001 Hyundai Sonata that resulted in three fatalities. The 2005 Chevrolet Cobalt was equipped with dual-stage air bags for the driver and front right passenger positions that did not deploy in the crash. The vehicle's Event Data Recorder (EDR) was imaged during the SCI investigation and a non-deployment event was recovered. The driver air bag in the Hyundai Sonata deployed during the impact. The 73-year old unrestrained driver and the 13-year old unrestrained front right passenger of the Chevrolet and the 47-year old unrestrained driver of the Hyundai were all pronounced deceased at the crash site. A 12-month-old male was restrained in a forward facing convertible Child Restraint System (CRS) in the center rear position of the Chevrolet. The child sustained a critical cervical spine

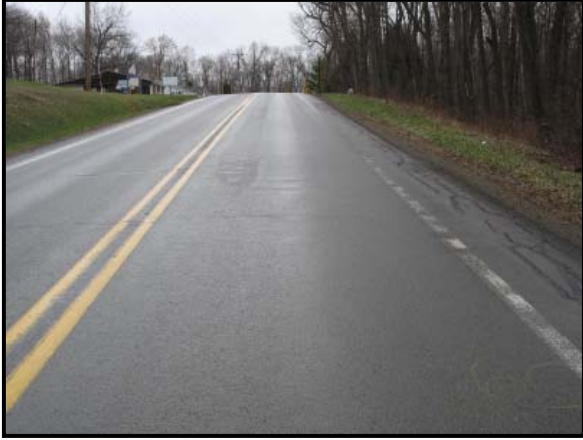
Figure 3: Eastbound approach view 90 m (300 ft) from the point of impact.

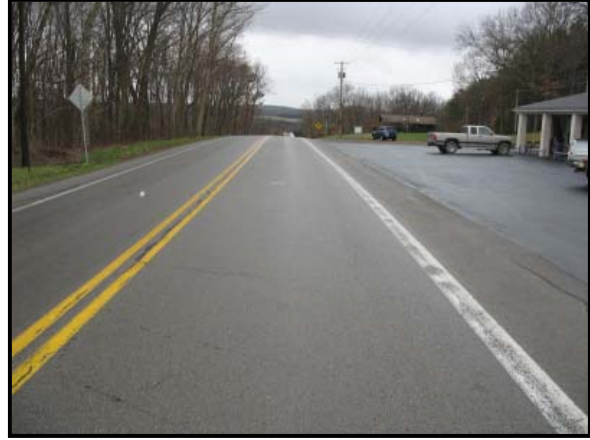
Figure 4: Westbound approach view 60 m (200 ft) from the point of impact.

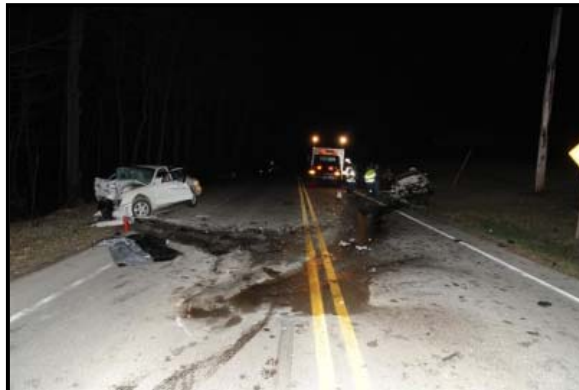
clockwise (CW) as they separated. The Hyundai rotated approximately 200 degrees clockwise and slid to rest on the south road edge. The Hyundai came to rest facing southeast 9.6 m (31 ft) from the impact. The Chevrolet rotated approximately 30 degrees CW and slid to rest on the north roadside. The vehicle slid through the road side ditch and came to rest on the back slope 17.5 m (57 ft) from the impact. **Figure 5** is an on-scene police image of the point of impact and final rest positions of the vehicles.

**Figure 5: On-scene police image of the crash site.**

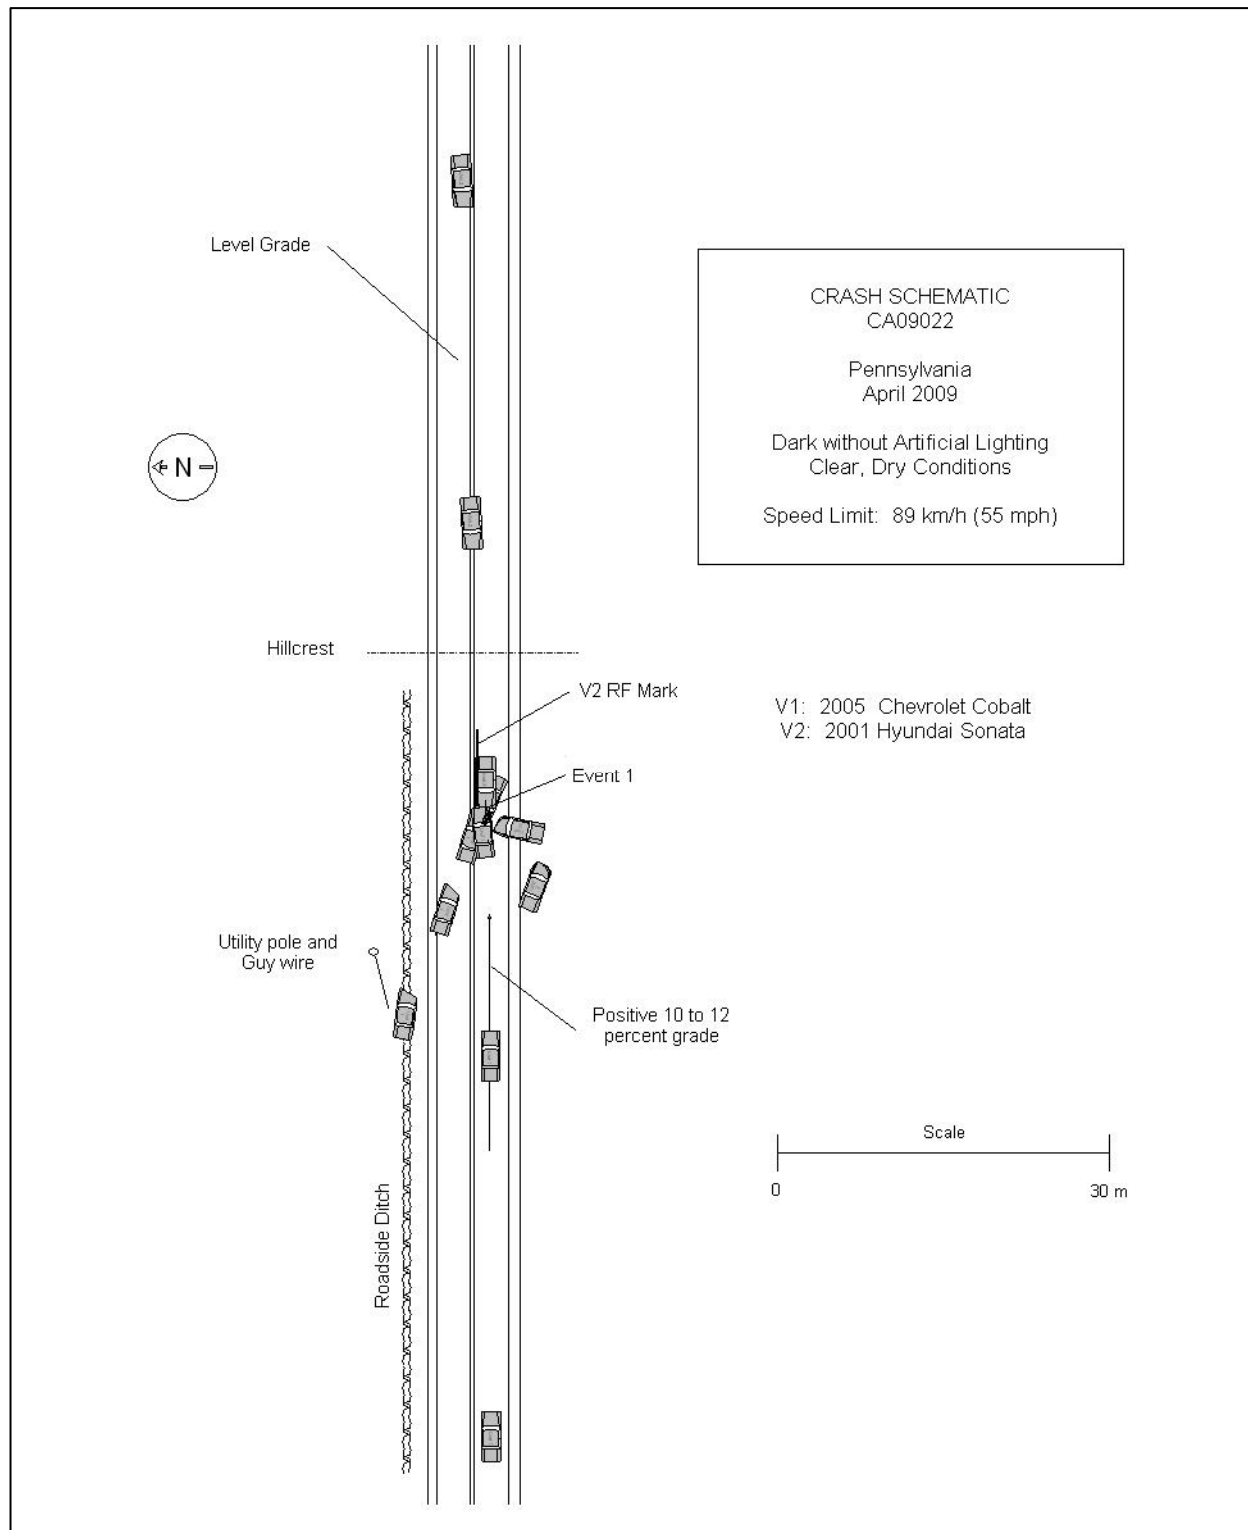
Figure 17: Crash schematic.

The front plane of the Hyundai impacted the front plane of the Chevrolet in a slight offset right configuration. The severity of the impact caused the driver air bag in the Hyundai to deploy. The frontal air bags in the Chevrolet did not deploy. The vehicles pitched down and the front structures deformed. The westbound momentum of the Hyundai halted the forward movement of the Chevrolet and reversed its direction. The offset collision caused the vehicles to rotate
