2005-7 Cobalt Airbag Presentation

ISR Presentation for 11/5/13

GMX351 HVAC Faceplate / Defrost (N130380) Janik
2013 SRX rear seat entertainment Baron
SRX Spare Wheel Marking Voyt
Cobalt/Ion/HHR Potential Airbag Non Deploy Stouffer

2005-7 Cobalt, G5, Pursuit, 2003-2007 Ion, 2006-2007 HHR

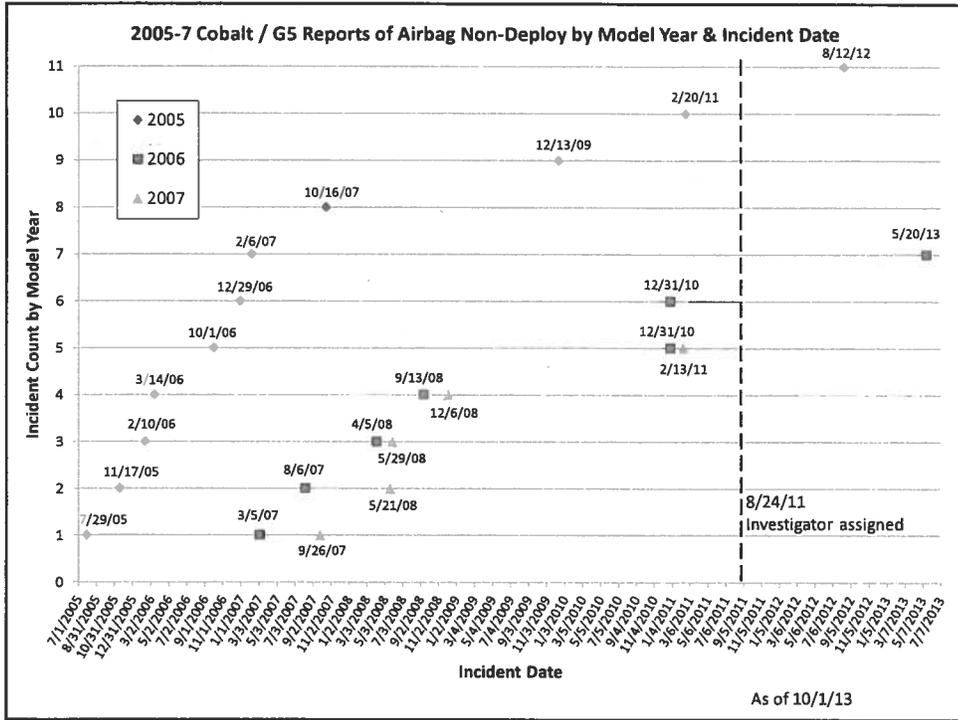
Vehicle Population & Incident Rate 2005-2007 Cobalt & G5

<u>2005</u>	<u>2006</u>	<u>2007</u>
Incidents*	11	7	5
IPTV/Yrs Exposure <small>(as of 10/1/13)</small>	0.0089	0.0039	0.0030

Incident rate for 2005 is over 2 times higher than 2006 and about 3 times higher than 2007

Combined IPTV/Yrs Exposure 0.0053

*Except for 1 2007 G5, all reports are Cobalt. There is 1 incident reported on a 2008 vehicle. 2008 vehicle had front sensor fault that disabled system prior to crash.

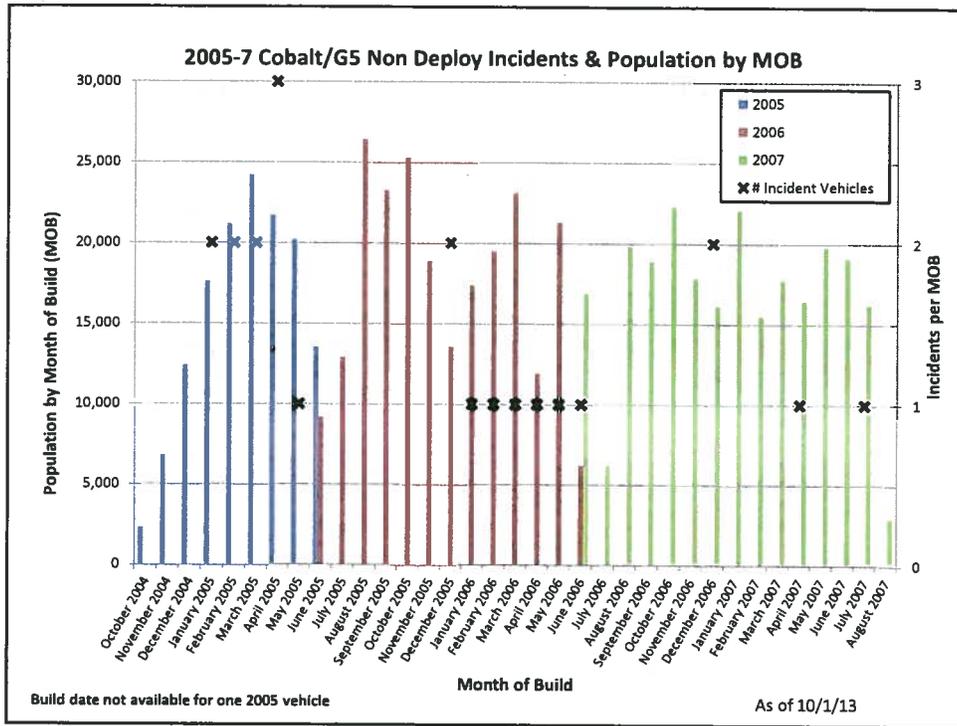
Vehicle Population & Incident Rate 2005-2007

<u>2005</u>	<u>2006</u>	<u>2007</u>
Cobalt/G5# Pursuit	140,464	229,231	248,137
Incidents	11	7	5
IPTV/Yrs Exposure	0.0089	0.0039	0.0030
 SOP – 1/1/09	 8	 4	 4
IPTV/Yrs Exposure	0.0142	0.0058	0.0081
 1/1/09-10/1/13	 3	 3	 1
IPTV/Yrs Exposure	0.0045	0.0028	0.00085

2000 GMT800 0.00698 IPTV/yr (approx 2 yrs exposure @ decision)

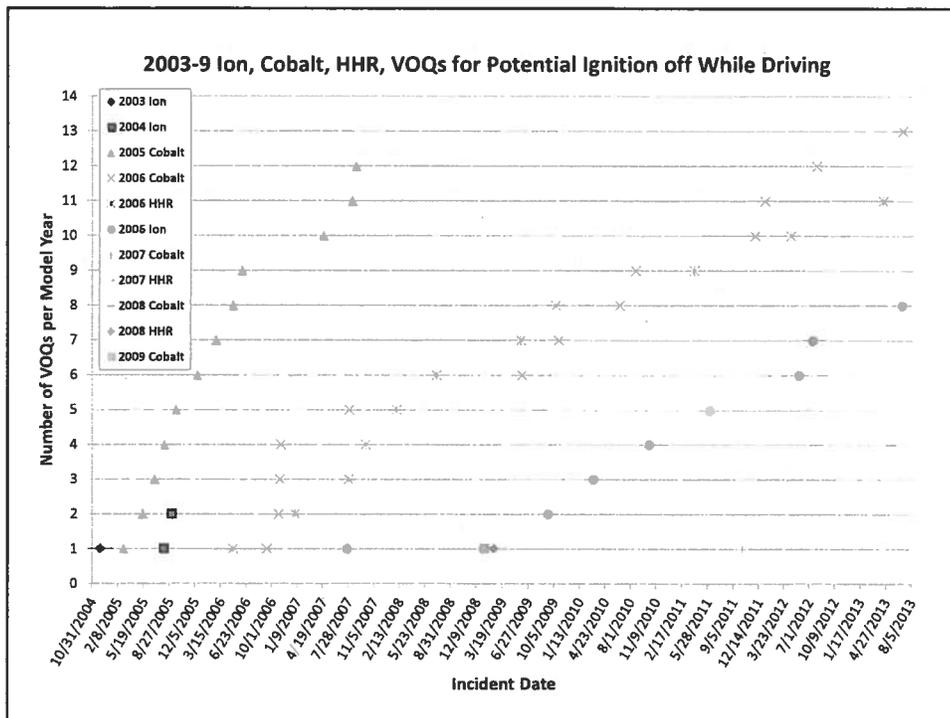
Stalling VOQs by Model Year (Search 10-7-13) Potential Key Motion (Stall with No DTCs & Immediate Restart)

Model	2003	2004	2005	2006	2007	2008	2009	Grand Total
COBALT			12	13	1	1	1	28
HHR				11	2	1		14
ION	1	2		8				11
Grand Total	1	2	12	32	3	2	1	53

Several HHR VOQs state that just prior to stall they hit a pothole or other discontinuity in road
