VI Damage Assessments

Summary of Preliminary Damage Assessments
For Task Orders 001 thru 004
November 13, 2017

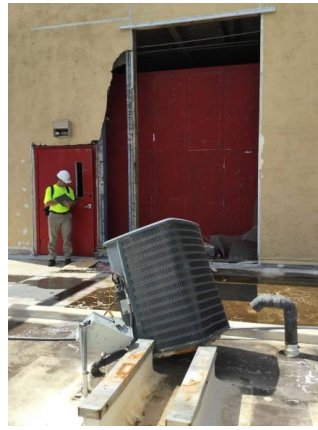
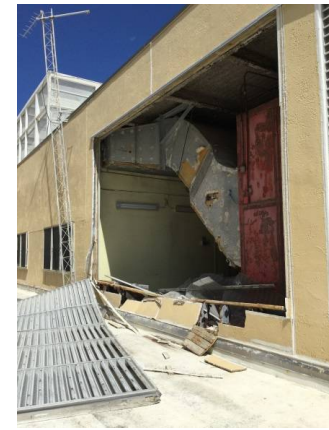
Facility Name	Architecture	Structure	Site_1	Mechanical/Plumbing	Electrical / Comm/ Security	Fire Protection	Overall Narrative Rating
Juan F. Luis Hospital	Catastrophic Damage to roofing and roof insulation causing mold remediation in ceiling plenums and replacement of spray-on fireproofing. -Minor damage to EIFS siding and louvers. -Minor to moderate damage to ceilings, walls and floors from water damage.	Moderate Damage, only limited structural systems damaged. - Multiple large openings, especially louvers, which failed now require reinforcing around the rough openings. - Some long span steel stud walls which failed require intermediate members to support the walls	Minor to Moderate Damage. Majority of site infrastructure is in useable condition, some debris is present from elements of the building, Majority of exterior lighting damaged.	Moderate to significant damage, multiple exterior equipment including pumps, fans, condensing units, and exterior piping and duct insulation has sustained significant to major damage on the roof and exterior locations. Variable refrigerant system serving the OR area has been destroyed. Insulation within the building on duct and piping that has water damage has to be removed and replaced.	Moderate to significant damage, Main electrical concerns are automatic transfer switches not automatic but operating manually and almost half of the interior lighting is nonoperational. Main communications damage is public address system has very poor sound quality	Significant damage- FA devices on level 3 damaged, moderate FA device issues on level 2, and on level 1.	Catastrophic- Remediation efforts that will be necessary as a result of roof damage will require replacement of a significant portion of all partitions and building systems within the building.

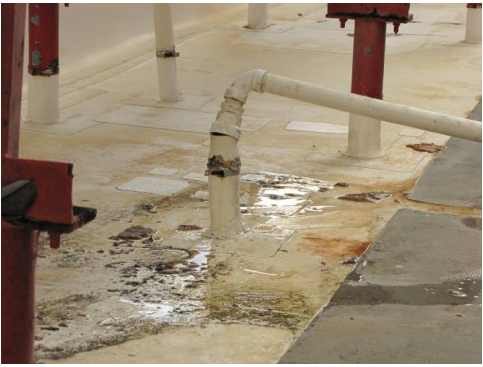
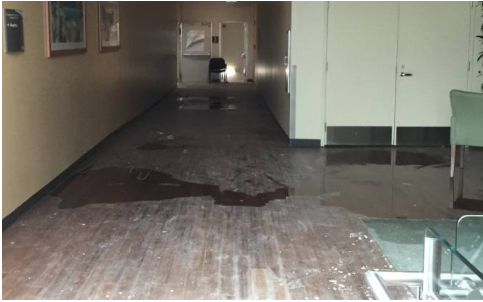
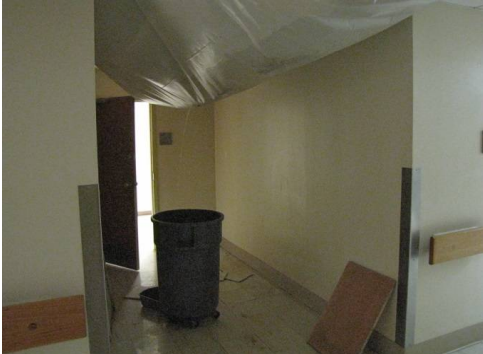
Facility Name	Architecture	Structure	Site_1	Mechanical/Plumbing	Electrical / Comm/ Security	Fire Protection	Overall Narrative Rating
Schneider Regional Medical Center	Catastrophic Damage to roofing an roof insulation causing mold remediation in ceiling plenums and replacement of spray-on fireproofing. -Minor damage to EIFS siding and louvers. -Moderate damage to ceilings, walls and floors from water damage.	Moderate Damage, only limited structural systems damaged. - Multiple large openings, especially louvers, which failed now require reinforcing around the rough openings. - Some long span steel stud walls which failed require intermediate members to support the walls	Minor to Moderate Damage, Majority of site infrastructure is in useable condition, some debris is present from elements of the building, all exterior lighting damaged.	Catastrophic damage to the HVAC roof top equipment is missing or dislodged from roof curbs or original locations. Roof experiencing ponding and leaking into lower levels. Insulation and equipment on upper levels has been compromised with water from leaking. Cancer Center - HVAC moderate damage throughout, domestic water shutdown due to leaks in the system.	Catastrophic damage. The interior lighting and branch wiring suffered moderate to significant damage estimated at approximately half.	Moderate damage. FA Devices appear to be damaged by water infiltration. Sprinkler System does not appear to show any damage.	Catastrophic- Remediation efforts that will be necessary as a result of roof damage will require replacement of a significant portion of all partitions and building systems within the building.

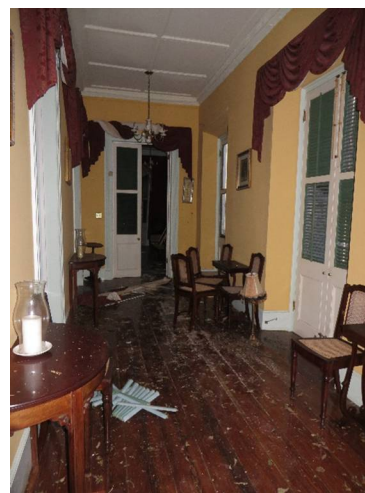
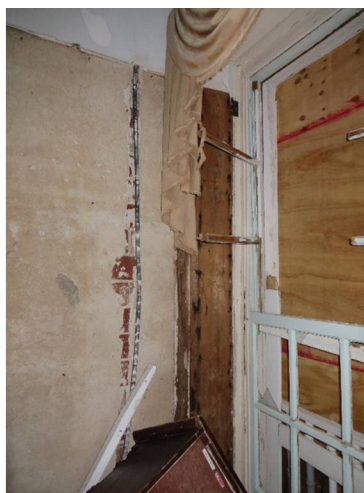
Facility Name	Architecture	Structure	Mechanical/Plumbing	Electrical / Comm/ Security	Overall Narrative Rating
Estate Catherineberg	Significant damages. The storm breached/blew out several exterior shutters/windows. Wind and rain damage to interiors. Damage to historic plasterwork and floors, and damage to wood tray ceiling in the parlor. The building also exhibits widespread mold growth.	Significant Damage. - Exterior two flag poles yielded at base. - All windows and shutter broken. - Ceiling Damage due to water intrusion. - Significant damage to building exterior and gazebo.	Mechanical equipment has moderate to catastrophic damage. Outdoor condensing units were dislodged and destroyed. Some indoor units sustained water damage as well.	Electrical conduits and wiring of branch have been affected. The generator is operational but further inspection and maintenance is required. Almost half of Exterior lighting fixtures have been affected, further inspection is required. Some interior lighting fixtures have been affected. Some Comm/Security and public address devices have been affected.	Severe but repairable - Remediation efforts that will be necessary as a result of water intrusion will require replacement of a significant portion of all partitions and building systems within the building.

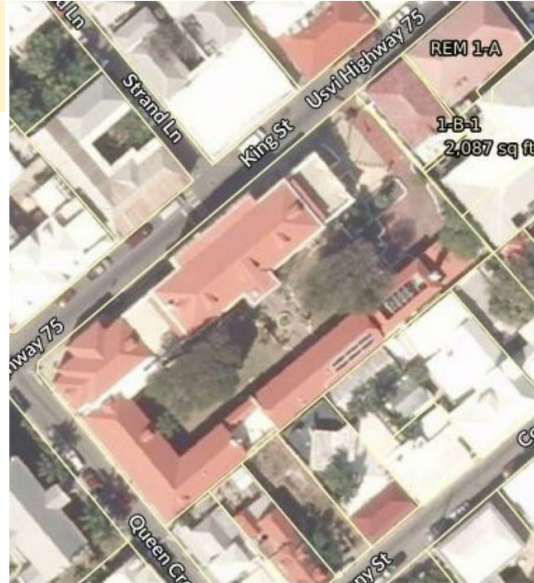
After Storm

Facility Name	Architecture	Structure	Mechanical/Plumbing	Electrical / Comm/ Security	Fire Protection	Overall Narrative Rating
Government House, St. Croix, Christiansted	Exterior: Overall minor damage. Roofing-Portion of gutter and downspout drainage system. Resealing of all roof corrugated metal deck laps joints. HAZMAT materials verification recommended prior to any scope of work performance. Wall(s)-Damage requires crack and stucco repairs (chimney and walls). Repainting of exterior facade/ walls areas required. Interior moderate damages. Plaster, wood trim and paint damaged by water penetration, some mold is present.	Moderate Damage. Exterior cracks to column capitals, Exterior walkway slab cracks due to possible foundation settlements, ceiling damage, and minor wall cracking at third floor kitchen wall.	Mechanical equipment has minor to significant damage. exterior louvers sustained a majority of the damage ranging from blockage and screen damage to bent louver blades. Exterior condensing units had moderate coil damage. Plumbing equipment suffered moderate to catastrophic damage. Roof drains and gutter systems were significantly impacted causing leaks and other damage. Corrosion on plumbing fixtures was also noted in a few areas.	Electrical conduits and wiring of branch circuits have been affected due to roof leaking. One of two generator is not operational. The elevator is not working. Almost half of all exterior lighting fixtures have been affected.	Fire alarm system damaged. Fire alarm devices suffered moderate to catastrophic damage in the Inner Courtyard.	Severe but repairable - Remediation efforts that will be necessary as a result of roof damage will require replacement of a significant portion of all partitions and building systems within the building.

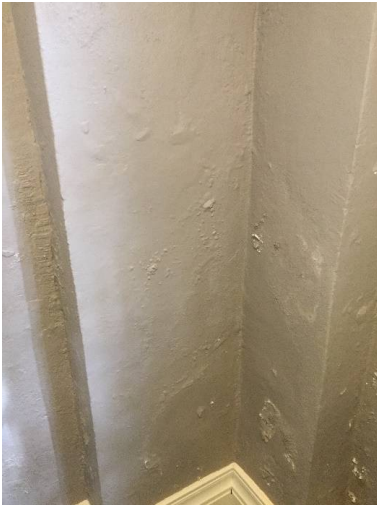
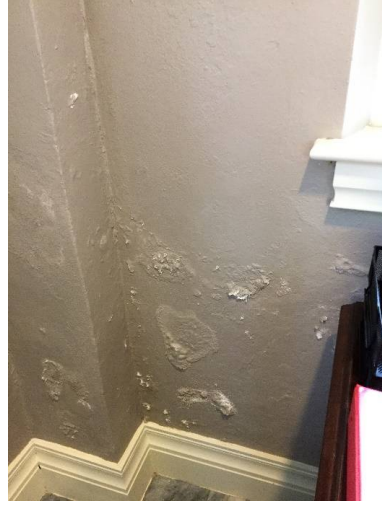
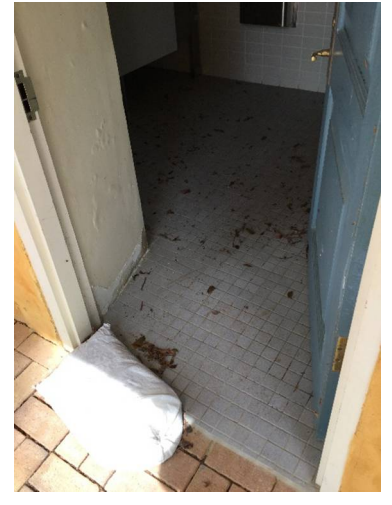
Facility Name	Architecture	Structure	Mechanical/Plumbing	Electrical / Comm/ Security	Fire Protection	Overall Narrative Rating
Government House, St. Croix, Fredricksted	Exterior: Overall significant damage. Roofing- majority of gutter and downspout drainage system have been damaged or blown-off due to high wind event. Resealing of all existing roof corrugated metal deck laps joints and flashings required. HAZMAT materials verification recommended prior to any scope of work performance. Wall(s)-portion of existing stucco has been damaged or blown-off due to high wind event Repainting of exterior facade/ walls areas required. Recommendation for crack/stucco/ waterproofing/ paint for exterior building envelope walls. Replacement of existing broken window/glazing required. Interior minor damages. Plaster, wood trim and paint damaged by water penetration, some mold is present.	Minor Damage. Minor wall cracks in second floor and meeting house. Some minor water damage to architectural finishes due to roof leaks.	Plumbing systems have moderate to catastrophic damage. Plumbing fixtures require moderate repairs or replacement but roof gutter system has substantial damage and leaks. Mechanical has moderate damage to generator exhaust.	Electrical conduits and wiring of branch circuits have been affected. Exterior lighting fixtures have been affected. Exterior disconnect Switches have been affected, all need complete replacement.	Some damaged, require further inspection.	Severe but repairable Remediation efforts that will be necessary as a result of roof damage will required replacement of a significant portion of all partitions and building systems within the building.

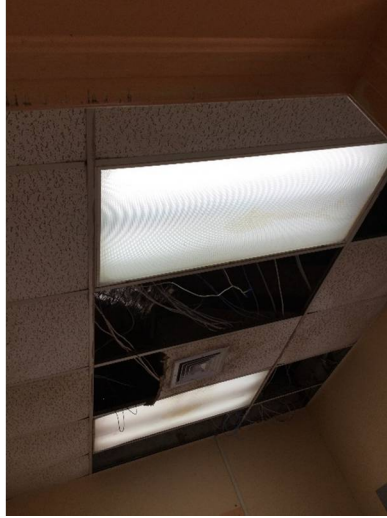
Facility Name	Architecture	Structure	Mechanical/Plumbing	Electrical / Comm/ Security	Fire Protection	Overall Narrative Rating
Government House, St. John	Exterior: Overall catastrophic damage. Roofing-Entire roof system at Main Bldg. including gutter and downspouts and structural wood T & G/ beam assembly failure in high wind event. Wall(s)-portion of existing stucco has been damaged or blown-off. Repainting of exterior facade/ walls areas required. Recommendation for crack/stucco/ waterproofing/ paint for exterior building envelope walls and concrete spalling conditions. Replacement of existing broken window/glazing required. Extensive water damage to all exterior finishes. Overall minor damage. At Secondary Bldg. portion of gutter and downspout drainage system. Resealing of all roof corrugated metal deck laps joints. HAZMAT materials verification recommended prior to any scope of work performance. Wall(s)-Damage requires crack and stucco repairs (chimney and walls).	Significant damage to catastrophic damage in some items. - Complete roof was blown away - Cracked balcony beams - Pool ornaments broken - Boat mast broken and damaged support retaining wall - 2nd floor ceilings and slab damage - Licensing building gutter blown away on one side	Mechanical systems suffered significant to catastrophic damage, most split systems were destroyed or damaged. Some ductwork damage was also documented. Plumbing systems experienced significant to catastrophic damage. Roof gutter system was completely destroyed on the main building and the sewage system is rusted and broken in	Electrical conduits and wiring of branch circuits have been severely damaged. Half of interior lighting has been severely damaged. The exterior lighting is a total loss. All low voltage systems are down, we recommend the entire electrical system to be replaced.	Almost all of the fire alarm system damaged.	Severe to catastrophic Remediation efforts that will be necessary as a result of roof damage will required replacement of a significant portion of all partitions and building systems within the building.

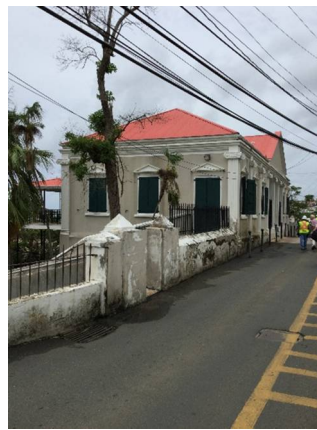
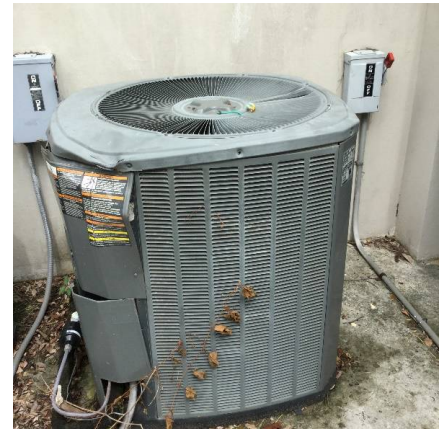
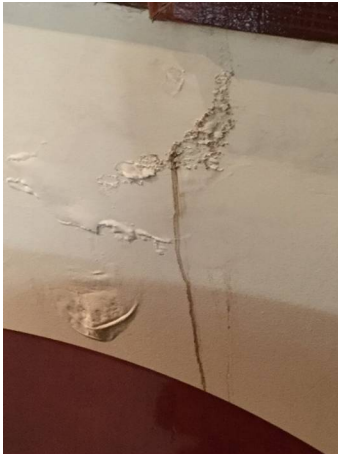
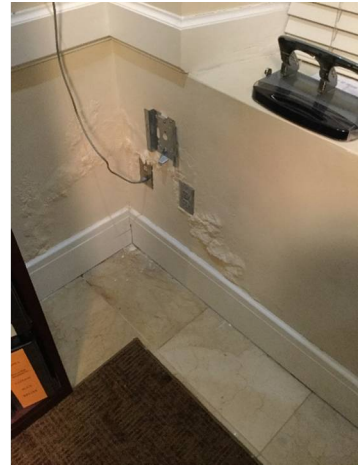
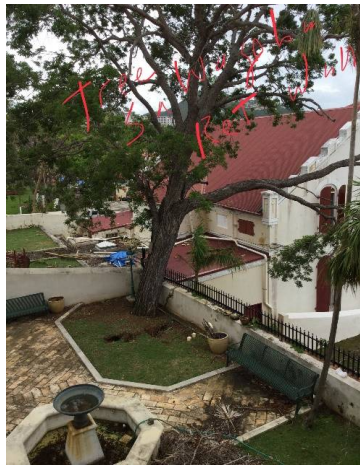
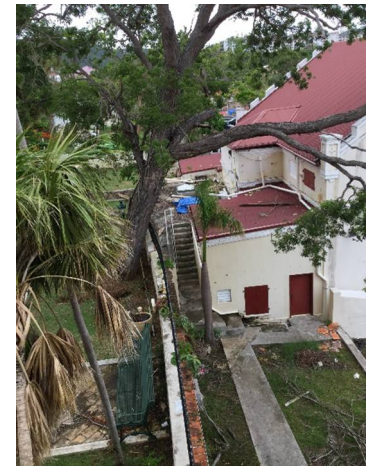
Facility Name	Architecture	Structure	Mechanical/Plumbing	Electrical / Comm/ Security	Fire Protection	Overall Narrative Rating
Office of the Governor's Finance and Communication Building	Exterior: Overall Moderate damage. Roofing - Resealing of all existing roof systems including corrugated metal deck laps joints and flashings required. HAZMAT materials verification recommended prior to any scope of work performance. Wall(s) - Repainting of exterior facade/ walls areas required. Recommendation for crack/stucco/ waterproofing/ paint for exterior building envelope walls. Interior-Plaster, wood trim and paint damaged by water penetration, some mold is present.	Moderate Damage. - Warped wood flooring due to water infiltration. - Ceiling Damage. - 1st floor room exterior door and shutters do not open due to possible water damage. - Stair from 1st to 2nd floor have cracked stringer due to possible settlement of supporting slab/foundation. - portion of retaining wall damaged by	Mechanical equipment suffered catastrophic damage, many outdoor condensing units are severely damaged with a few still operating but not full capacity. Mold has been noticed due to the AC systems not working properly or at all. Plumbing at main building appears intact but plumbing to adjacent structures have moderate deficiencies, lack of cold water at sinks and leaks.	Electrical conduits and wiring of branch circuits have been affected, requires further inspection. Almost half or more of exterior lighting fixtures have been affected. Some interior lighting is affected. Comm/Security and public address systems are not	Some of the Fire alarm System has been affected.	Severe but repairable - Remediation efforts that will be necessary as a result of water intrusion will required replacement of a significant portion of all partitions and building systems and equipments within the building.

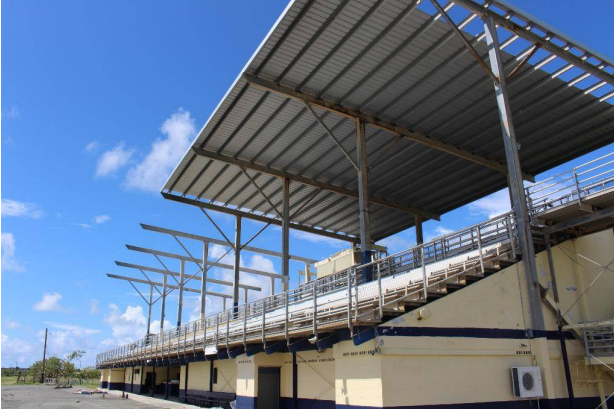
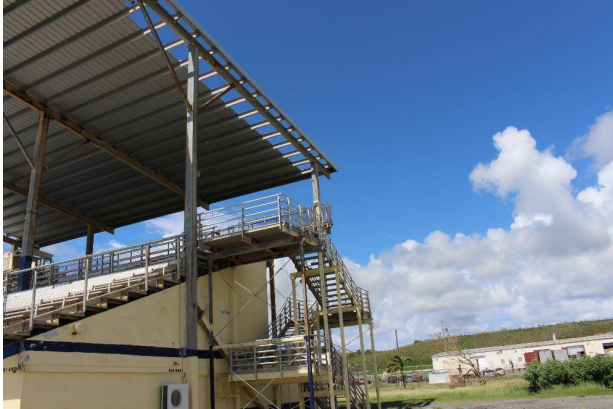
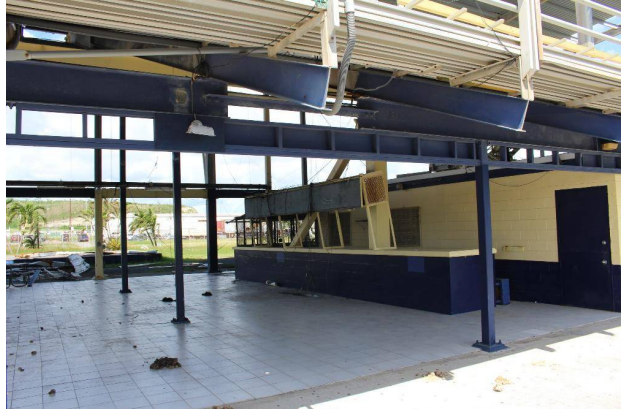
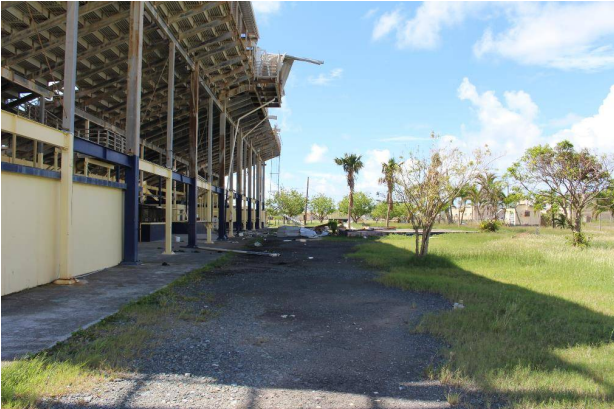
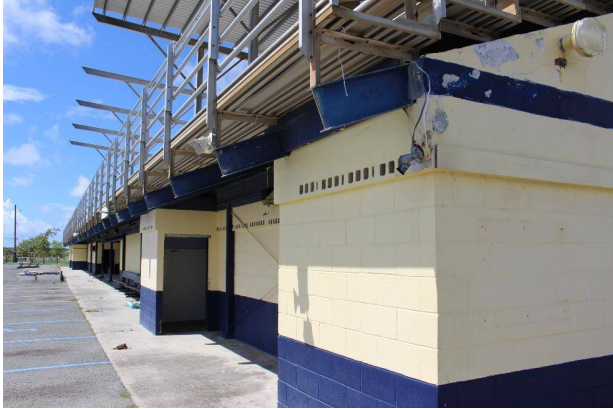
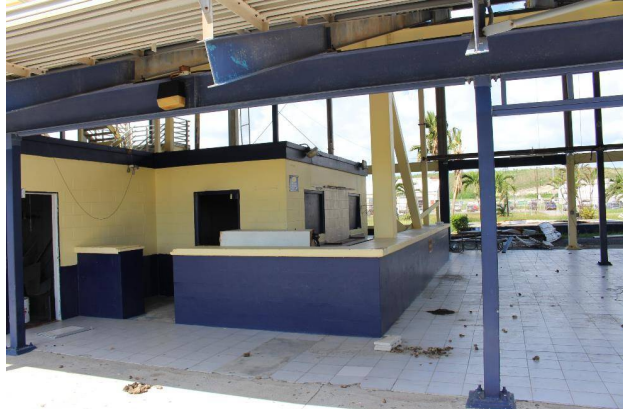
Randal Doc James Race Track

Facility Name	Architecture	Structure	Site_1	Mechanical/Plumbing	Electrical / Comm/ Security	Fire Protection	Overall Narrative Rating
Randall Doc James Racetrack	Minor to to Moderate Damage. Damage found at Horse Stable, Gate, Bleachers, and Press box.	Moderate Damage- Portions of the roof is missing.	Minor Damage, Some debris is present. Chain link fencing needs to be replaced in several areas.	Not Applicable	Minor Damage, Satellite dish has been destroyed.	Not Applicable	Minor Damage to Canopy, Horse Stable, Gate, Bleachers, and Press box.
