**KOMITE NASIONAL KESELAMATAN TRANSPORTASI
REPUBLIC OF INDONESIA**

KNKT.18.10.35.04

Aircraft Accident Investigation Report

**PT. Lion Mentari Airlines
Boeing 737-8 (MAX); PK-LQP
Tanjung Karawang, West Java
Republic of Indonesia
29 October 2018**

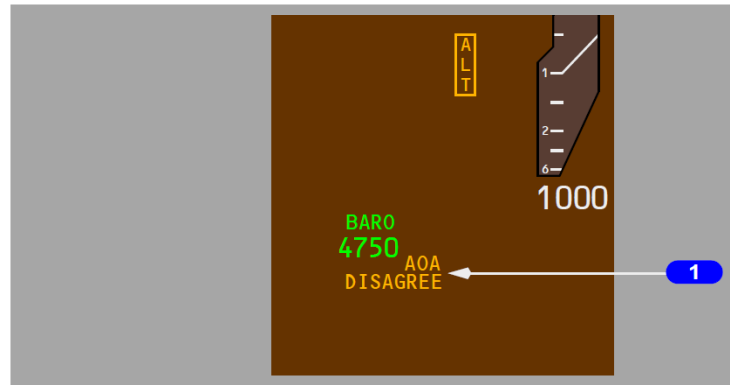
Figure 9: AOA Disagree message on the PFD

As shown in figure 9 the “AOA DISAGREE” message appears on the Captain and First Officer PFD when the values of the left and right AOA transmitted by the ADIRUs differ by 10° or more for 10 continuous seconds. The annunciation is only displayed in the air because AOA values are unreliable when the aircraft is stationary on the ground.

Lion Air did not select the optional AOA indicator feature on the PFD of their 737-8 (MAX) aircraft. As a result, the AOA DISAGREE did not appear on PK-LQP aircraft, even though the necessary conditions were met.

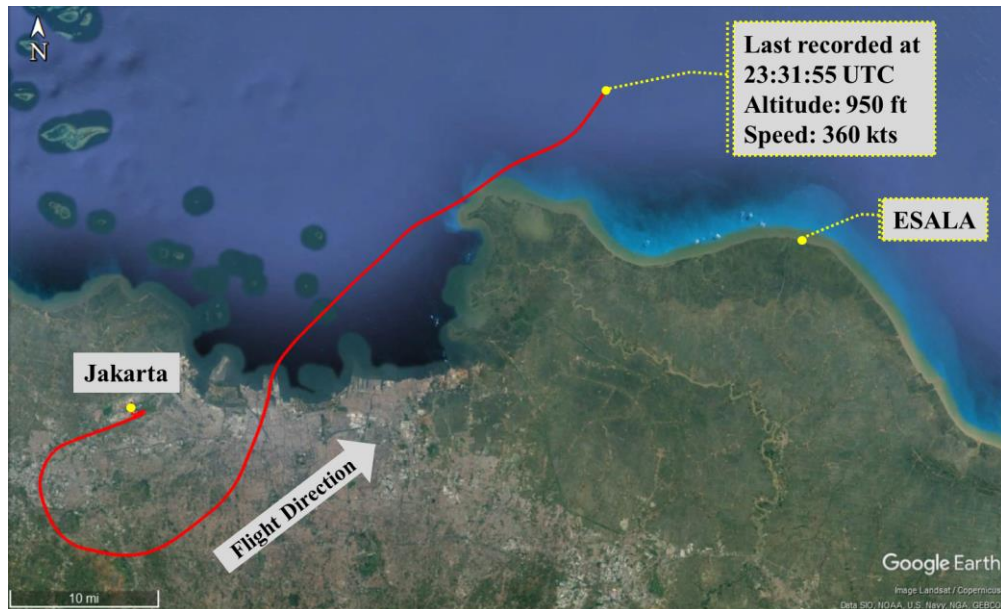
Figure 23: The flight track of LNI610 based on ADS-B

The flight track of the LNI610 based on the ADS-B data superimposed on Google Earth.

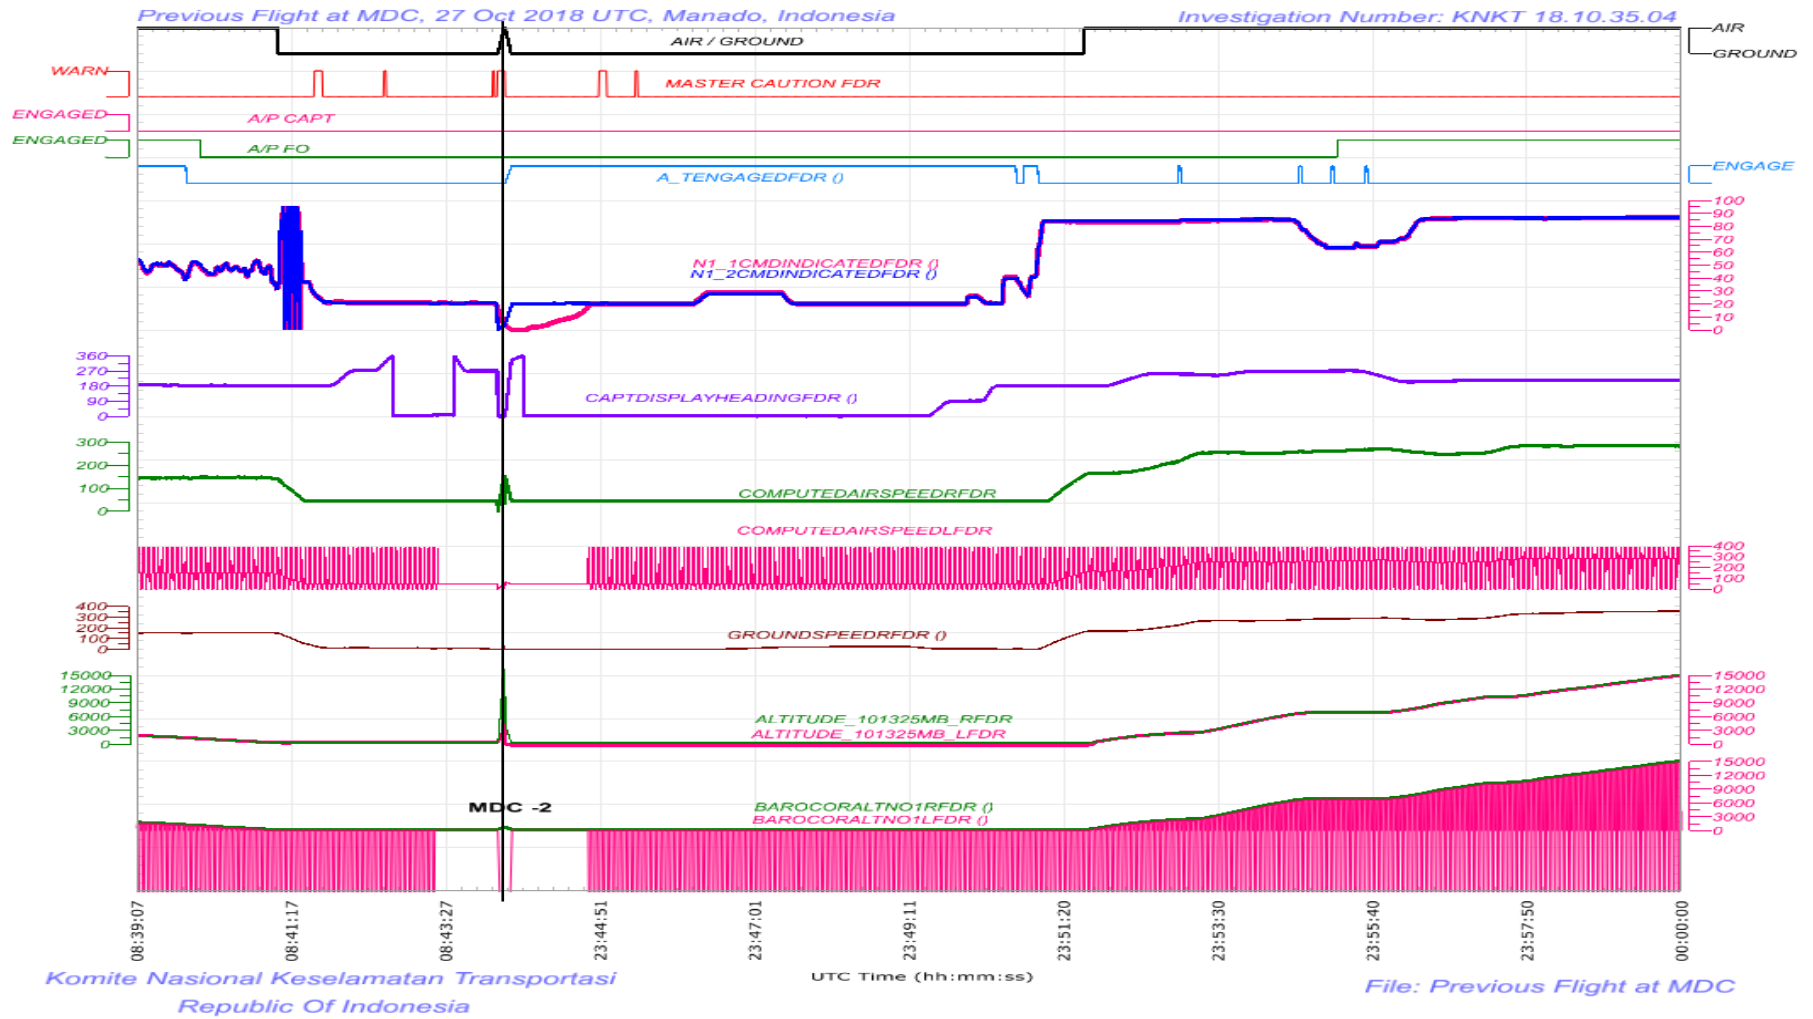
Figure 26: The FDR parameters of the flight from Manado to Denpasar on 28 October 2018 (MDC-2)

The DFDR parameters graphs of the flight from Manado to Denpasar on 28 October 2018 (MDC-2) on figure 26 showed:

6. When the aircraft altitude reached about 7,000 feet (refer to parameters labeled right Barometric Corrected Altitude (BAROCORALTNO1RFDR) and Altitude 101325MBFDR) the first officer autopilot (A/PFO) engaged. Other than the engagement of the autopilot, the DFDR graph did not show any invalid data change.

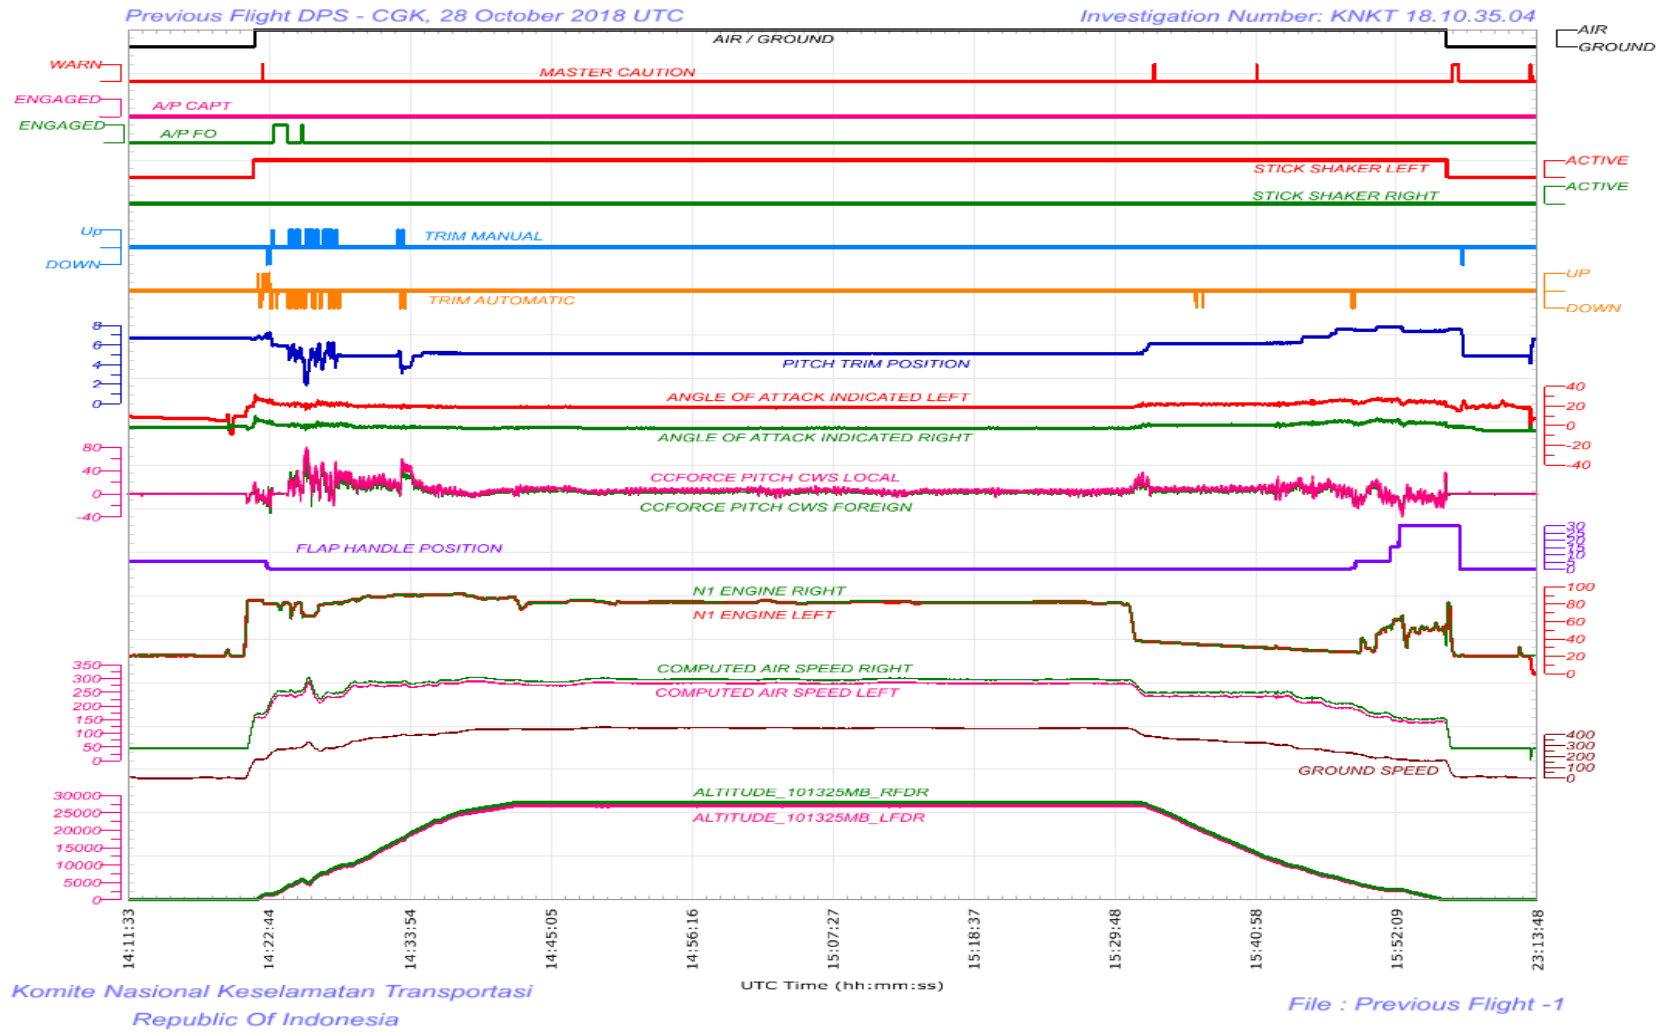
Figure 27: FDR parameters of the flight from Denpasar to Jakarta (DPS-1)

The DFDR parameters of the flight from Denpasar to Jakarta (DPS-1) plotted on figure 27 and 28 showed:

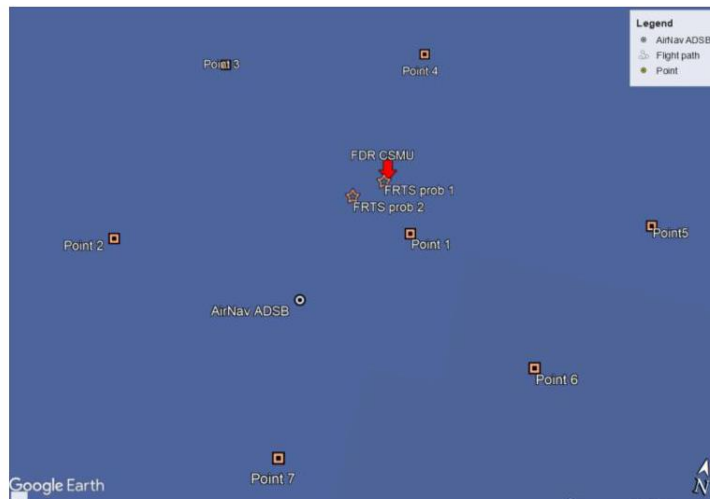
Figure 7 : The location of FDR CSMU

On the 1 November 2018 (the 3rd day of the search), a smaller team deployed to the first possible location using ping locator to narrow the search area. The team determined new possible location. The divers directed to the new possible location and about 1000 LT, the divers found the flight data recorder (FDR) CSMU with attached ULB. The CSMU FDR found approximately 10 meters from new possible location.

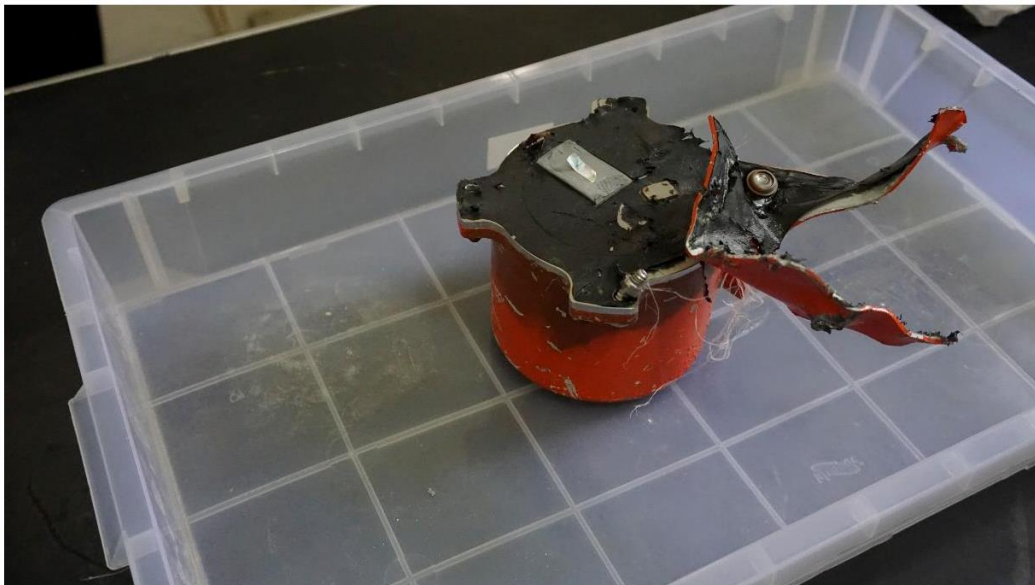
Figure 10 : The CVR CSMU at the KNKT recorder facility

At 08:48 LT, the CVR CSMU was recovered and at 09:00 the divers went up to the surface. The diver reported that the CVR CSMU was recovered at approximately 6 meters from the heavy object without the ULB.

The CVR CSMU condition was good with small discoloration on the metal case of the CSMU. The ULB was detached from the CVR CSMU which might be due to high impact force.
