**CALSPAN ON-SITE AIR BAG NON-DEPLOYMENT INVESTIGATION**

**CASE NO: CA05-049**

**VEHICLE: 2005 CHEVROLET COBALT**

**CRASH DATE: JULY 2005**

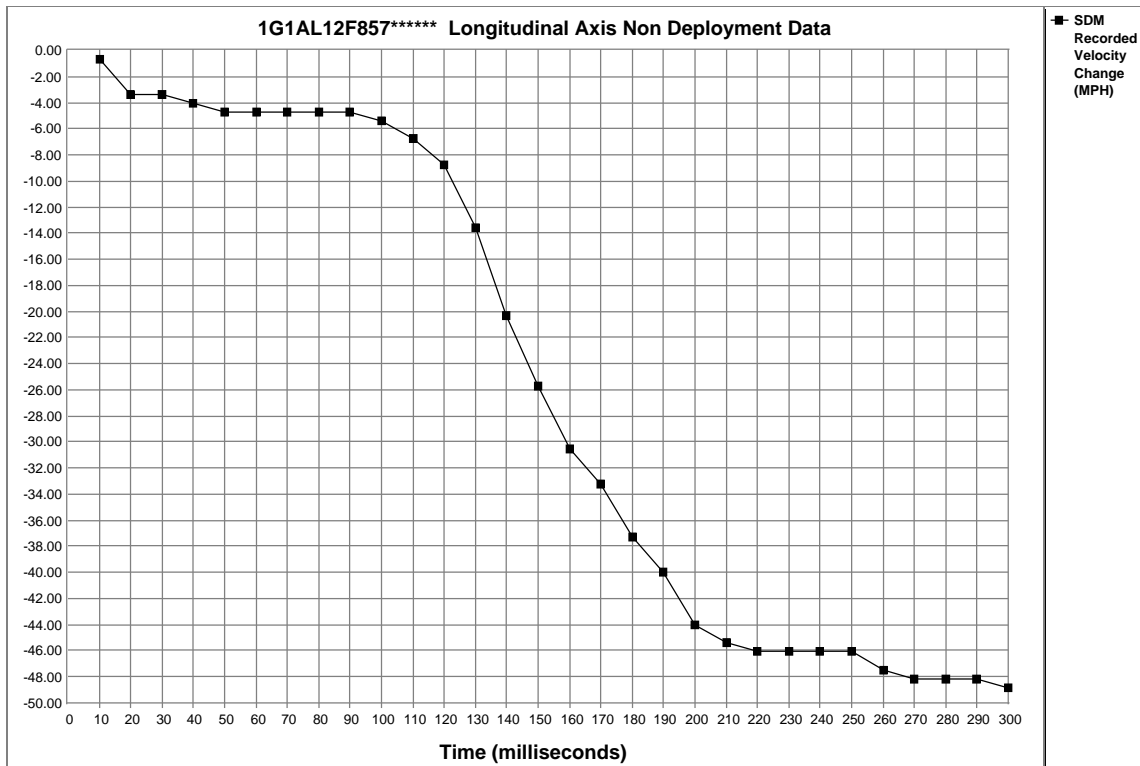
Time (milliseconds)	10	20	30	40	50	60	70	80	90	100	110	120	130	140	150
Longitudinal Axis Recorded Velocity	-0.68	-3.39	-3.39	-4.07	-4.74	-4.74	-4.74	-4.74	-4.74	-5.42	-6.78	-8.81	-13.56	-20.34	-25.76
Time (milliseconds)	160	170	180	190	200	210	220	230	240	250	260	270	280	290	300
Longitudinal Axis Recorded Velocity	-30.50	-33.21	-37.28	-39.99	-44.06	-45.42	-46.09	-46.09	-46.09	-46.09	-47.45	-48.13	-48.13	-48.13	-48.80
