INDIANA UNIVERSITY

TRANSPORTATION RESEARCH CENTER

ON-SITE AIR BAG NON-DEPLOYMENT INVESTIGATION

CASE NUMBER - IN-06-033
LOCATION - WISCONSIN
VEHICLE - 2005 CHEVROLET COBALT
CRASH DATE - October 2006

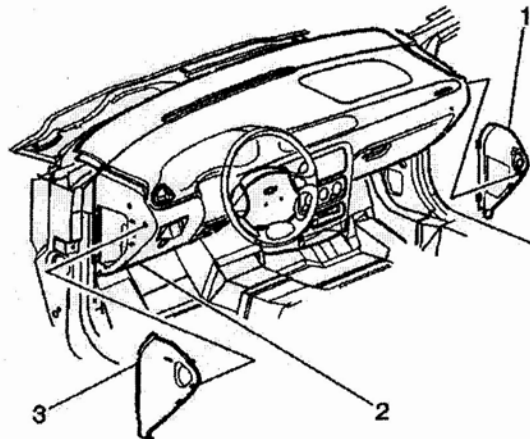
Figure 15: General Motors bulletin continued

- If the vehicle is equipped with a 2.2L engine (L61) *AND* air conditioning (C67), perform only the A/C Wiring (Jumper) Procedure
- If the vehicle is NOT equipped with a 2.2L engine (L61) *AND* air conditioning (C67), perform only the Airbag Wiring Procedure

1. Remove the SIR fuse from the BCM.
2. With a flat-bladed tool, separate the outer trim cover from the I/P.
3. Pull the outer trim cover rearward from the I/P to disengage the locating tabs.

4. Remove the outer trim cover from the I/P.
5. Disconnect the electrical connector from the trim cover.
6. Remove the connector position assurance (CPA) clip from the connector.
