ON-SITE AIR BAG NON-DEPLOYMENT INVESTIGATION

CASE NUMBER - IN-06-033

VEHICLE - 2005 CHEVROLET COBALT

CRASH DATE - October 2006

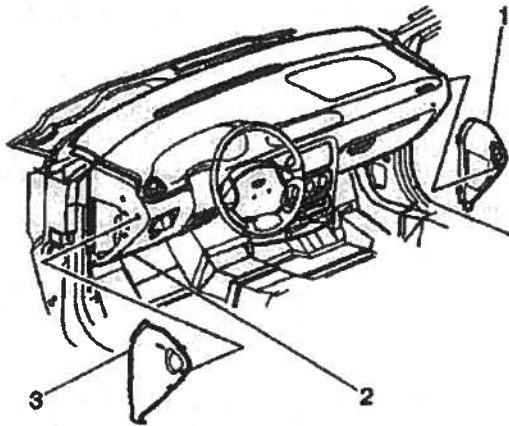
Figure 15: General Motors bulletin continued

1. Remove the SIR fuse from the BCM.
2. With a flat-bladed tool, separate the outer trim cover from the I/P.
3. Pull the outer trim cover rearward from the I/P to disengage the locating tabs.

4. Remove the outer trim cover from the I/P.
5. Disconnect the electrical connector from the trim cover.
6. Remove the connector position assurance (CPA) clip from the connector.
