From: John R Dolan
To: David Carey; John Capp
CC: Lisa D. Weber; Vipul Modi
BCC:
Sent Date: 2012-05-15 13:50:22:000
Received Date:
Subject: Slides for Cobalt Issue
Attachments: cobalt key.pptx *Attached*

Cobalt Issue Activities

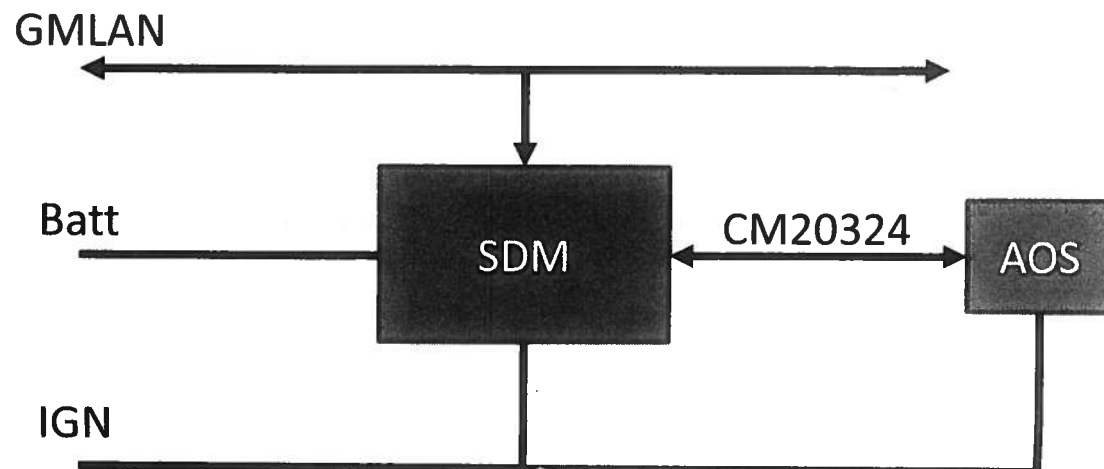
- Changing the SDM power down behavior is high risk. The power moding, fail safe operation, and diagnostics portion of the SW would need to be modified.

- Diagnostics of the IGN line and AOS module (perhaps other U-Codes) would need to be modified
 - Changes to the design of the SDM will need to be done by engineers who were not part of the original design team.

- Note that the AOS module is powered from IGN not battery – so it will power off when the key transitions from run. The FMVSS requirement is that the correct airbag state be displayed within 10 secs – so if the SDM shut off delay lasted longer than 10 seconds or if a transition of airbag state happened with 2-3 seconds of power mode change, there may be a violation of this requirement.

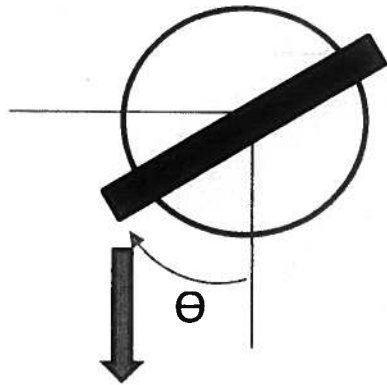
Key Drawing

Weight

θ for Cobalt > 60

The concern is more likely to occur if the driver is short and has a large and/or heavy key chain. In these cases, this condition was documented and the driver's knee would contact the key chain while the vehicle was turning and the steering column was adjusted all the way down. This is more likely to happen to a person who is short, as they will have the seat positioned closer to the steering column.

Engineering has come up with an insert for the key ring so that it goes from a "slot" design to a hole design. As a result, the key ring cannot move up and down in the slot any longer – it can only rotate on the hole. In addition, the previous key ring has been replaced with a smaller, 13 mm (0.5 in) design. This will result in the keys not hanging as low as in the past.
