2005-7 Cobalt/G5 Frontal Airbags

Requests from 6/21/12 mtg to understand why only 2005-7

ON-SITE AIR BAG NON-DEPLOYMENT INVESTIGATION

CASE NUMBER - IN-06-083
LOCATION - WISCONSIN
VEHICLE - 2006 CHEVROLET COBALT
CRASH DATE - October 2006

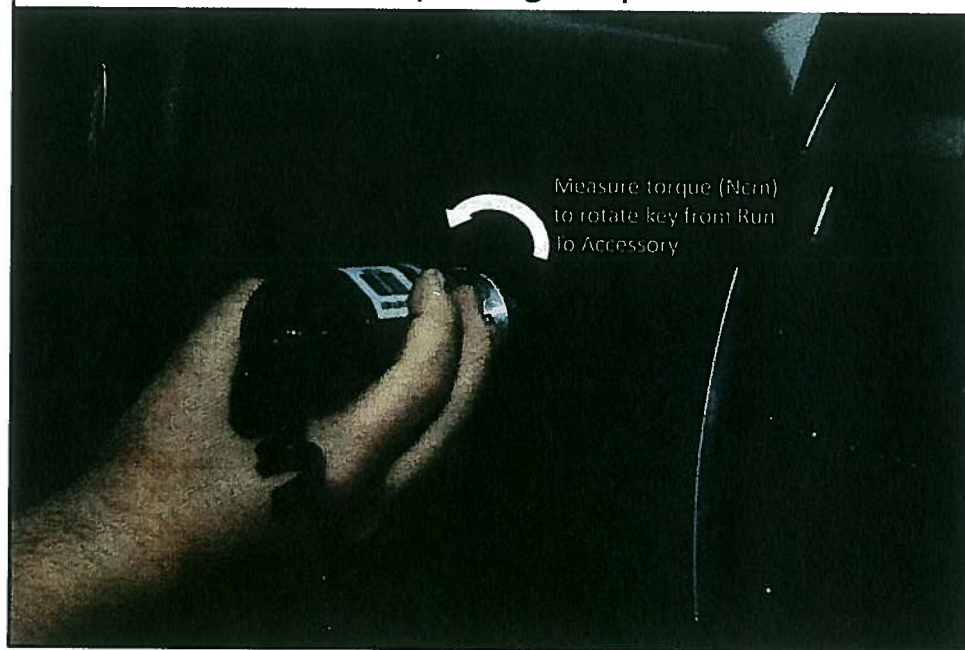
Test Set-up Using Torque Tool

- 5/22/12 44 vehicles in Davison salvage yard
 - Measured torque (Ncm) and force (N) to turn the ignition switch from Run to Accessory.
 - Five of the vehicles had a replacement key, or a key with a hole vs slot (force not measured)

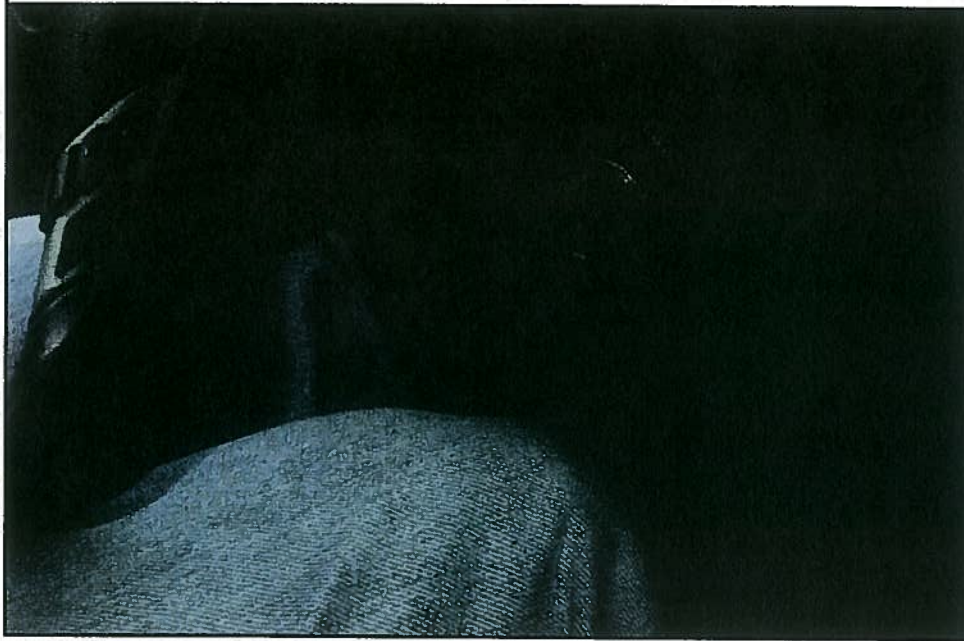
HHR Knee Clearance to Ignition (6'1" driver)

The concern is more likely to occur if the driver is short and has a large and/or heavy key chain. In these cases, this condition was documented and the driver's knee would contact the key chain while the vehicle was turning and the steering column was adjusted all the way down. This is more likely to happen to a person who is short, as they will have the seat positioned closer to the steering column.
