2005-2007 Cobalt/Pursuit/G5
Front Airbag Non-Deployment
709,741 Vehicles
Cost Estimate: \$14.2M-\$37.7M

ETQ N-130454

Root Cause:

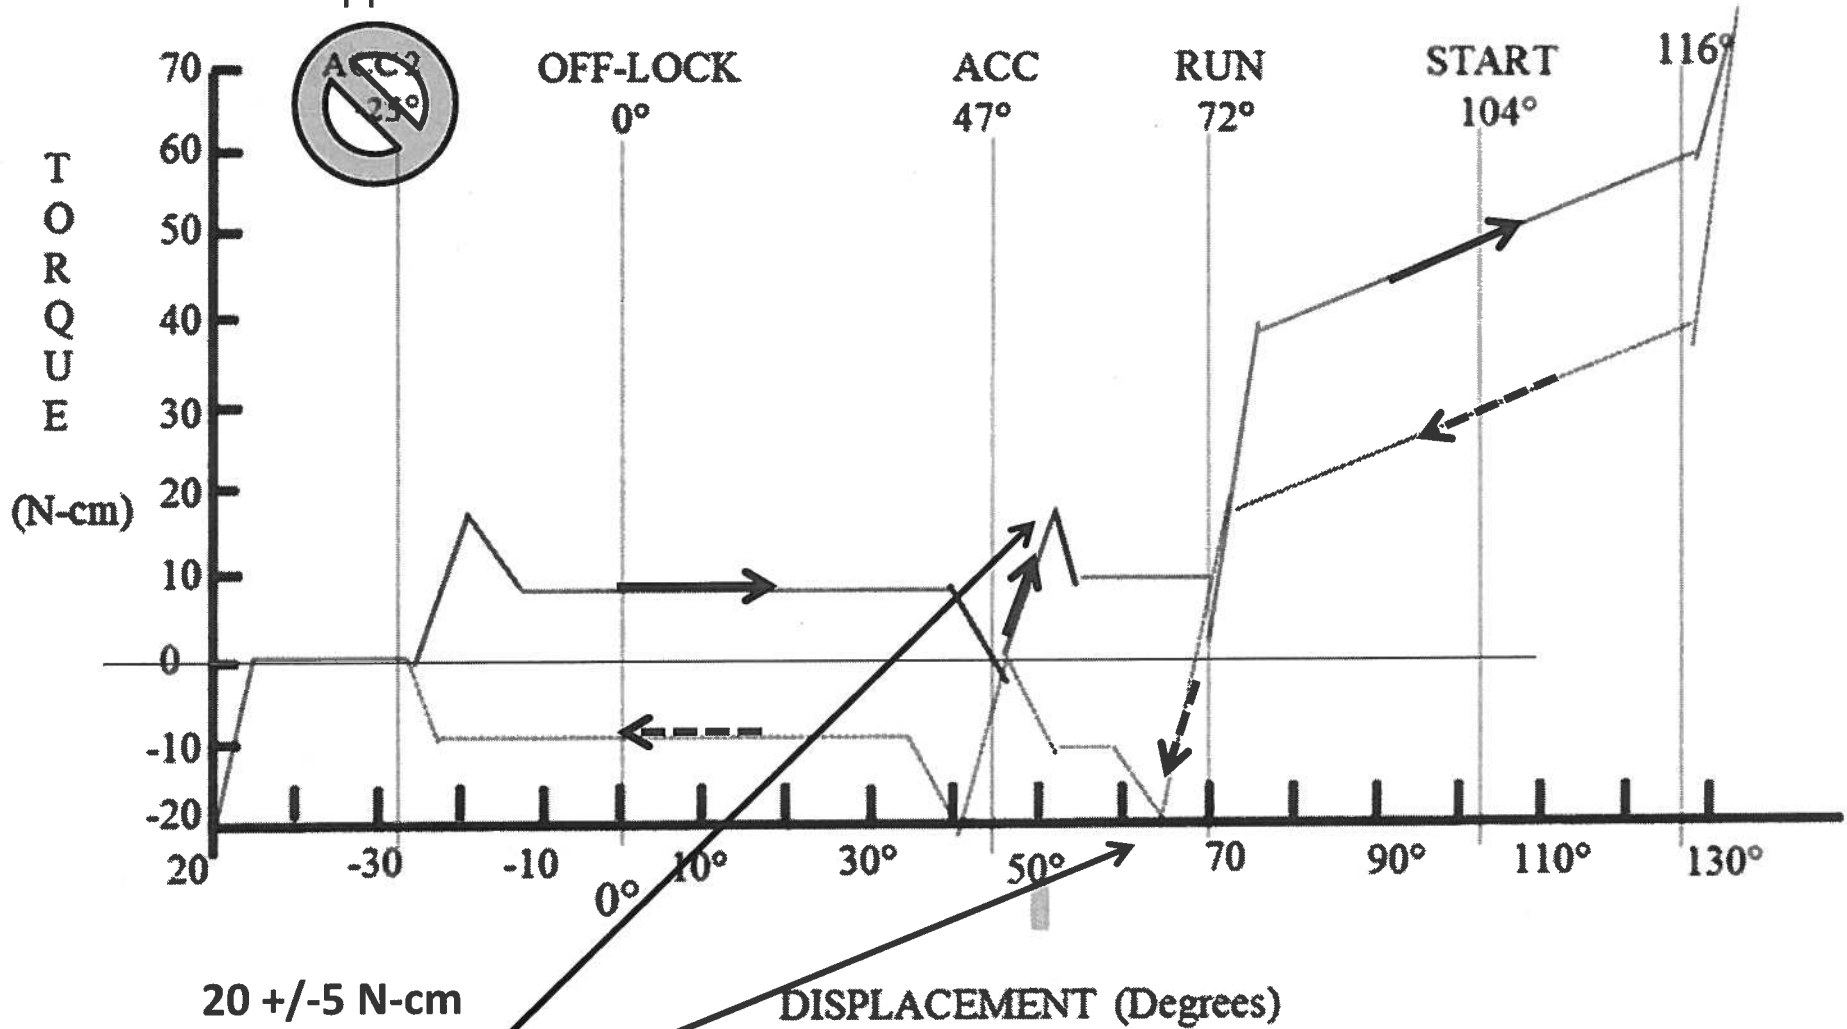
TORQUE vs. ROTATION

20 +/-5 N-cm

• ACC - RUN

• RUN - ACC

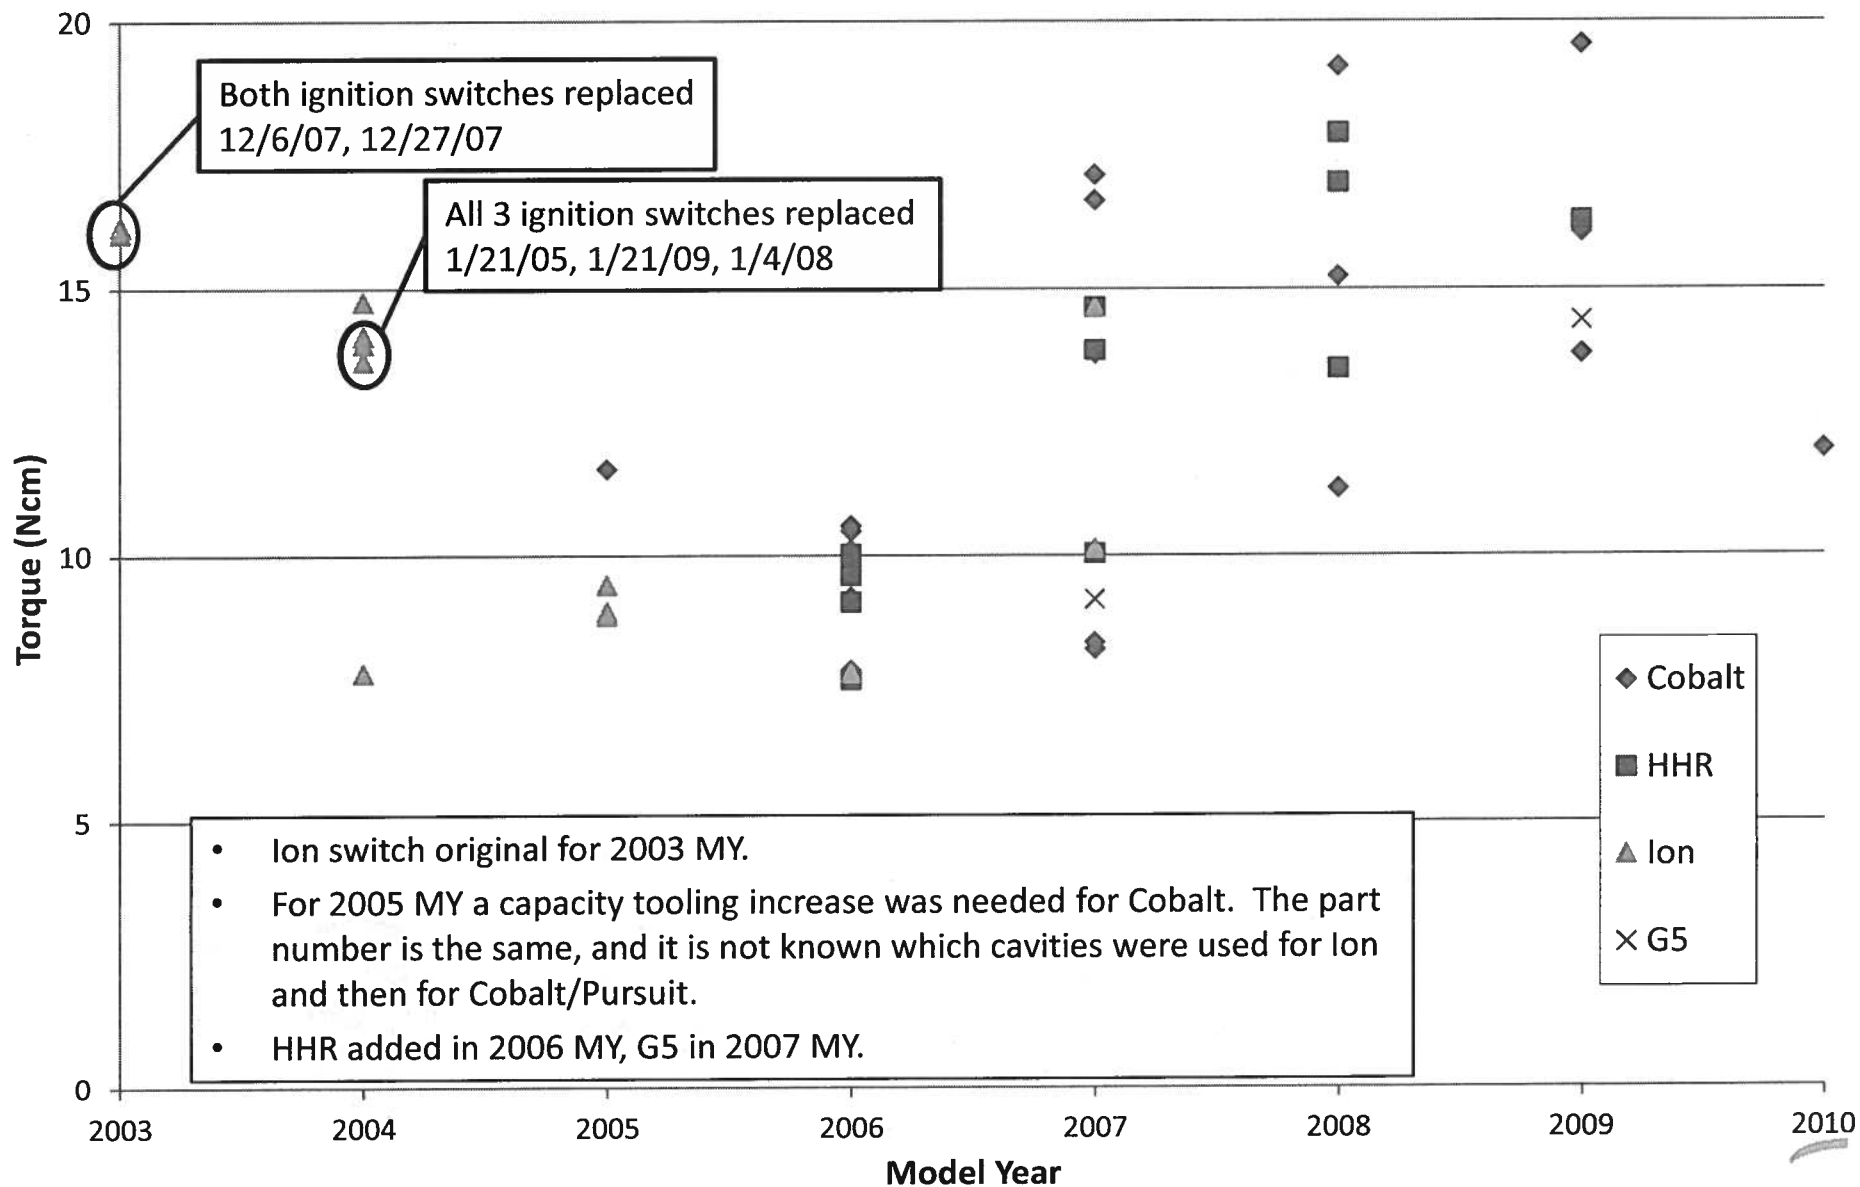
Torque to Rotate From Run to Accessory

It is unknown if any switches were replaced outside of warranty

**The Chevrolet Cobalt began production with the Saturn Ion ignition switch.
All model years Cobalt, Pursuit, G5, Ion and HHR use same ignition switch part number.**

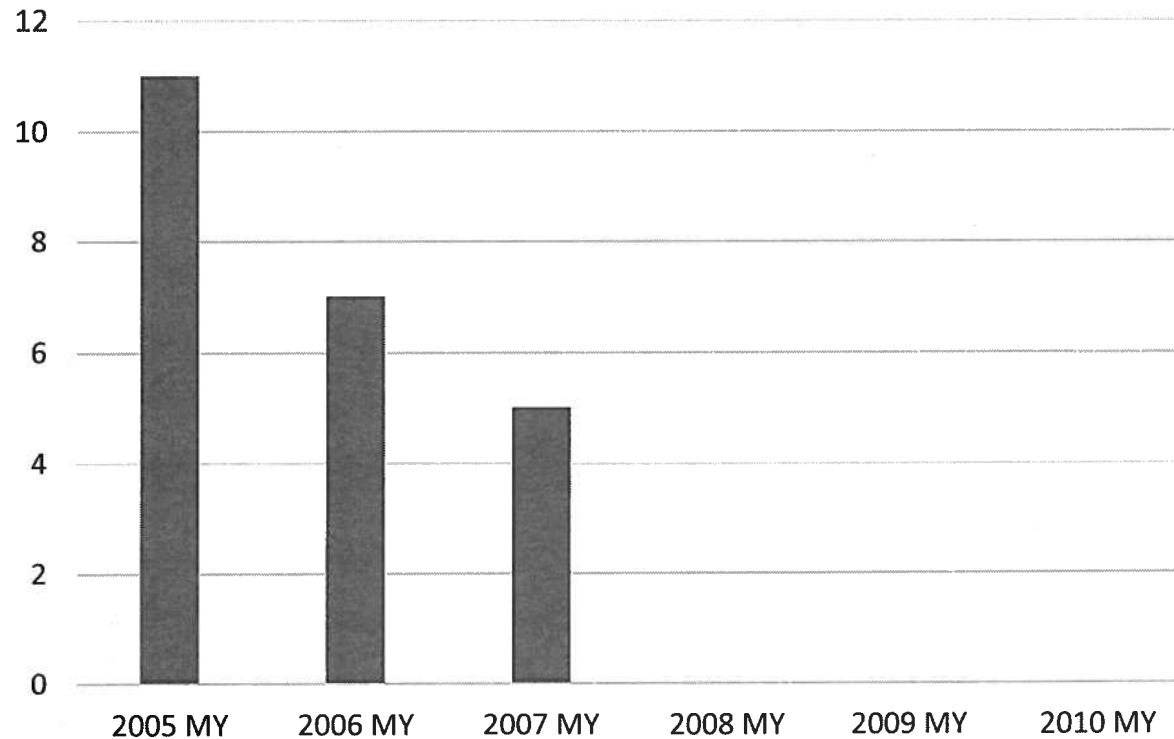
Non-Deployment Allegations by Model Year Cobalt (22), G5 (1)

- The mechanical characteristics of the ignition switch were unchanged for all model years.
- A revision to the switch occurred during the 2007 MY to increase the torque to rotate.
 - The part number was not changed and the breakpoint is unknown.
 - Incidents within the 2007 MY are distributed throughout the build months.

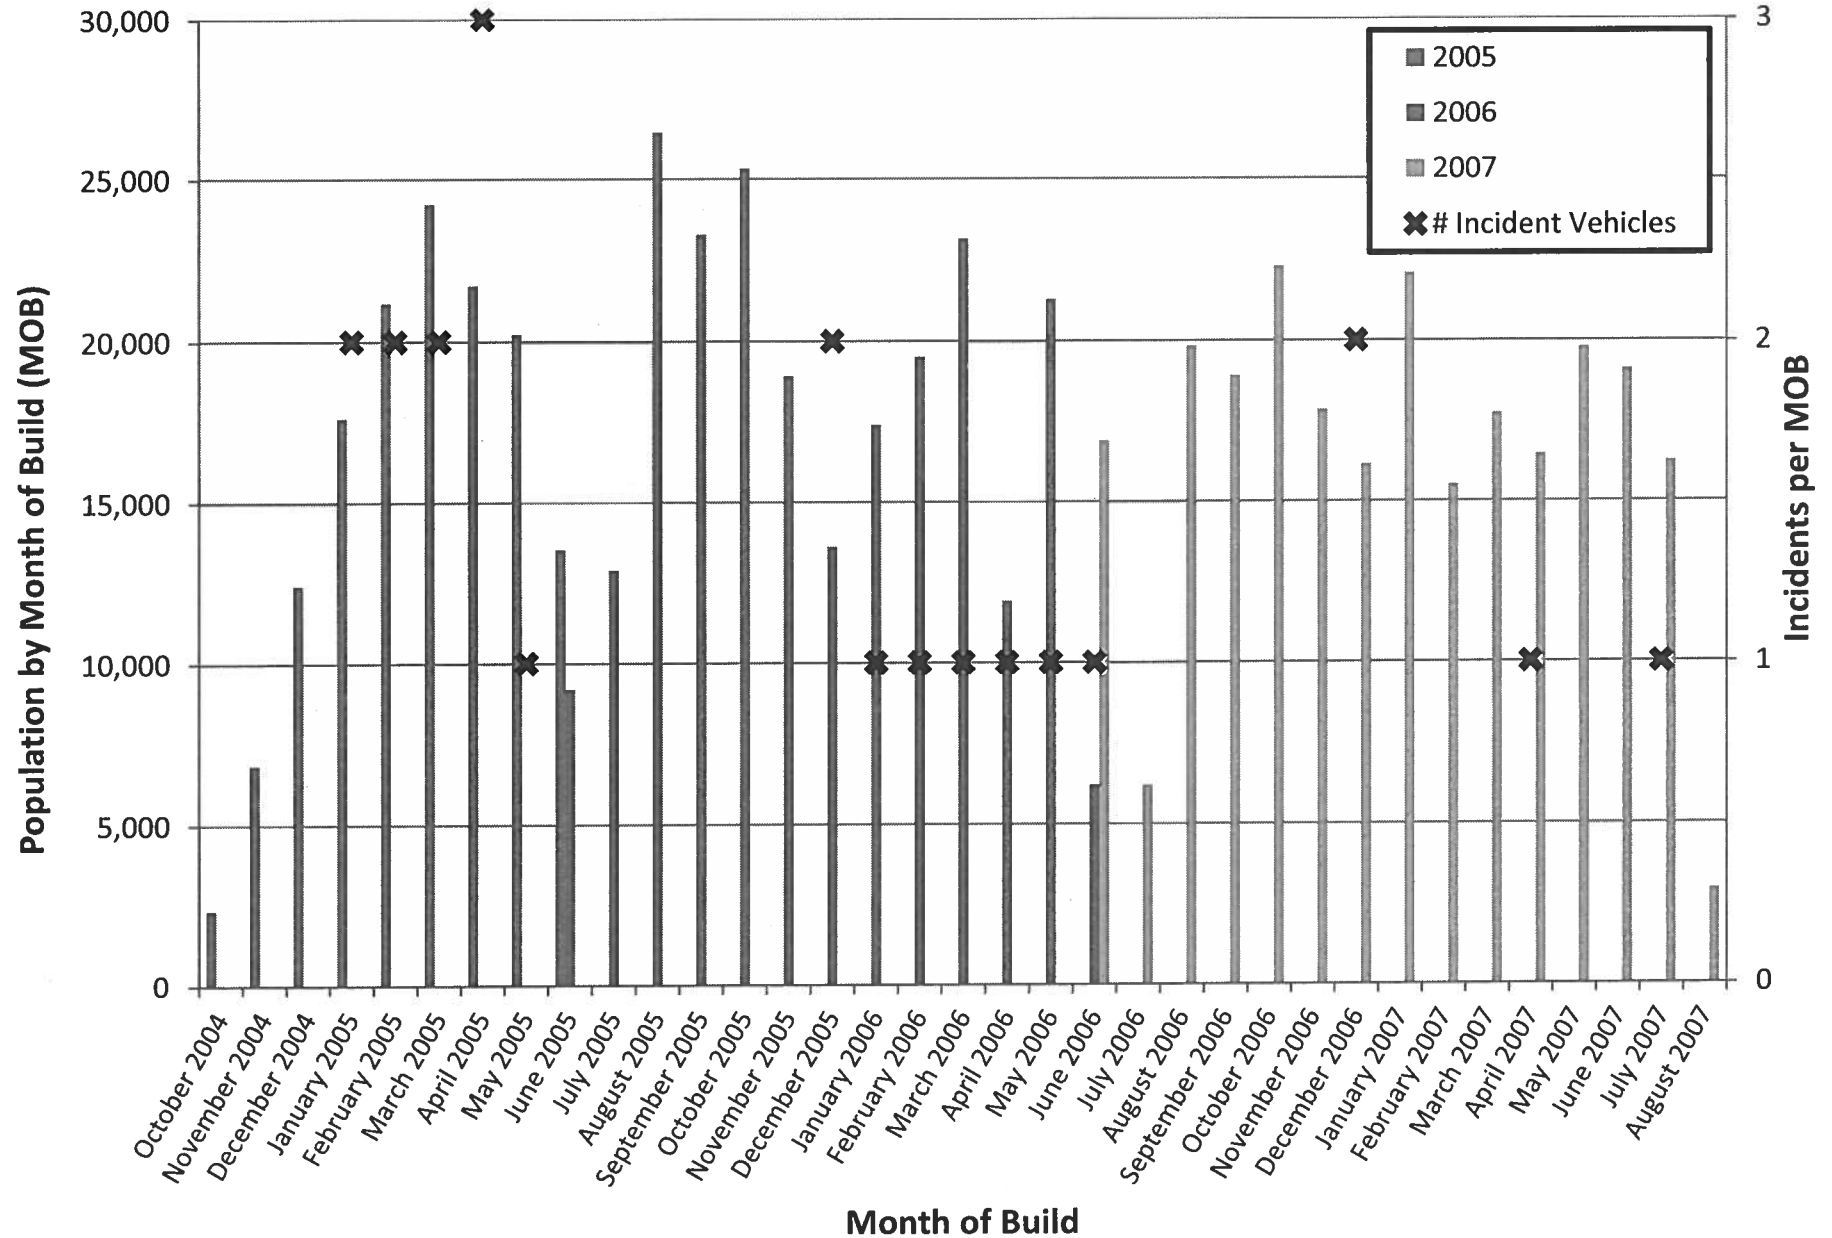
2005-7 Cobalt/G5 Non Deploy Incidents & Population by MOB

Build date not available for one 2005 vehicle

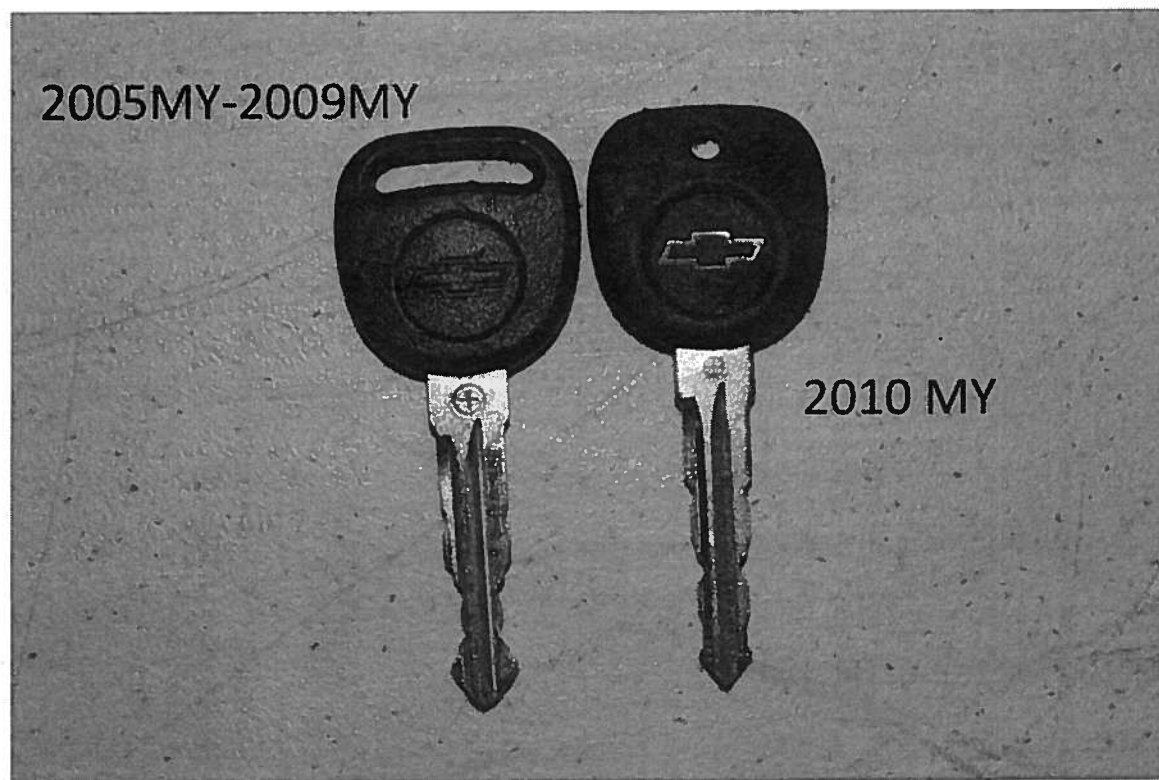
Key
Slot vs. Hole
Cobalt

Engineering has come up with an insert for the key ring so that it goes from a "slot" design to a hole design. As a result, the key ring cannot move up and down in the slot any longer – it can only rotate on the hole. In addition, the previous key ring has been replaced with a smaller, 13 mm (0.5 in) design. This will result in the keys not hanging as low as in the past.

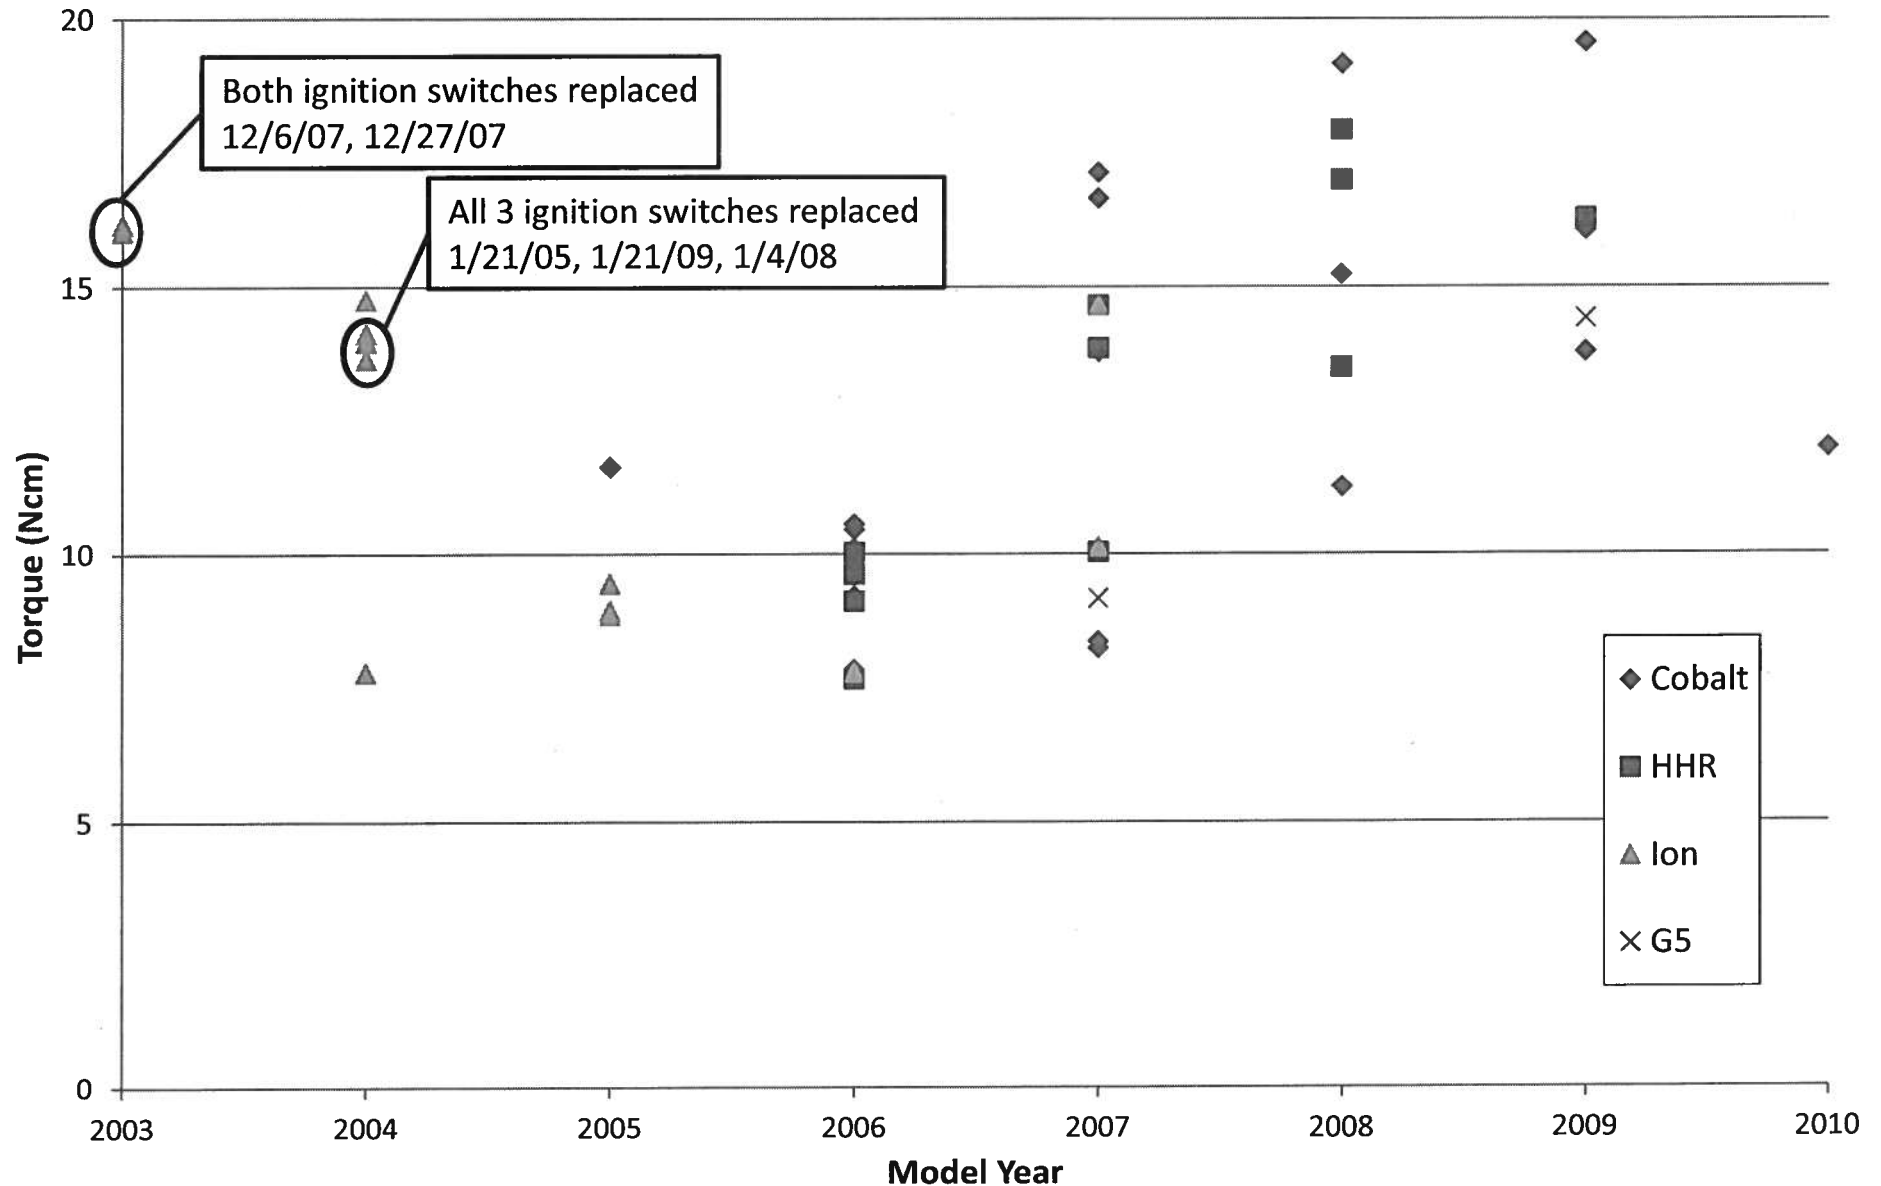
Torque to Rotate From Run to Accessory

- Ignition switch with increased effort passed validation 4/26/06.
- Part number not changed.
- Implementation date is unknown.

It is unknown if any switches were replaced outside of warranty

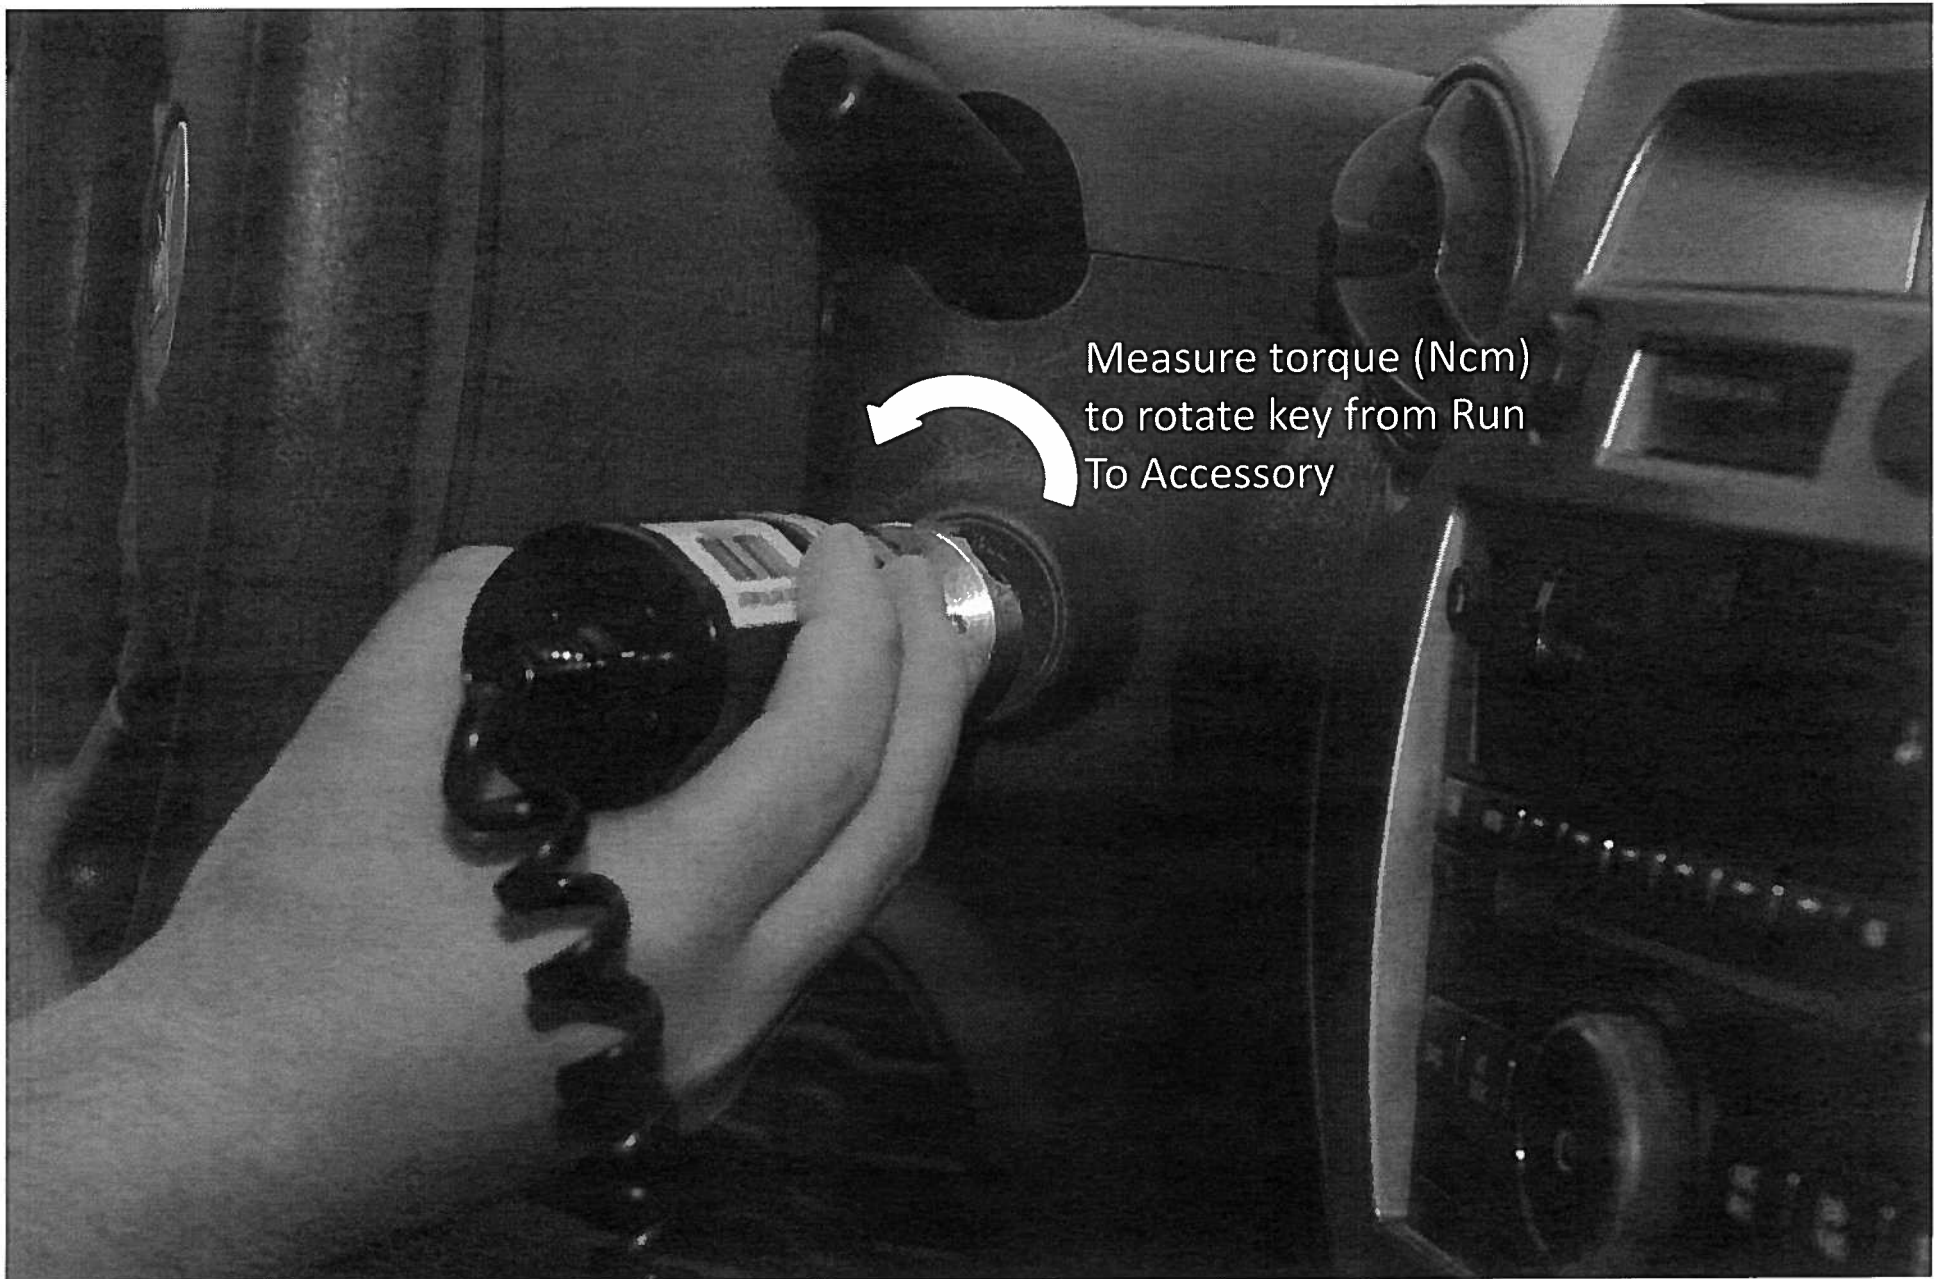
Test Set-up Using Torque Tool

- 5/22/12 44 vehicles in Davison salvage yard
 - Measured torque (Ncm) and force (N) to turn the ignition switch from Run to Accessory.
 - Five of the vehicles had a replacement key, or a key with a hole vs slot (force not measured)

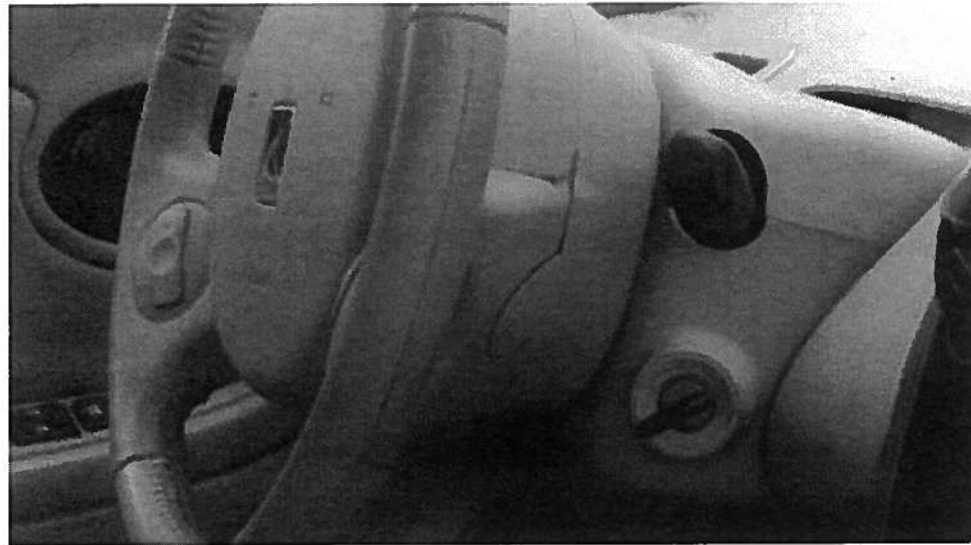
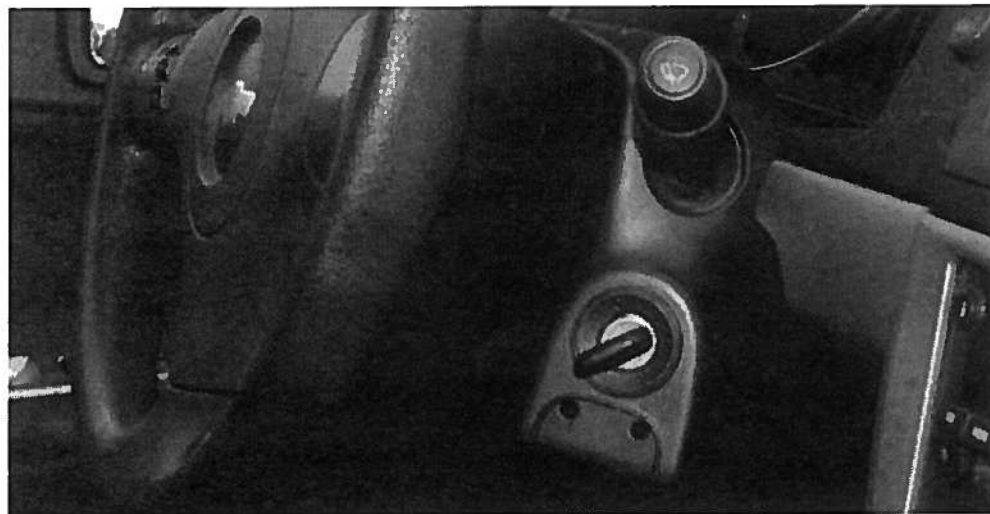
2003 Ion vs 2007 Cobalt

- Review indicates 2 potential non-deploys for Ion, but are not confirmed to be the same cause.
- Ion has different column shroud which could affect potential for key interaction
- HHR has more clearance to the driver's knee
