## Accident Investigation Report

## Radiological Release Event at the Waste Isolation Pilot Plant, February 14, 2014

April 2015

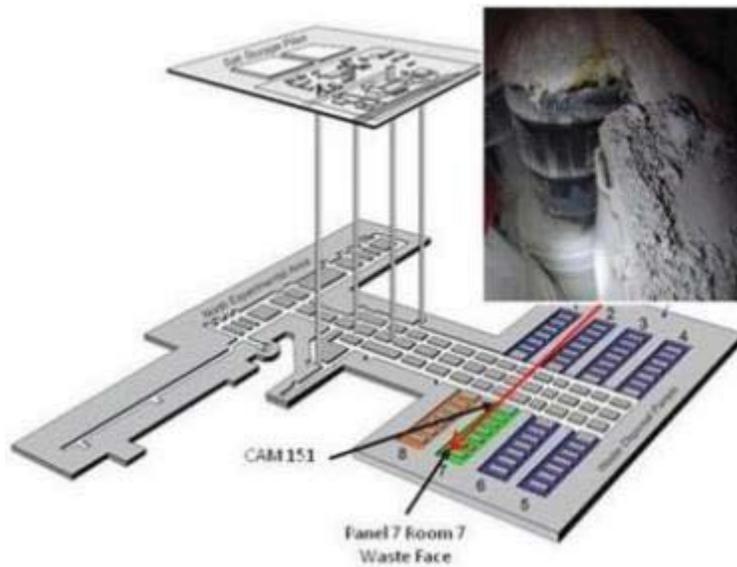
**Figure ES-1: Location of the Accident**

On February 14, 2014, there was a release of radioactive material from a transuranic (TRU) waste container emplaced in Panel 7 Room 7 of the Department of Energy (DOE) Waste Isolation Pilot Plant (WIPP) underground (Figure ES-1) near Carlsbad, New Mexico. The release was detected by a continuous air monitor (CAM) monitoring the Panel and an alarm activated on the Central Monitoring System in the Central Monitoring Room on the WIPP surface, which initiated a shift to filtration of the underground ventilation.

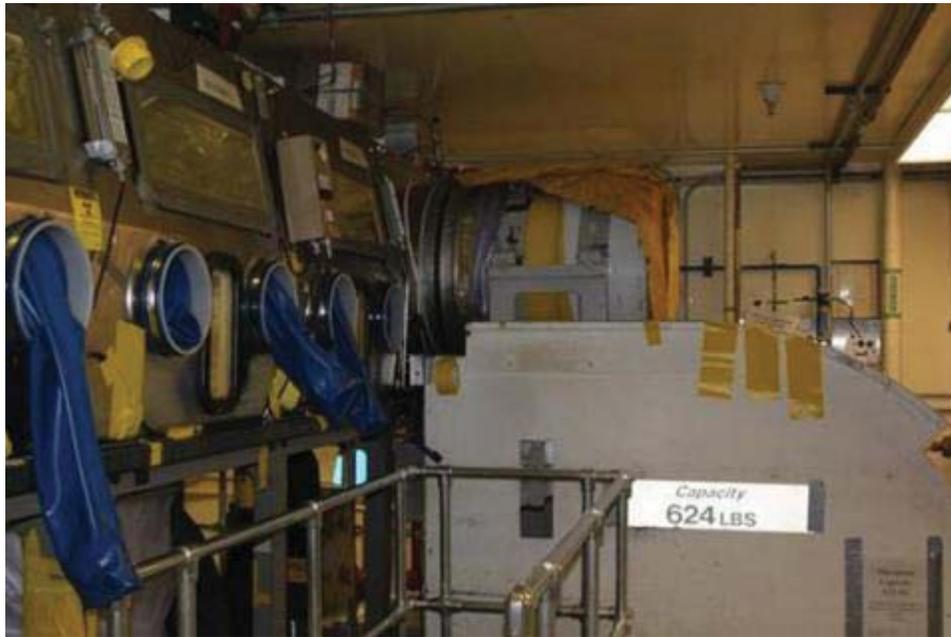
**Figure ES-3: Waste Characterization Glovebox in WCRRF at LANL**

Remediation of nitrate salt drums at the WCRRF began on September 1, 2011. Remediation consisted of retrieving drums from storage and transporting them to the WCRRF where the drum contents were processed in the Waste Characterization Glovebox (Figure ES-3).
