# GMX001 Lock Module Detent in RUN

## *First Design Concept*

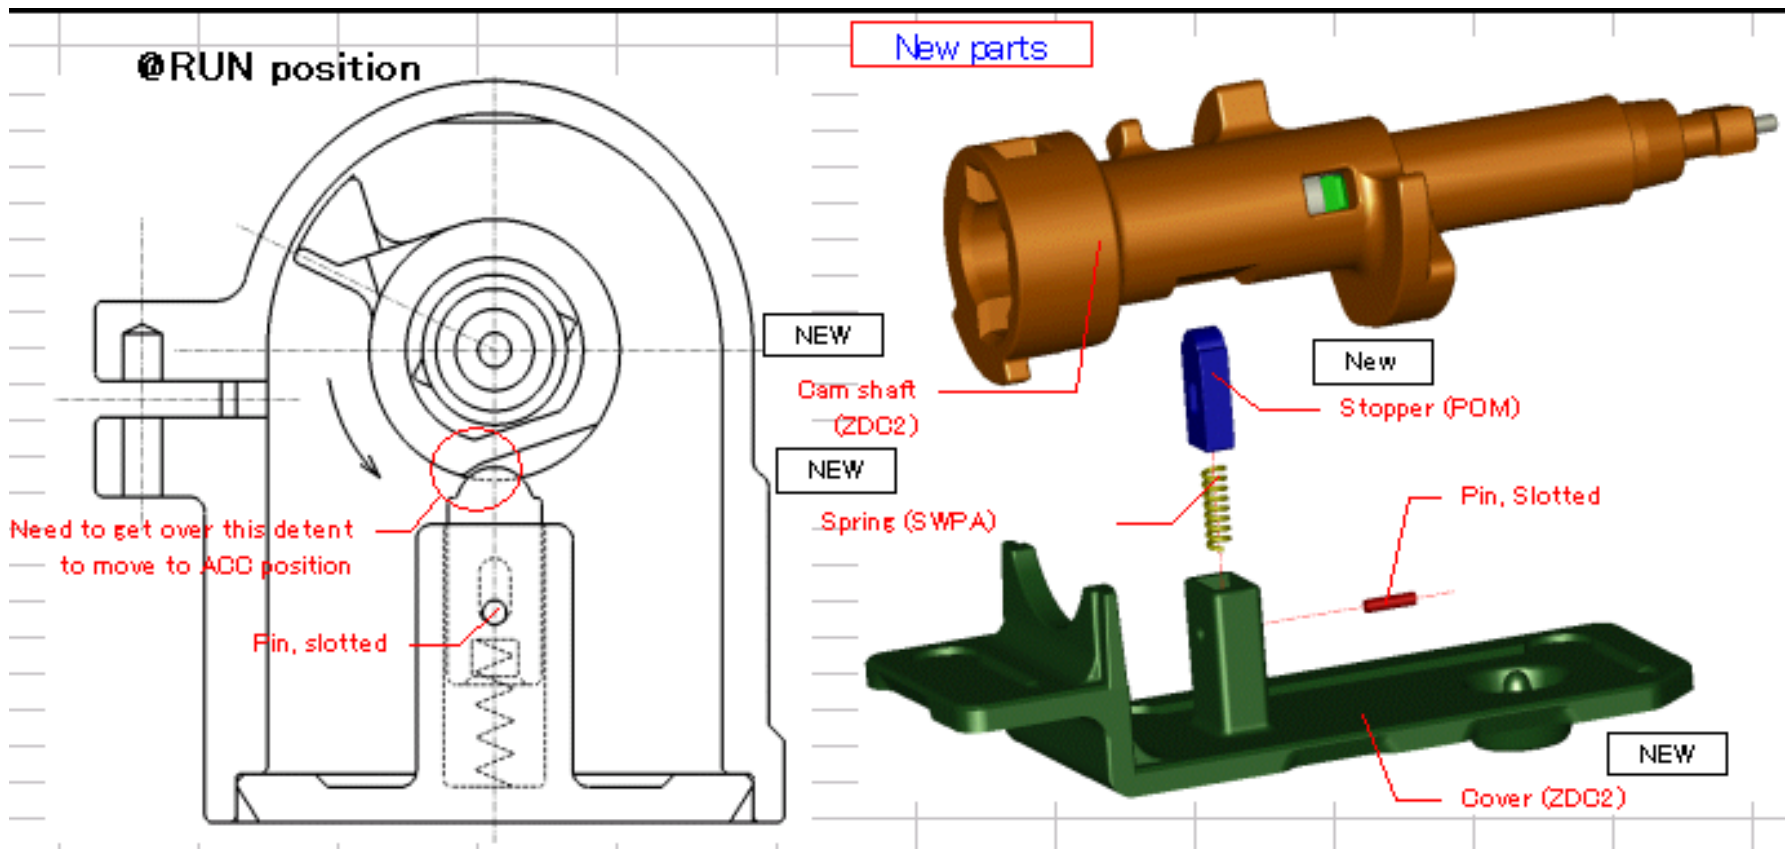
- Detent between lock cover and cam shaft:

- Design Evaluation (Engineering and Cost)
  - The most preferred by supplier

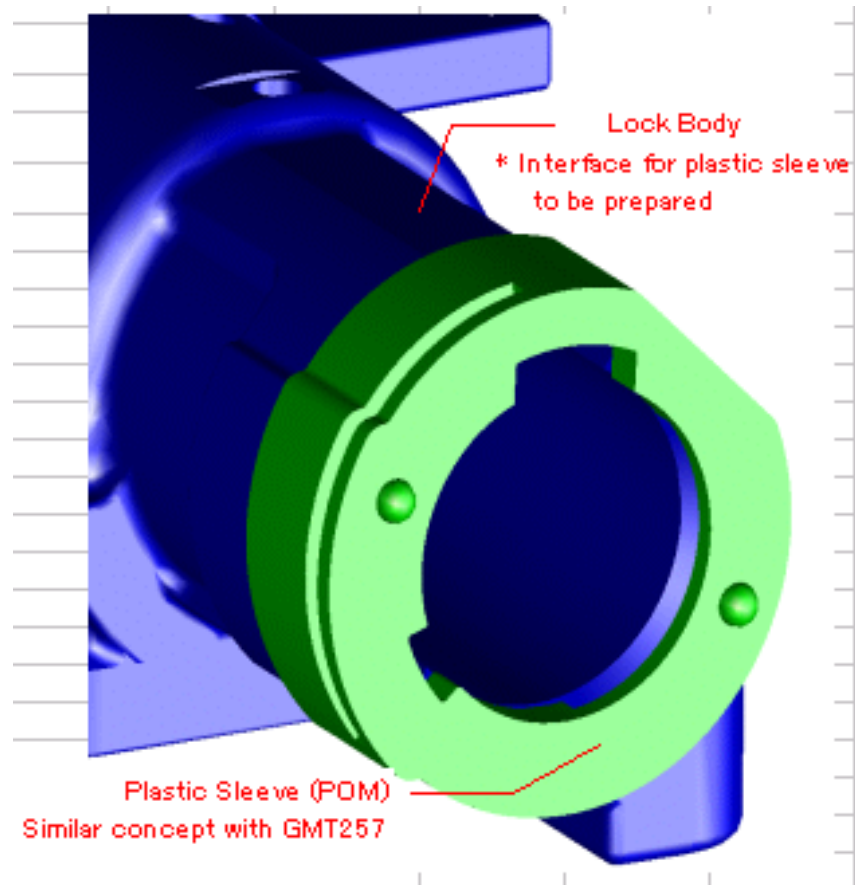
- Adding a plastic sleeve to the lock housing-lock cylinder interface:

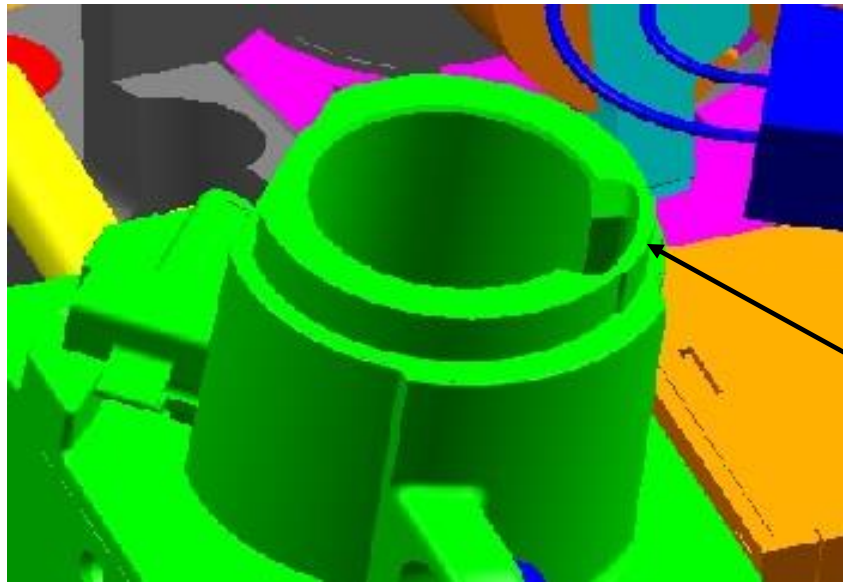
- Main concern with trimming of the lock housing to accommodate plastic sleeve

Material thickness  
creates concern for  
GMX001 lock hosing

GMT 257 UG Data Shown

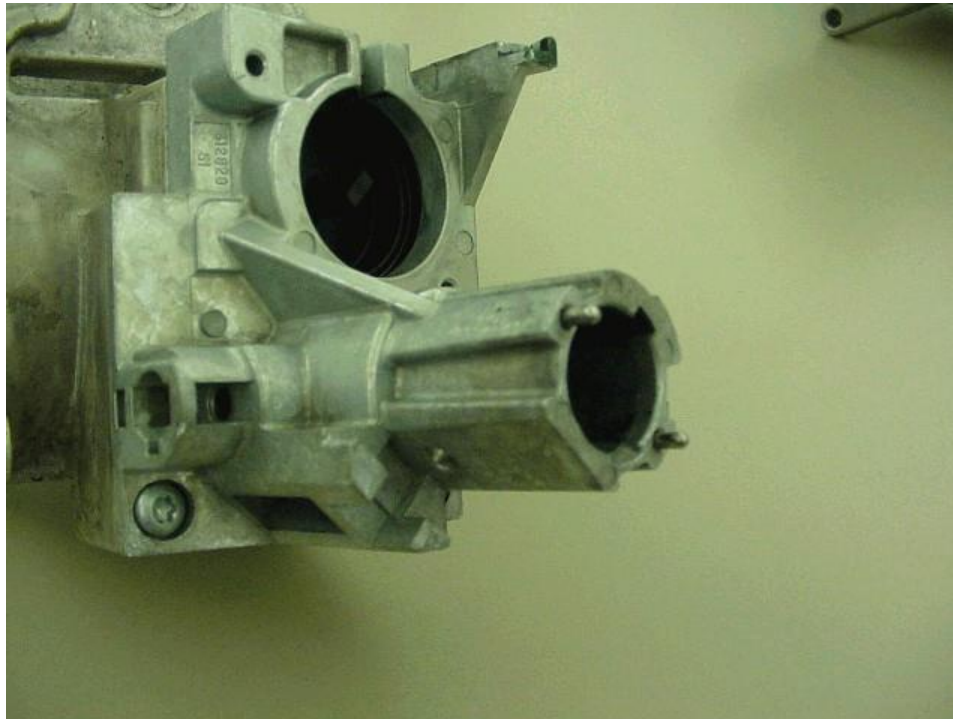
- Adding spring loaded pins to the lock housing:

- Main concern with complexity in warranty.
- Ruled out by lock housing supplier

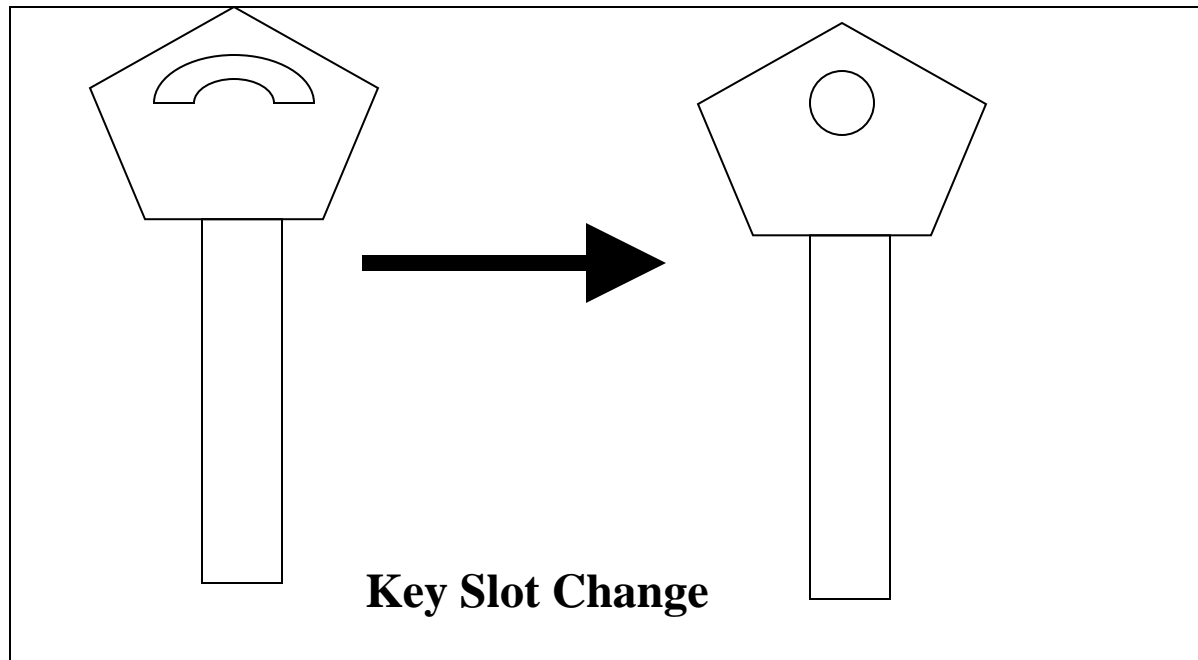
➤ Changing the slot in the key in order to reduce lever arm and thus the torque:

- It was determined that the lever arm still present due to the fob ring.
