**Subcommittee on Oversight and Investigations
Hearing on
“Power Struggle: Examining the 2021 Texas Grid Failure”
March 24, 2021**

**Update to April 6, 2021 Preliminary Report on
Causes of Generator Outages and Derates
During the February 2021 Extreme Cold Weather
Event**

ERCOT Public
April 27, 2021

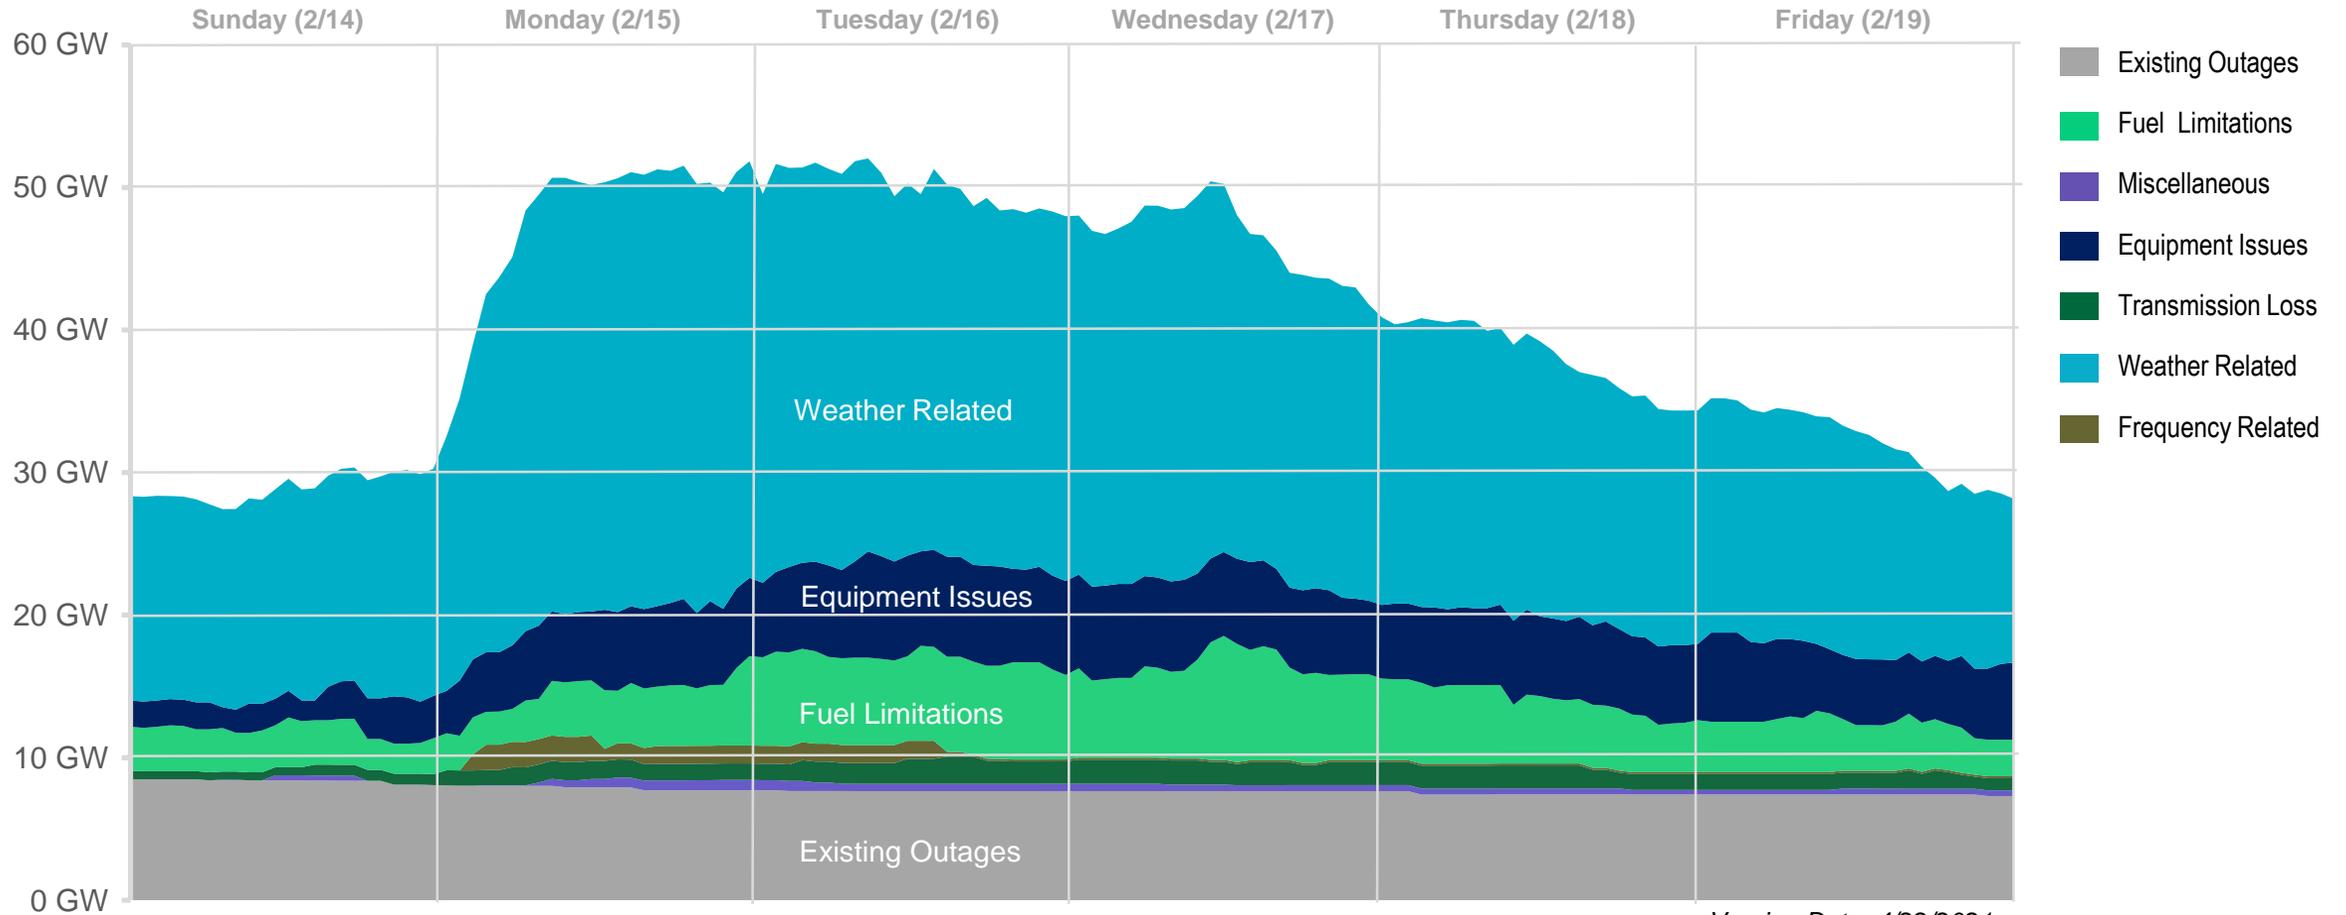
Net Generator Outages and Derates by Cause (MW)

February 14 – 19, 2021

Net generator outages at the beginning of each hour on February 14-19, 2021, by cause category.

- The amount of outaged capacity shown on the previous slide (slide 4) increased sharply as the storm arrived on Sunday and stayed fairly constant from late morning on Monday to mid-day on Wednesday.
- However, as shown on the next slide (slide 6), the net level of outages masks the volatility in generation availability that continued throughout the week, with generators continuing to go out of service and come into service throughout the duration of the event.
- This volatility made it difficult to accurately forecast an end to emergency conditions.

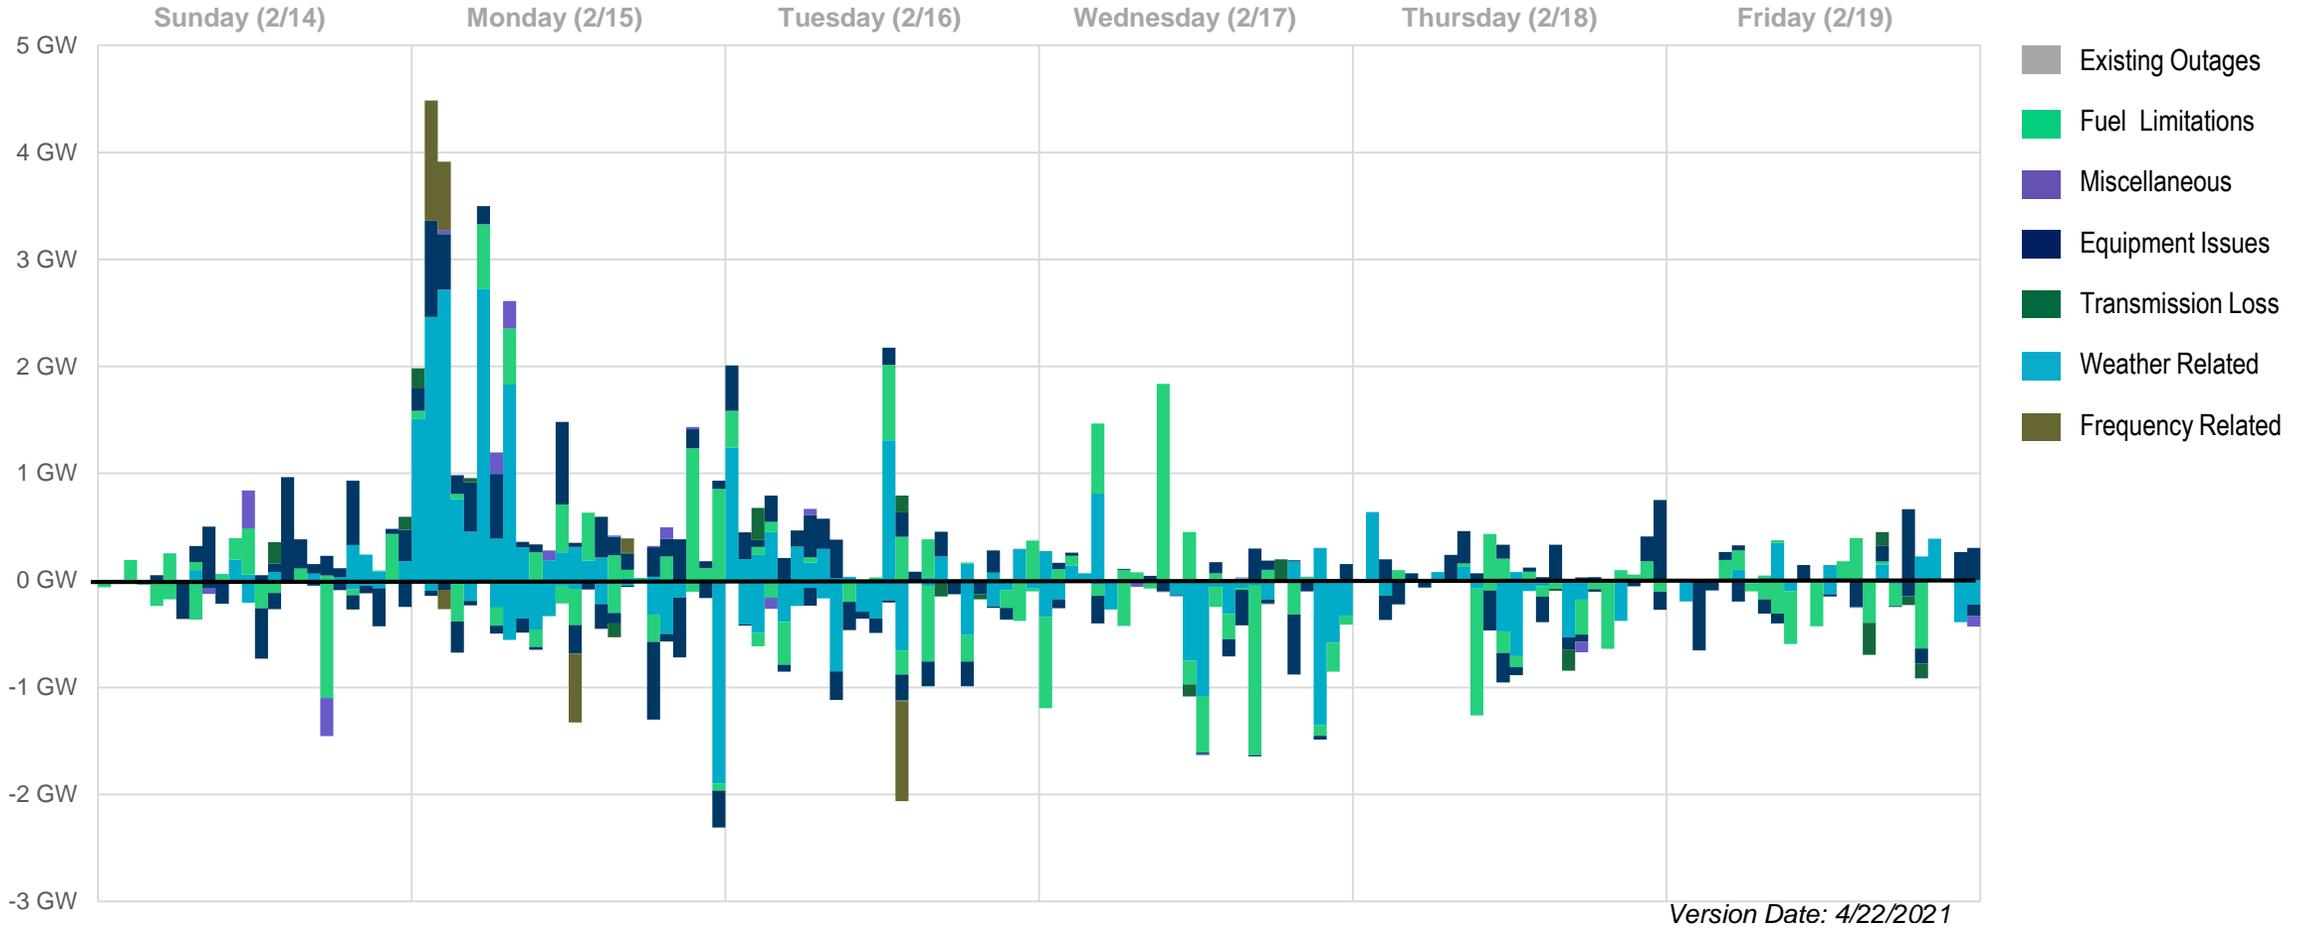
Incremental Generator Outage and Derates by Hour

starting 00:00 on 2.14.21

Outages and derates continued through the week at a high rate.

- The graph on the previous slide shows the generator outages and derates that started or ended in each hour on February 14-19, 2021, by cause category. The quantity of outages starting during a given hour are shown as positive values, and the quantity of outages ending during a given hour are shown as negative values.
- For example, if a 100 MW generator started an outage at 2 p.m. on February 14 due to a fuel limitation, and that outage ended at 5 p.m. on February 17, it would show as a positive 100 MW in the fuel limitation category for 2 p.m. on February 14 and a negative 100 MW in the fuel limitation category at 5 p.m. on February 17.
- This graph does not include the start of any outage or derate that occurred before February 14, but it does include the incremental reduction in outaged MW for any of those outages or derates that ended during the February 14-19 window.

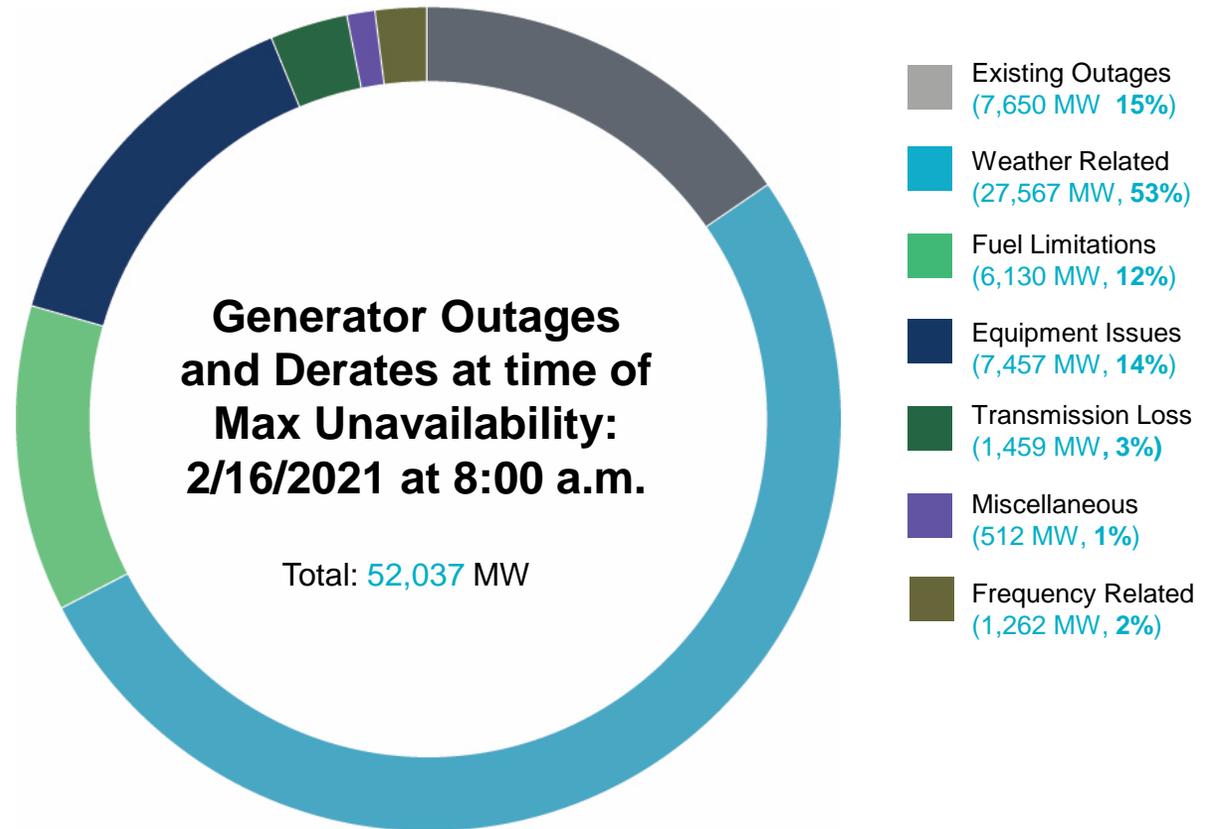
Generator Outage and Derates: Maximum Unavailability

- The highest amount of unavailable capacity during the period of February 14-19, 2021 occurred on February 16 at ~8:00 AM and was 52,037 MW.
- This chart shows the MW of the generator outages or derates that were occurring at that point in time by cause category.
- Note that the total outaged and derated capacity at this time is different than what was previously reported (52,277 MW) due to additional information received in response to the RFIs.

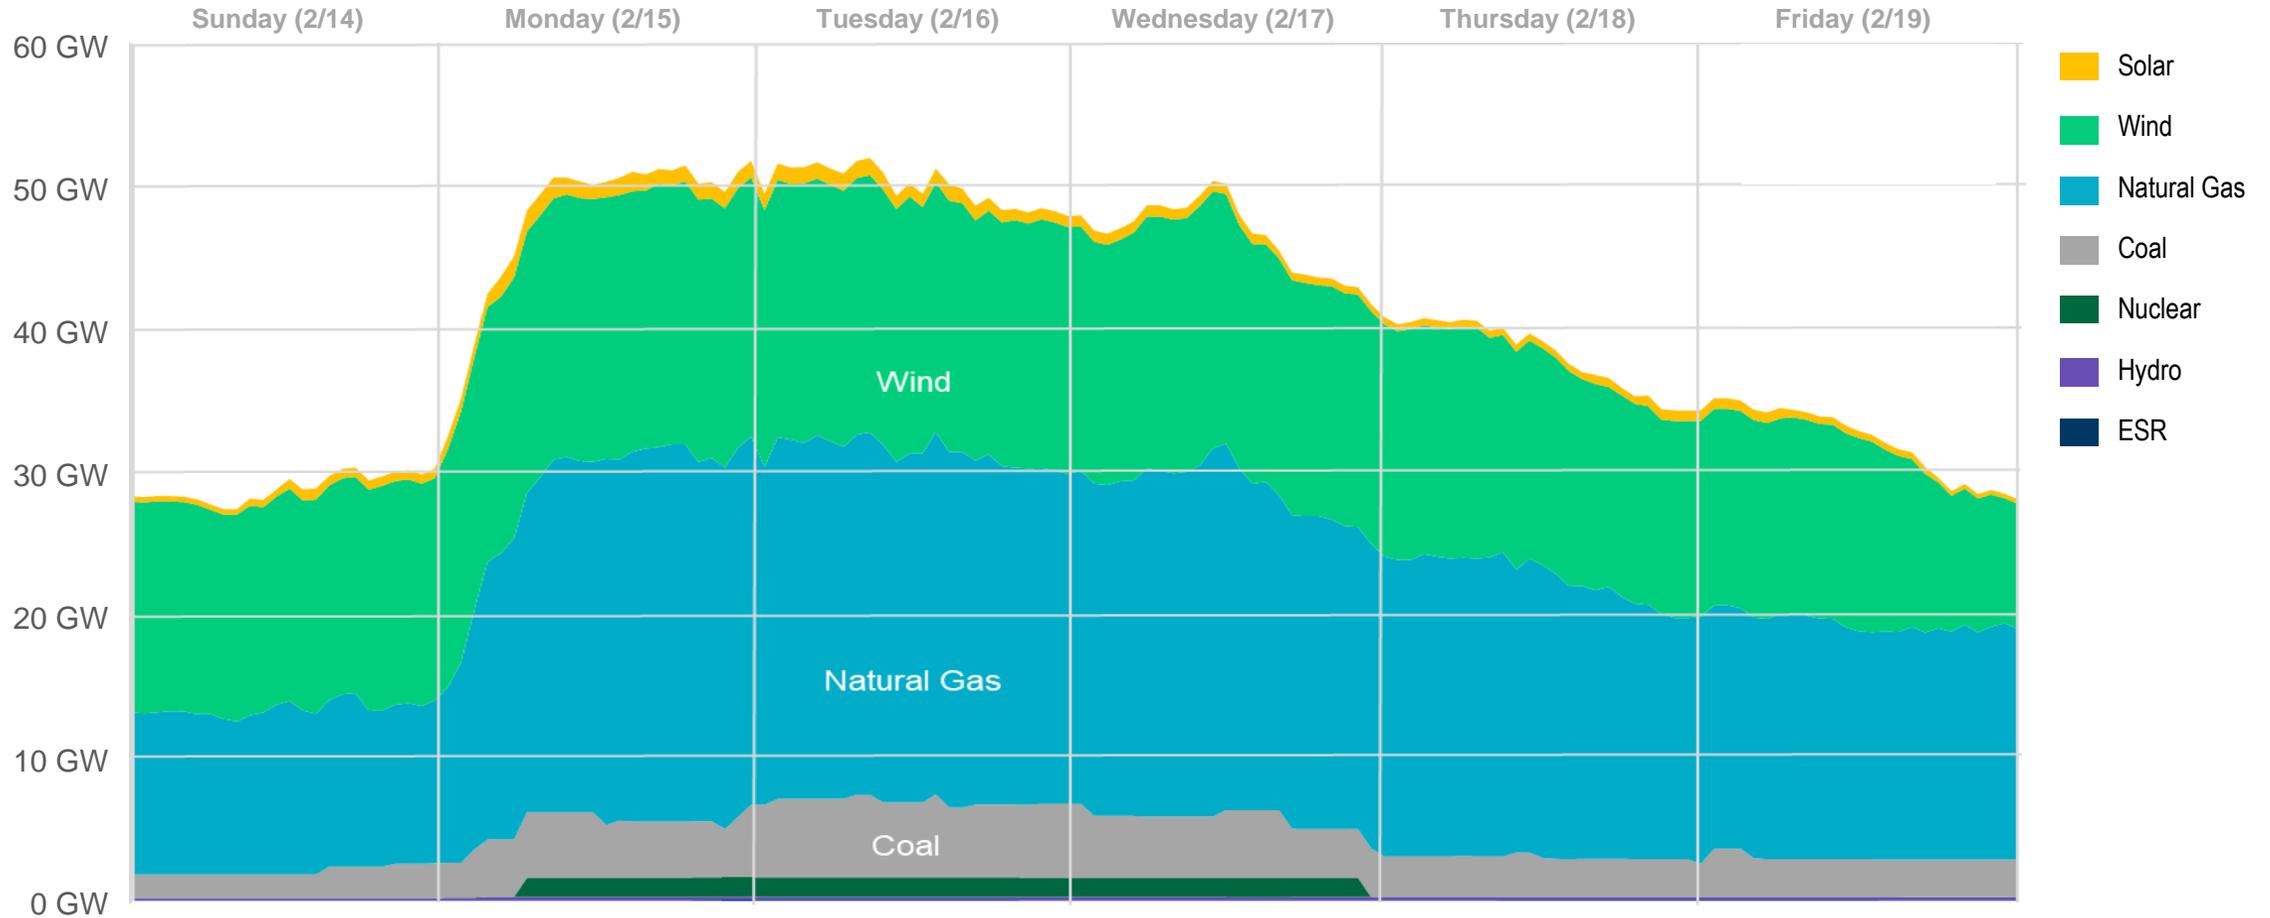
Net Generator Outages and Derates by Fuel Type (MW)

Outage and derate MW for Wind in this graph are based on capacity.

- These estimates were then used to reproduce the Net Generator Outages and Derates by Fuel Type graph on slide 16 based on the actual wind and solar production lost due to the outages or derates of solar and wind generation units.

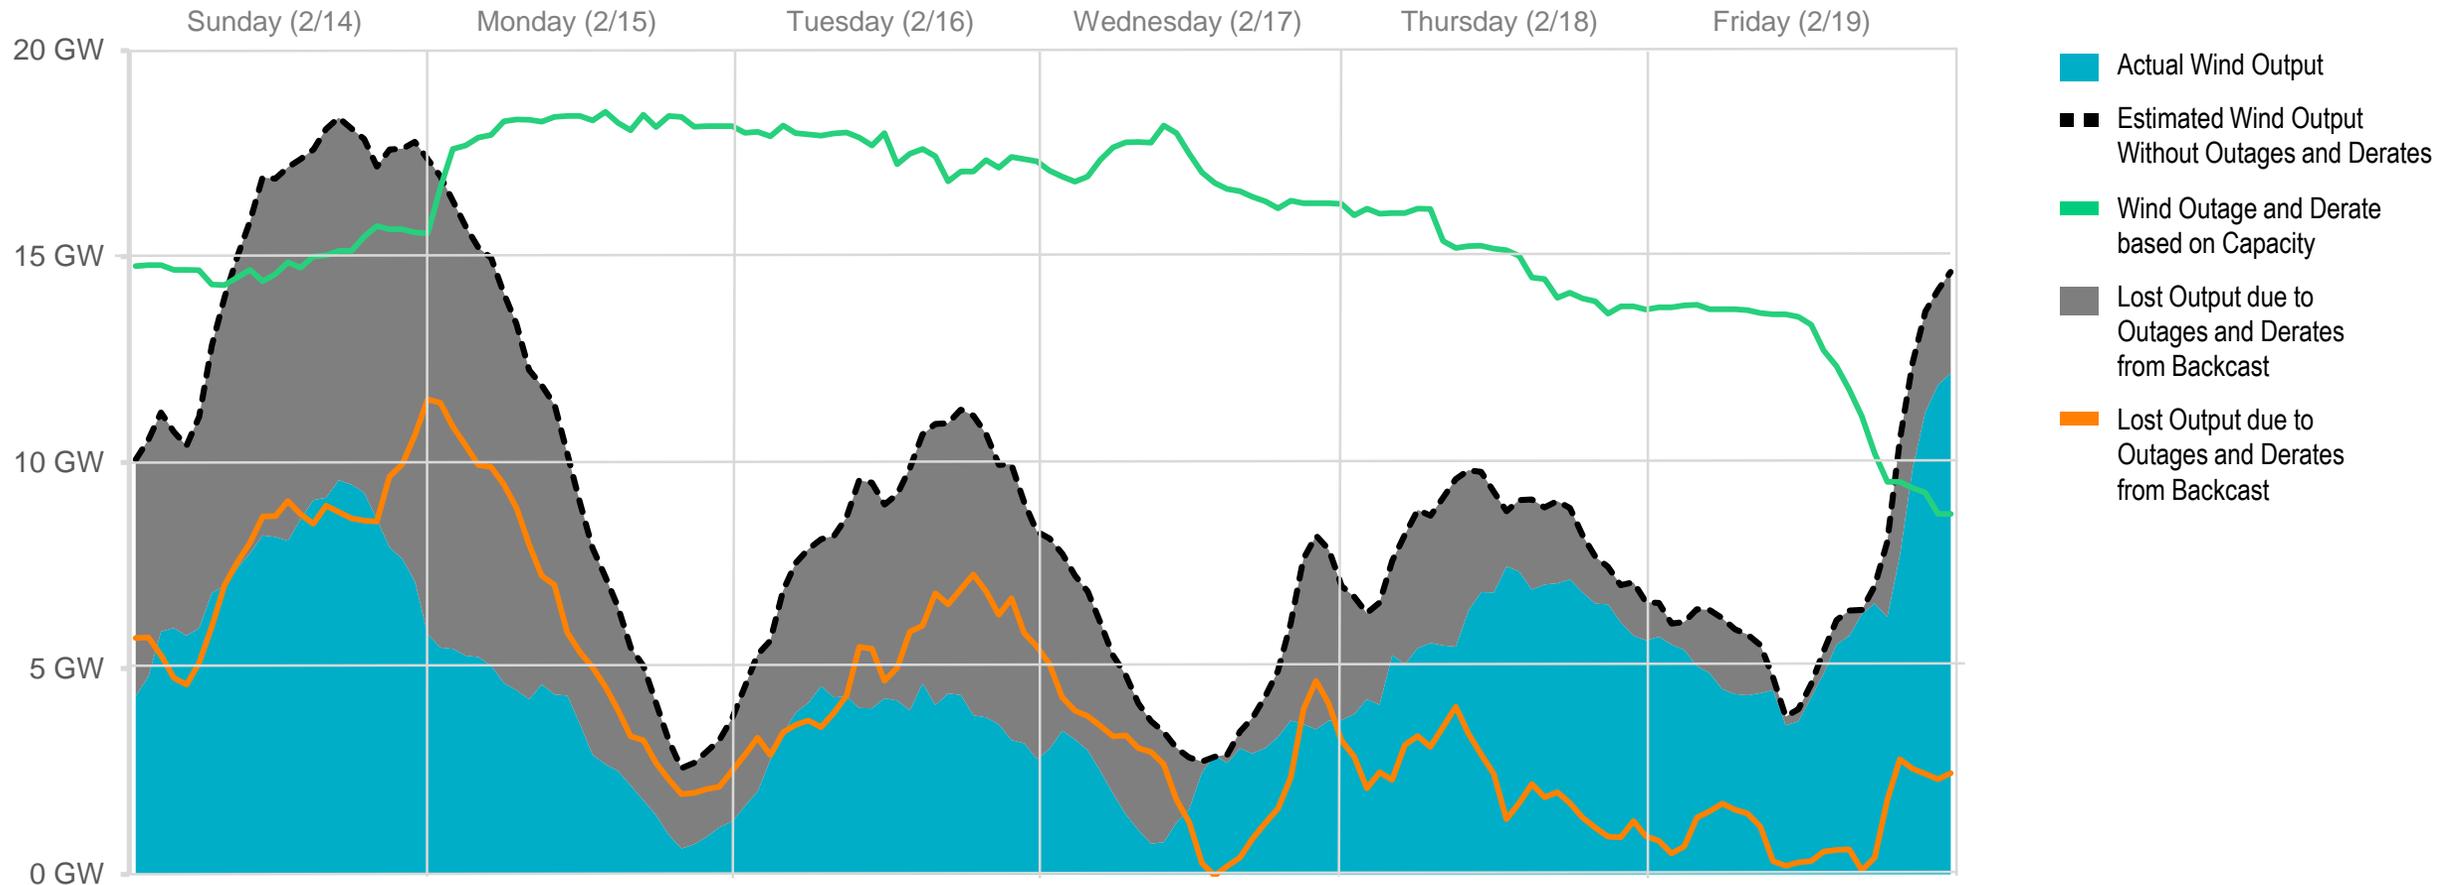
Estimated Impacts of Outages and Derates on Wind Output

Magnitude of orange line and gray area are both equal to the estimated impact of wind outages and derates.

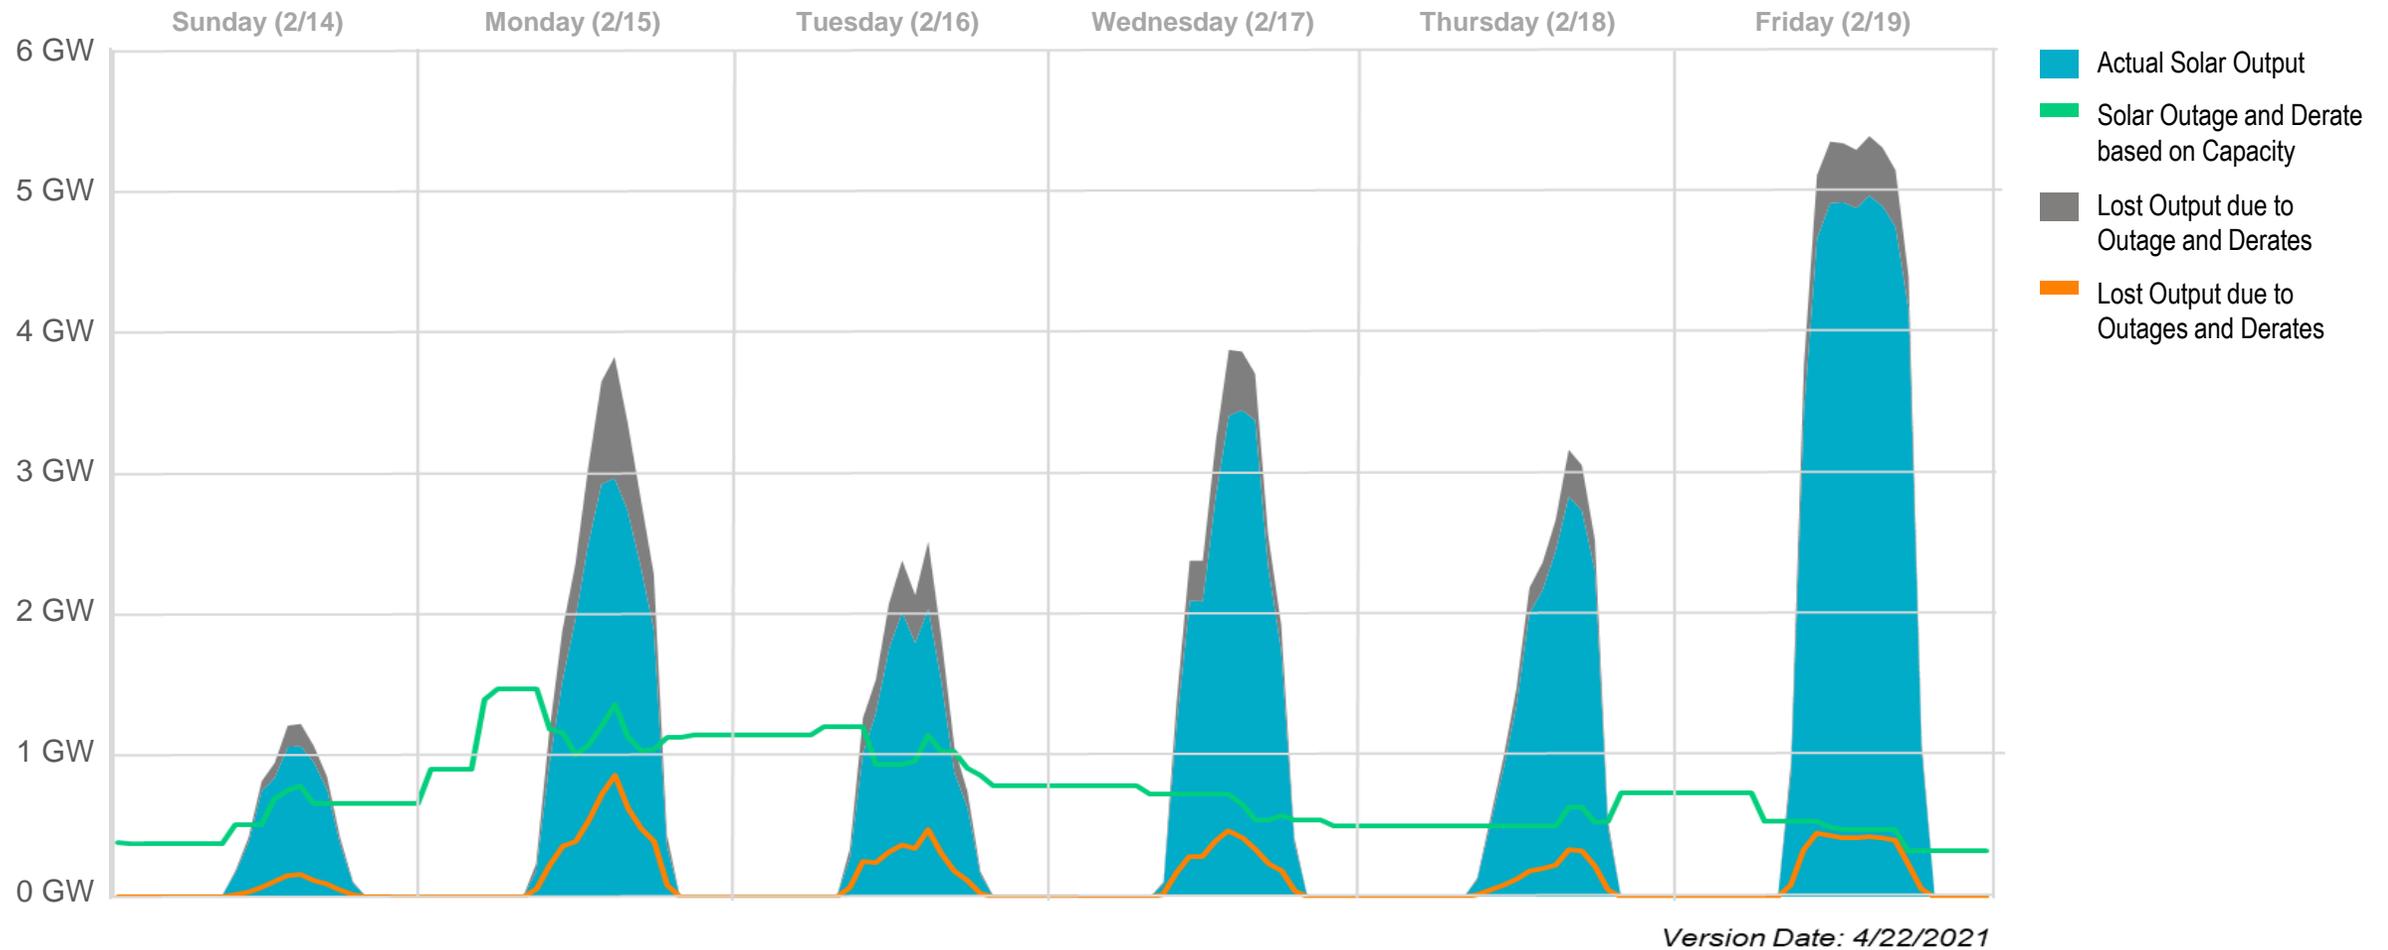
Estimated Impacts of Outages and Derates on Solar Output

Magnitude of orange line and gray area are both equal to the estimated impact of wind outages and derates.

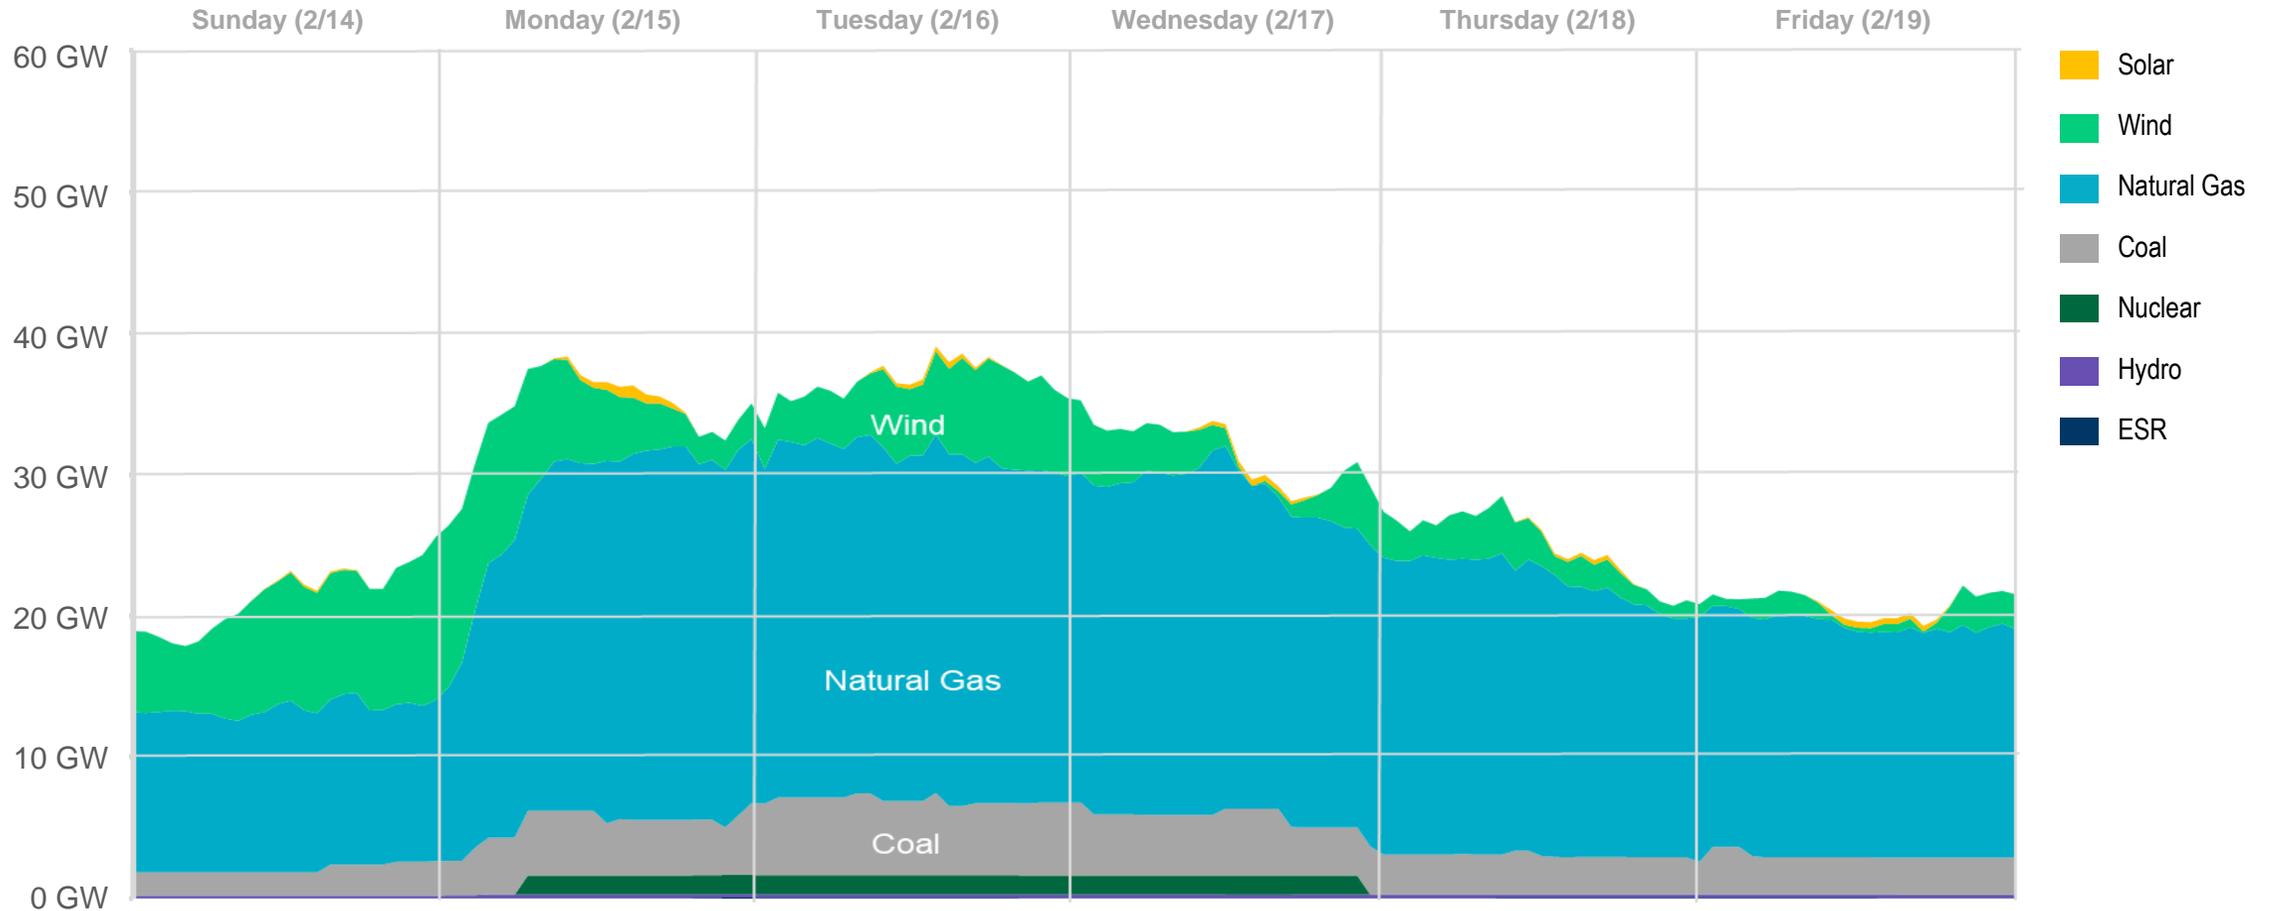
Net Generator Outages and Derates by Fuel Type (MW)

Wind and solar MW values based on estimated lost output due to outages and derates from slides 15 and 16.

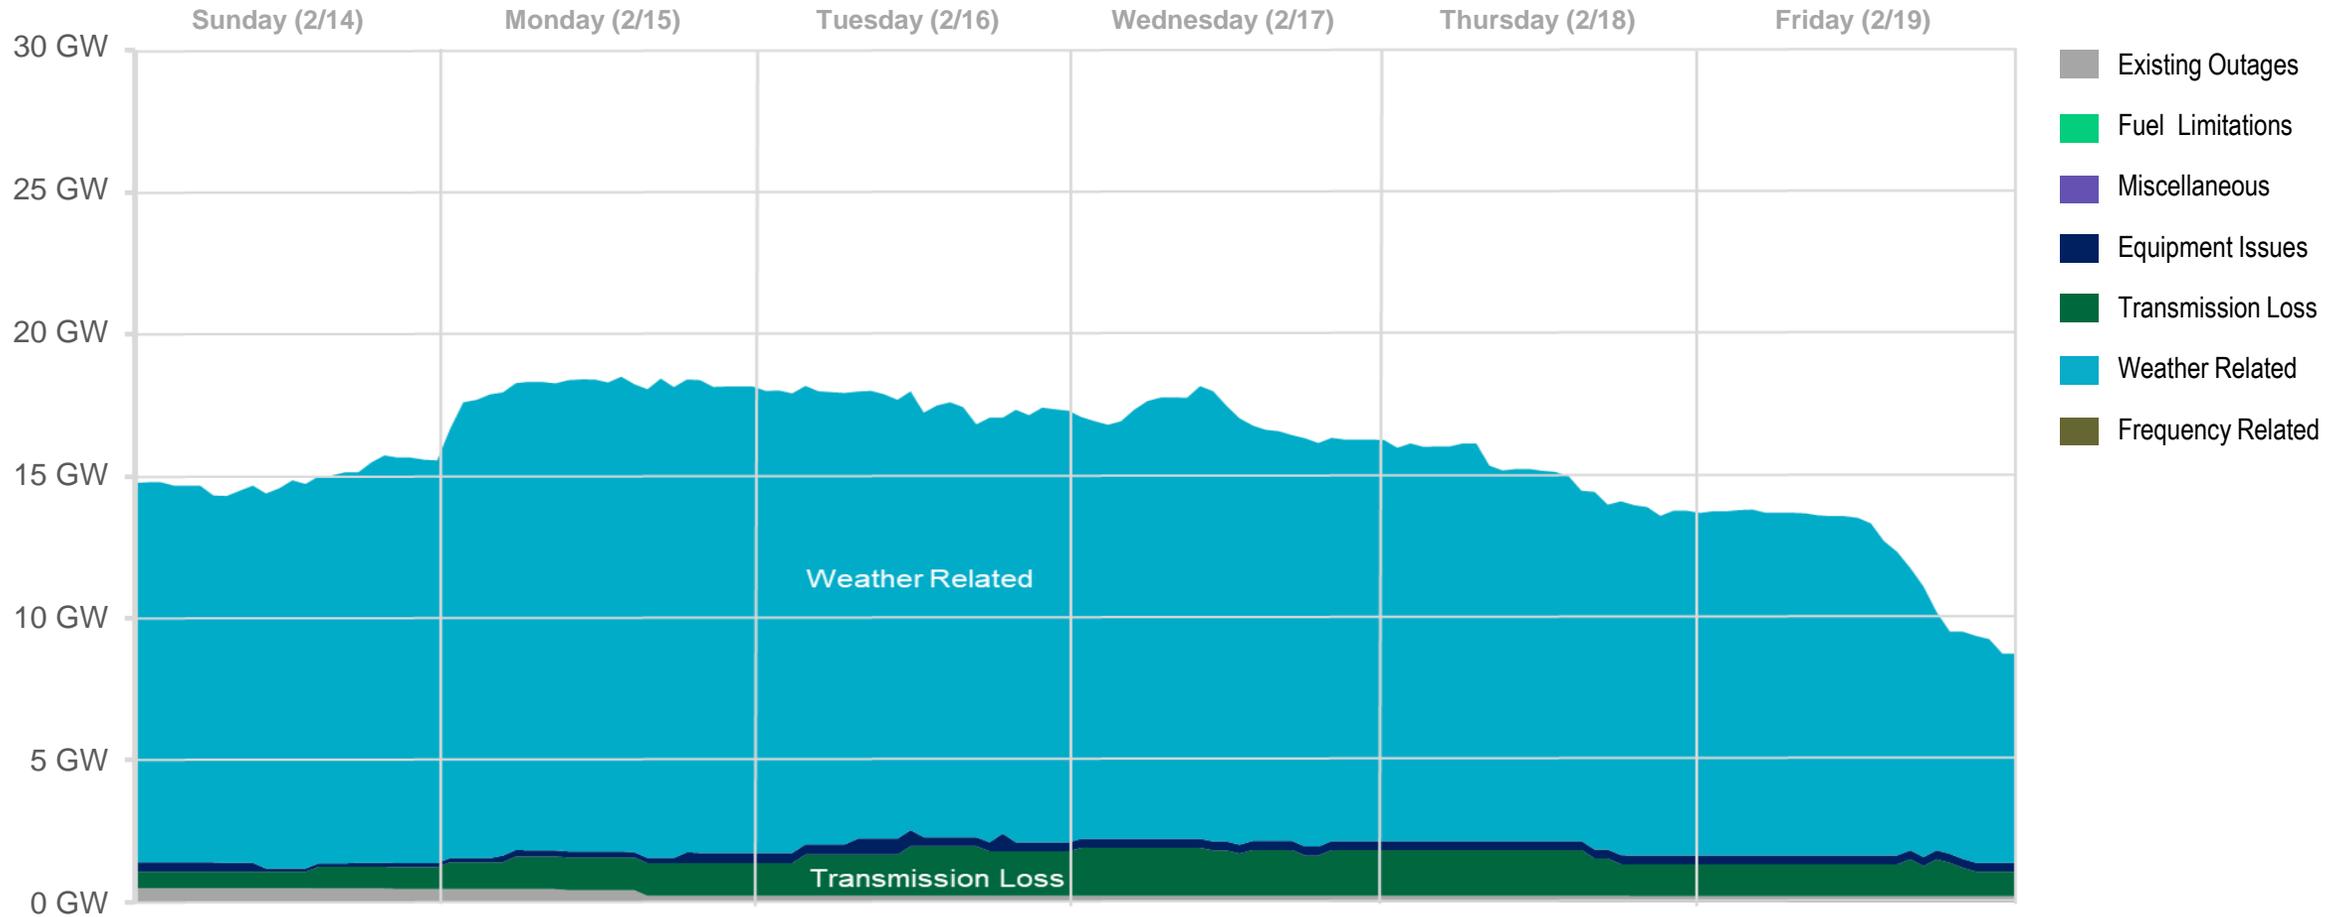
Net Generator Outages or Derates for Wind Generators by Cause

Outage and derate MW values are based on capacity.

- Graphs are included for gas, coal, and wind generator outages and derates.
- For wind generators, the outages and derate values on slide 20 are based on capacity, and the values on slide 21 are based on estimated lost wind output. On slide 21, the allocation of the lost wind output to each cause code is based on the proportion of total outaged wind capacity assigned to each cause for each hour; this is an approximation, as the backcasted lost output is not available on a unit-by-unit basis.
- Graphs are not included for nuclear, hydro, solar and energy storage because the number of outages is small and it would be possible to identify individual generating unit outage causes.

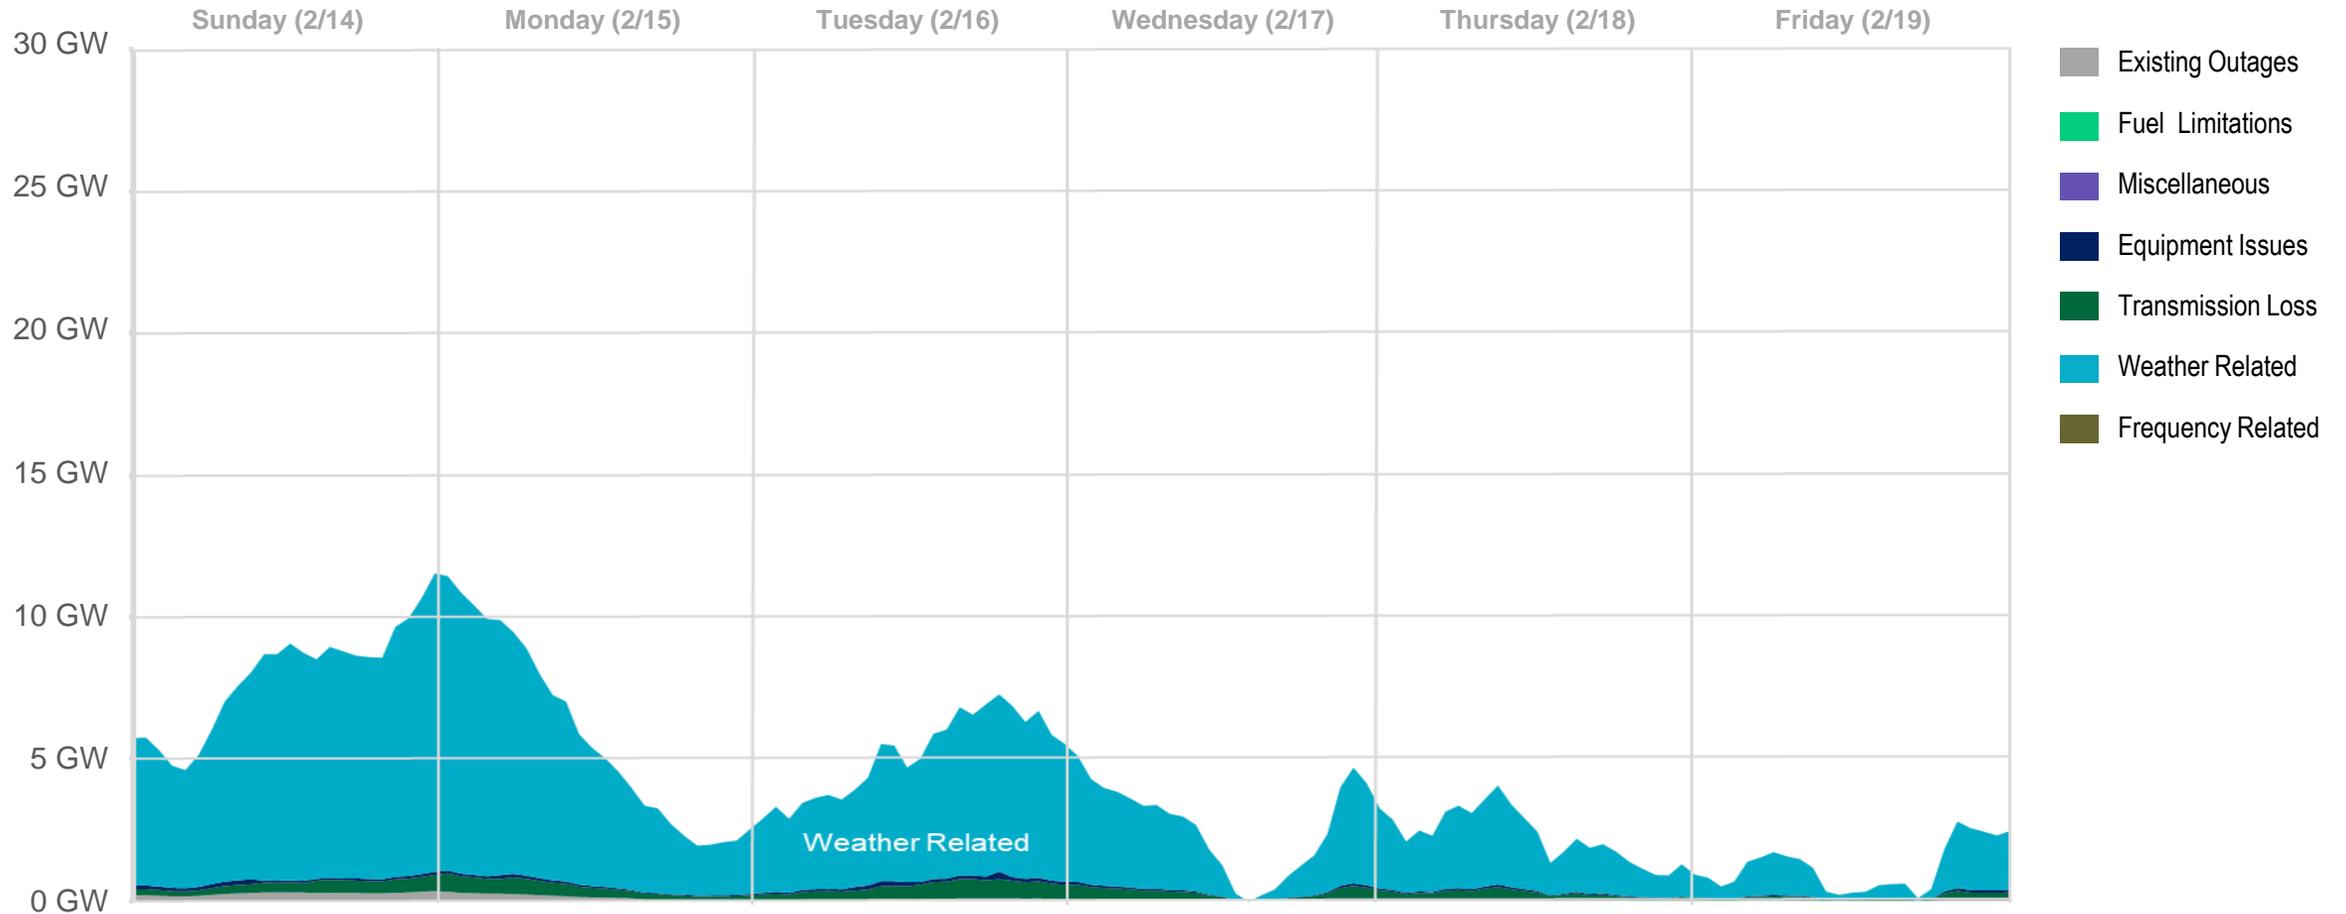
Net Generator Outages or Derates for Wind Generators by Cause

Outage and derate MW values are estimated based on the proportion of total outaged wind capacity assigned to each cause for each hour.

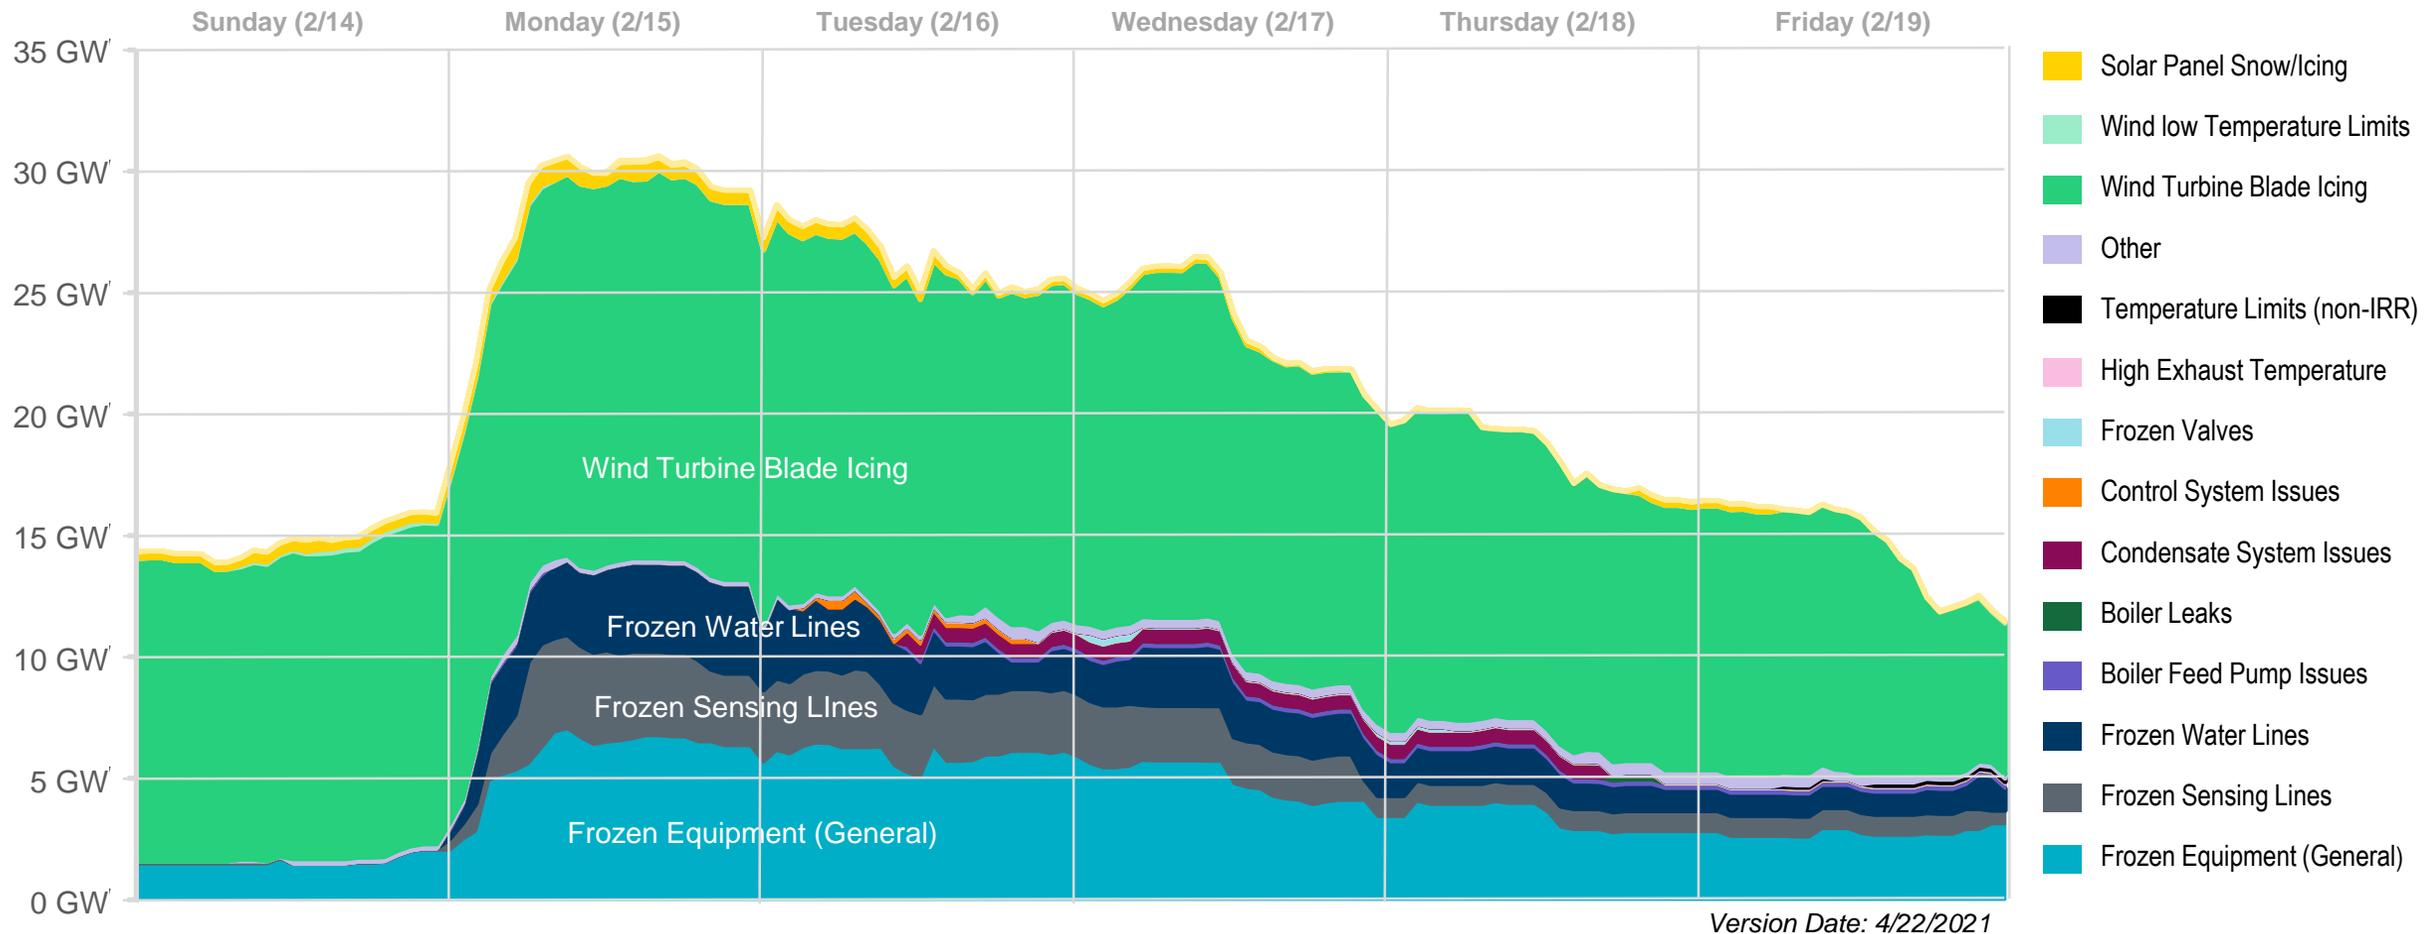
Weather Related Generator Outages and Derates by Sub Cause

Outage and derate MW for wind and solar are based on capacity.

- *Slide 23 provides the sub-causes for the Weather Related outages using the capacity for wind outages. Slide 24 uses the estimated lost output due to outages and derates for wind outages based on the proportion of total outaged wind capacity assigned to each cause for each hour.*
- *Slide 25 provides the sub-causes for the Fuel Limitations outages.*
