**Subcommittee on Oversight and Investigations
Hearing on
“Power Struggle: Examining the 2021 Texas Grid Failure”
March 24, 2021**

**Update to April 6, 2021 Preliminary Report on
Causes of Generator Outages and Derates
During the February 2021 Extreme Cold Weather
Event**

ERCOT Public
April 27, 2021

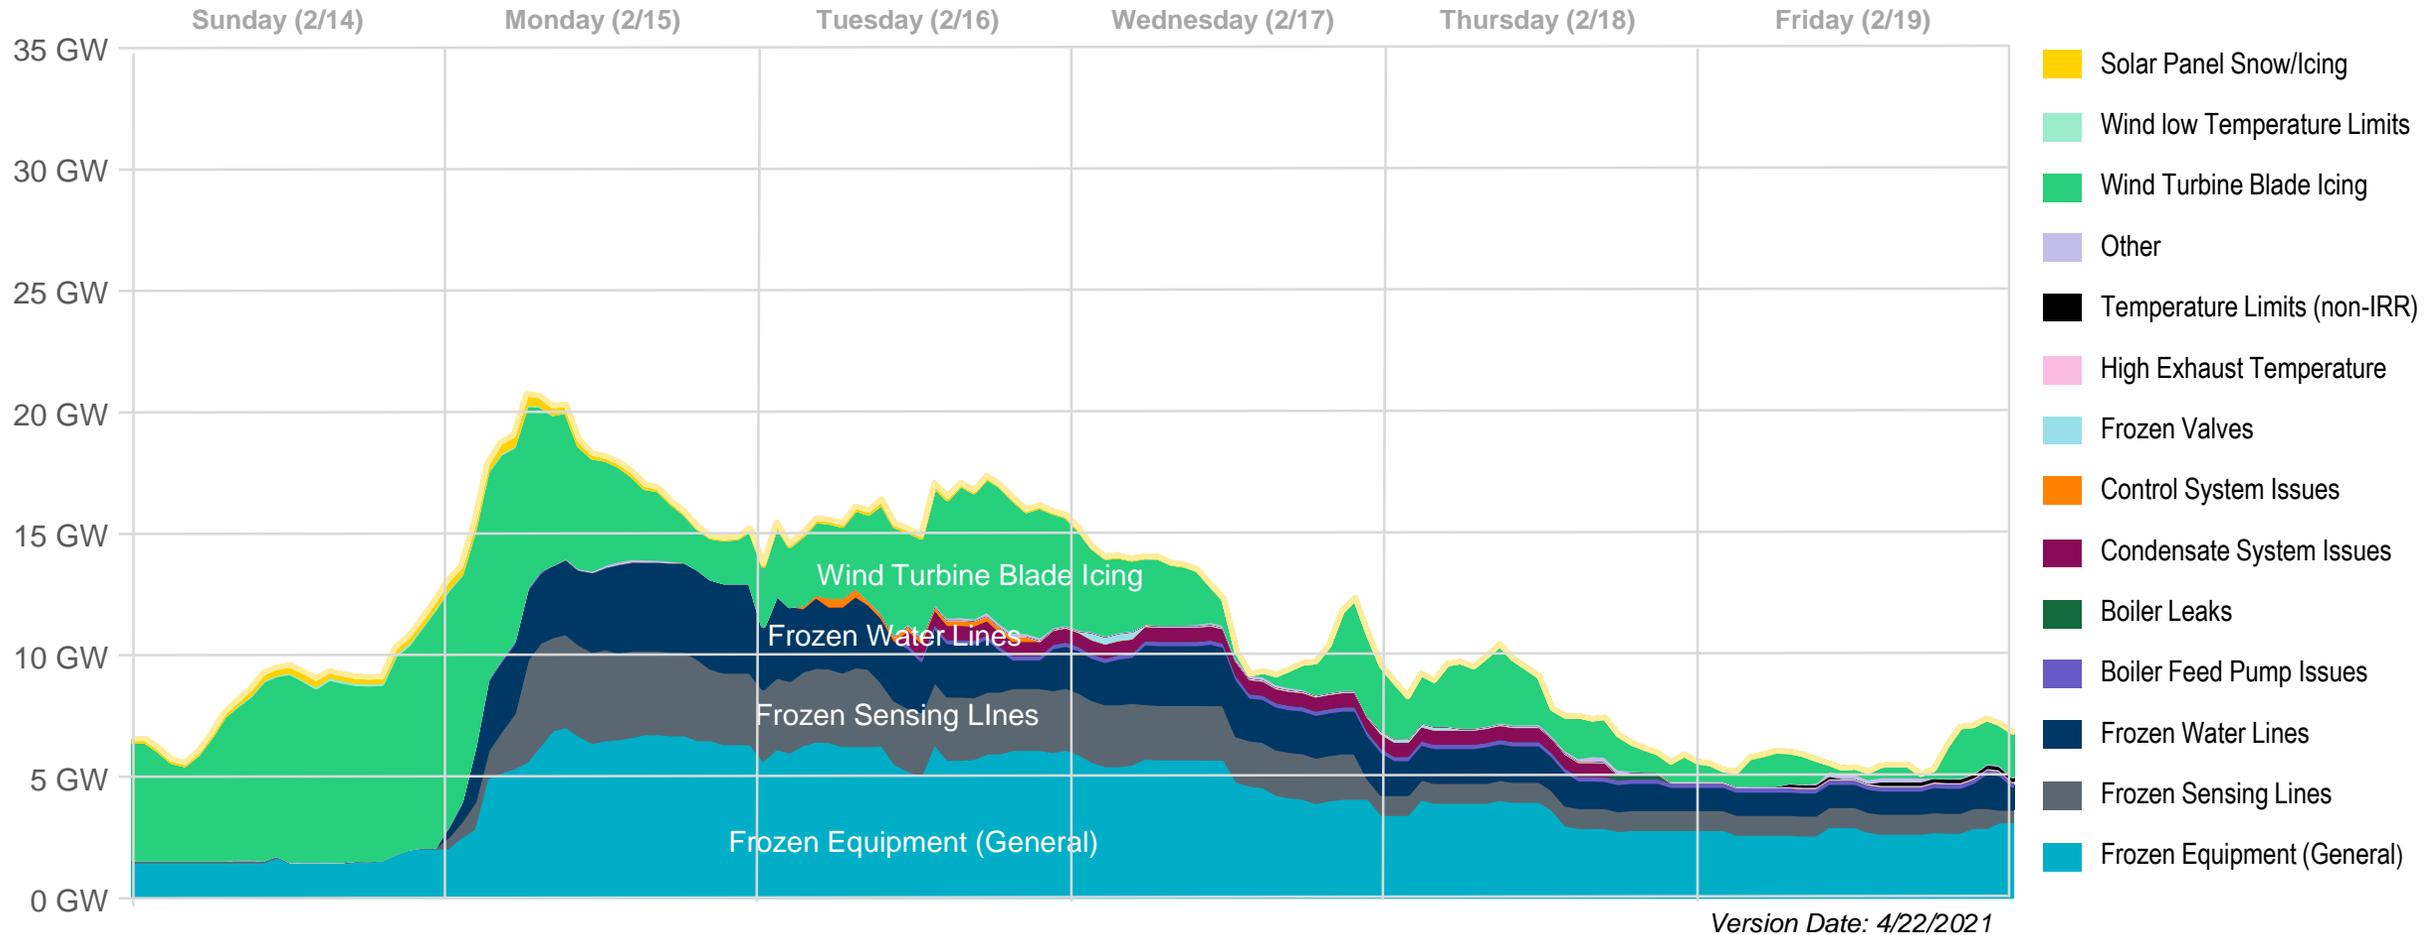
Weather Related Generator Outages and Derates by Sub Cause

Outage and derate MW for wind are estimated based on the proportion of total outaged wind capacity assigned to each cause for each hour.

- *Slide 23 provides the sub-causes for the Weather Related outages using the capacity for wind outages. Slide 24 uses the estimated lost output due to outages and derates for wind outages based on the proportion of total outaged wind capacity assigned to each cause for each hour.*
- *Slide 25 provides the sub-causes for the Fuel Limitations outages.*
