## **Pennsylvania's Environmental Good Samaritan Program<sup>1</sup>**

Eric E. Cavazza, P.E.<sup>2</sup> and John J. Stefanko

**Abstract:** Pennsylvania enacted an Environmental Good Samaritan Act (PA EGSA) in 1999. The law is intended to encourage landowners and others to reclaim abandoned mineral extraction lands and abate water pollution caused by abandoned mines or orphaned oil and gas wells. The law protects landowners, groups and individuals who volunteer to do such projects from civil and environmental liability under Pennsylvania law. Prior to the PA EGSA, anyone who voluntarily reclaimed abandoned lands or treated water pollution for which they were not liable could be held responsible for treating the residual pollution under Pennsylvania law. This dissuaded people and groups from pursuing these types of projects.

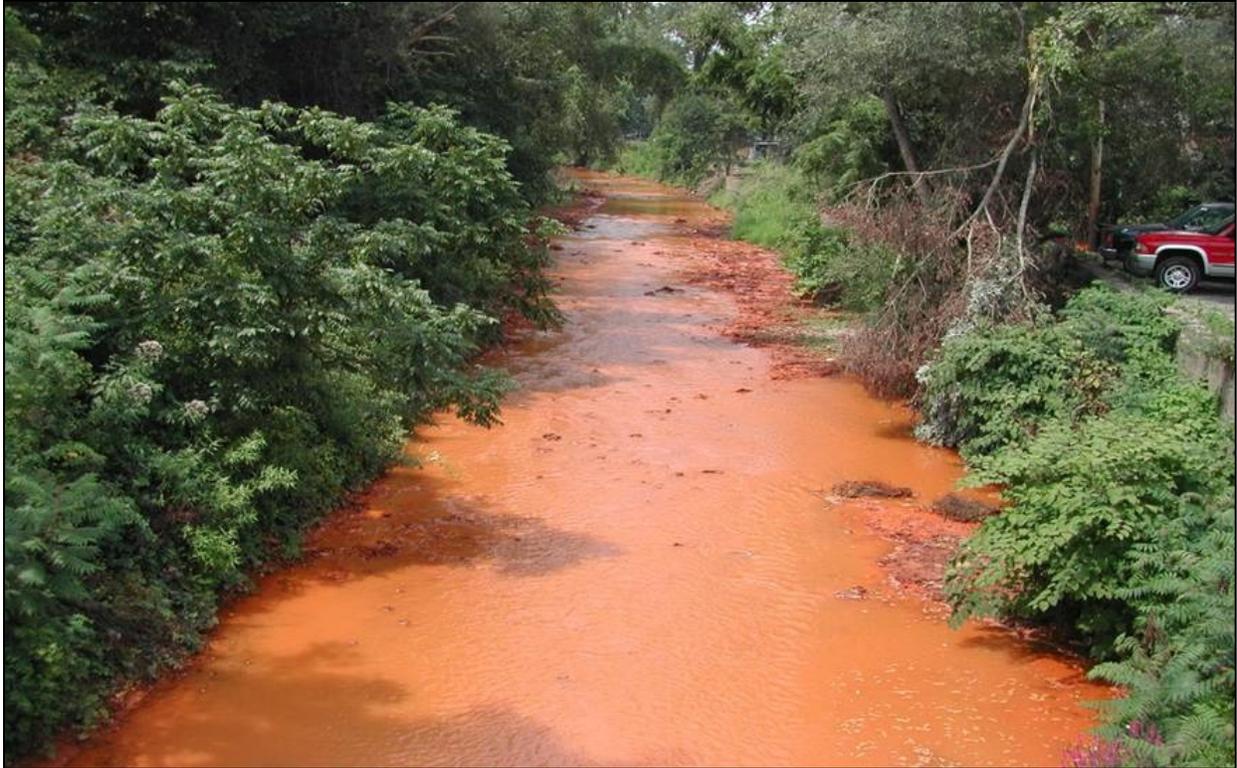
Figure 2. AMD impaired stream, Millers Run, Allegheny County, PA

So why does Pennsylvania need a Good Samaritan Act? First and foremost, Pennsylvania has over 5,500 miles of abandoned or acid mine drainage (AMD) impaired streams. Figure 1 shows the location of these AMD impaired streams within Pennsylvania. Figure 2 is a photograph of an AMD impaired stream (Millers Run) in Allegheny County, PA, just west of the City of Pittsburgh. Additionally, Pennsylvania has 1,000's of abandoned mine discharges. These discharges range,

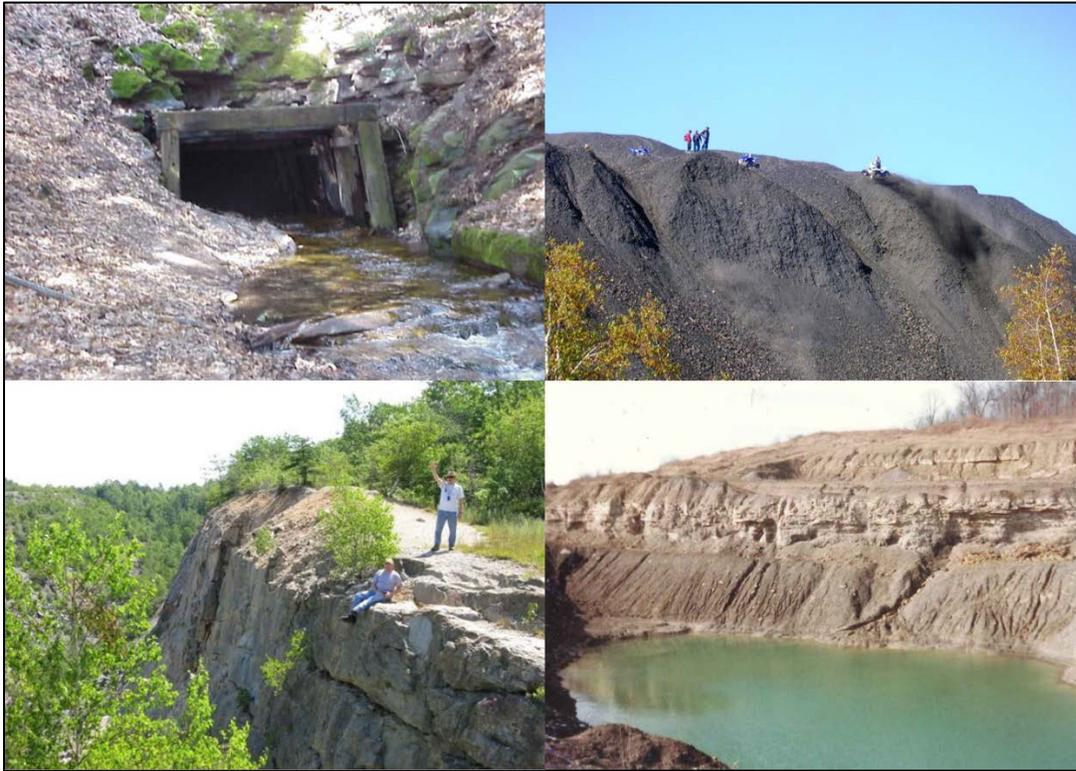
Figure 4. Examples of unreclaimed abandoned mine land in Pennsylvania

on average from a few gallons per minute (gpm) to nearly 45,000 gpm. In fact, Pennsylvania's top 100 orphaned abandoned mine discharges alone have a combined average flow rate of over 455,000 gpm which equates to more than 656 million gallons per day of untreated AMD entering Pennsylvania rivers and streams. In addition to abandoned mine drainage problems, Pennsylvania has over 100,000 acres of unreclaimed abandoned mine land (AML). Figure 3 shows the location of unreclaimed AML in Pennsylvania, and Figure 4 shows several examples of unreclaimed AML features.

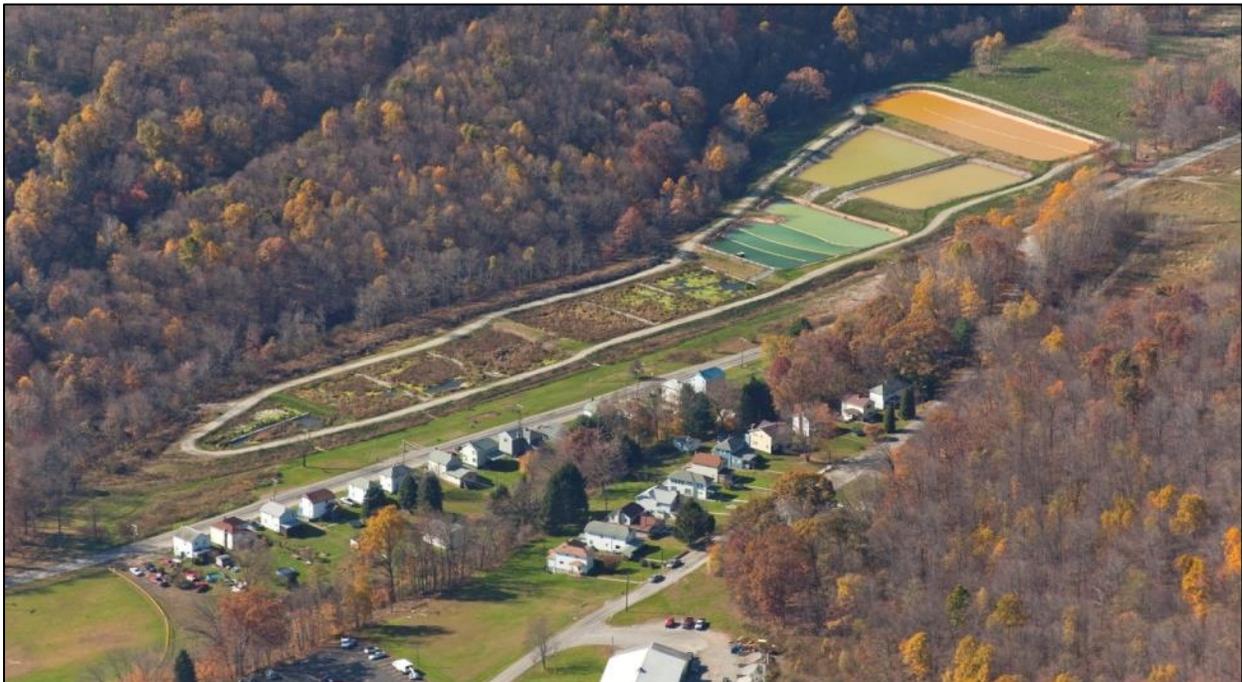
Figure 8. Aerial view of the Melcroft passive mine drainage treatment system

The MWA completed a watershed assessment of the Indian Creek Watershed in 1998. The study revealed that mine drainage from abandoned surface and underground mines was the biggest source of impairment in the watershed and degrading the quality and quantity of 17.4 miles of Indian Creek and its tributaries. Unregulated mining began in the watershed in the late 1800s and continued into the 1960s. One hundred and nineteen (119) mine drainage discharges were documented in the watershed. An analysis of those discharges revealed that the 10 most significant discharges in the watershed accounted for 94% of the total acid load, 90% of the iron load and 94% of the aluminum load in the watershed. MWA worked with the NRCS to develop a Watershed Restoration Plan (completed in October 2000) to address the most severe discharges and restore water quality in the Indian Creek Watershed. Since that time, MWA, NRCS and PA-DEP-BAMR have constructed six passive mine drainage treatment systems to treat the worst discharges in the watershed. Figure 8 shows an aerial view of one of the passive treatment systems constructed in the Indian Creek Watershed.

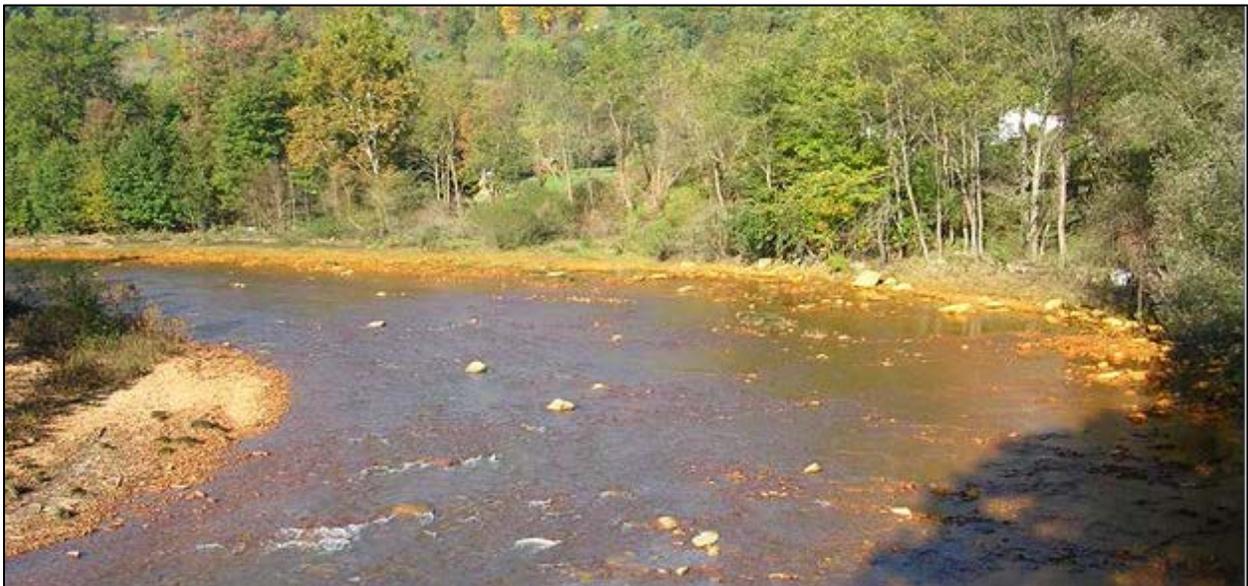
Figure 10. AMD impacted main stem of the Bennett Branch prior to restoration

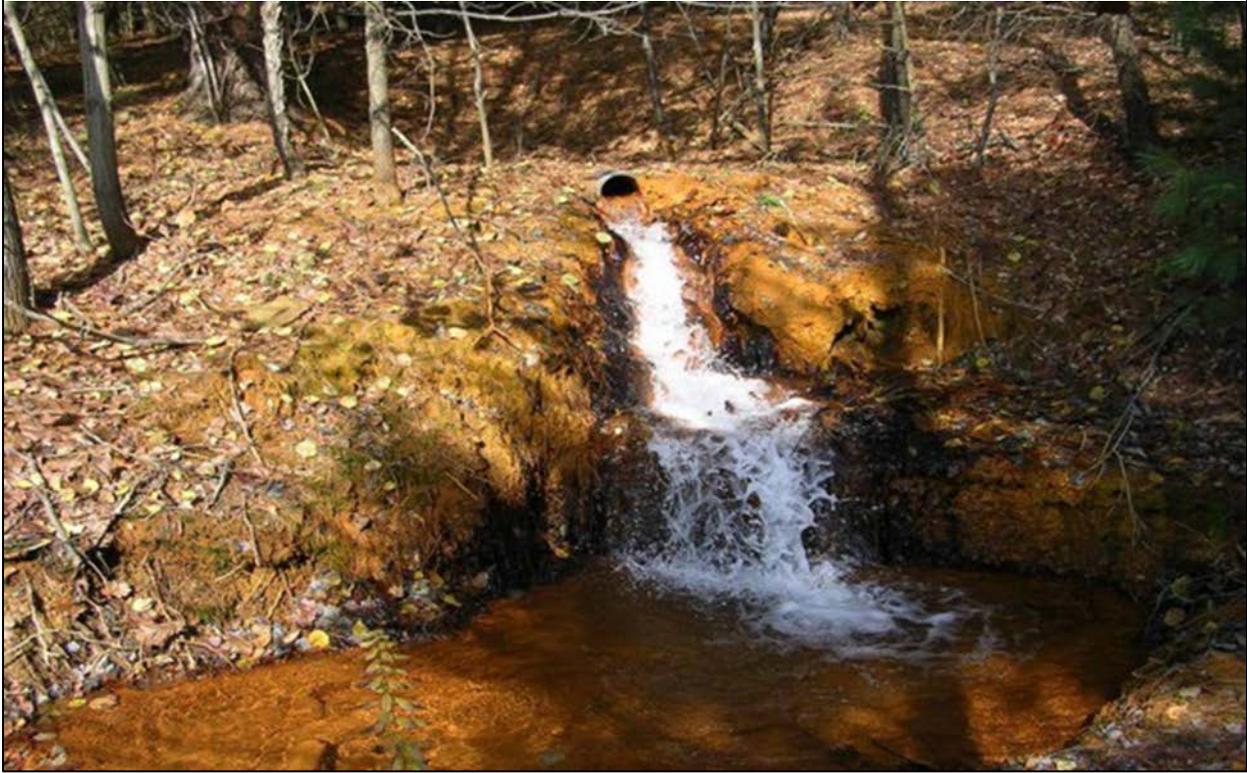
Figure 11. AMD discharge in the Bennett Branch prior to restoration

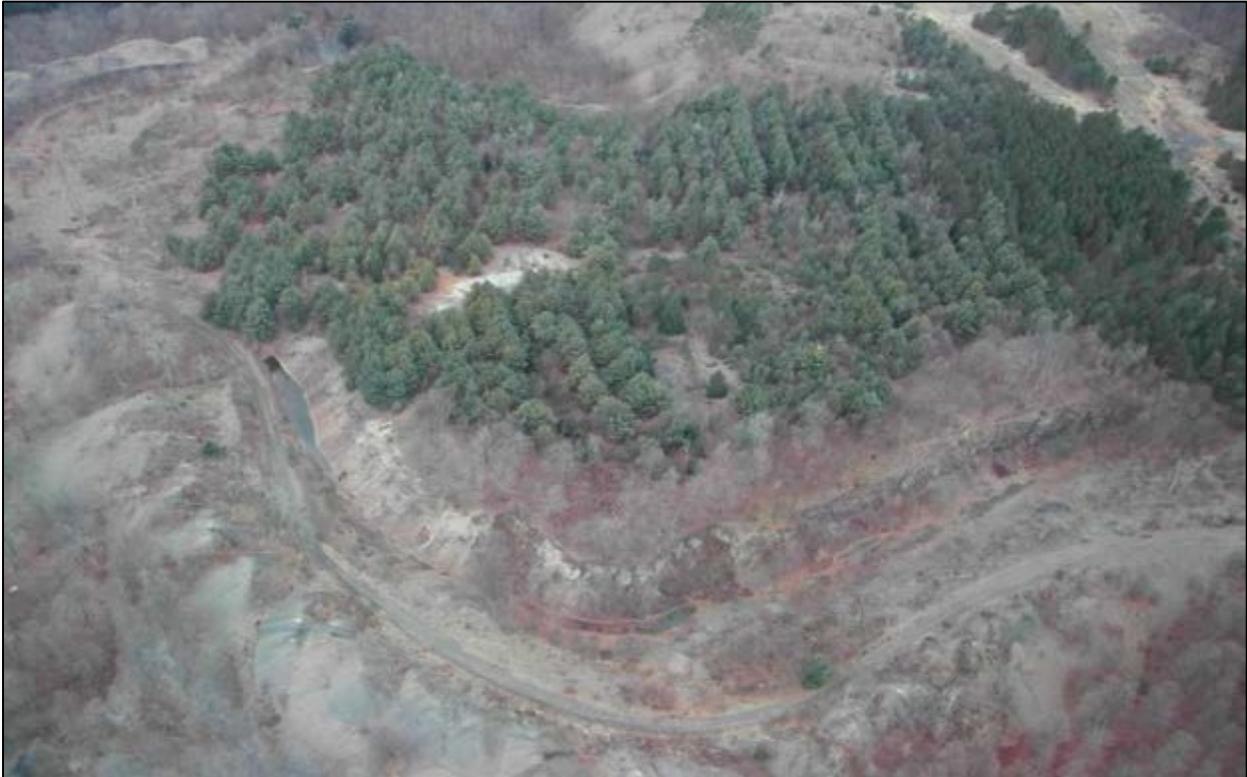
Figure 12. Unreclaimed AML site with dangerous highwalls located on State Game Lands in the Bennett Branch Watershed prior to restoration

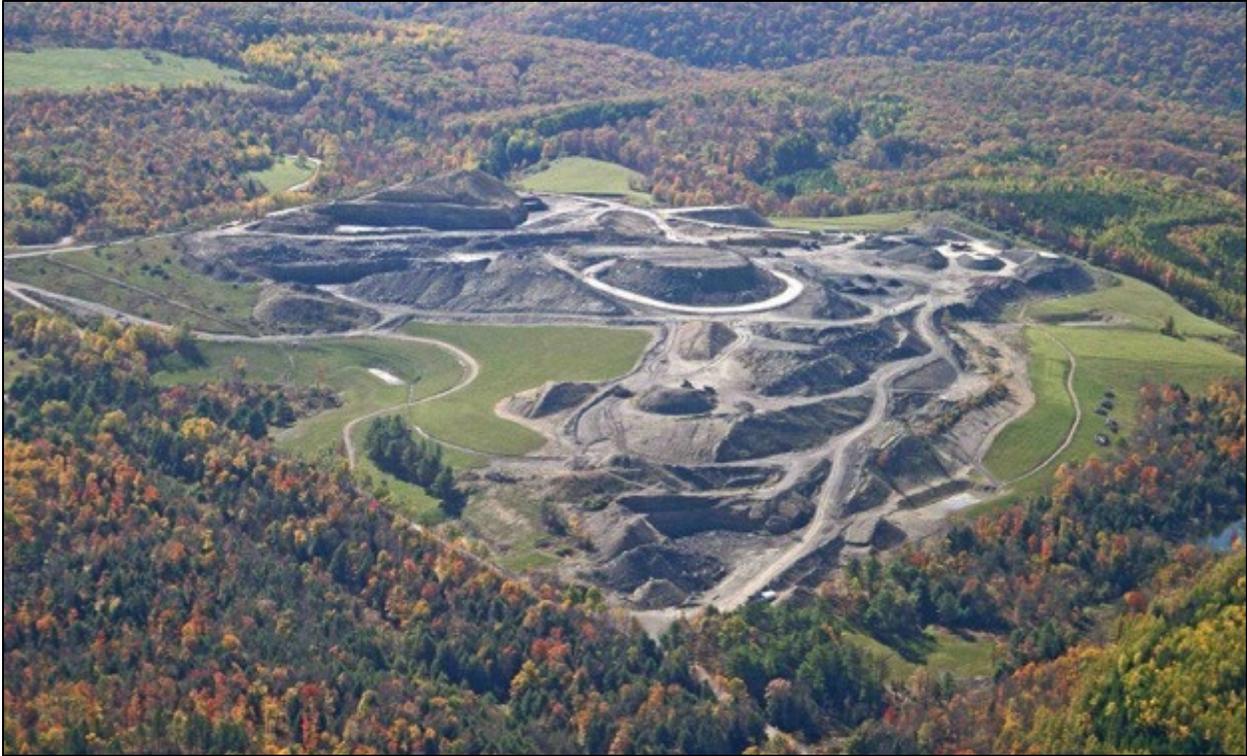
Figure 13. Aerial view of the remining operation that provided limestone for alkaline addition for surface mine reclamation sites in the Bennett Branch

mine drainage treatment. Limestone reserves within the project area provided an opportunity to incorporate alkaline addition in the surface reclamation. Mineable reserves of Upper and Middle Kittanning Coal within the limestone extraction area provided an opportunity to partner with the mining industry in project implementation. The re-mining was conducted under a demonstration permit authorized under Project XL, an experimental permitting process cooperatively developed by EPA, OSM and PA-DEP to both facilitate re-mining and highlight its benefits. The restoration work was also pursued in conjunction with the PA Wilds Initiative which advocates economic development and tourism throughout north-central Pennsylvania. Figure 13 shows an aerial view of re-mining operation that provided limestone for other reclamation sites in the Bennett Branch Watershed.

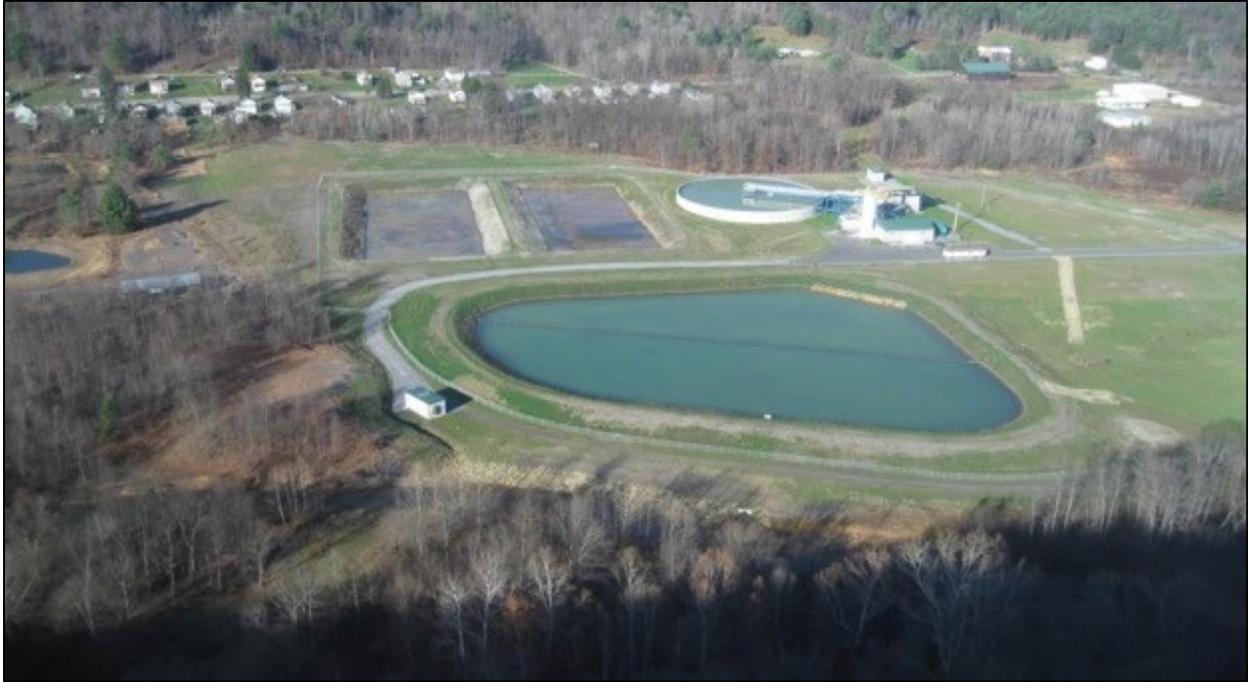
Figure 15. Aerial view of the Hollywood AMD Treatment Plant

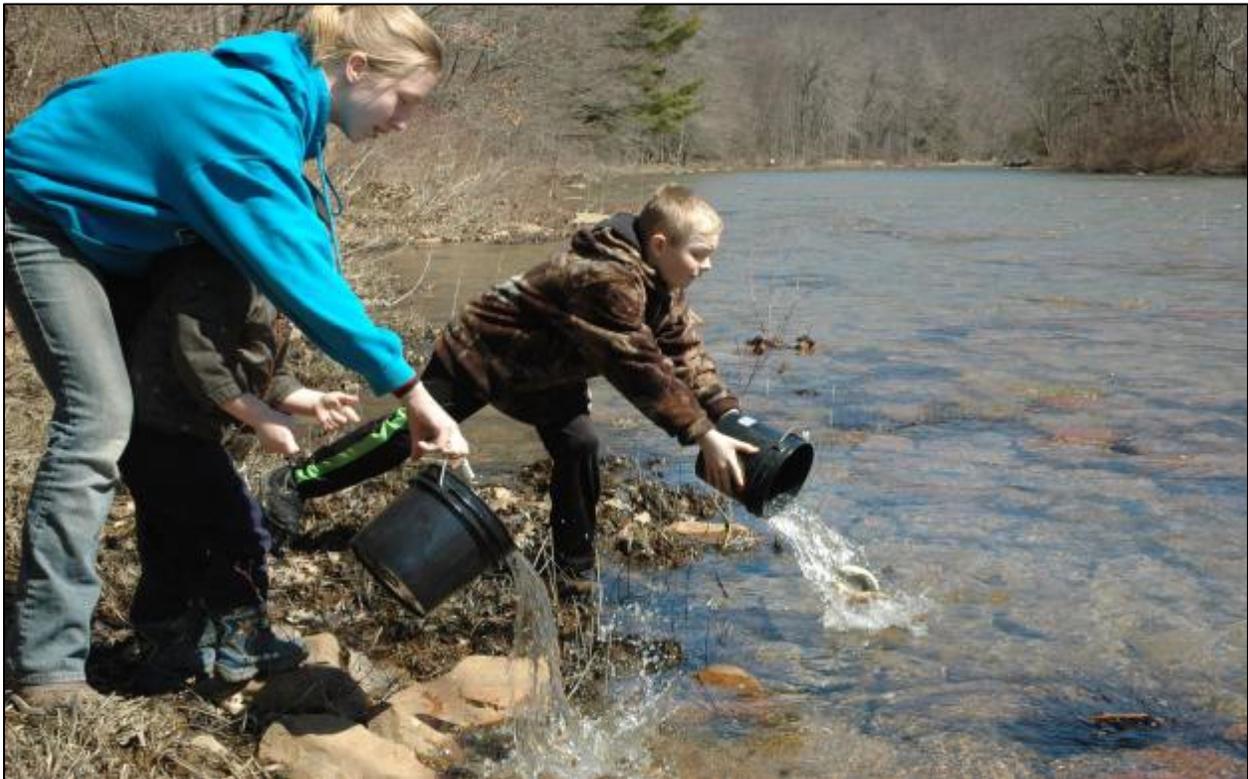
Figure 16. Fish being stocked in the Bennett Branch in April 2013

remaining 75%. Water quality has been significantly improved to the point where, beginning in 2013, fish are now being stocked in the main stem of the Bennett Branch and fish have returned to the Dents Run tributary for the first time in roughly 100 years. In addition to restoration of the main stem of the Bennett Branch, the project allowed for the reconnection of numerous high-quality tributaries which facilitated that rapid biological recovery of the watershed. Figure 16 shows trout being stocked in the restored stream in 2013, and Figure 17 shows the main stem of the Bennett Branch following restoration. One of the project's primary partners, the Bennett Branch Watershed Association, applied for and received EGSA approval for several of the passive mine drainage treatment systems constructed as part of the overall watershed restoration effort. PA-DEP developed a short documentary about the project which is posted on the Department's YouTube channel and can be viewed at the following web link: <https://www.youtube.com/watch?v=xERv4sYgyLY>.

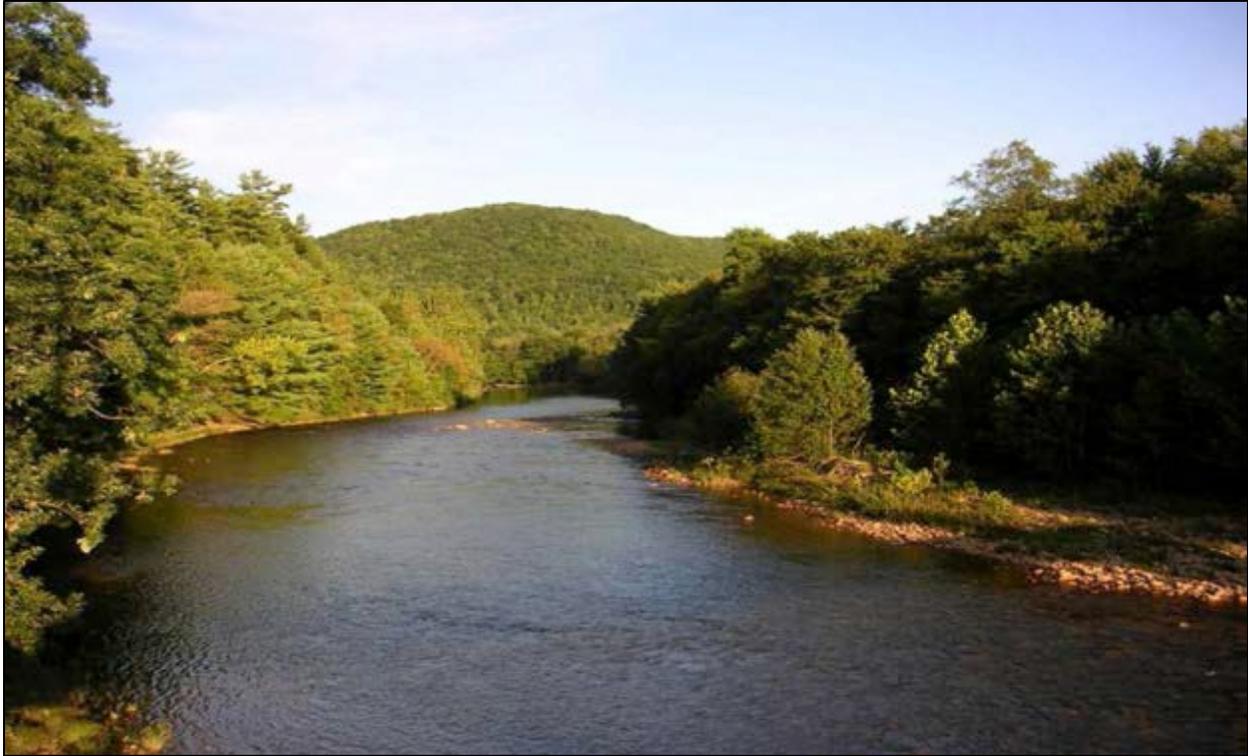
Figure 17. Main stem of the Bennett Branch following restoration

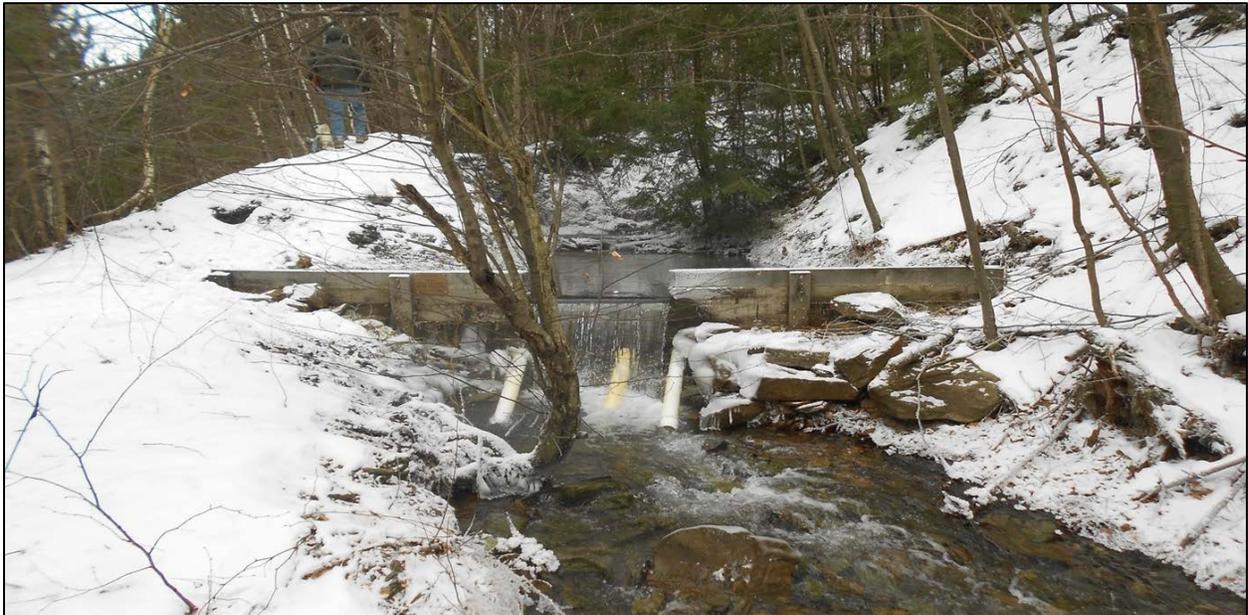
Figure 18. Fallbrook AMD Discharge – Ward Township, Tioga County

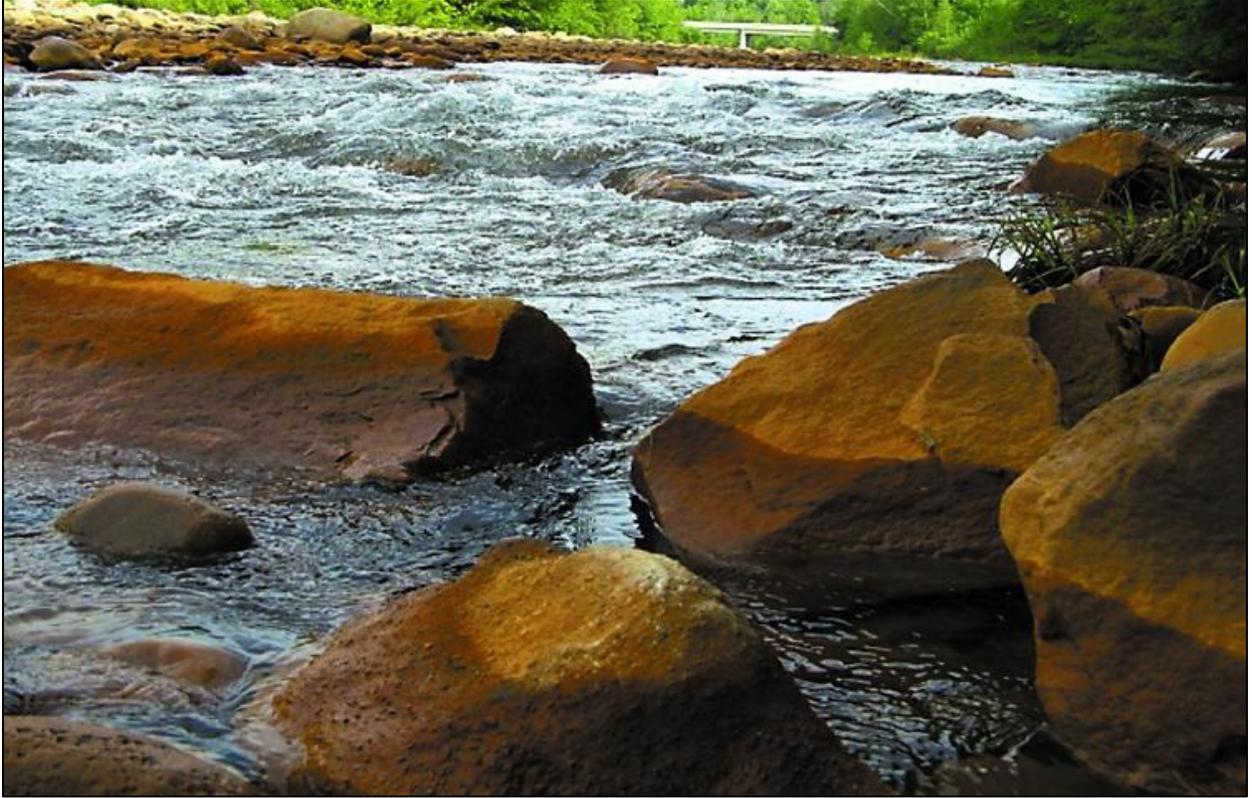
Figure 19. Iron-stained rocks in the AMD impacted main stem of the Tioga River downstream of Fallbrook Run prior to restoration

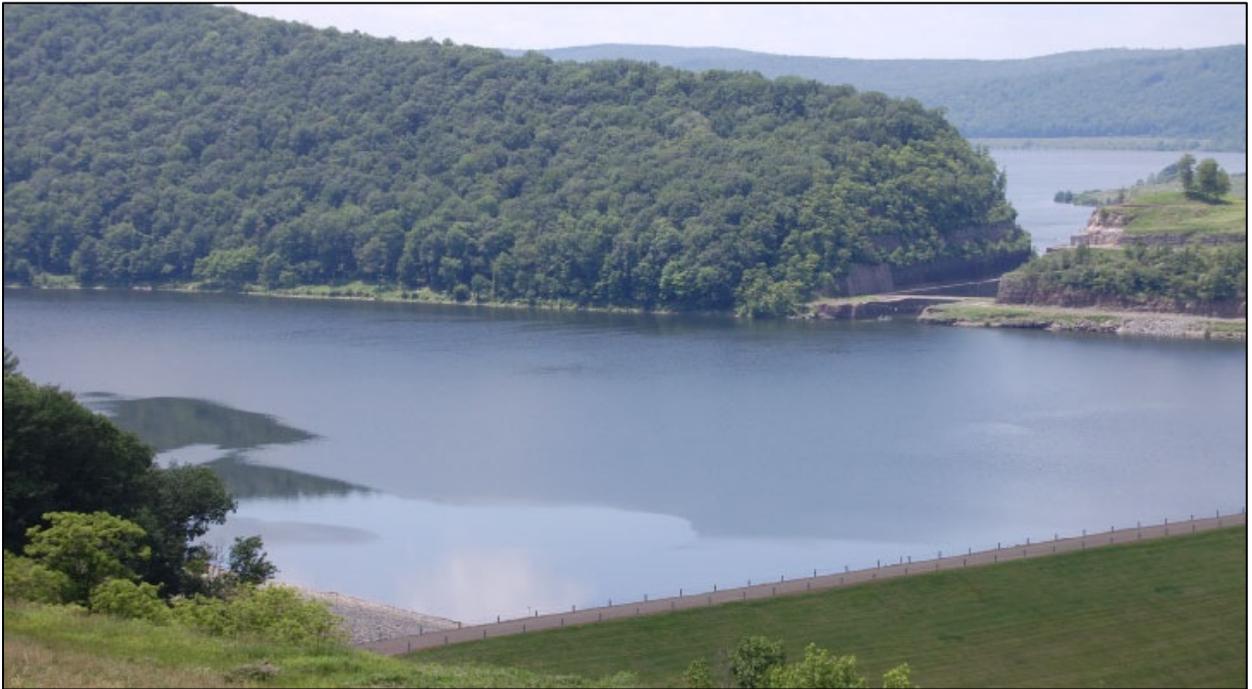
Figure 20. The Tioga Hammond Dam was constructed in 1978 and put into operation in 1981 as part of a flood control project (*The unnatural blue-green color frequently seen in Tioga Lake is due to the precipitation of Aluminum which results when the AMD becomes neutralized by alkaline water*)

DEP as a regional watershed priority because of the severe impacts from acid mine drainage, and its location in the Susquehanna River Basin, which serves as a major water source for the Chesapeake Bay. Fall Brook is the first of four major tributaries contributing to AMD pollution in the Tioga River that has left approximately 13 miles of the River void of aquatic life. Treatment of the Fall Brook discharge resulted in approximately 2 miles of Fall Brook and 3 miles of the Tioga River being restored to a condition that can support stocked trout populations. It also reduces AMD pollution loads in the mainstem of the River all the way to the Tioga/Hammond Dam complex and lays the ground work for future reclamation projects. Figure 18 shows the Fallbrook AMD discharge, and Figure 19 shows the AMD impacted main stem of the Tioga River upstream of the Tioga/Hammond Dam complex. Figure 20 shows an aerial view of the Tioga/Hammond Dam.

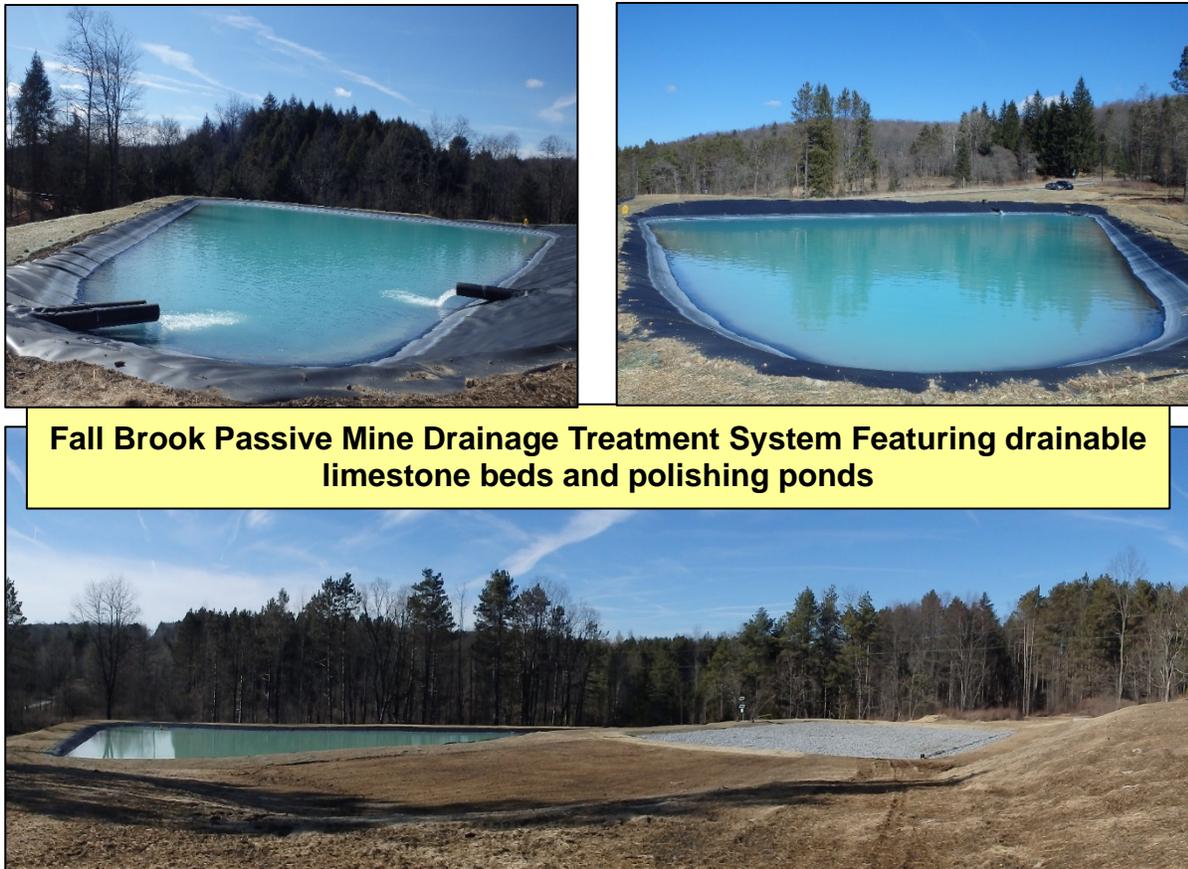
Figure 21. The Fallbrook Passive Treatment System

The treatment systems went on-line in November of 2015, restoring approximately 2 miles of Fall Brook and 3 miles of the Tioga River to conditions that support stocked trout populations. Wild Brook Trout have been seen in this section of the River as well. Two separate passive AMD treatment systems were constructed. One system addresses three smaller AMD discharges on the north side of River Road and the other treatment system treats a single large AMD discharge on the south side of River Road. Figure 21 shows photos of the Fallbrook passive AMD treatment system and Figure 22 shows the outfall from the treatment system where treated AMD discharges back into Fallbrook Run.

The approximate cost of this project (including establishment of the O&M trust fund) was \$2.7 million. These treatment systems consist of drainable limestone beds and polishing ponds. A solar powered automatic flushing system was installed to automatically flush the limestone beds and remove contaminants that build-up over time. The treated water is ultimately discharged back into Fall Brook above the Fall Brook Falls. Water samples taken below the Falls indicate a significant increase in pH from 3.6 to 7. Increasing the pH is only one component of the water chemistry that impacts the ability of fish and bugs to survive. Aluminum, iron, and manganese

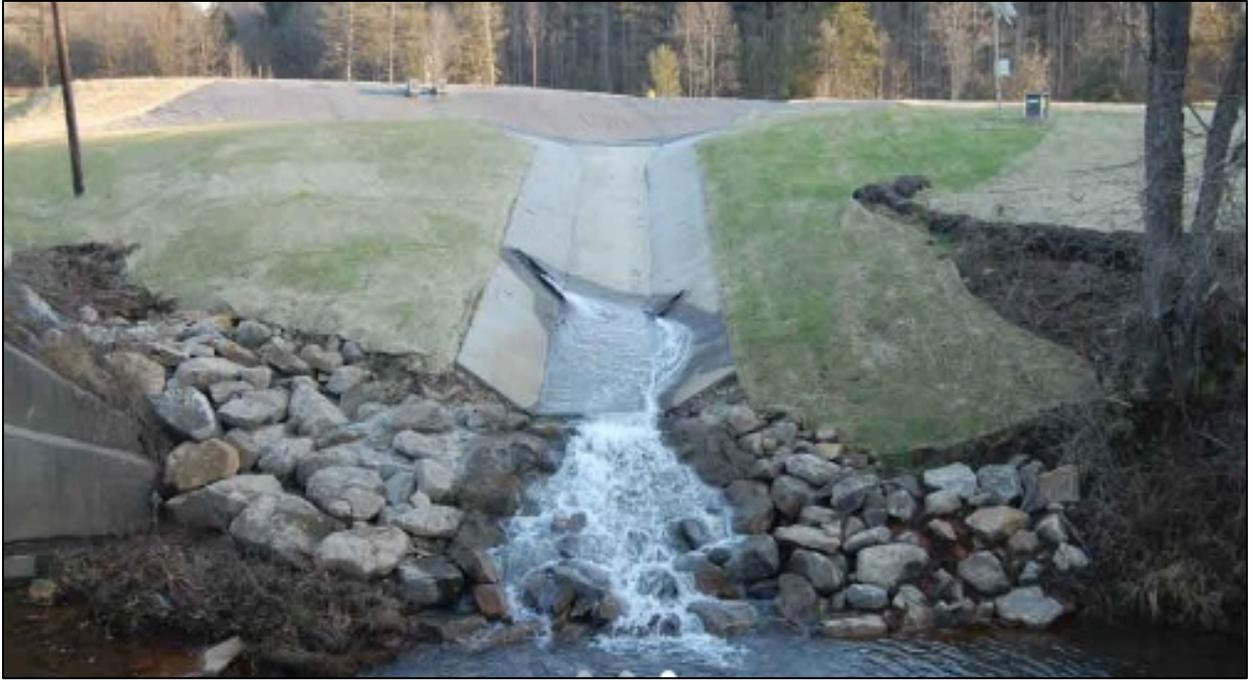
Figure 22. Effluent from the Fallbrook Passive Treatment System
