Robert Squires - Squires Consulting LLC
Landowner Advocate

Opening Statement for May 5, 2021 Subcommittee on Civil Rights and Civil Liberties Hearing:
“Pipelines Over People (Part II): Midship Pipeline’s Disregard for Landowners in Its Pathway”

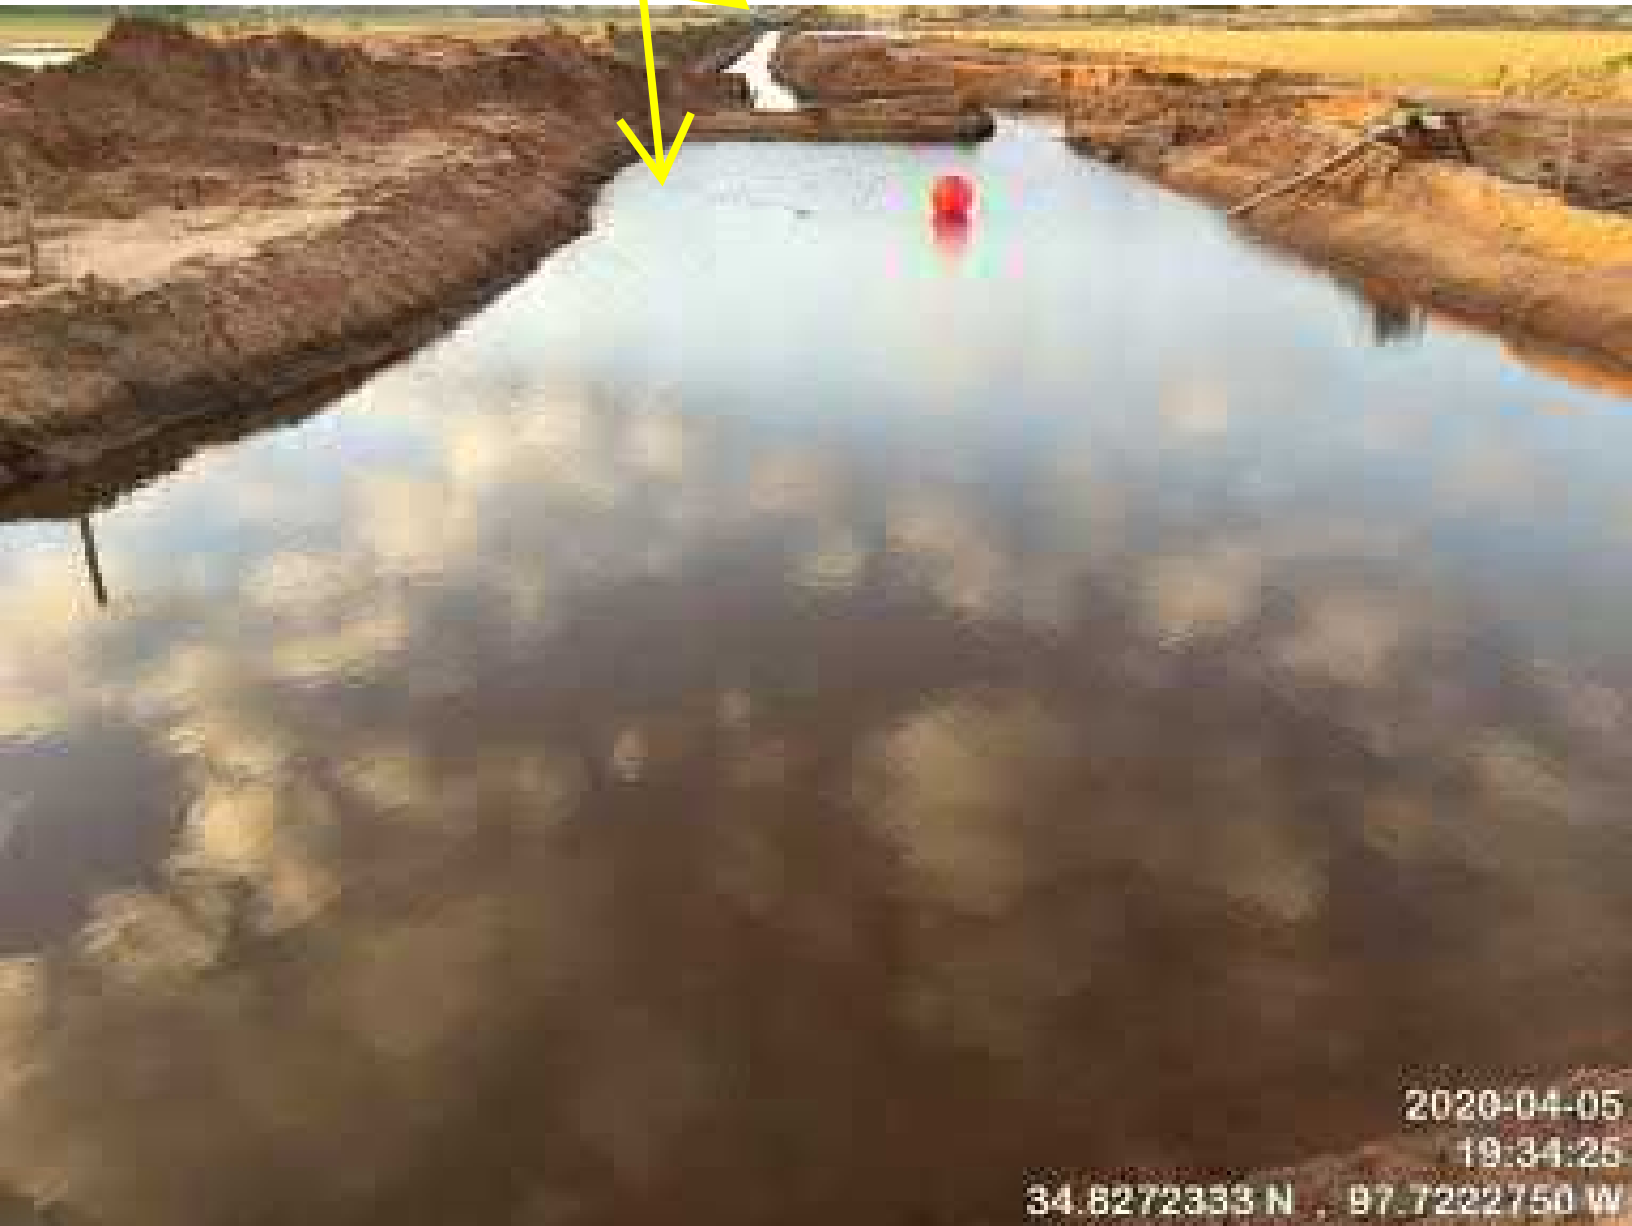
Open Trench

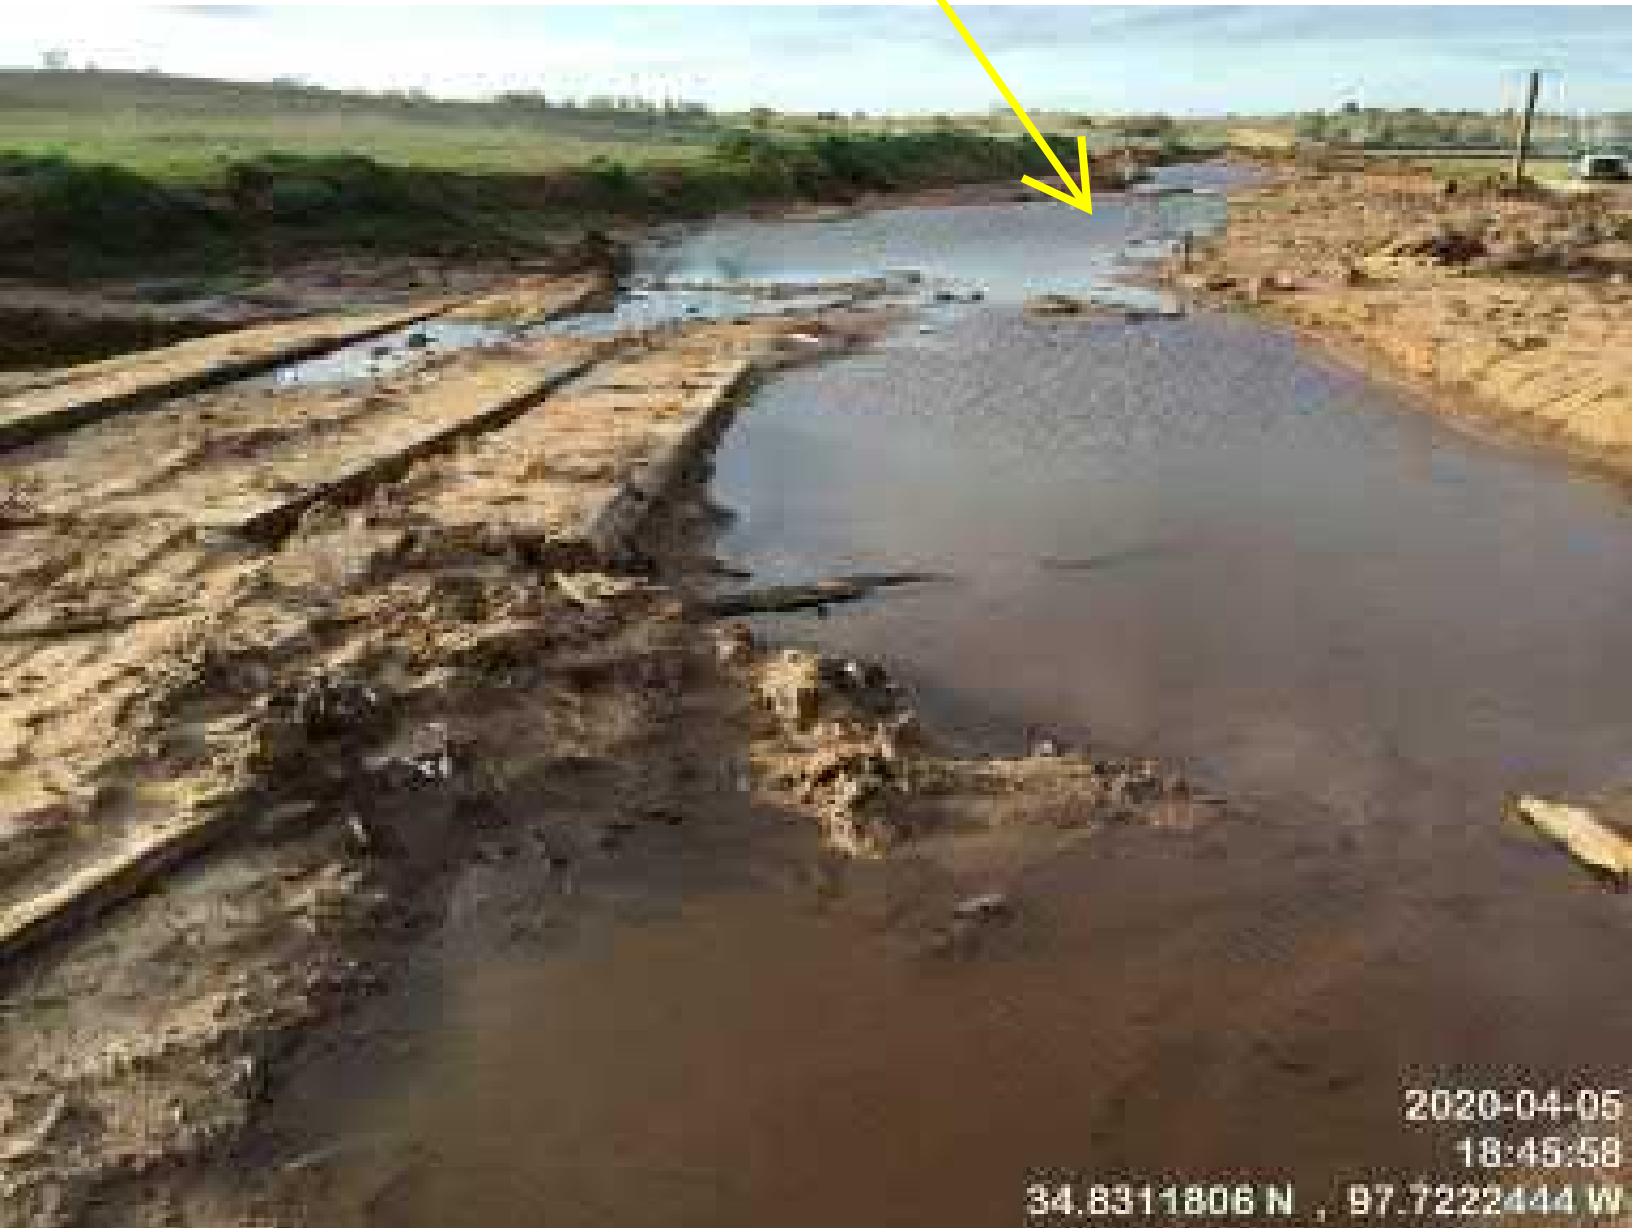
Open Trench

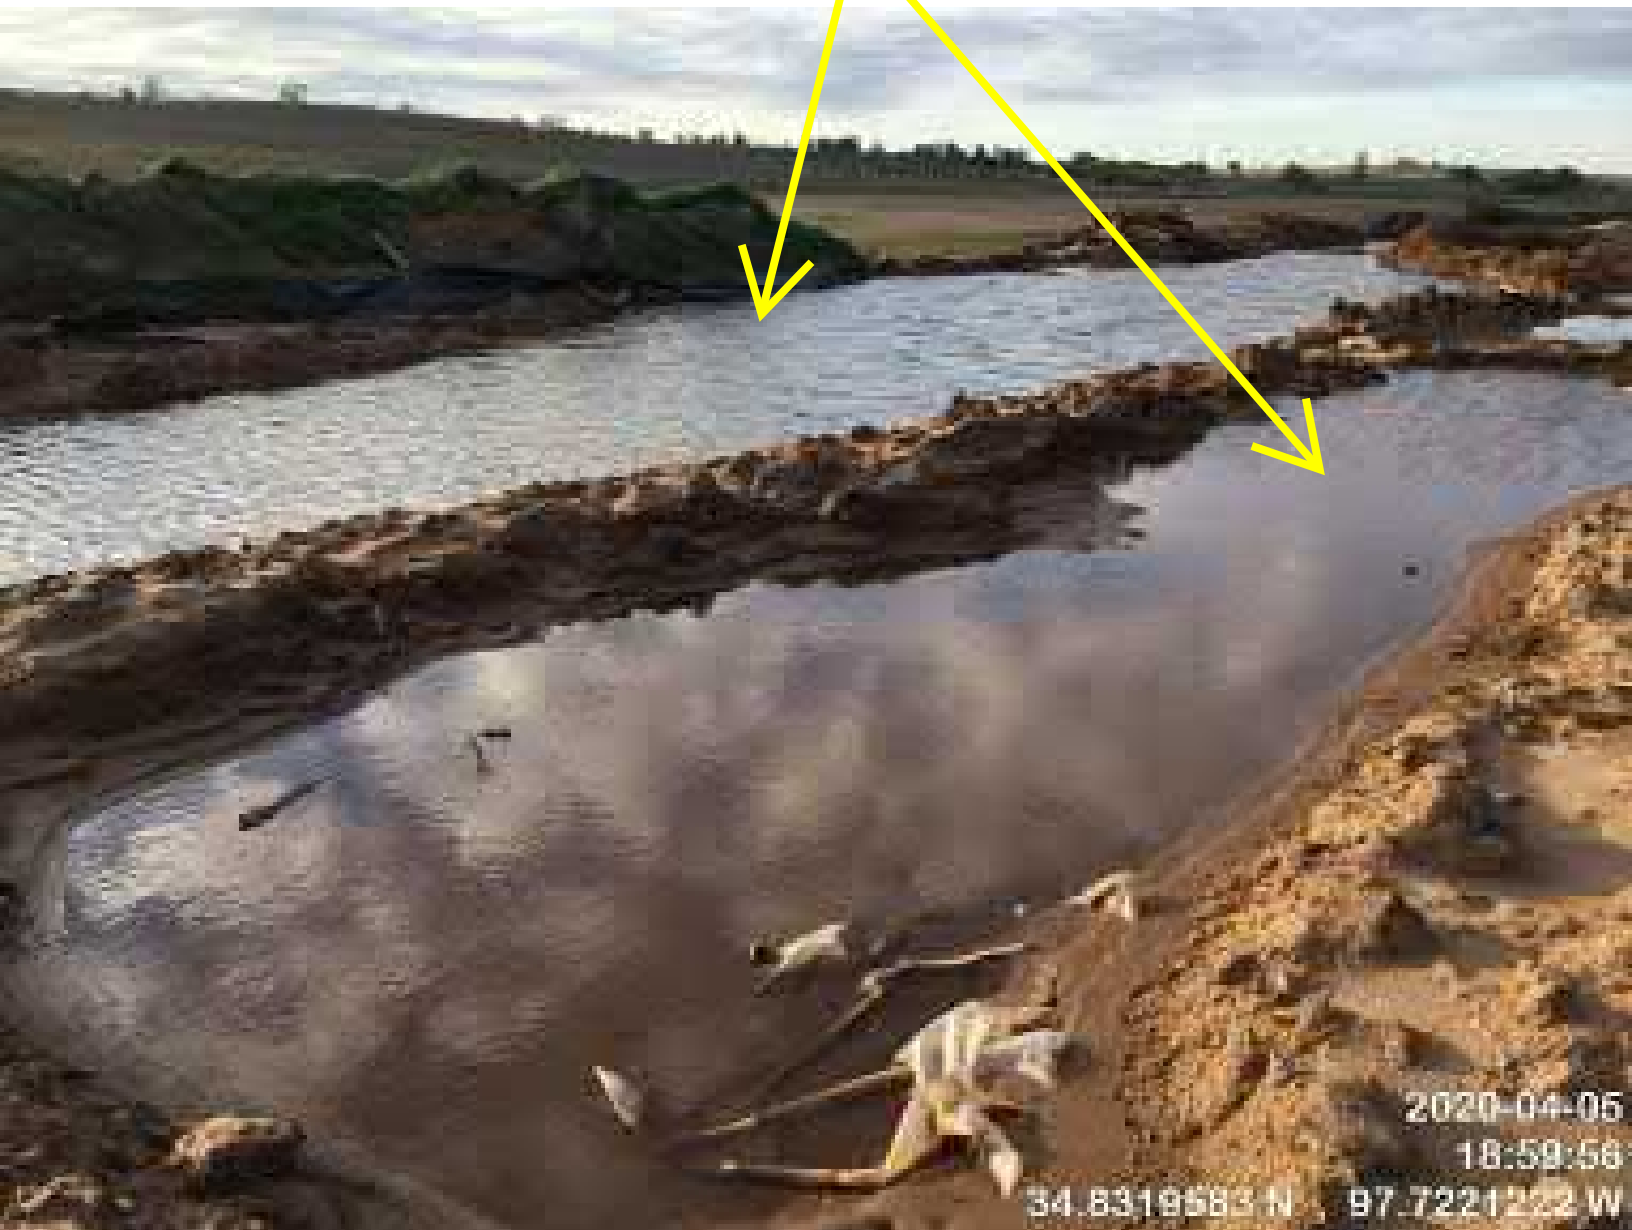
Open Trench

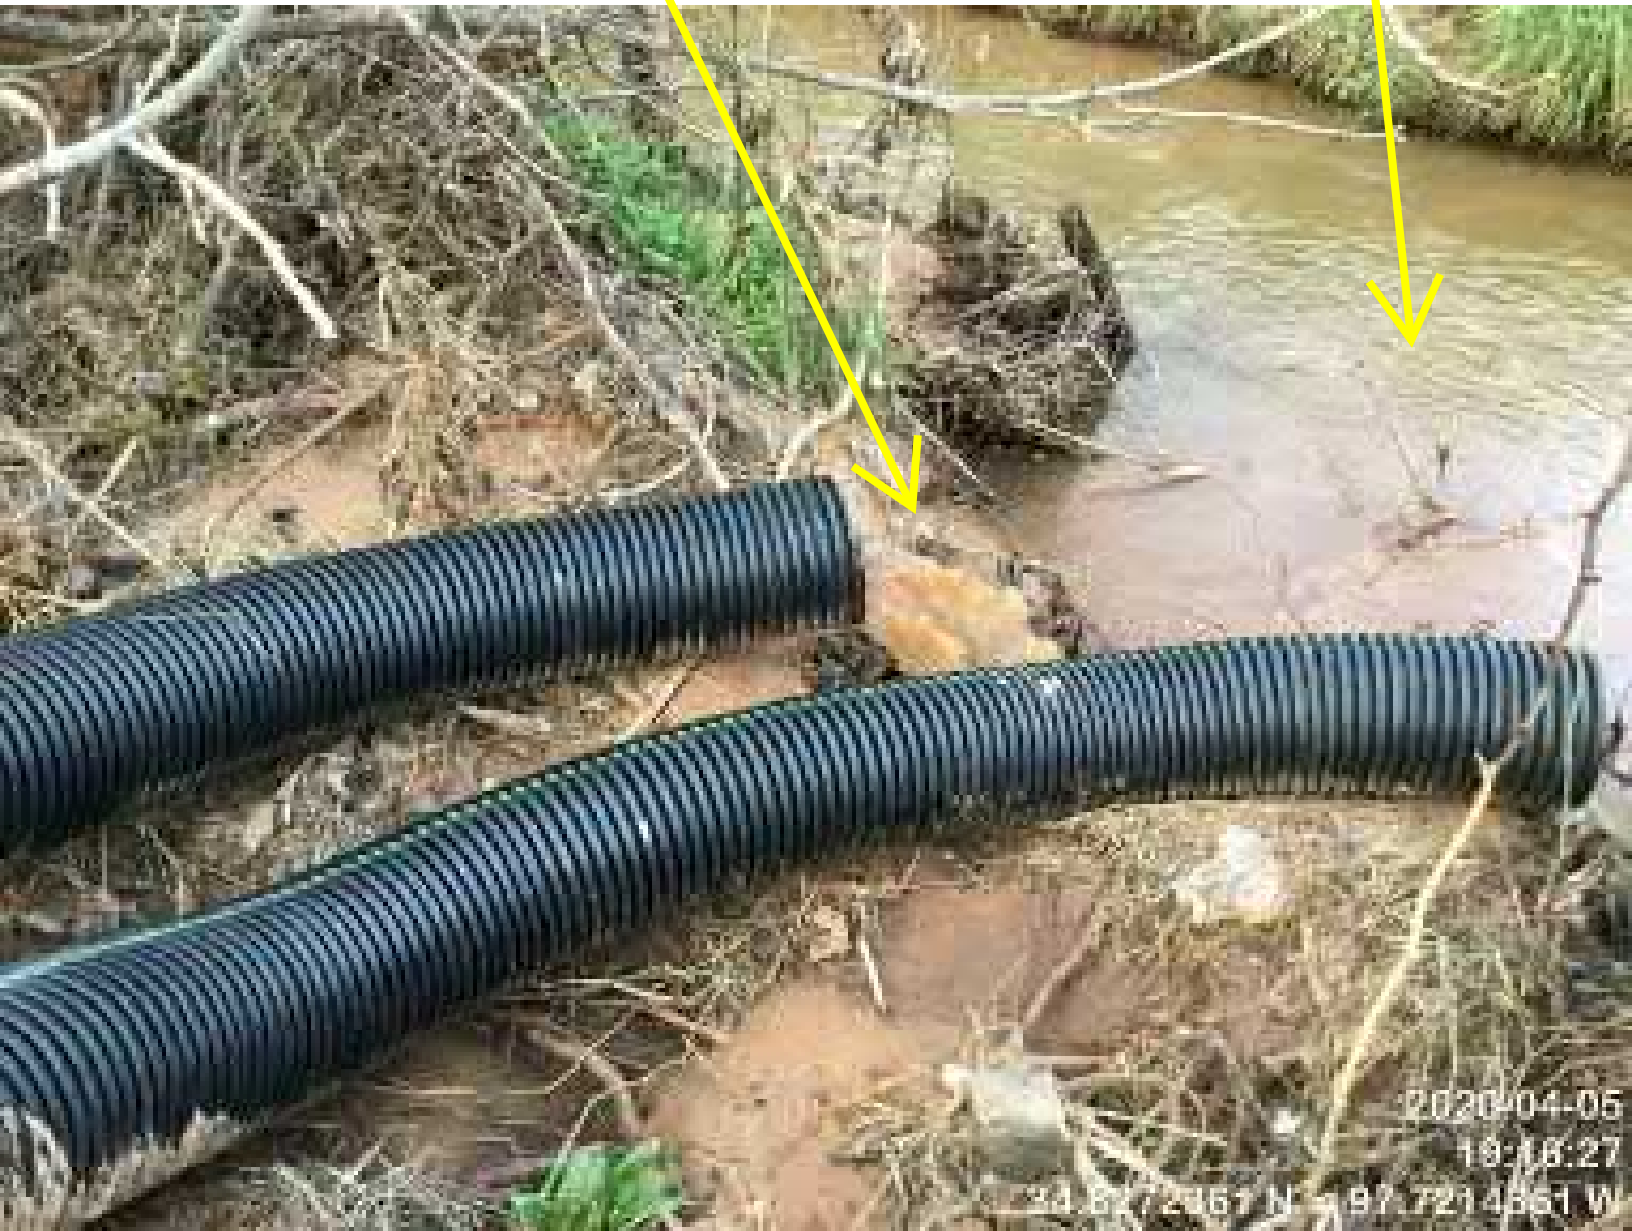
Sandy Creek (SGR-008)

Unfiltered Dewatering into SGR-008

Unfiltered, Silt-Laden
Water Pumped into
Creek

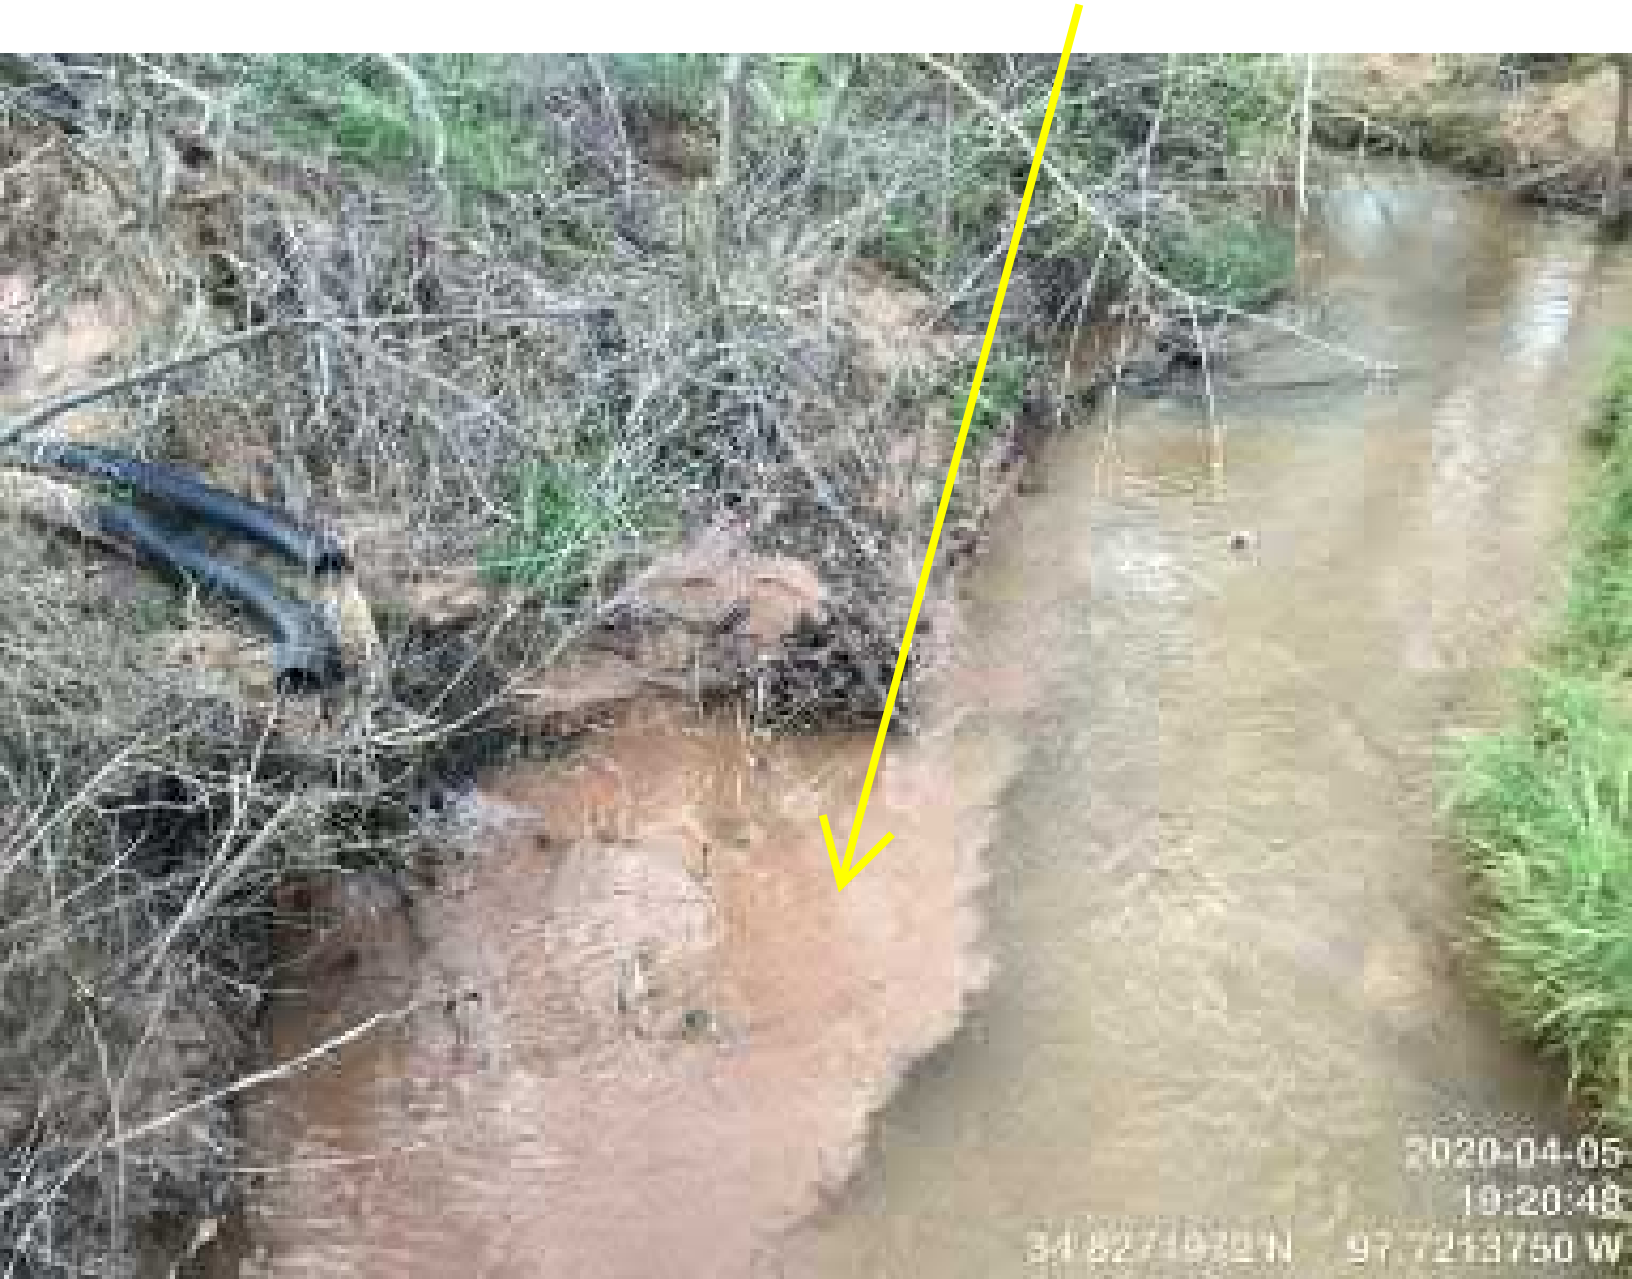
Sediment Plume

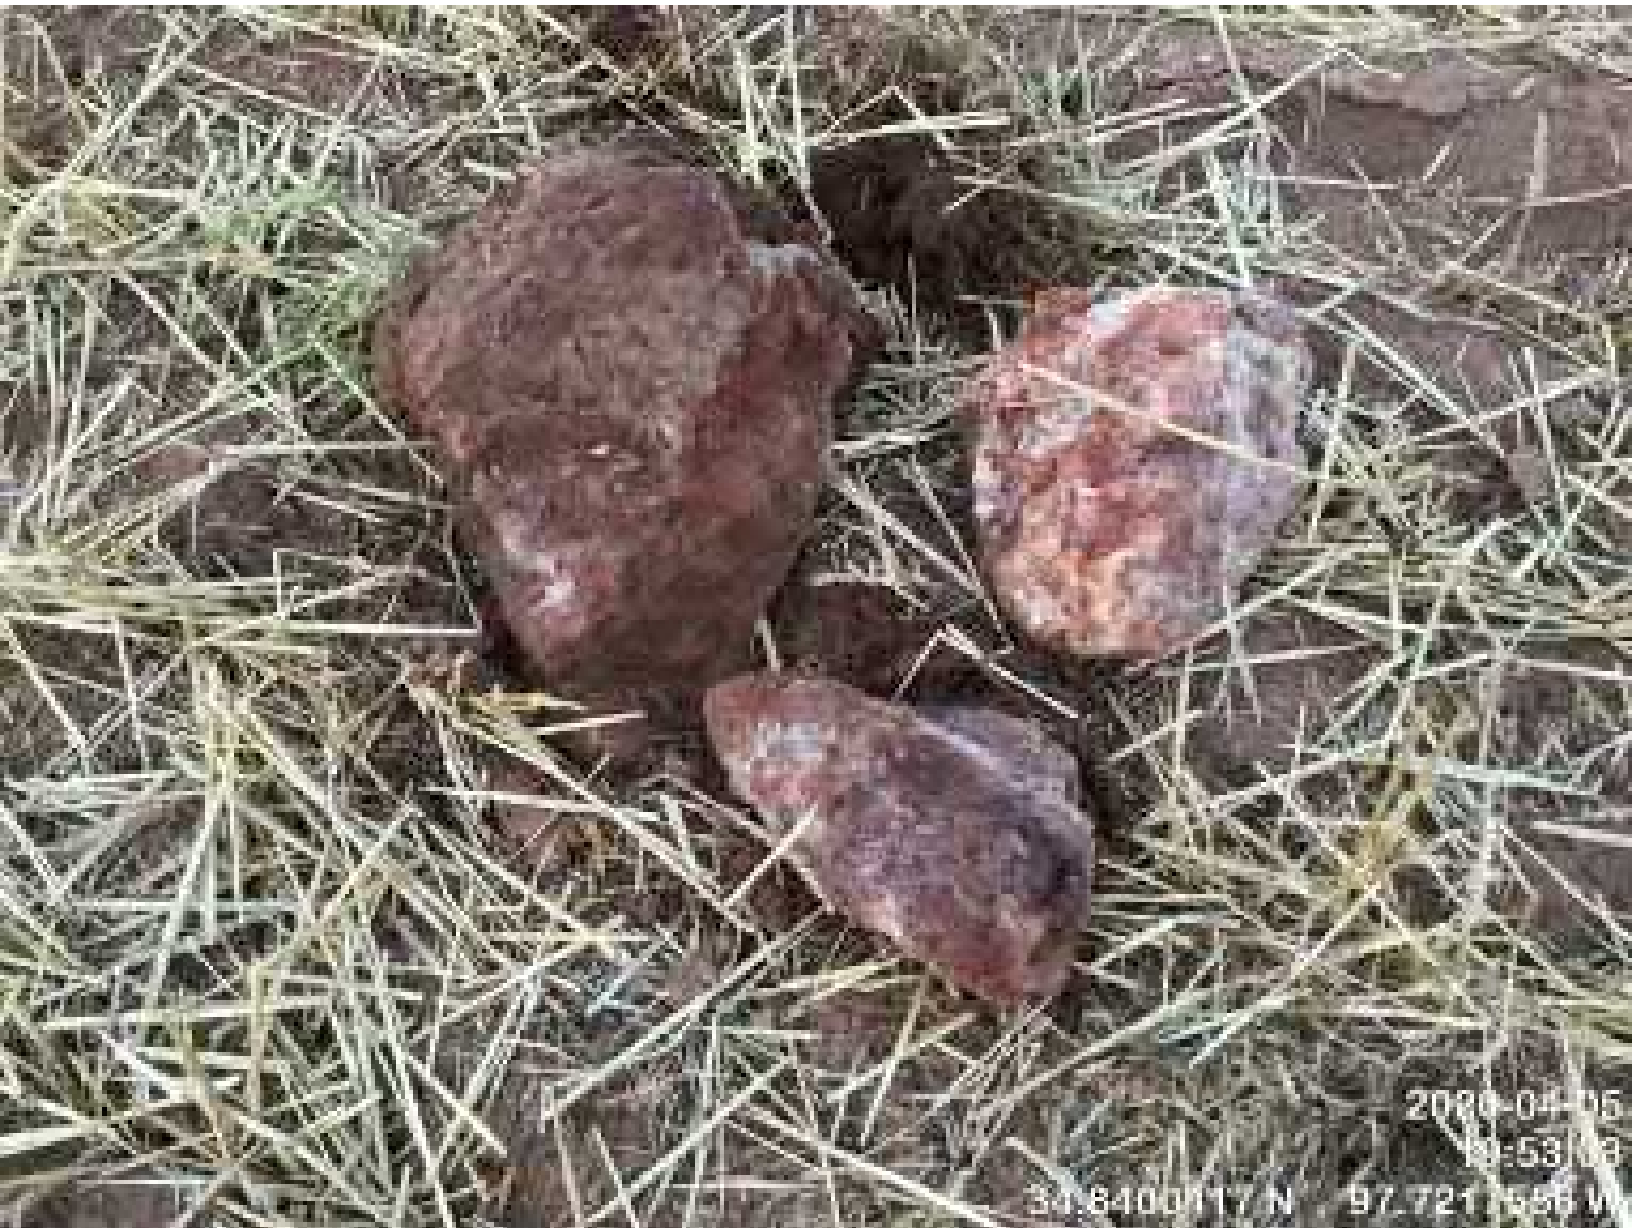
Buried Rocks and Construction Debris

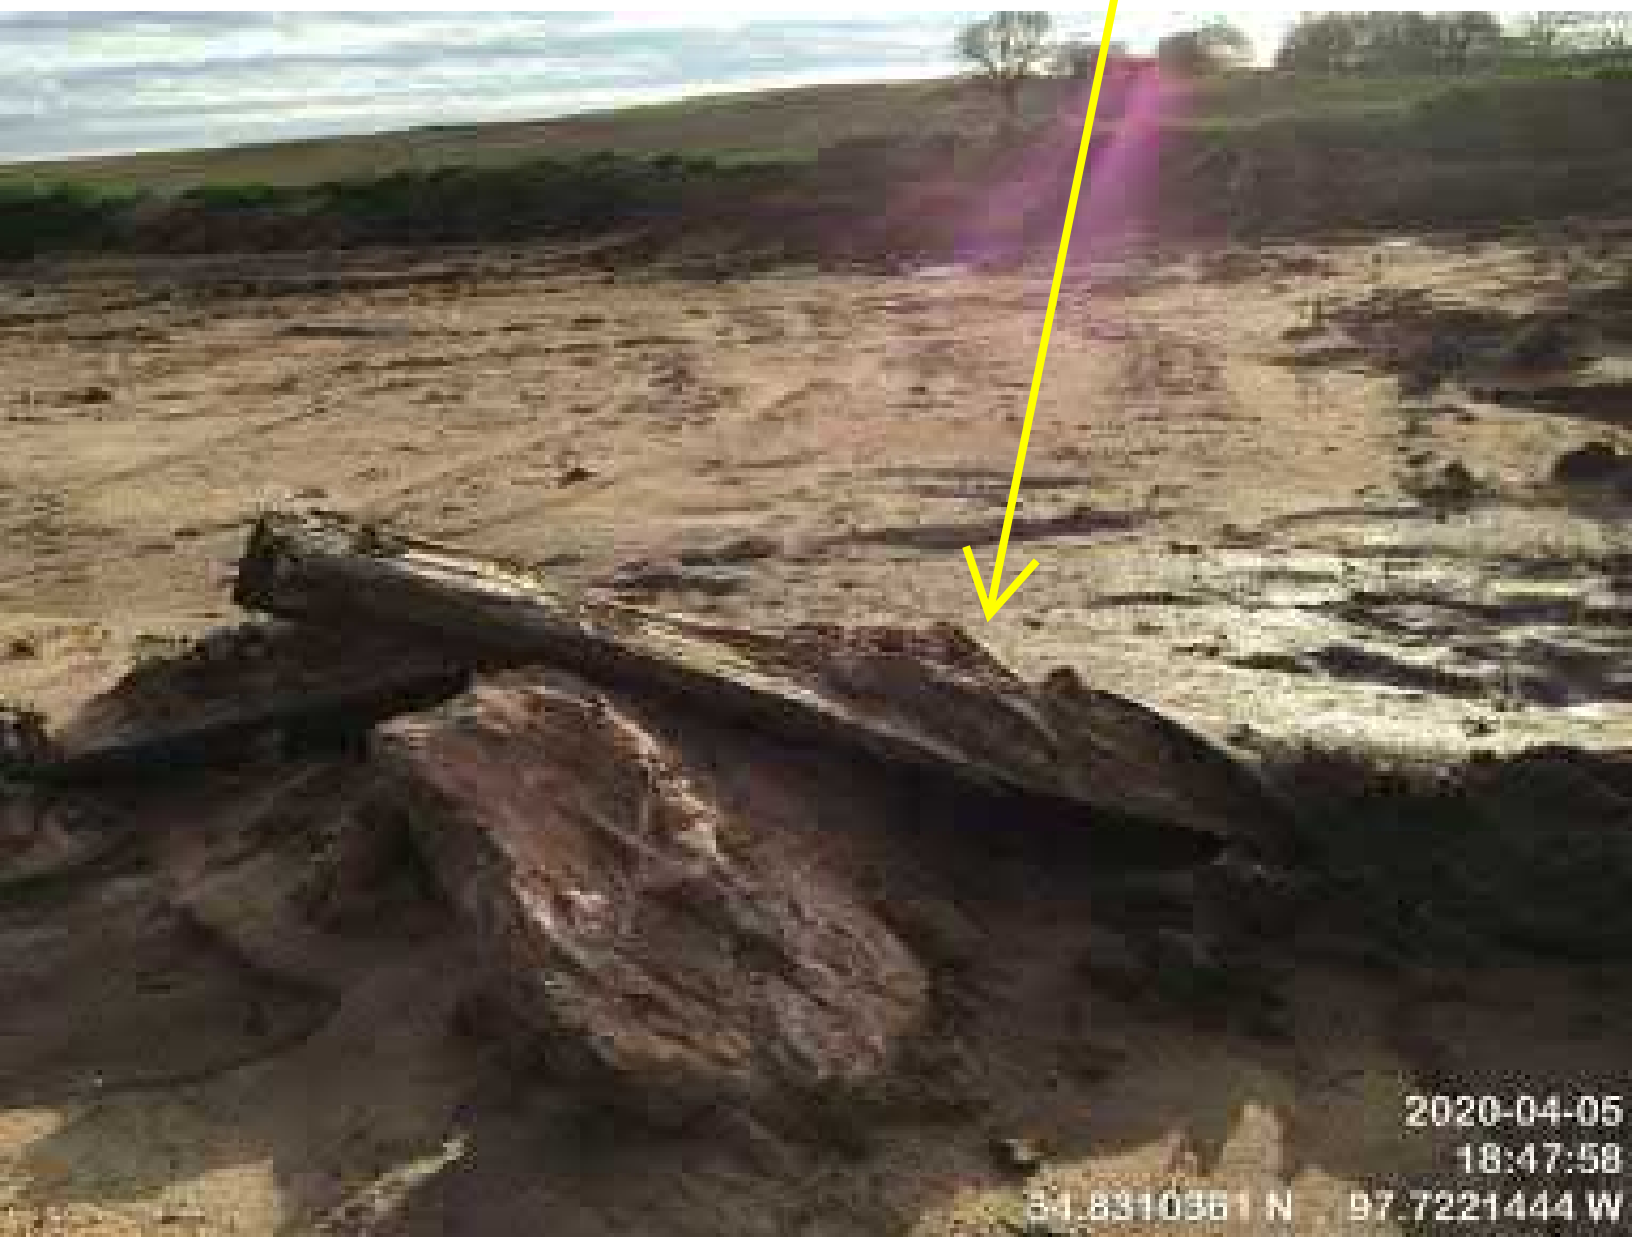
Buried Matting

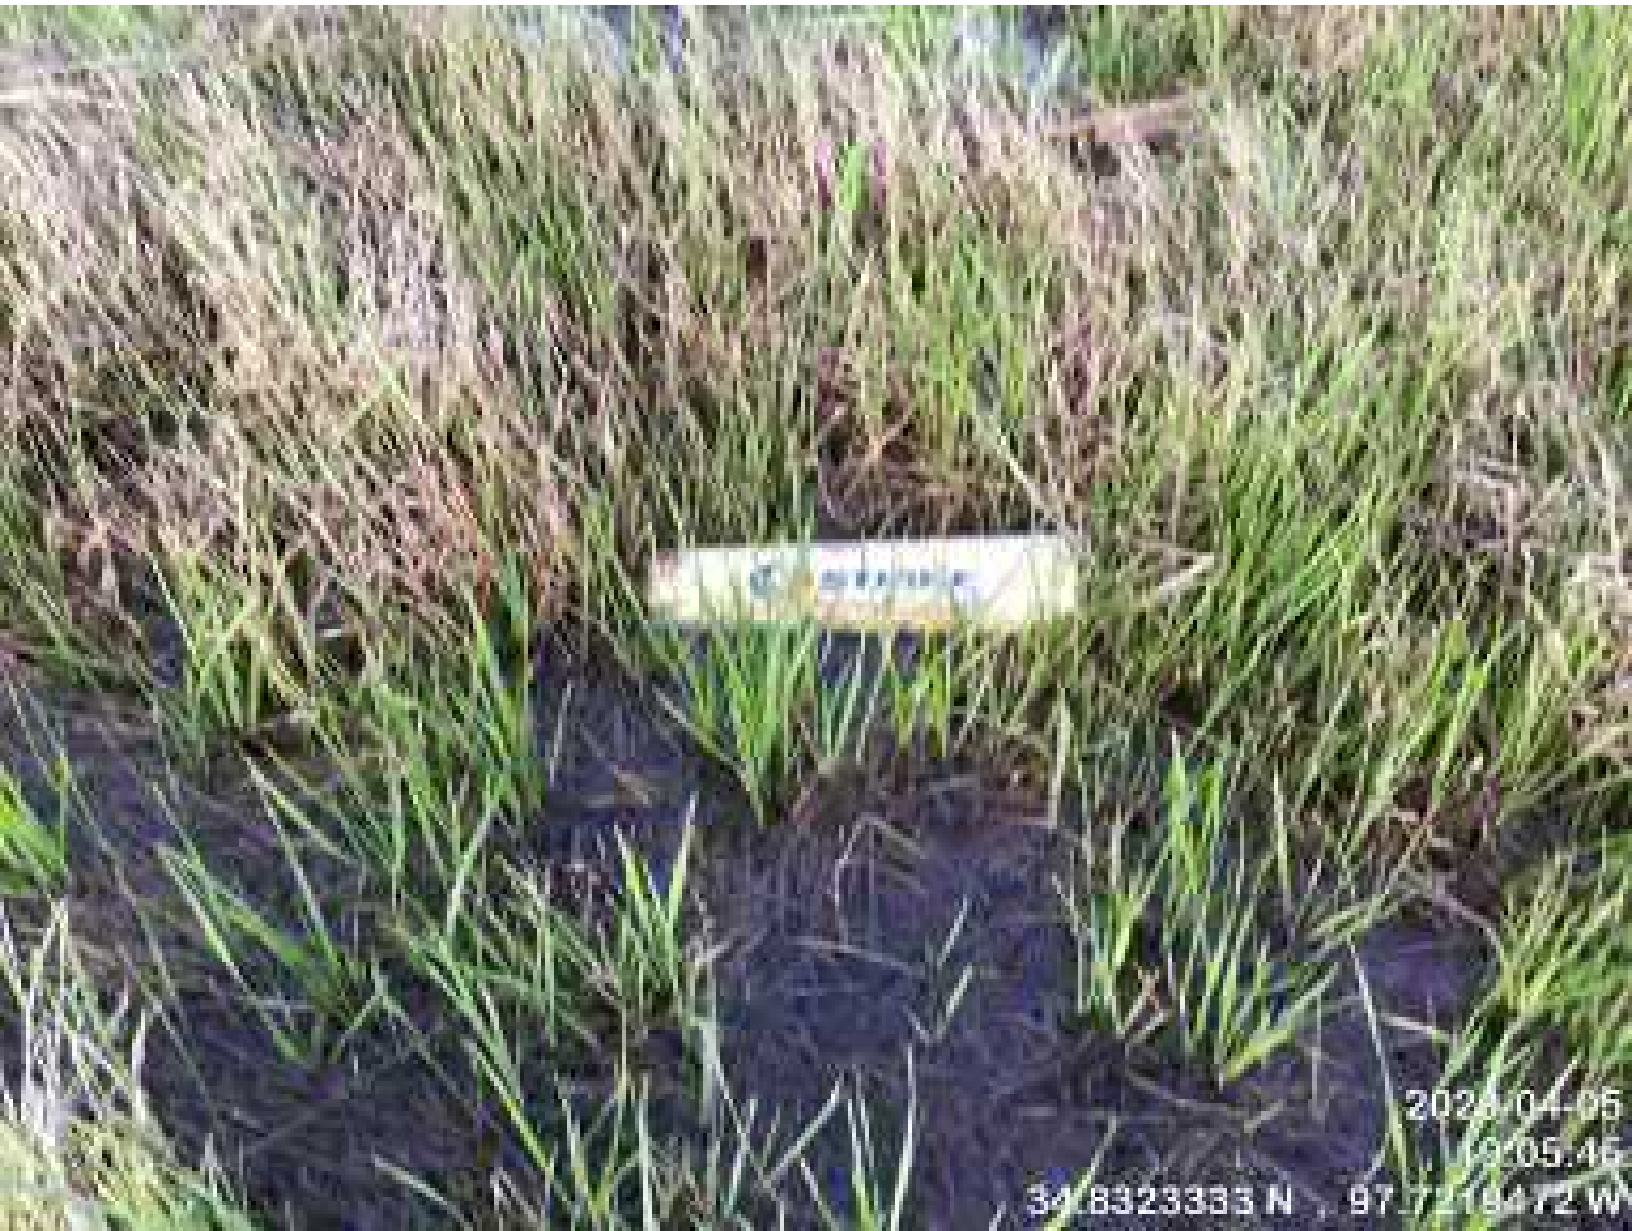
Off Right-of-Way Debris

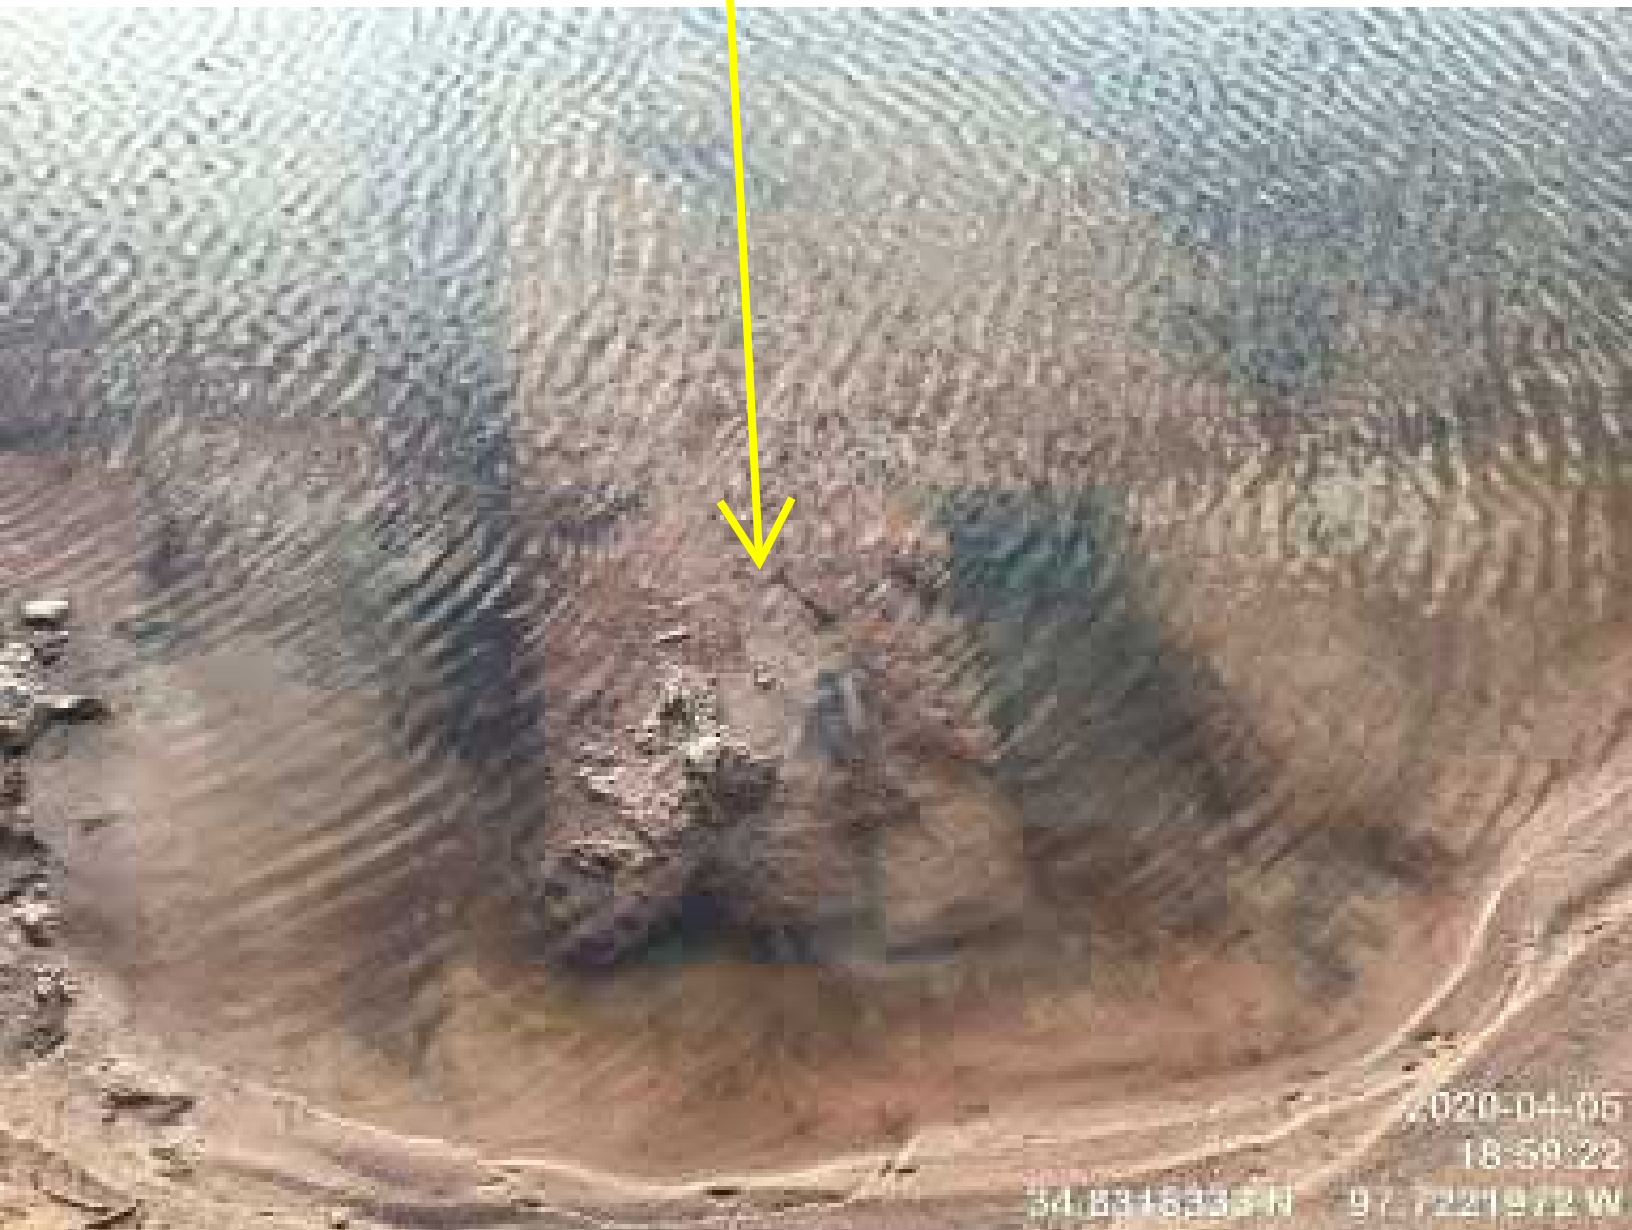
Construction Debris

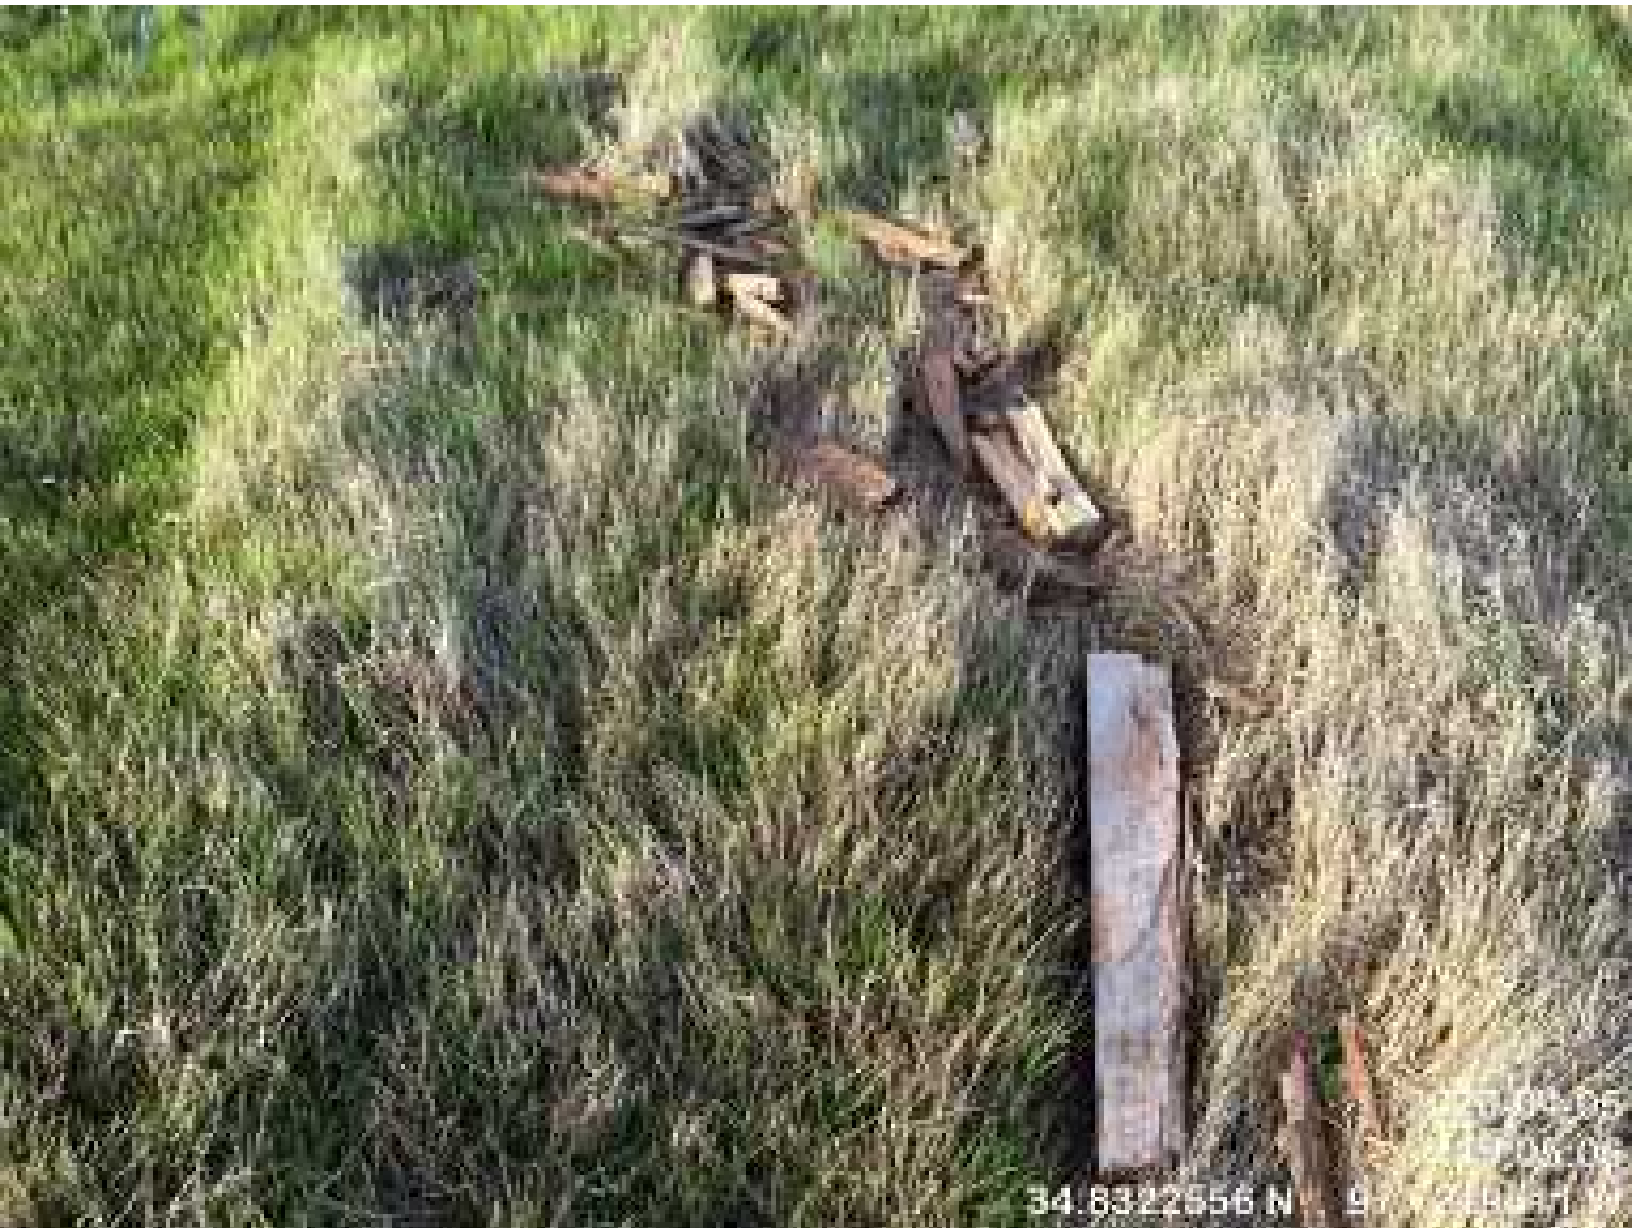
Off Right-of-Way Debris

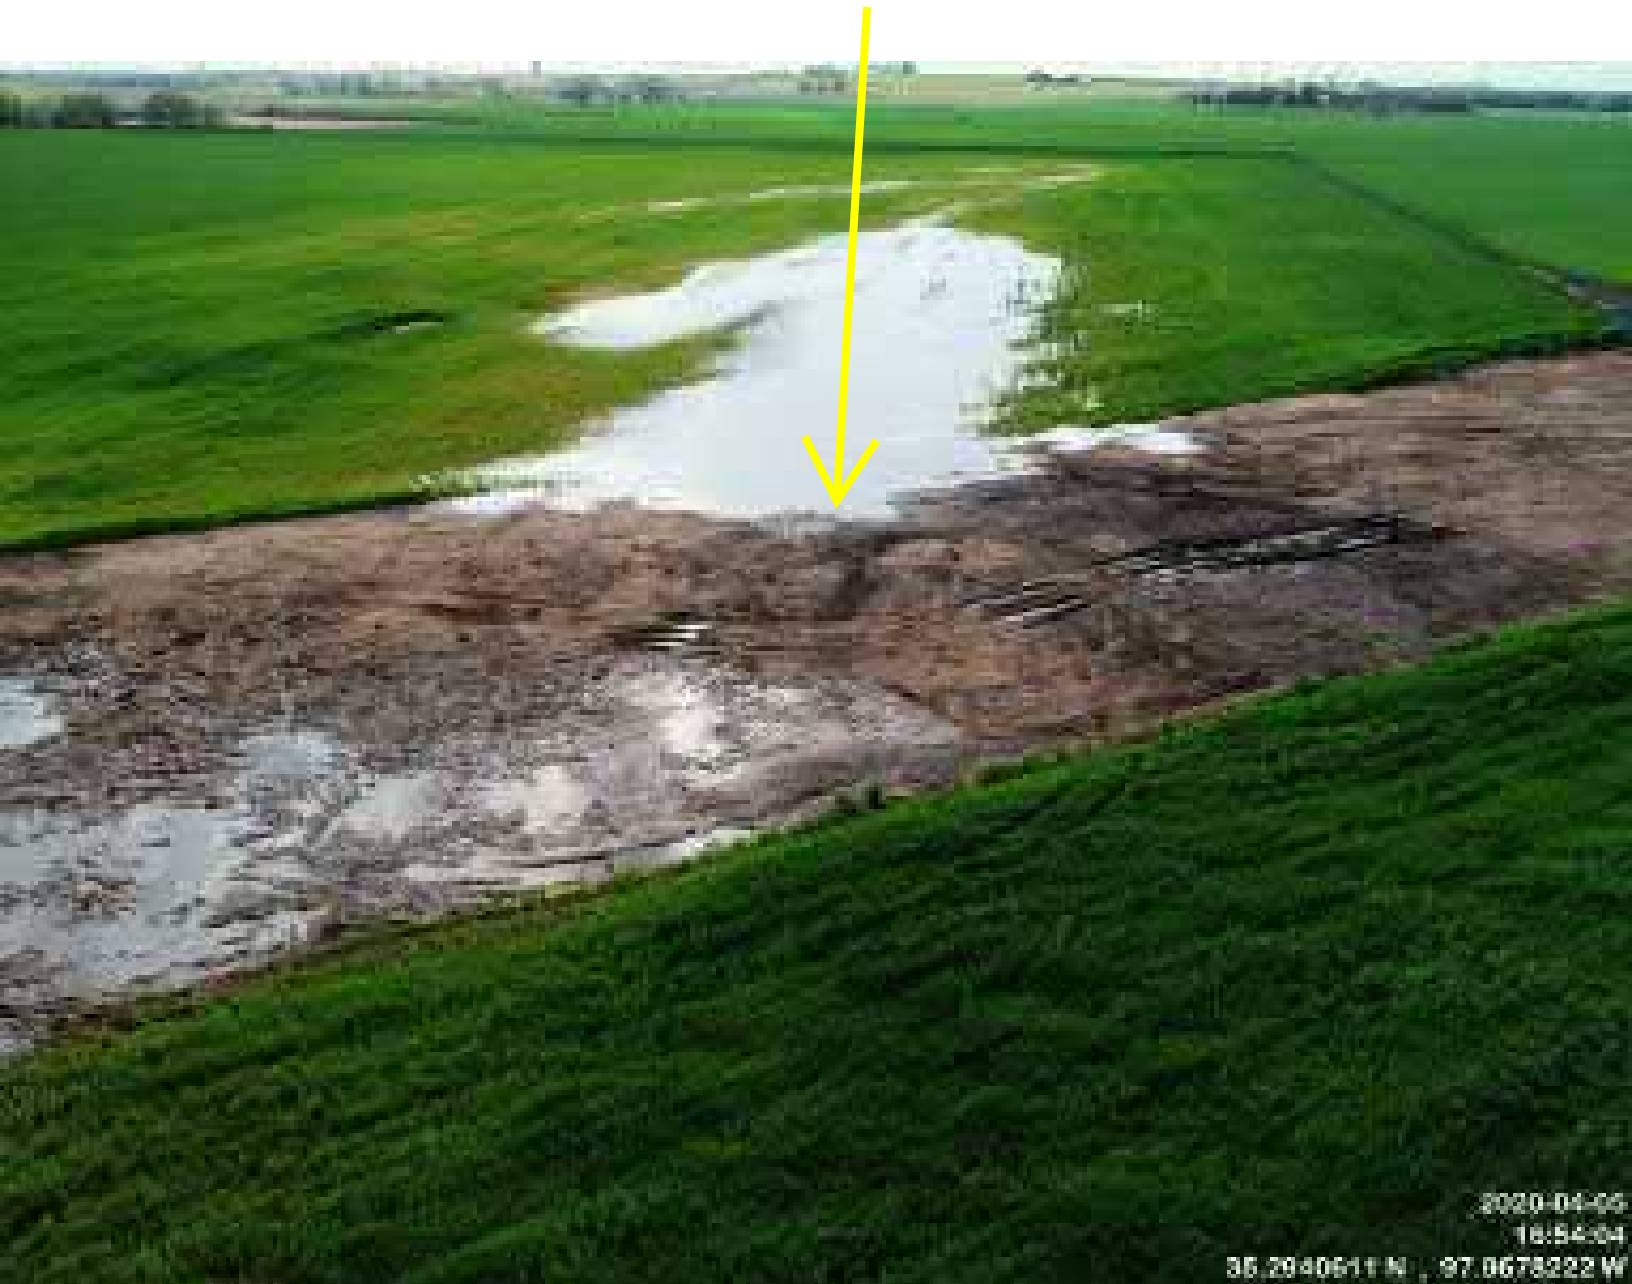
Ponding Due to Blocked Drainage Inside Right-of-Way
