Robert Squires - Squires Consulting LLC
Landowner Advocate

Opening Statement for May 5, 2021 Subcommittee on Civil Rights and Civil Liberties Hearing:
“Pipelines Over People (Part II): Midship Pipeline’s Disregard for Landowners in Its Pathway”

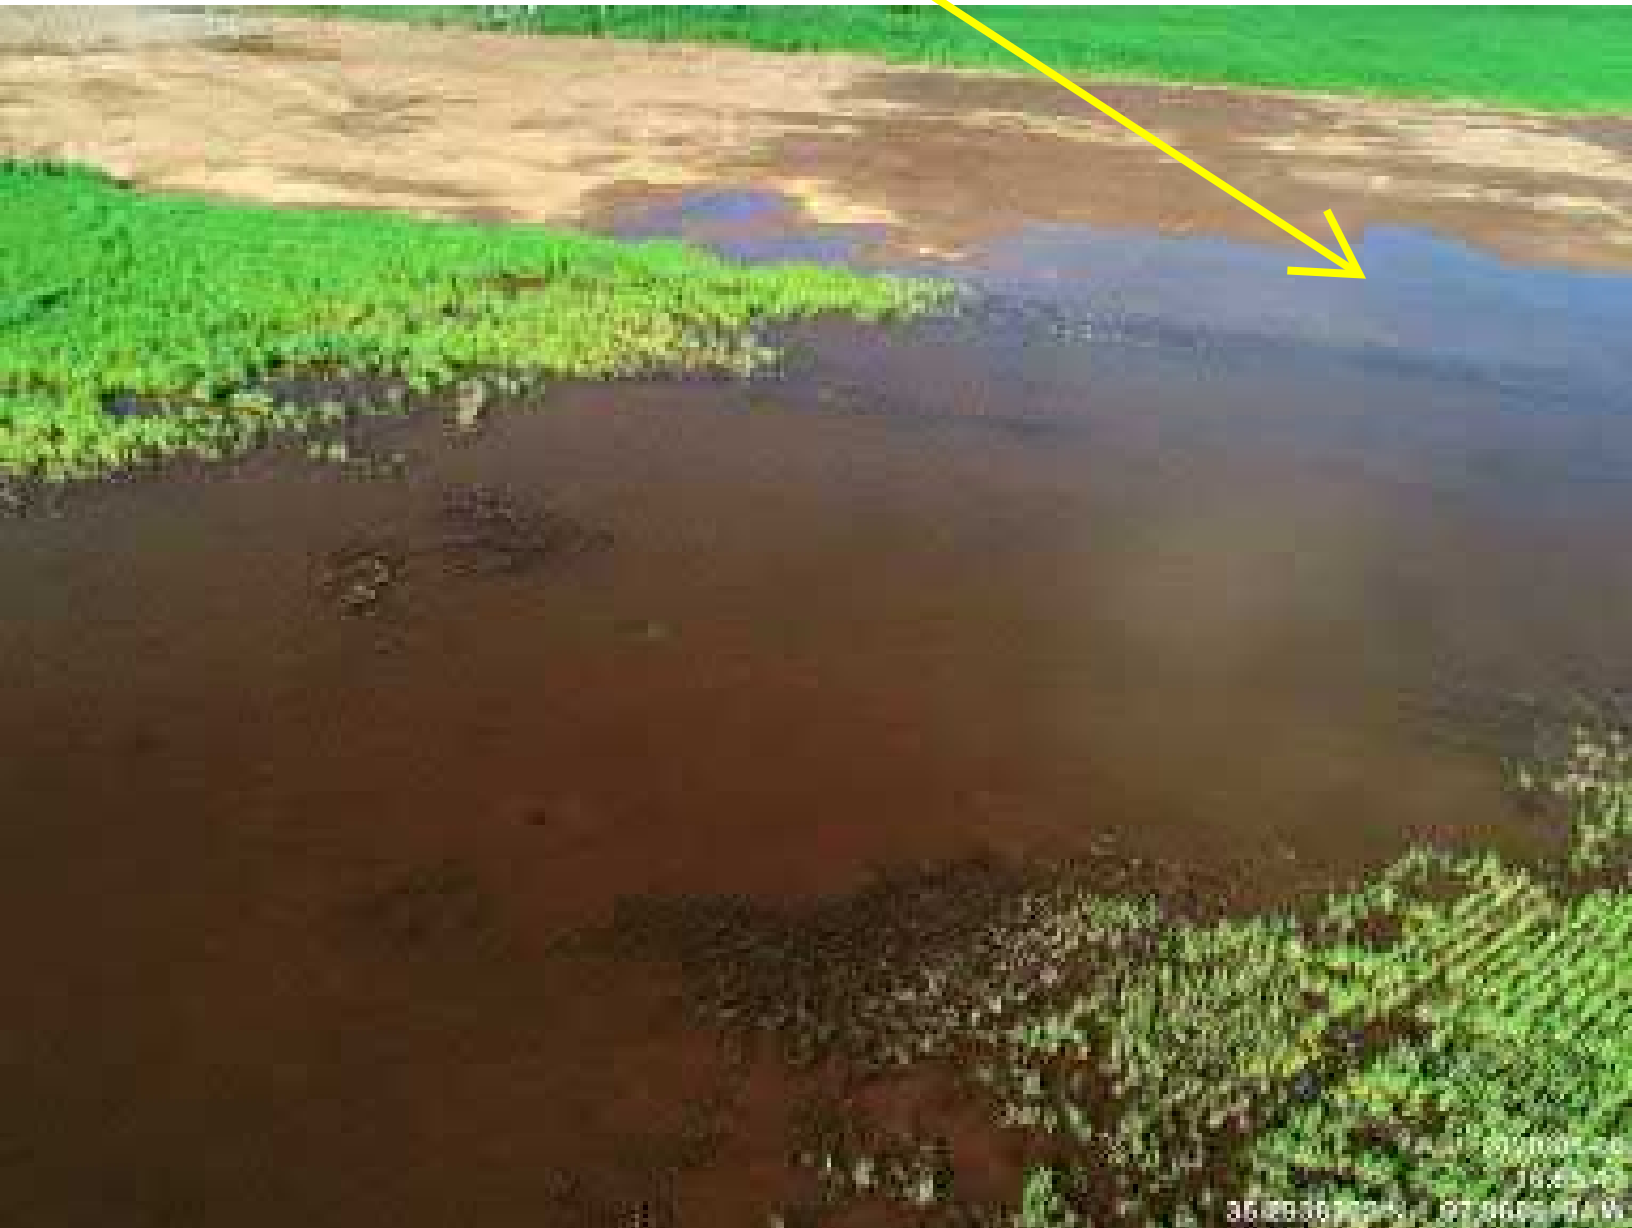
Ponding Due to Blocked Drainage Inside Right-of-Way

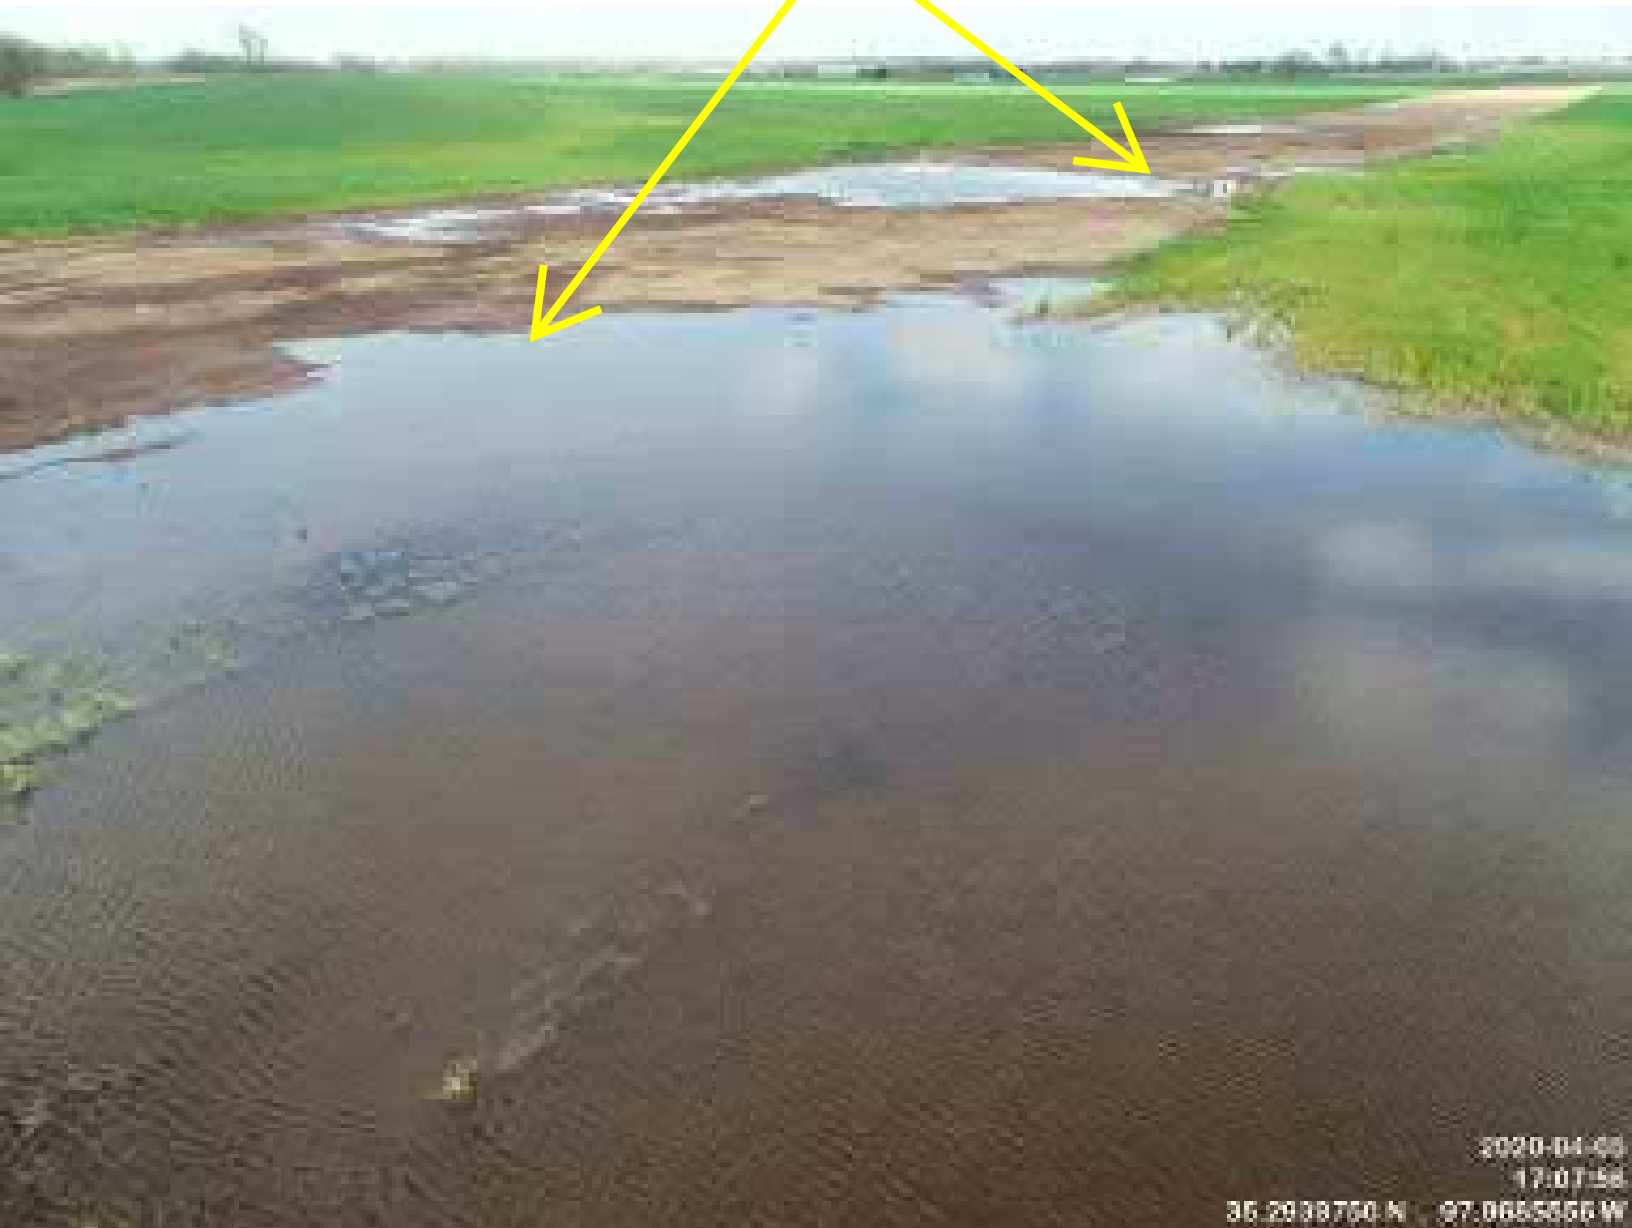
Ponding Due to Blocked Drainage Inside Right-of-Way

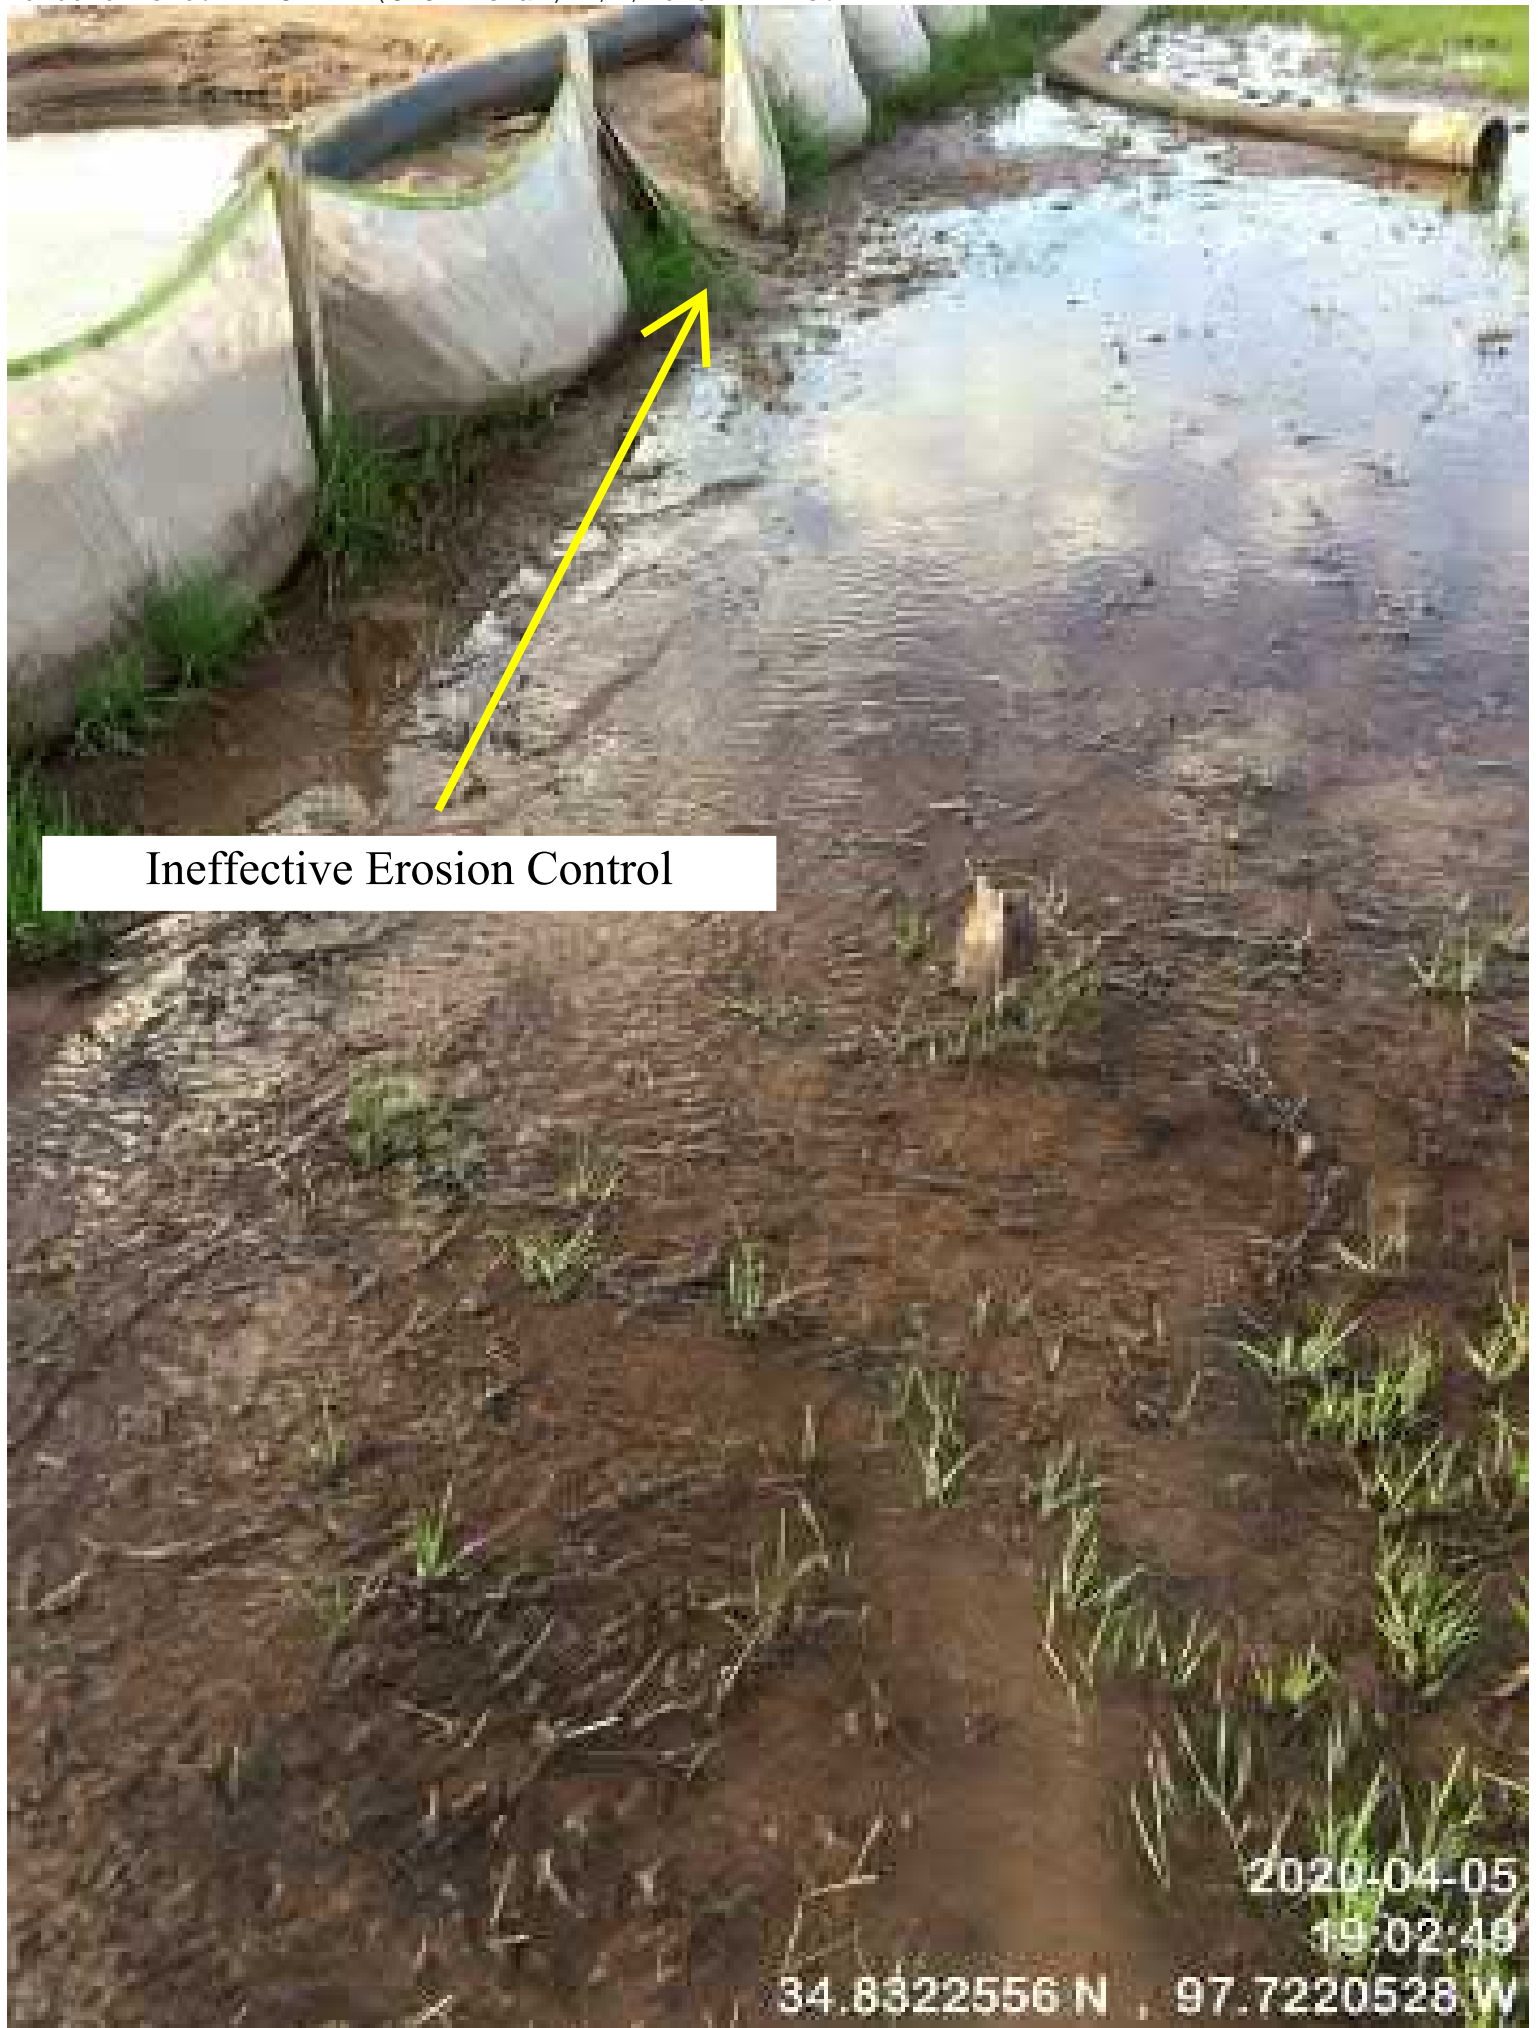
Ineffective Erosion Control

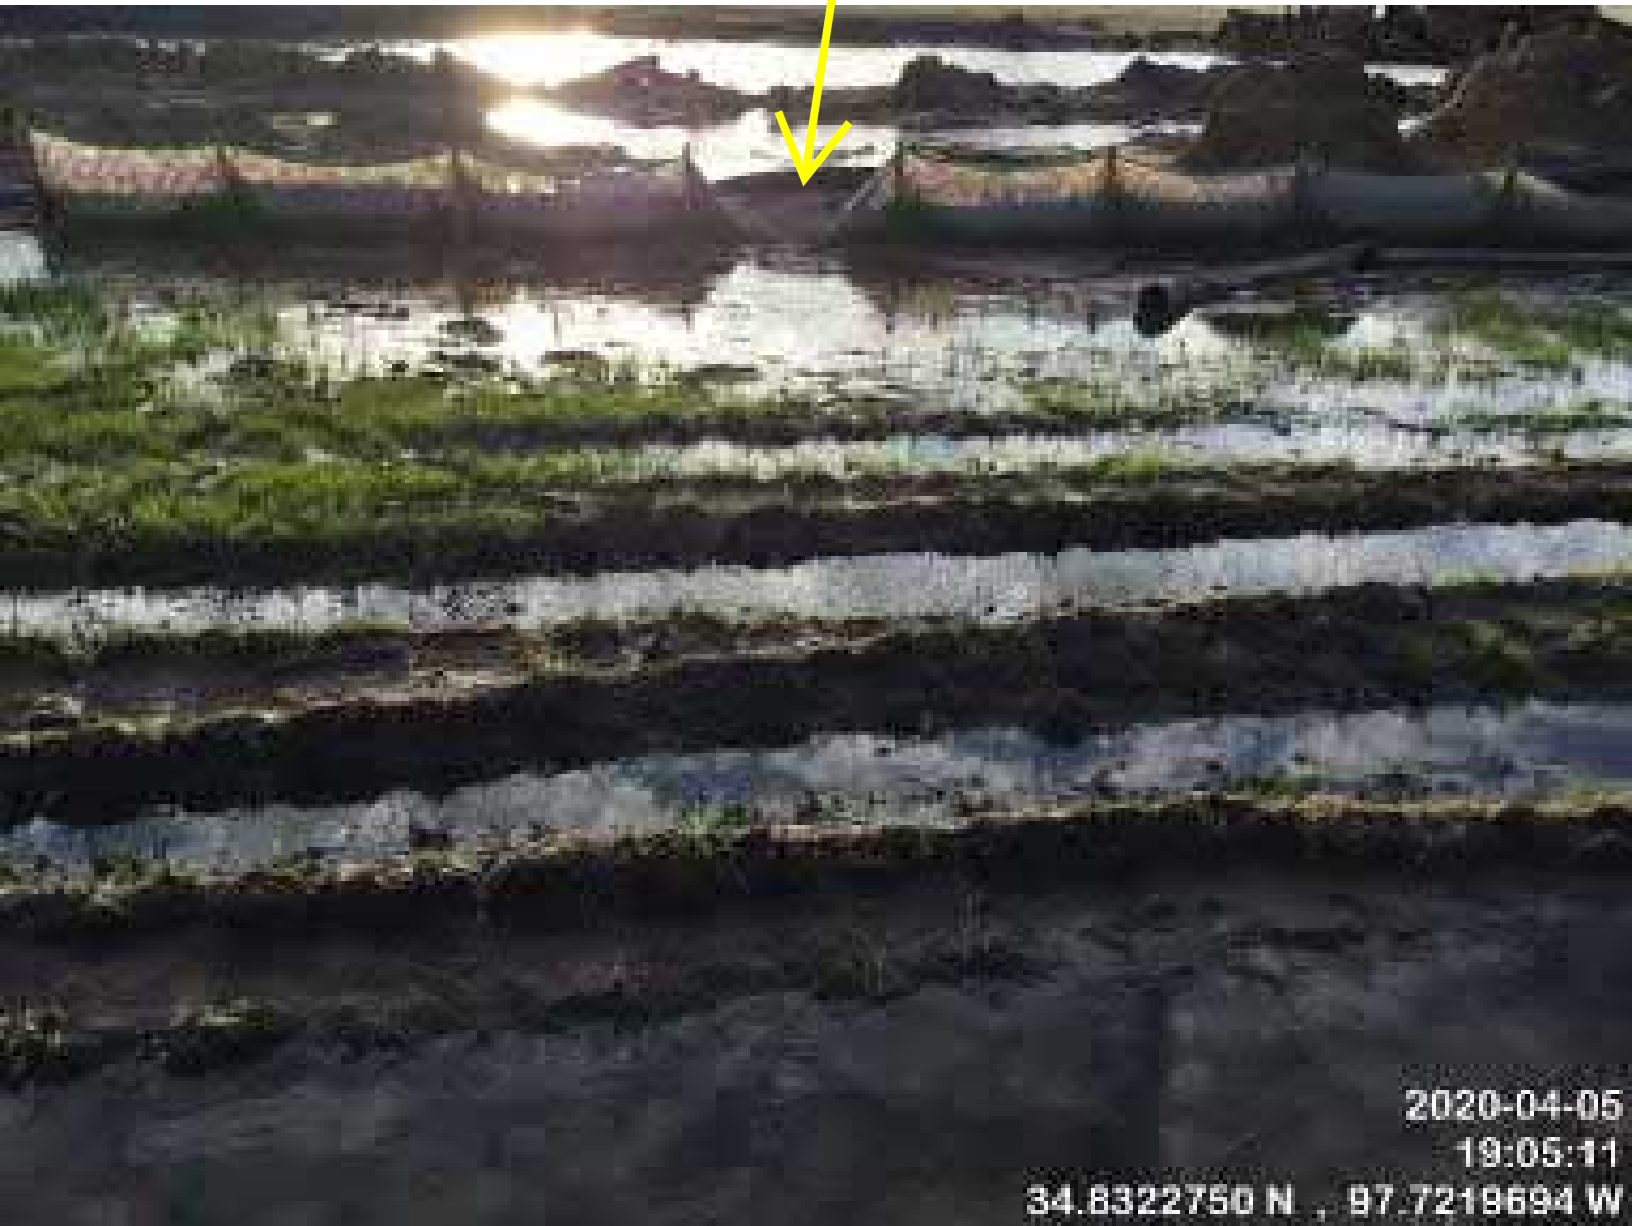
Ineffective Erosion Control

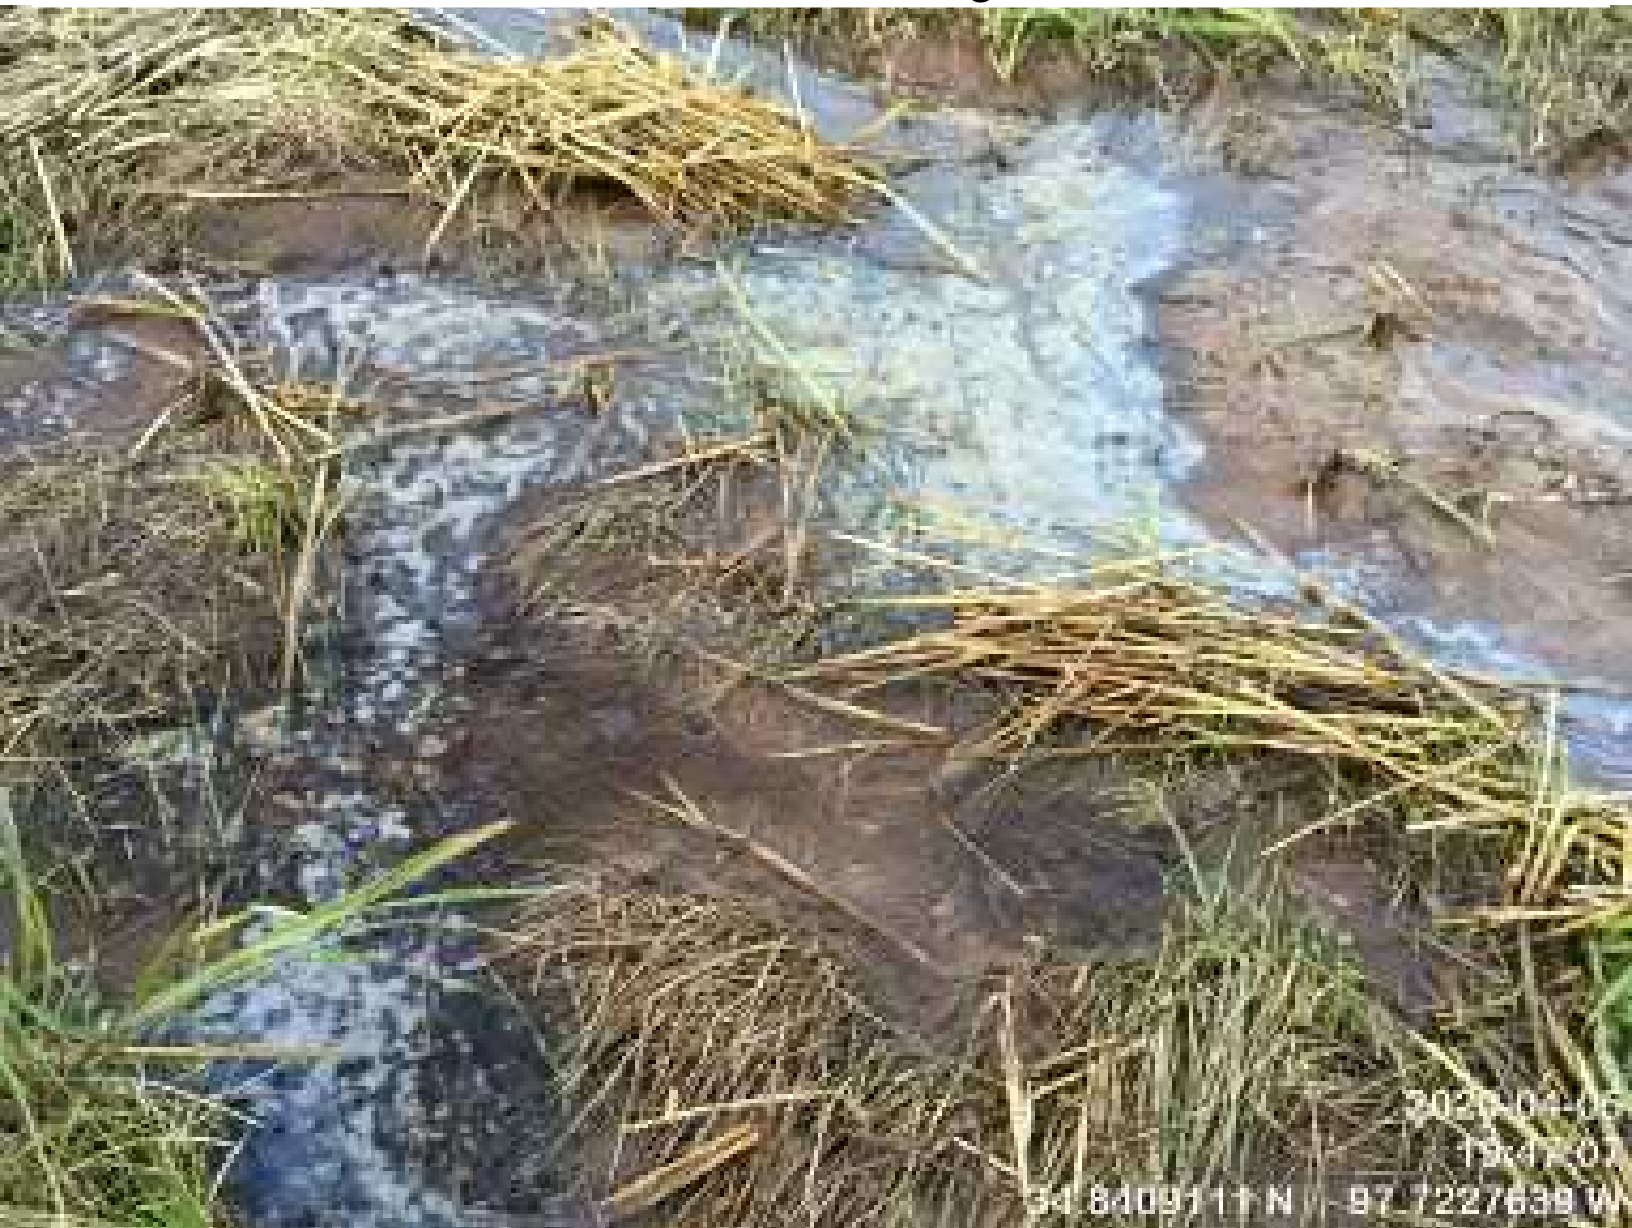
Sheeny Substance Flowing Away from Right-of-Way Less than 100 feet from Irrigation Pond

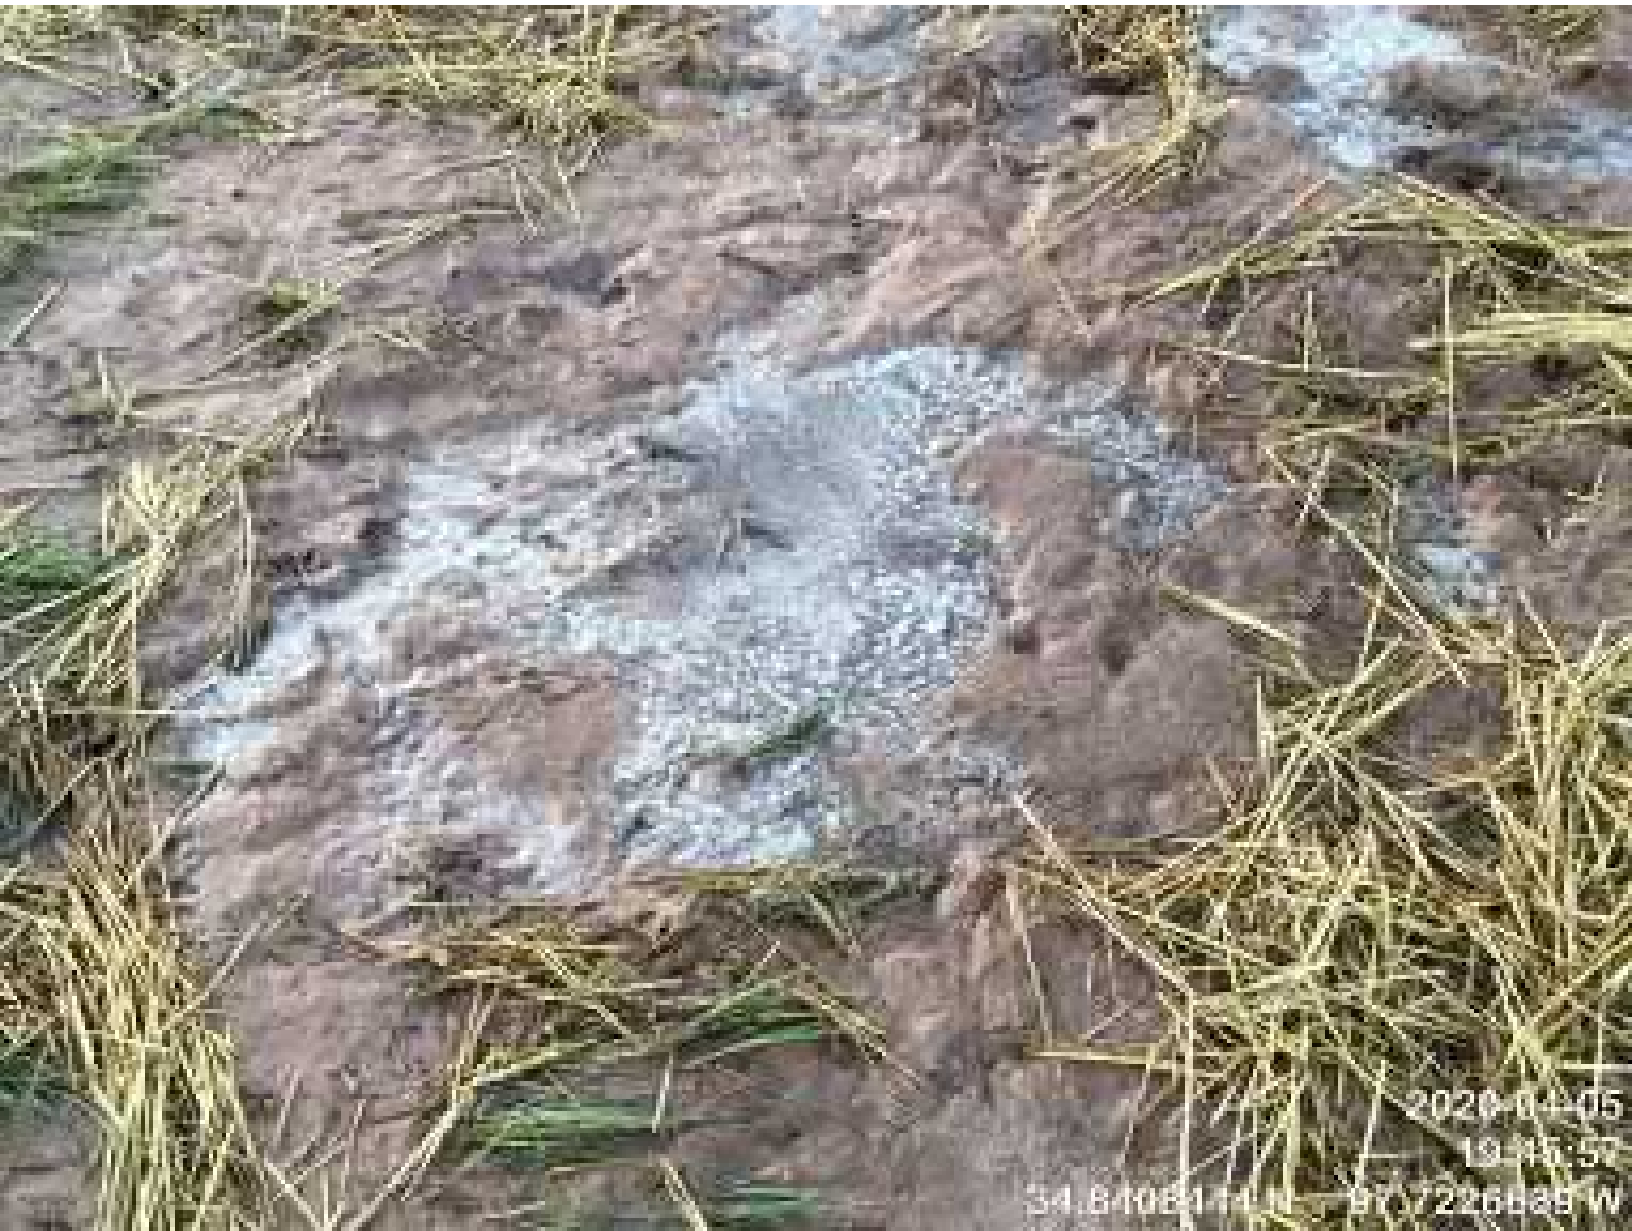
Sheeny Substance at Edge of Right-of-Way Less than 100 feet from Irrigation Pond

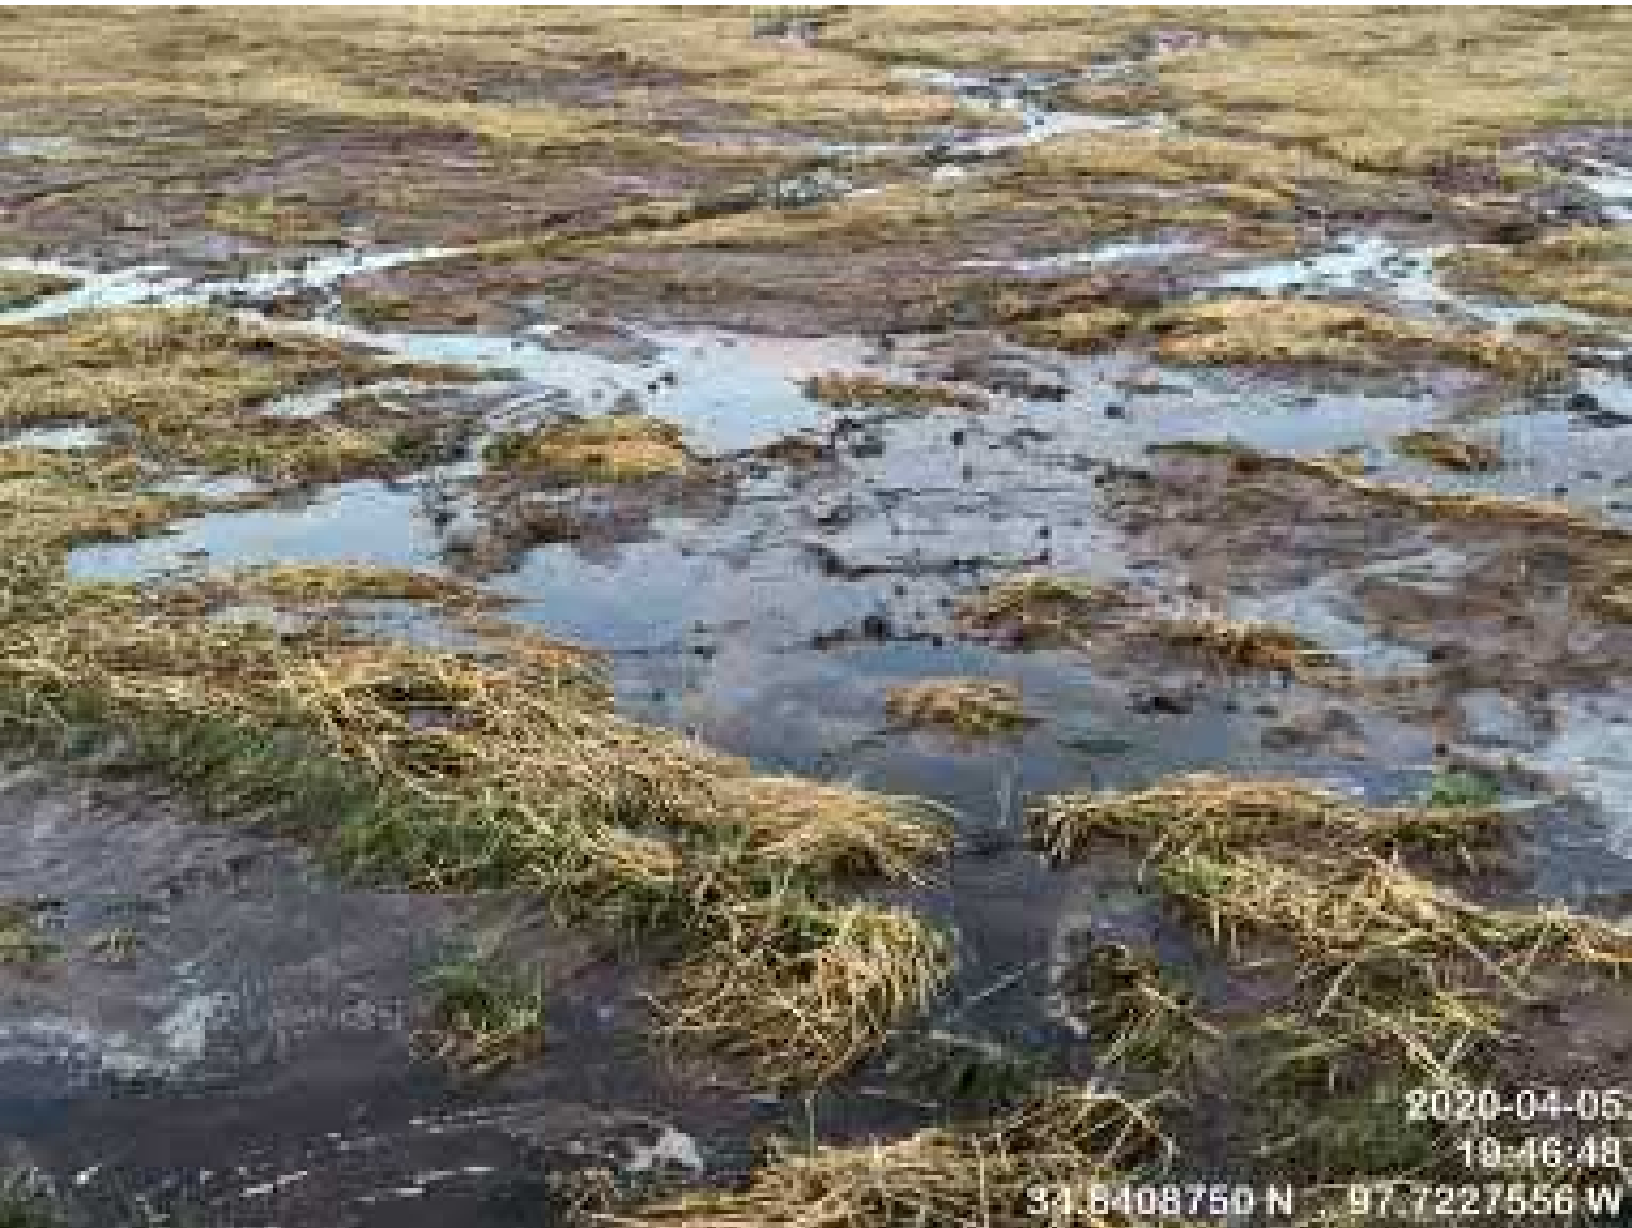
Sheeny Substance Flowing Away from Right-of-Way Less than 100 feet from Irrigation Pond

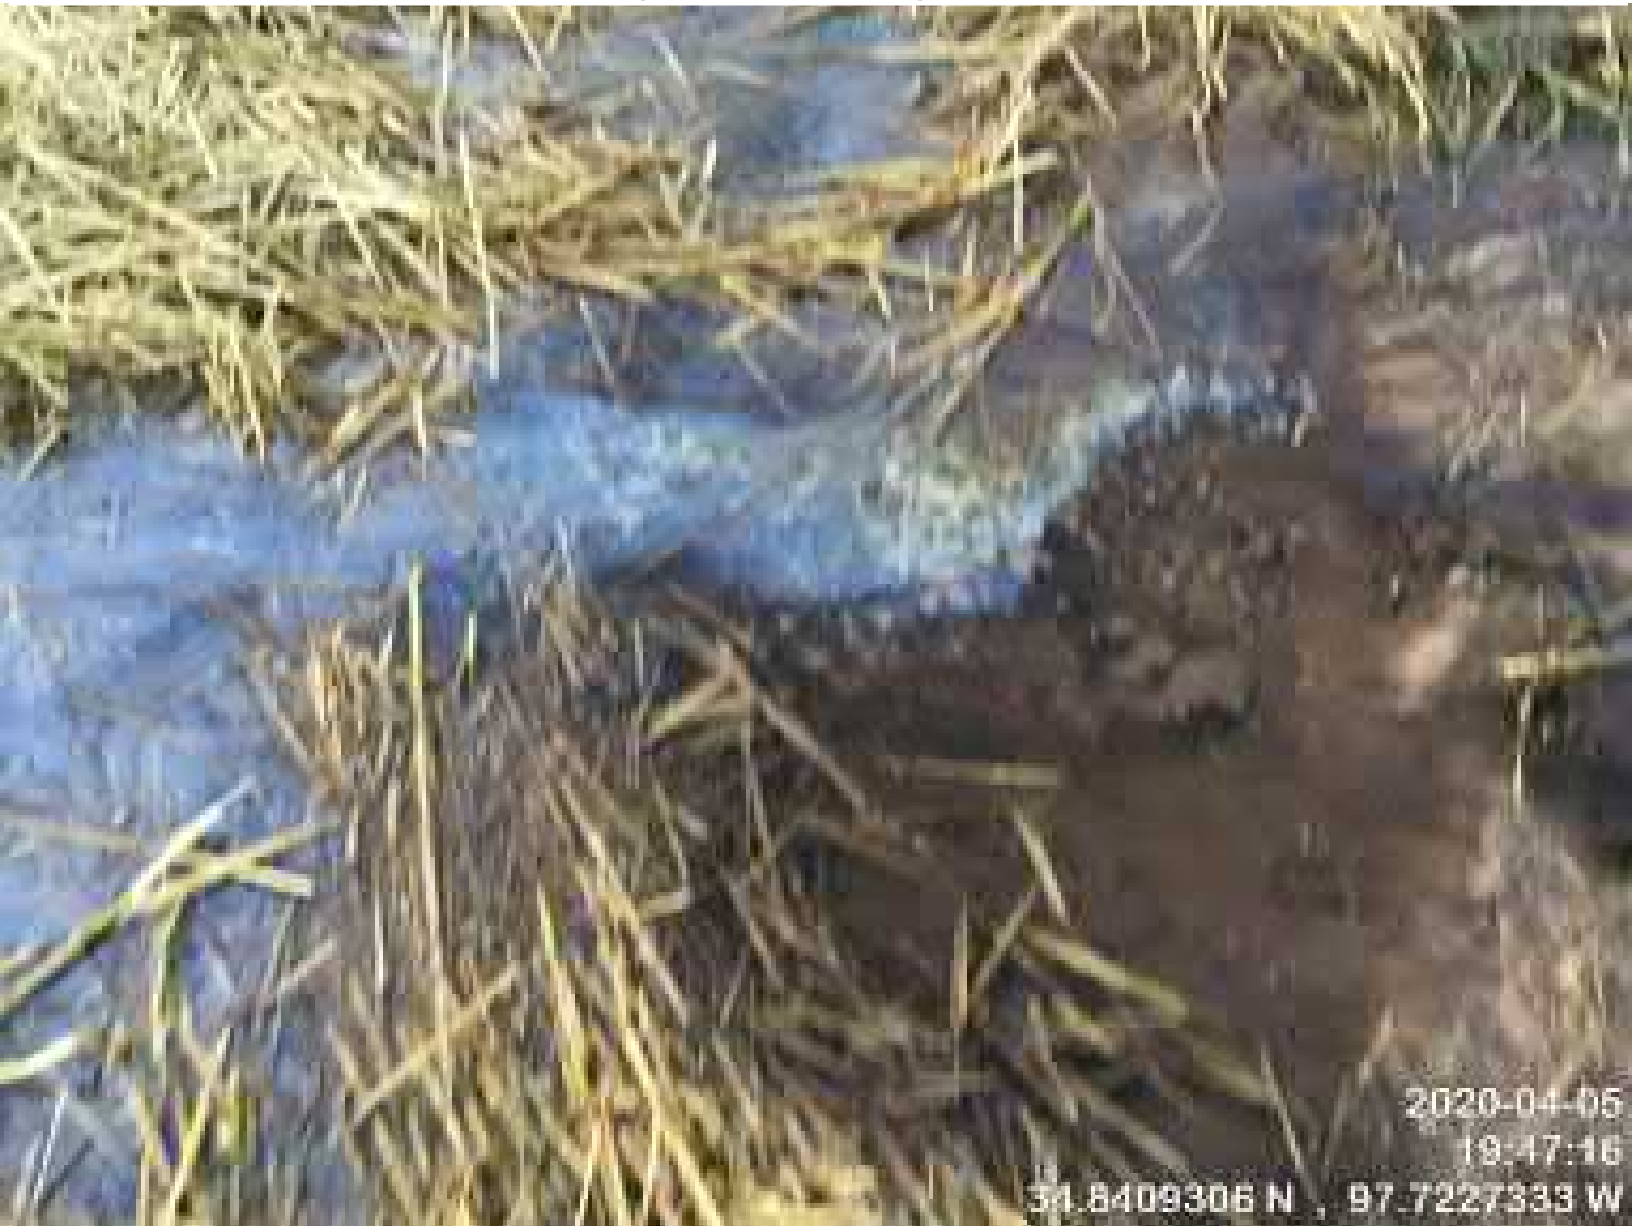
Sheeny Substance at Edge of Right-of-Way Flowing Towards Irrigation Pond

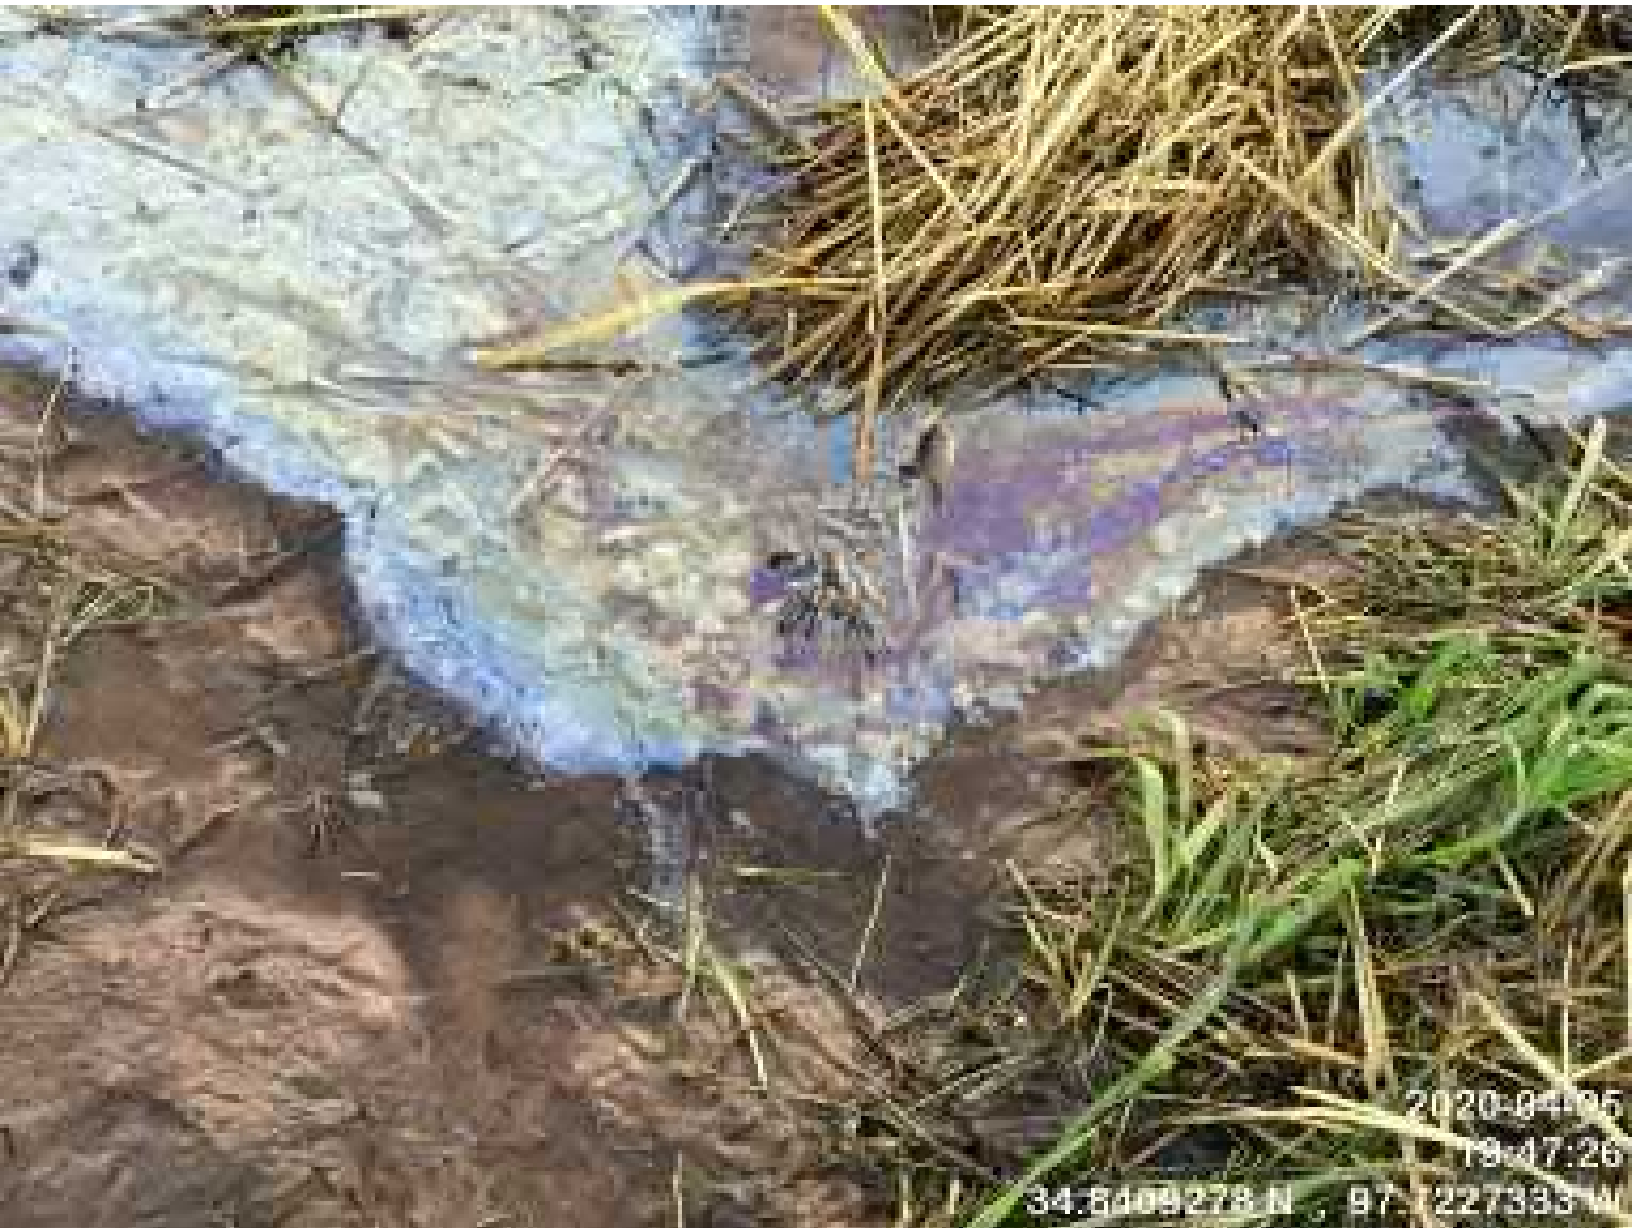
Sheeny Substance at Edge of Right-of-Way Flowing Towards Irrigation Pond

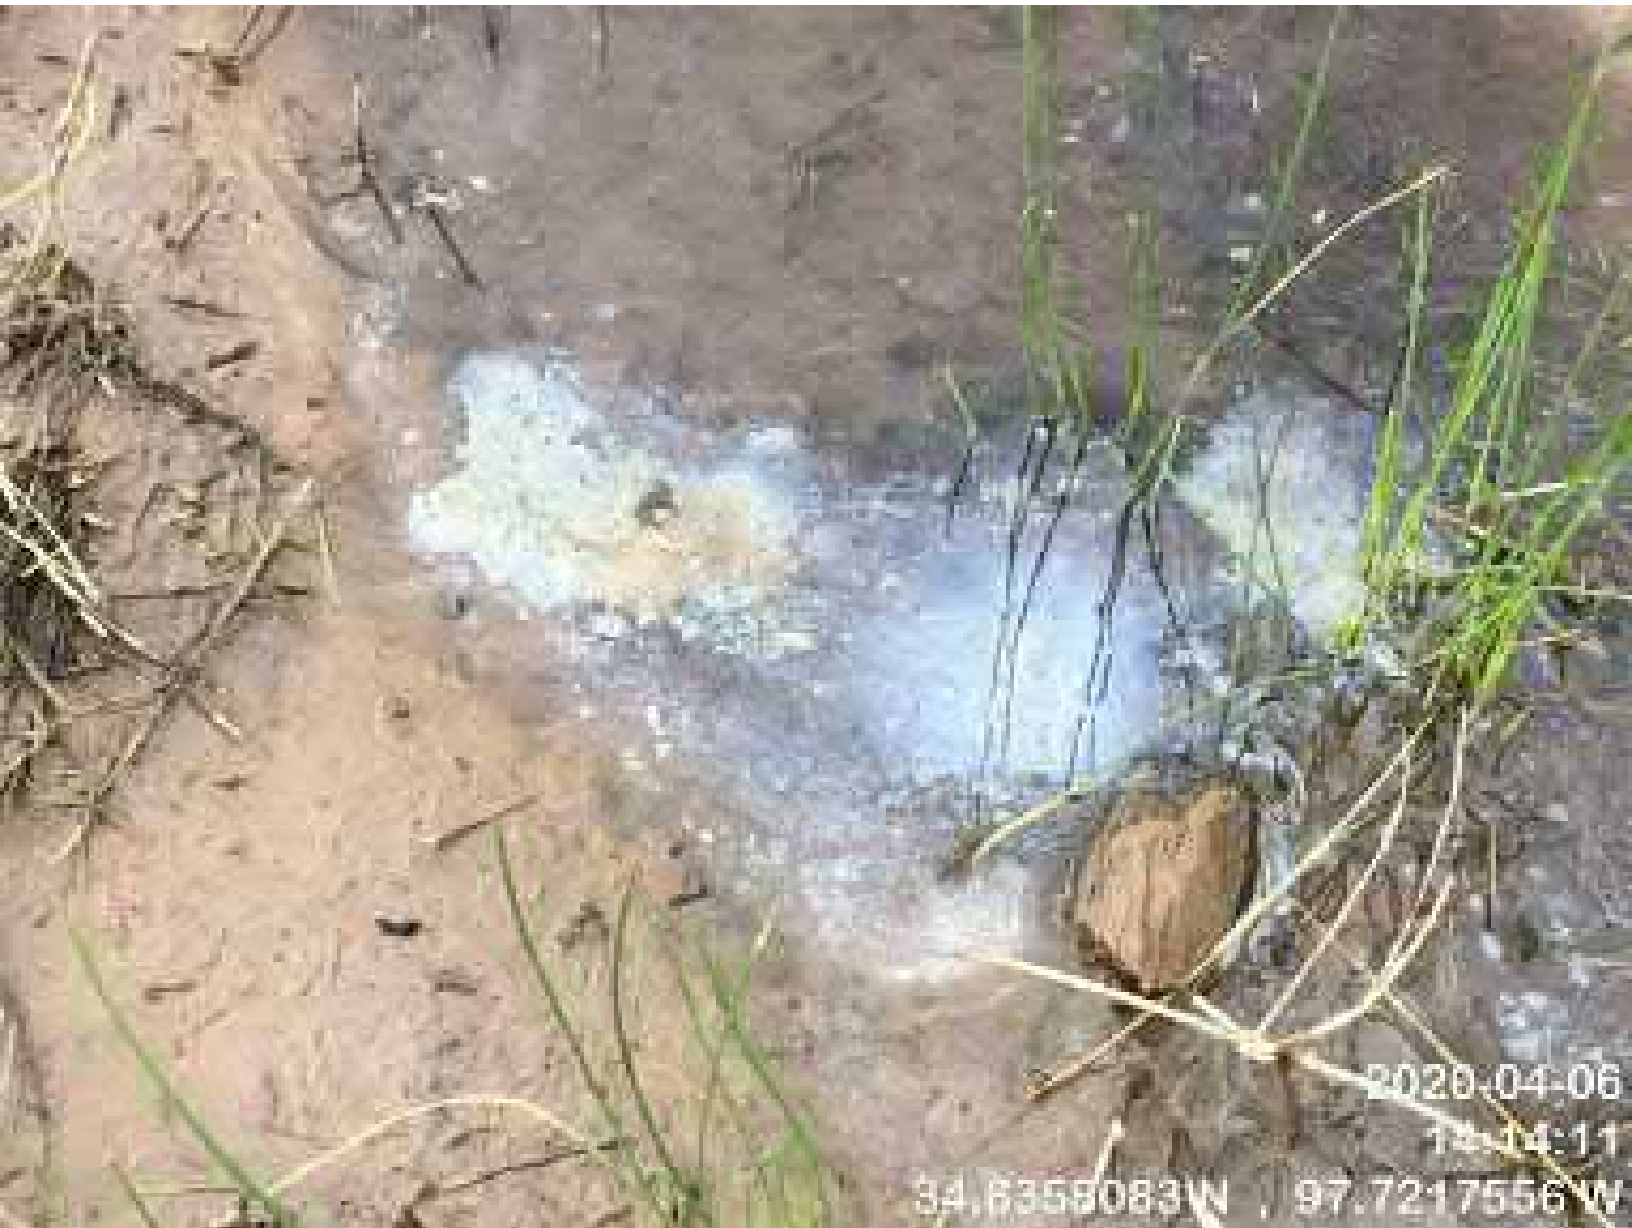
Sheeny Substance Inside Right-of-Way

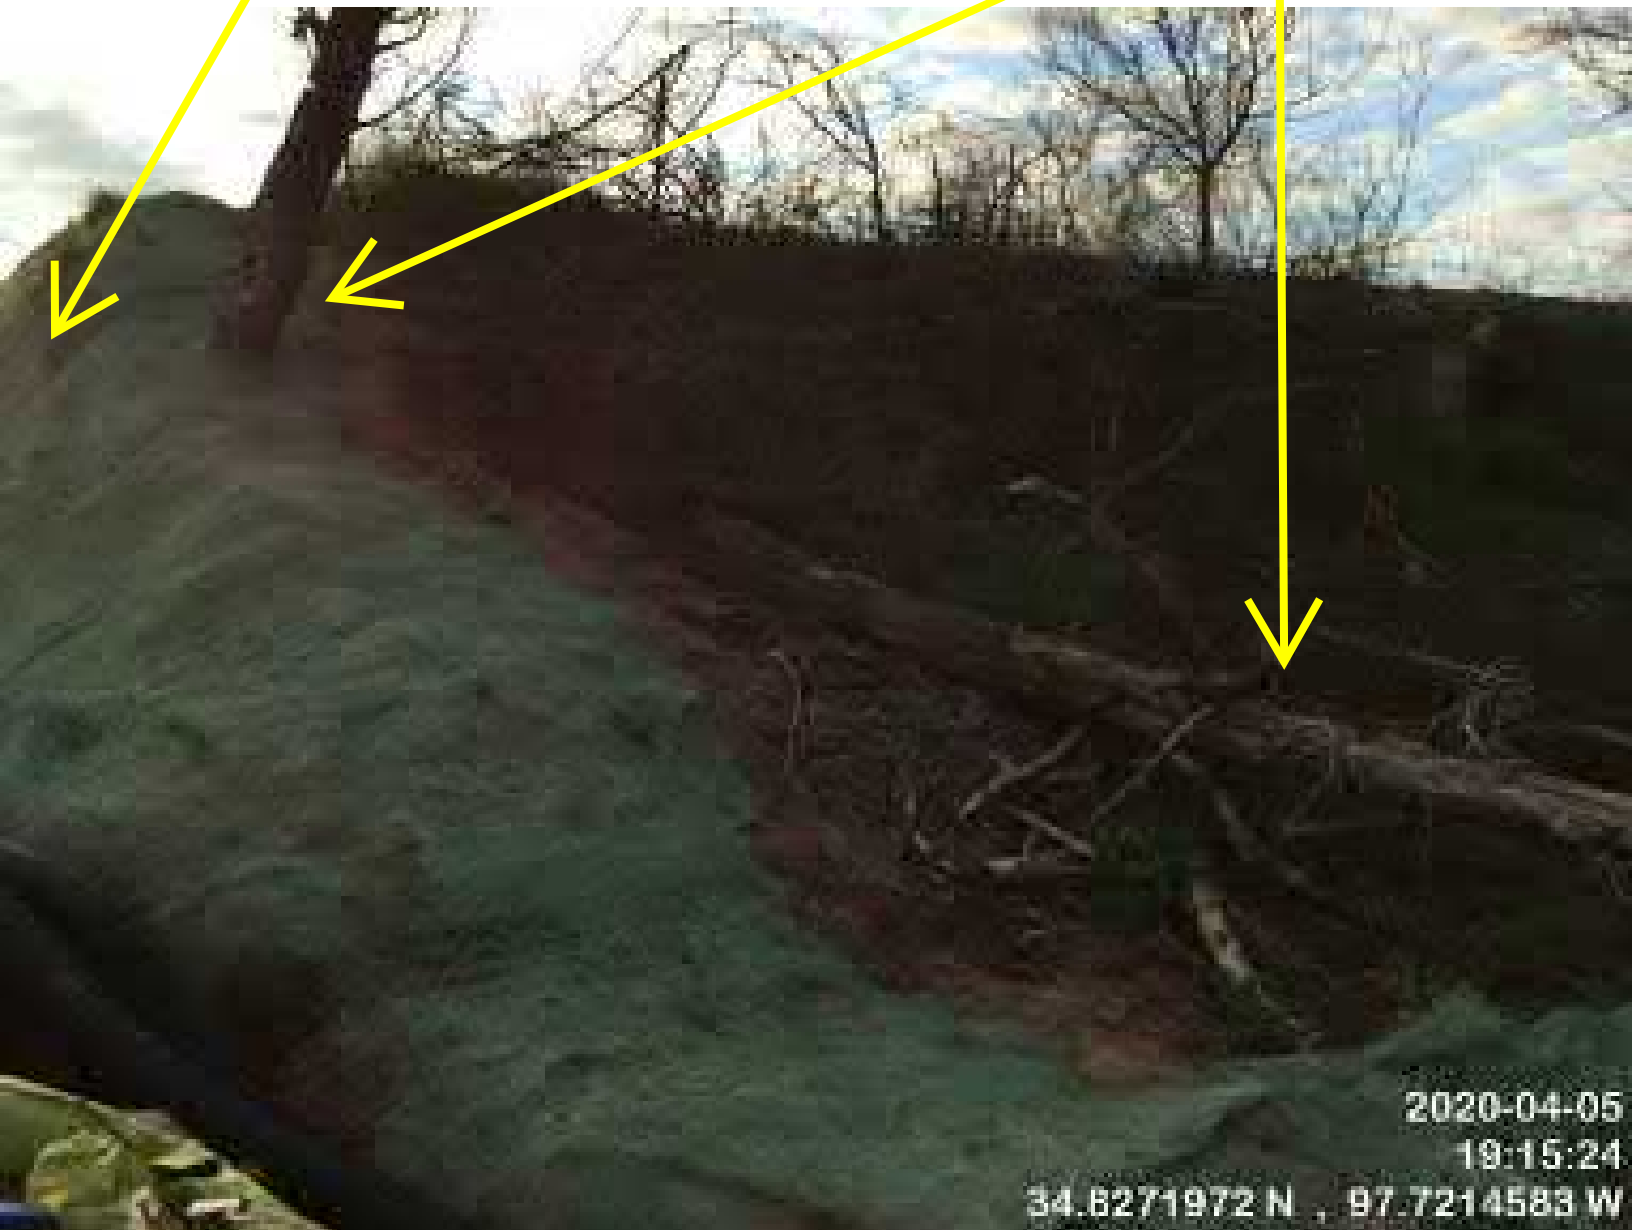
Trees Falling and Slipping Towards Creek
