Robert Squires - Squires Consulting LLC
Landowner Advocate

Opening Statement for May 5, 2021 Subcommittee on Civil Rights and Civil Liberties Hearing:
“Pipelines Over People (Part II): Midship Pipeline’s Disregard for Landowners in Its Pathway”

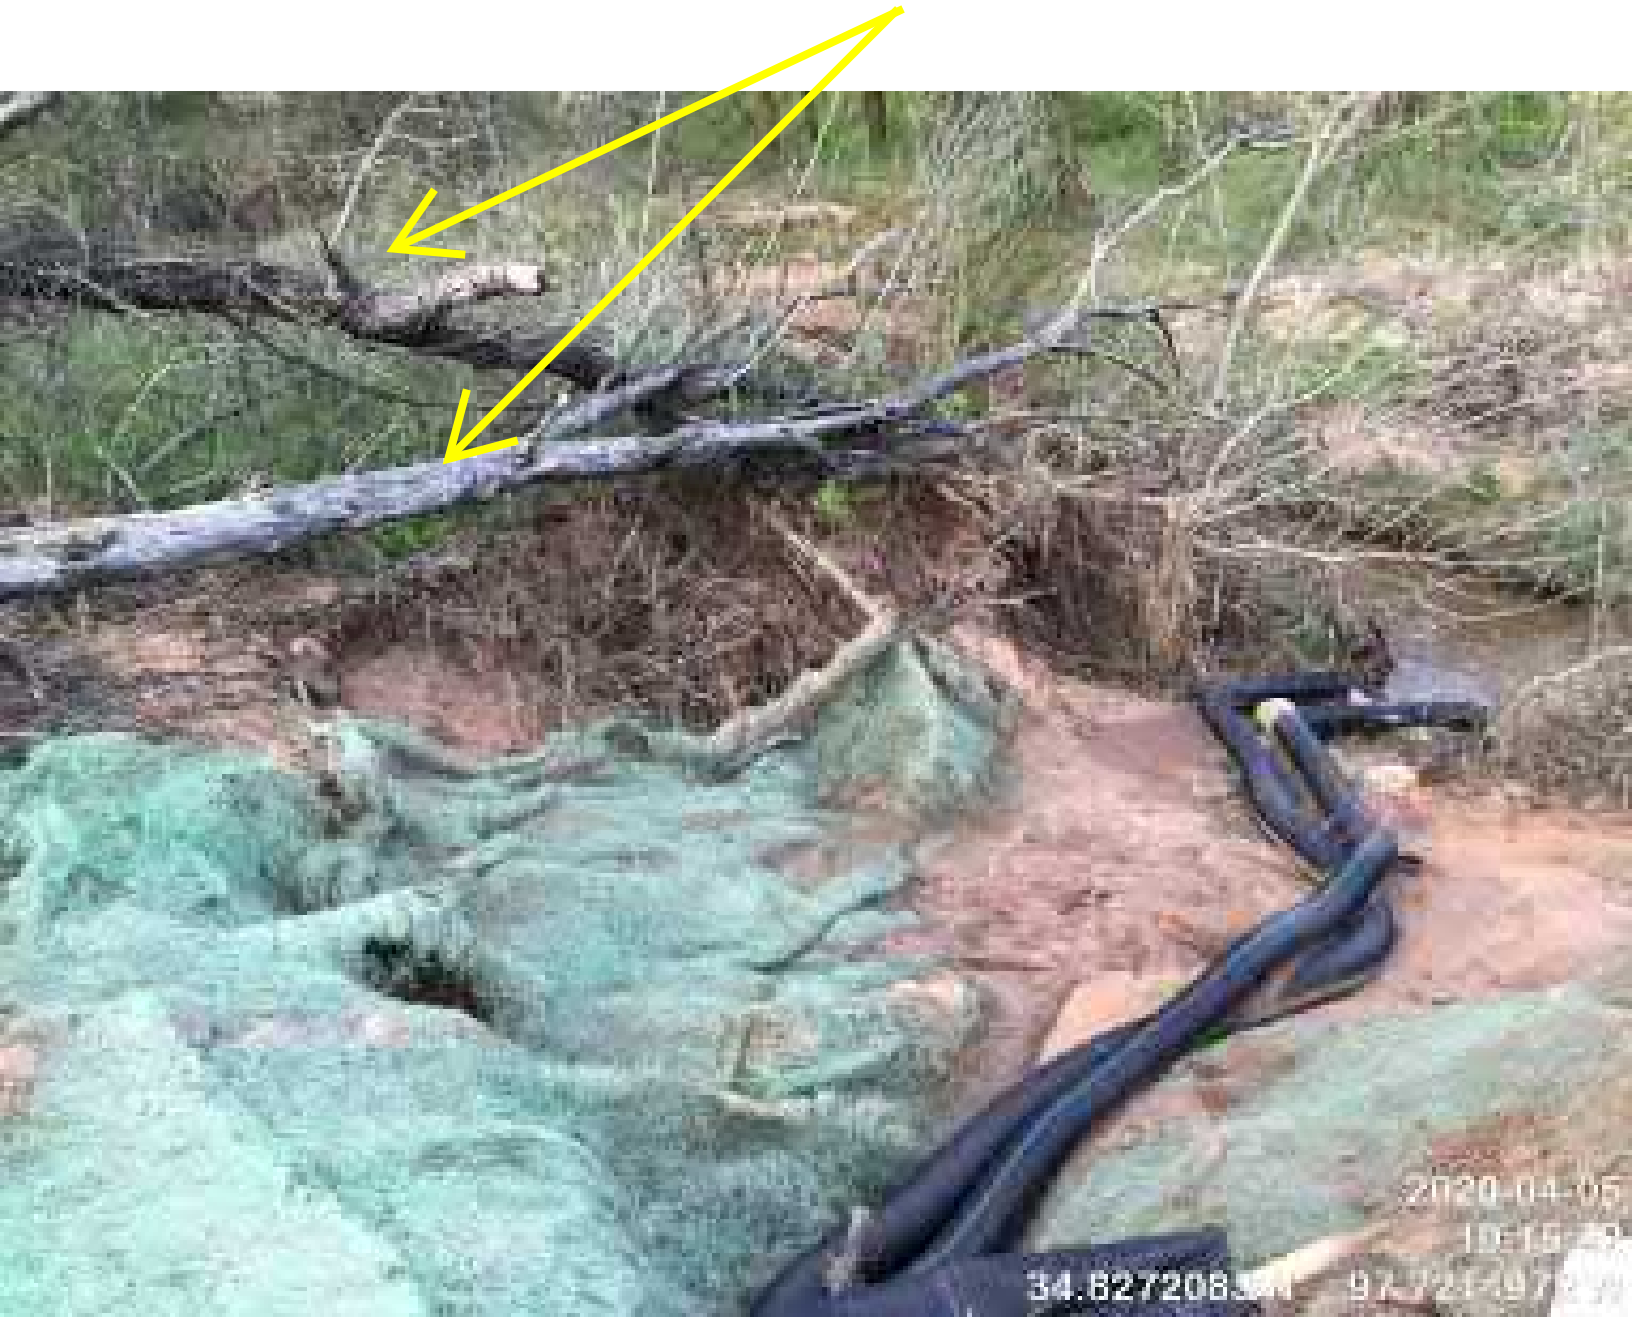
Trees Falling and Slipping Towards Creek

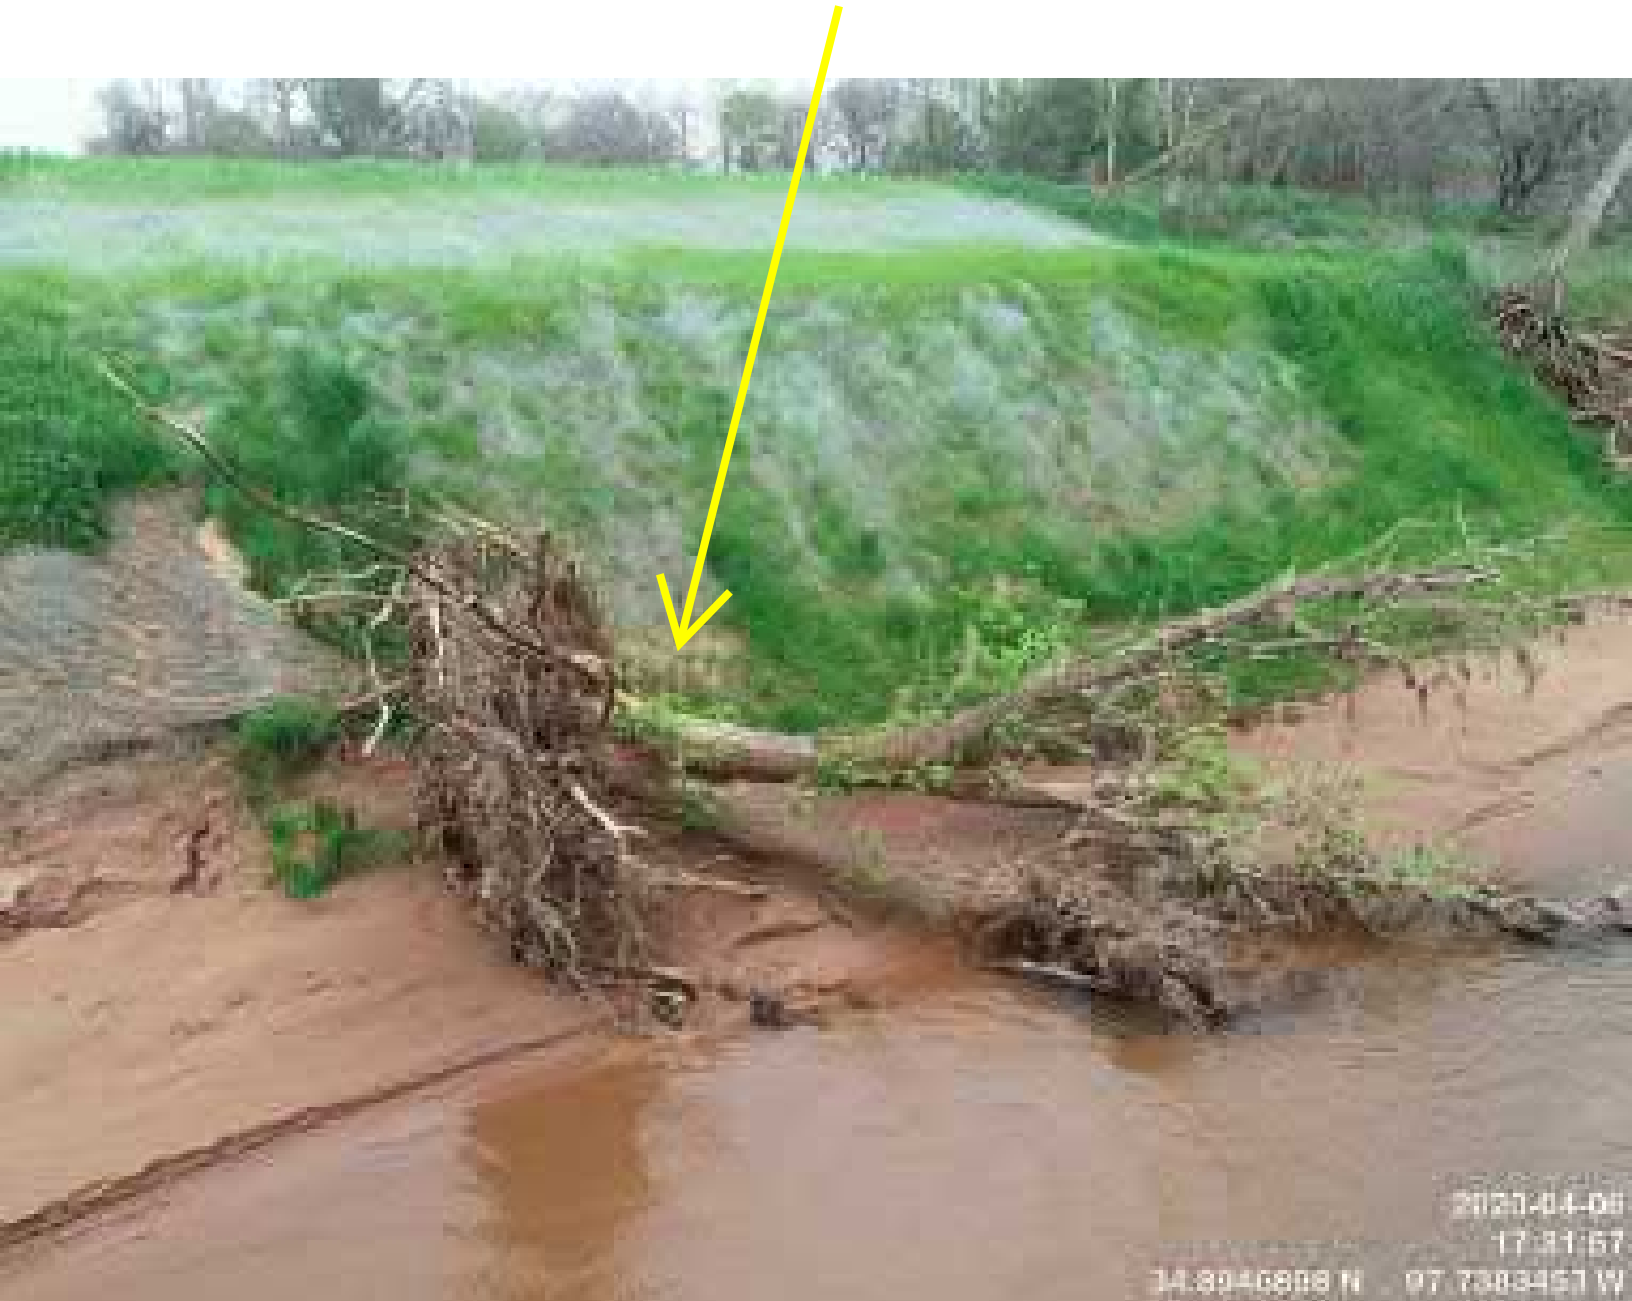
Unstable Creek Bank Causing Trees and Vegetation to Slide into Creek

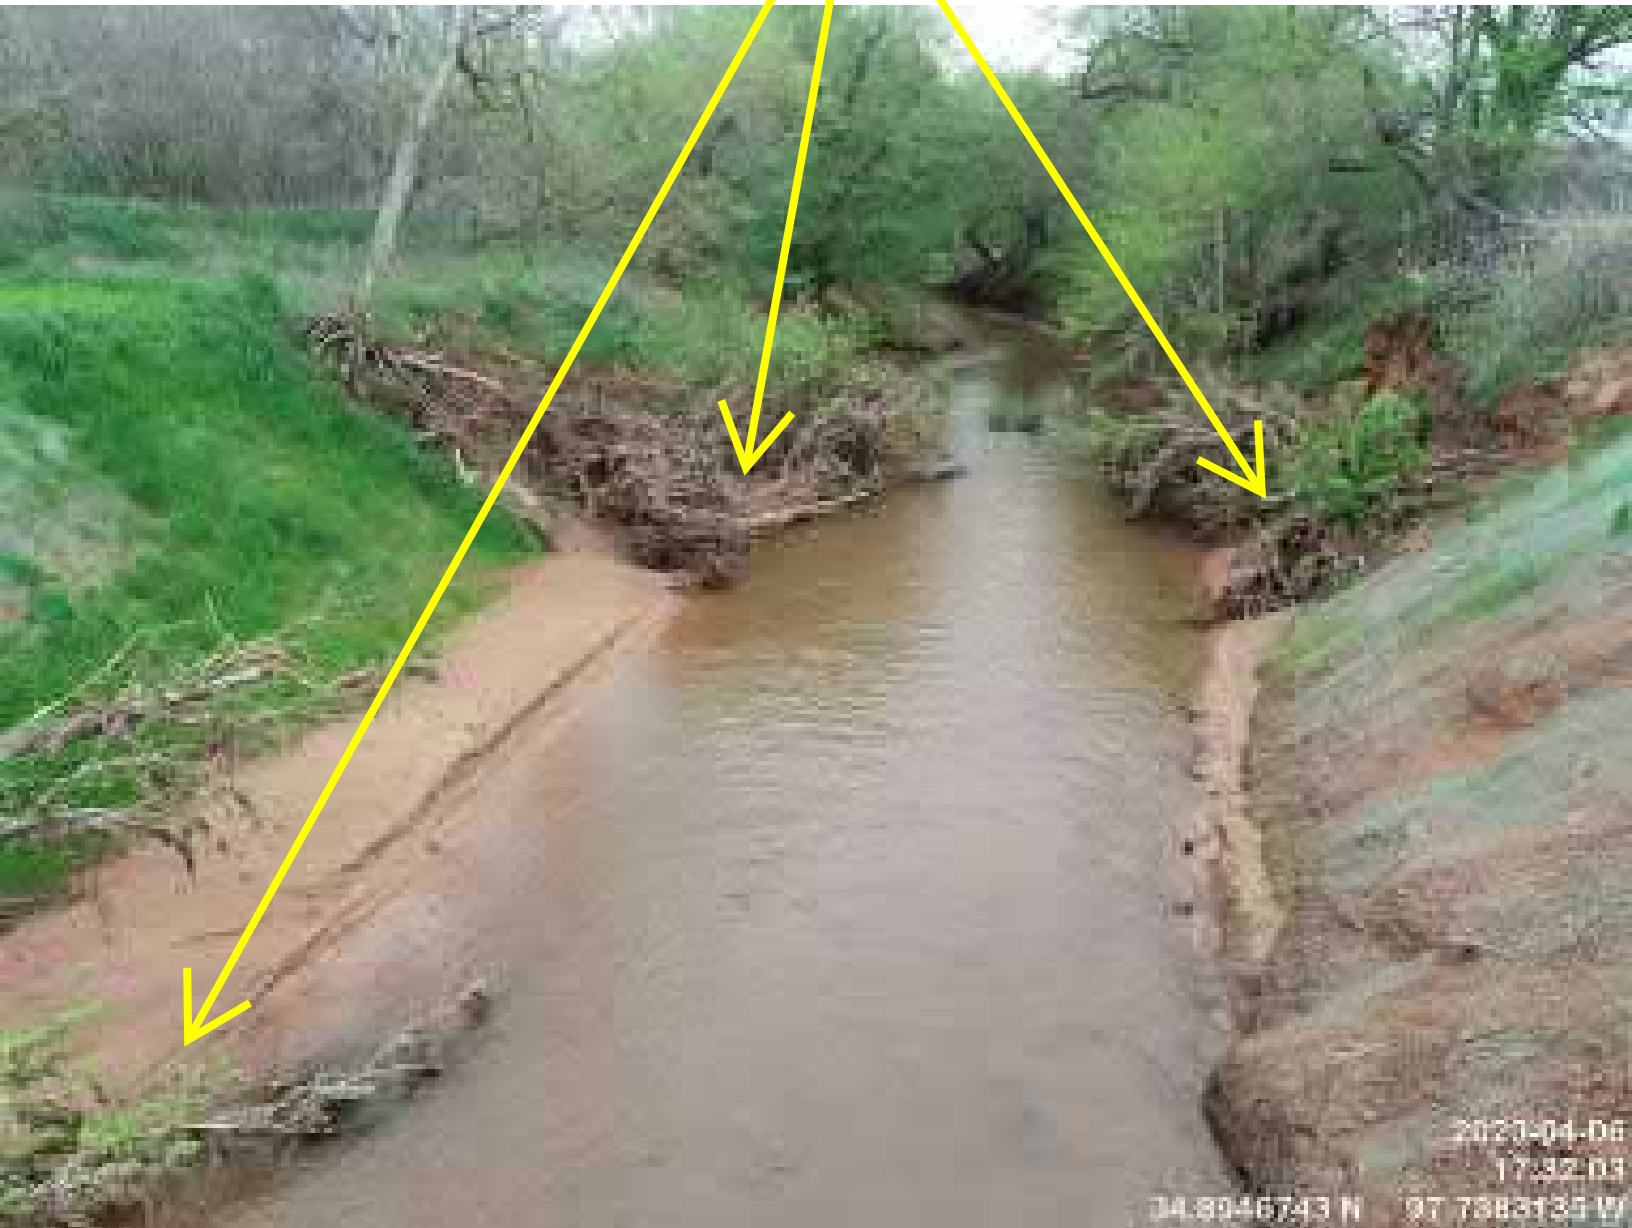
Unstable Creek Bank Causing Trees and Vegetation to Slide into Creek

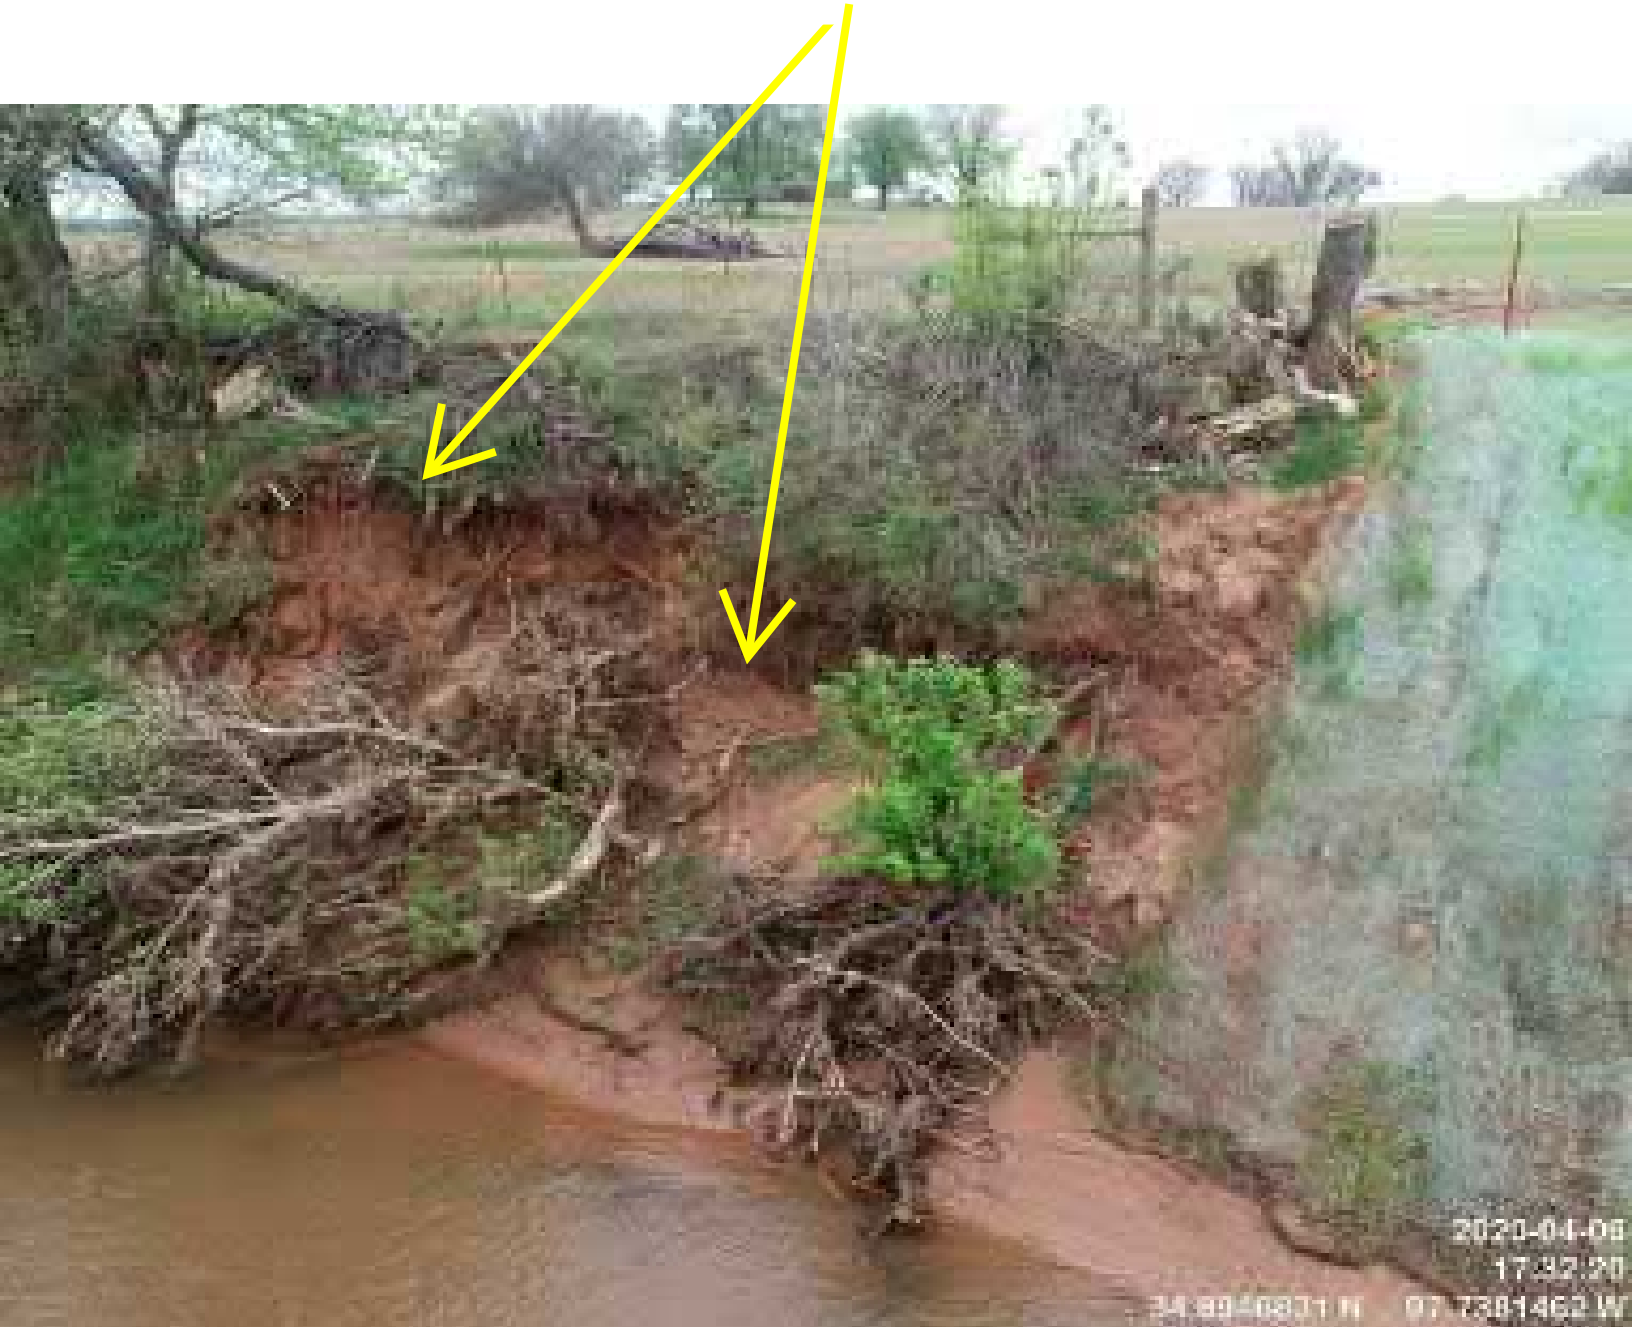
Unstable Creek Bank Causing Trees and Vegetation to Slide into Creek

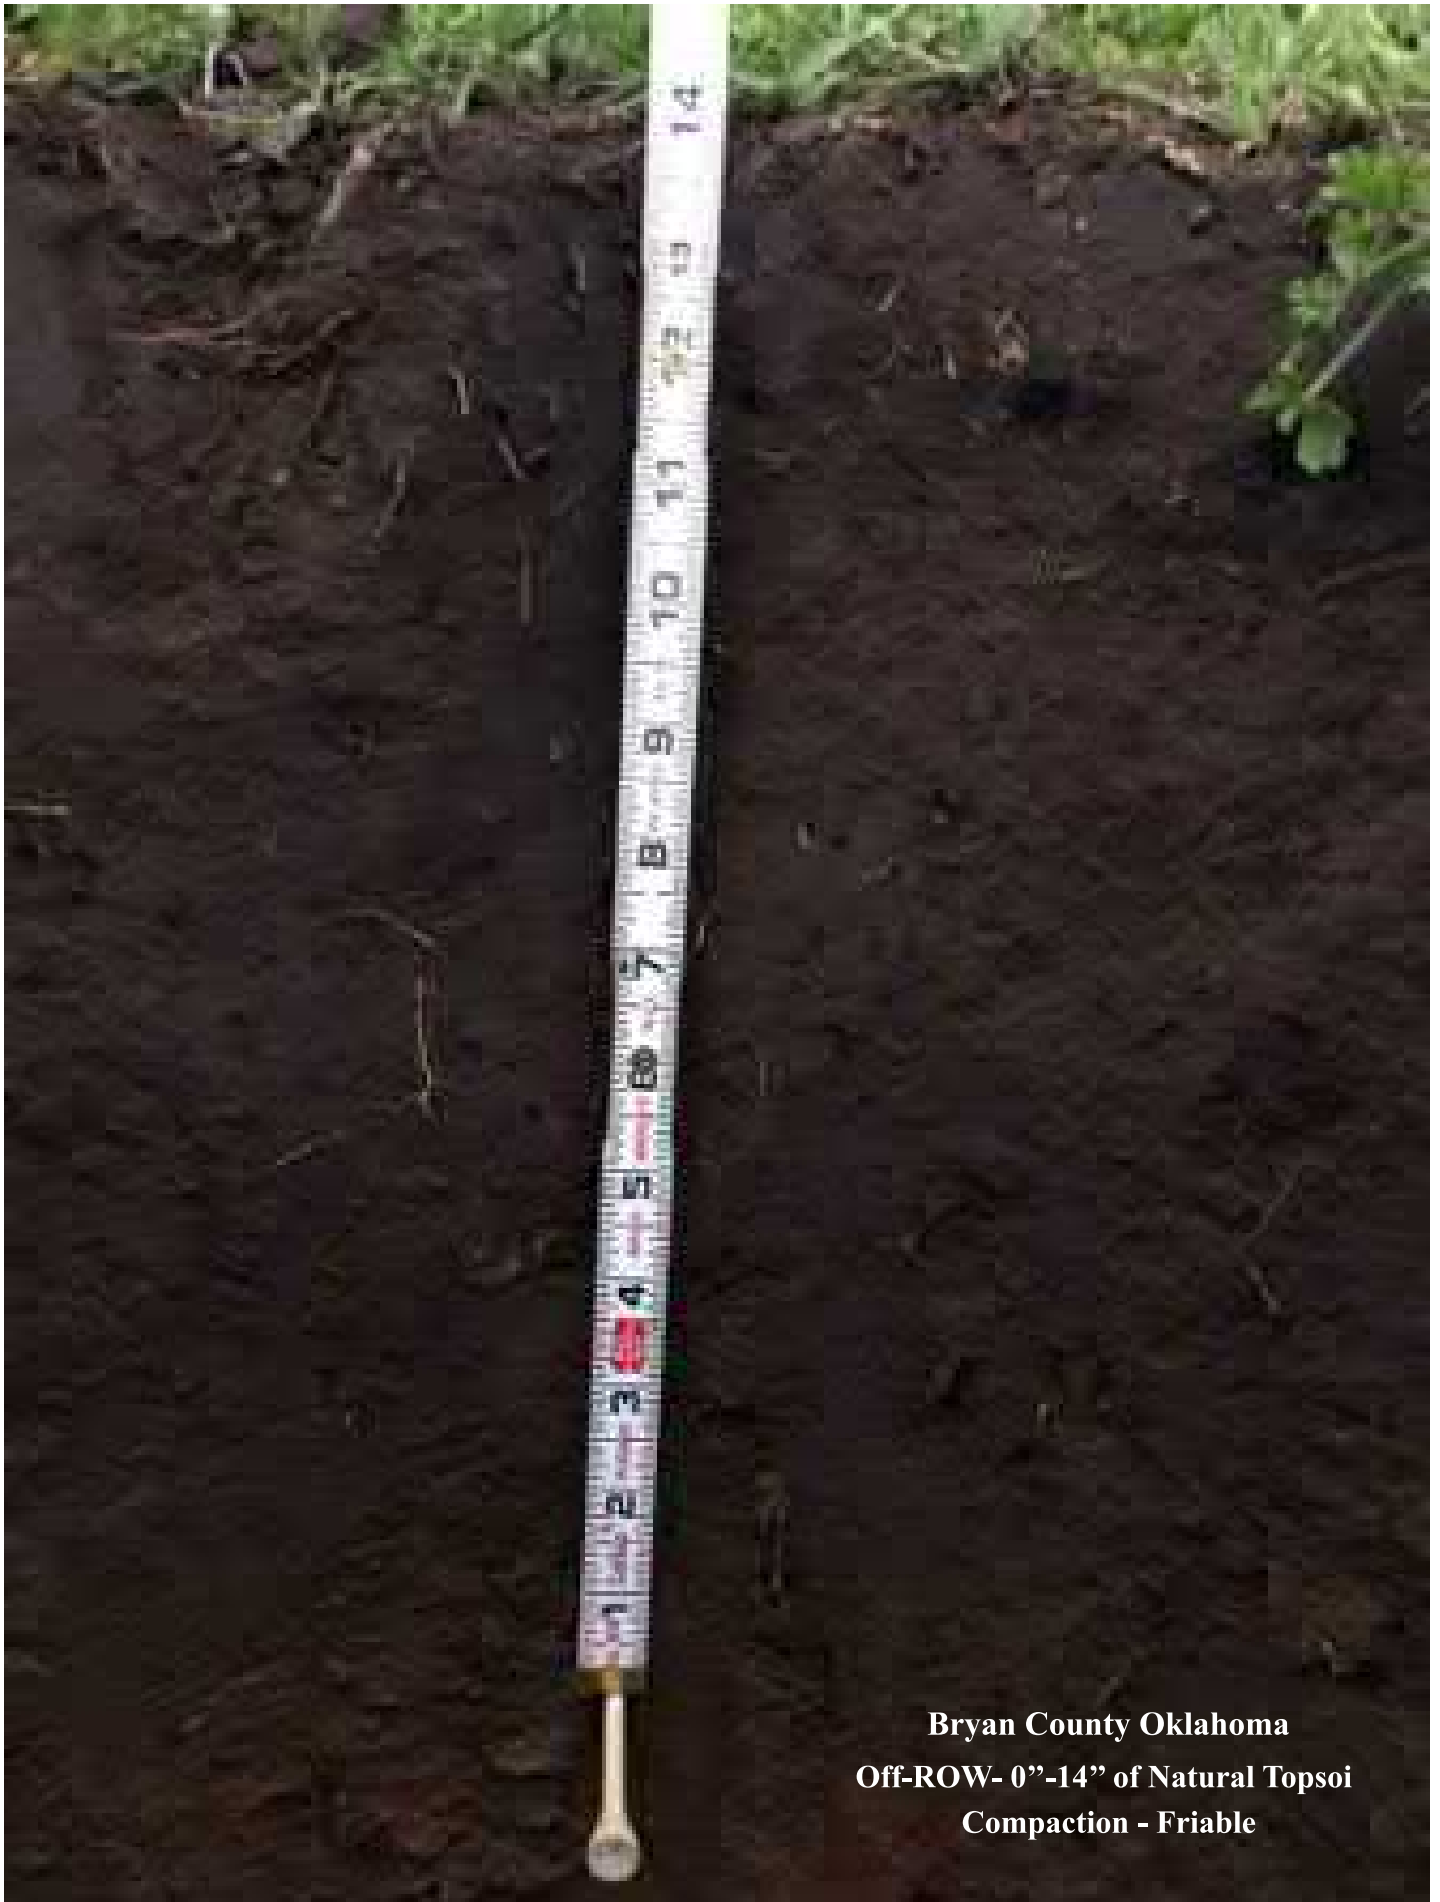
**Bryan County, Oklahoma
Gene Grounds Soil Investigation
Off-ROW Topsoil is up to 14" Deep
Midship Easement has No Natural Topsoil
and Extremely Compacted with Several
Large Rocks.**

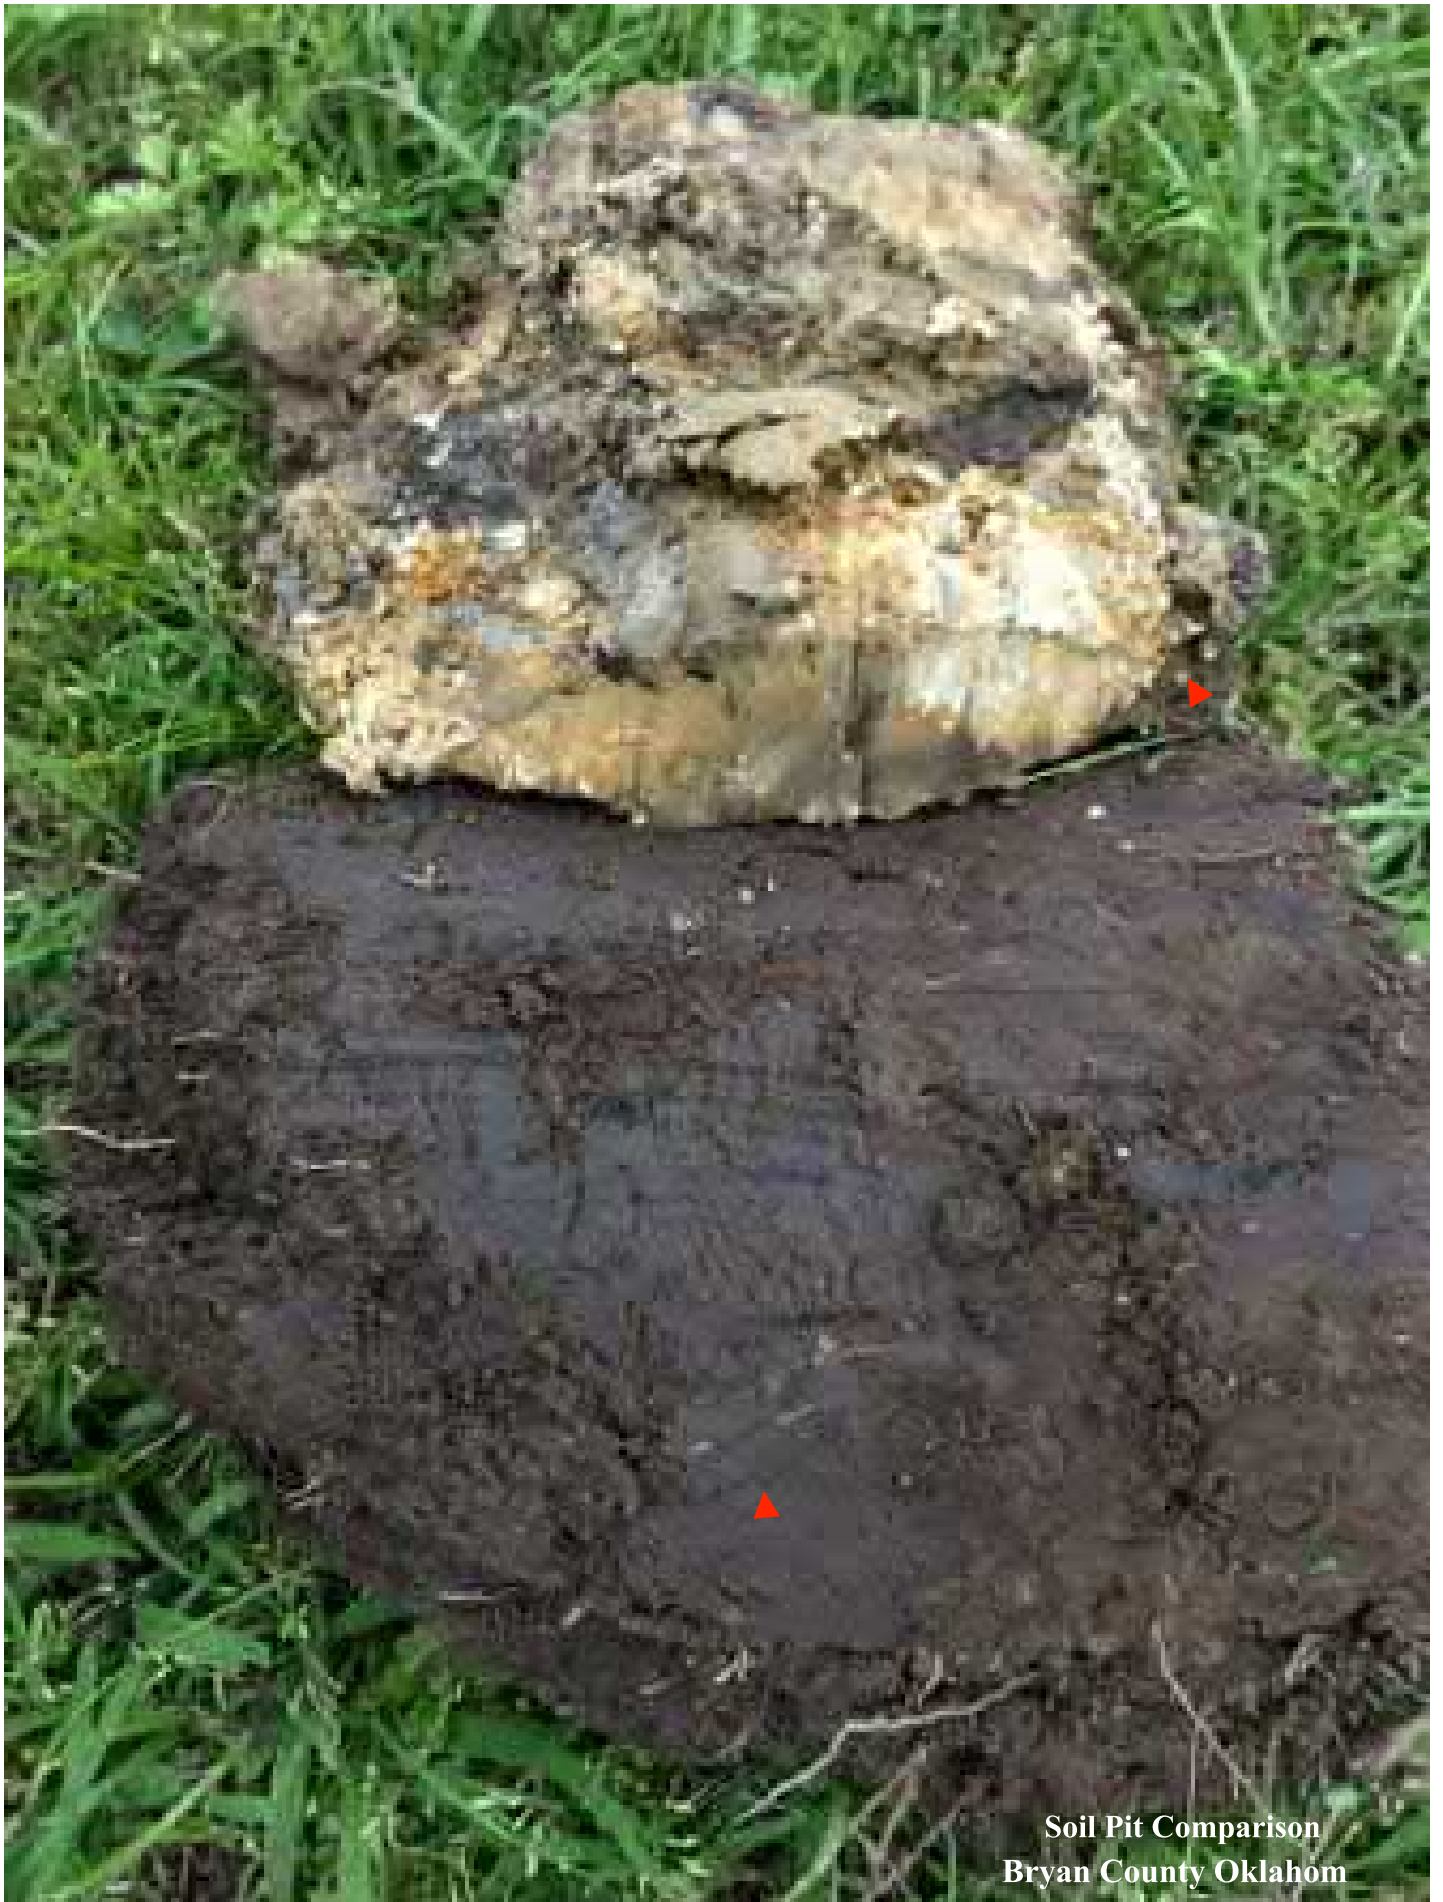
**Bryan County Oklahoma
In-ROW - 0" of Natural Topsoil
Compaction - Extreme -
Exceeds the Limit**

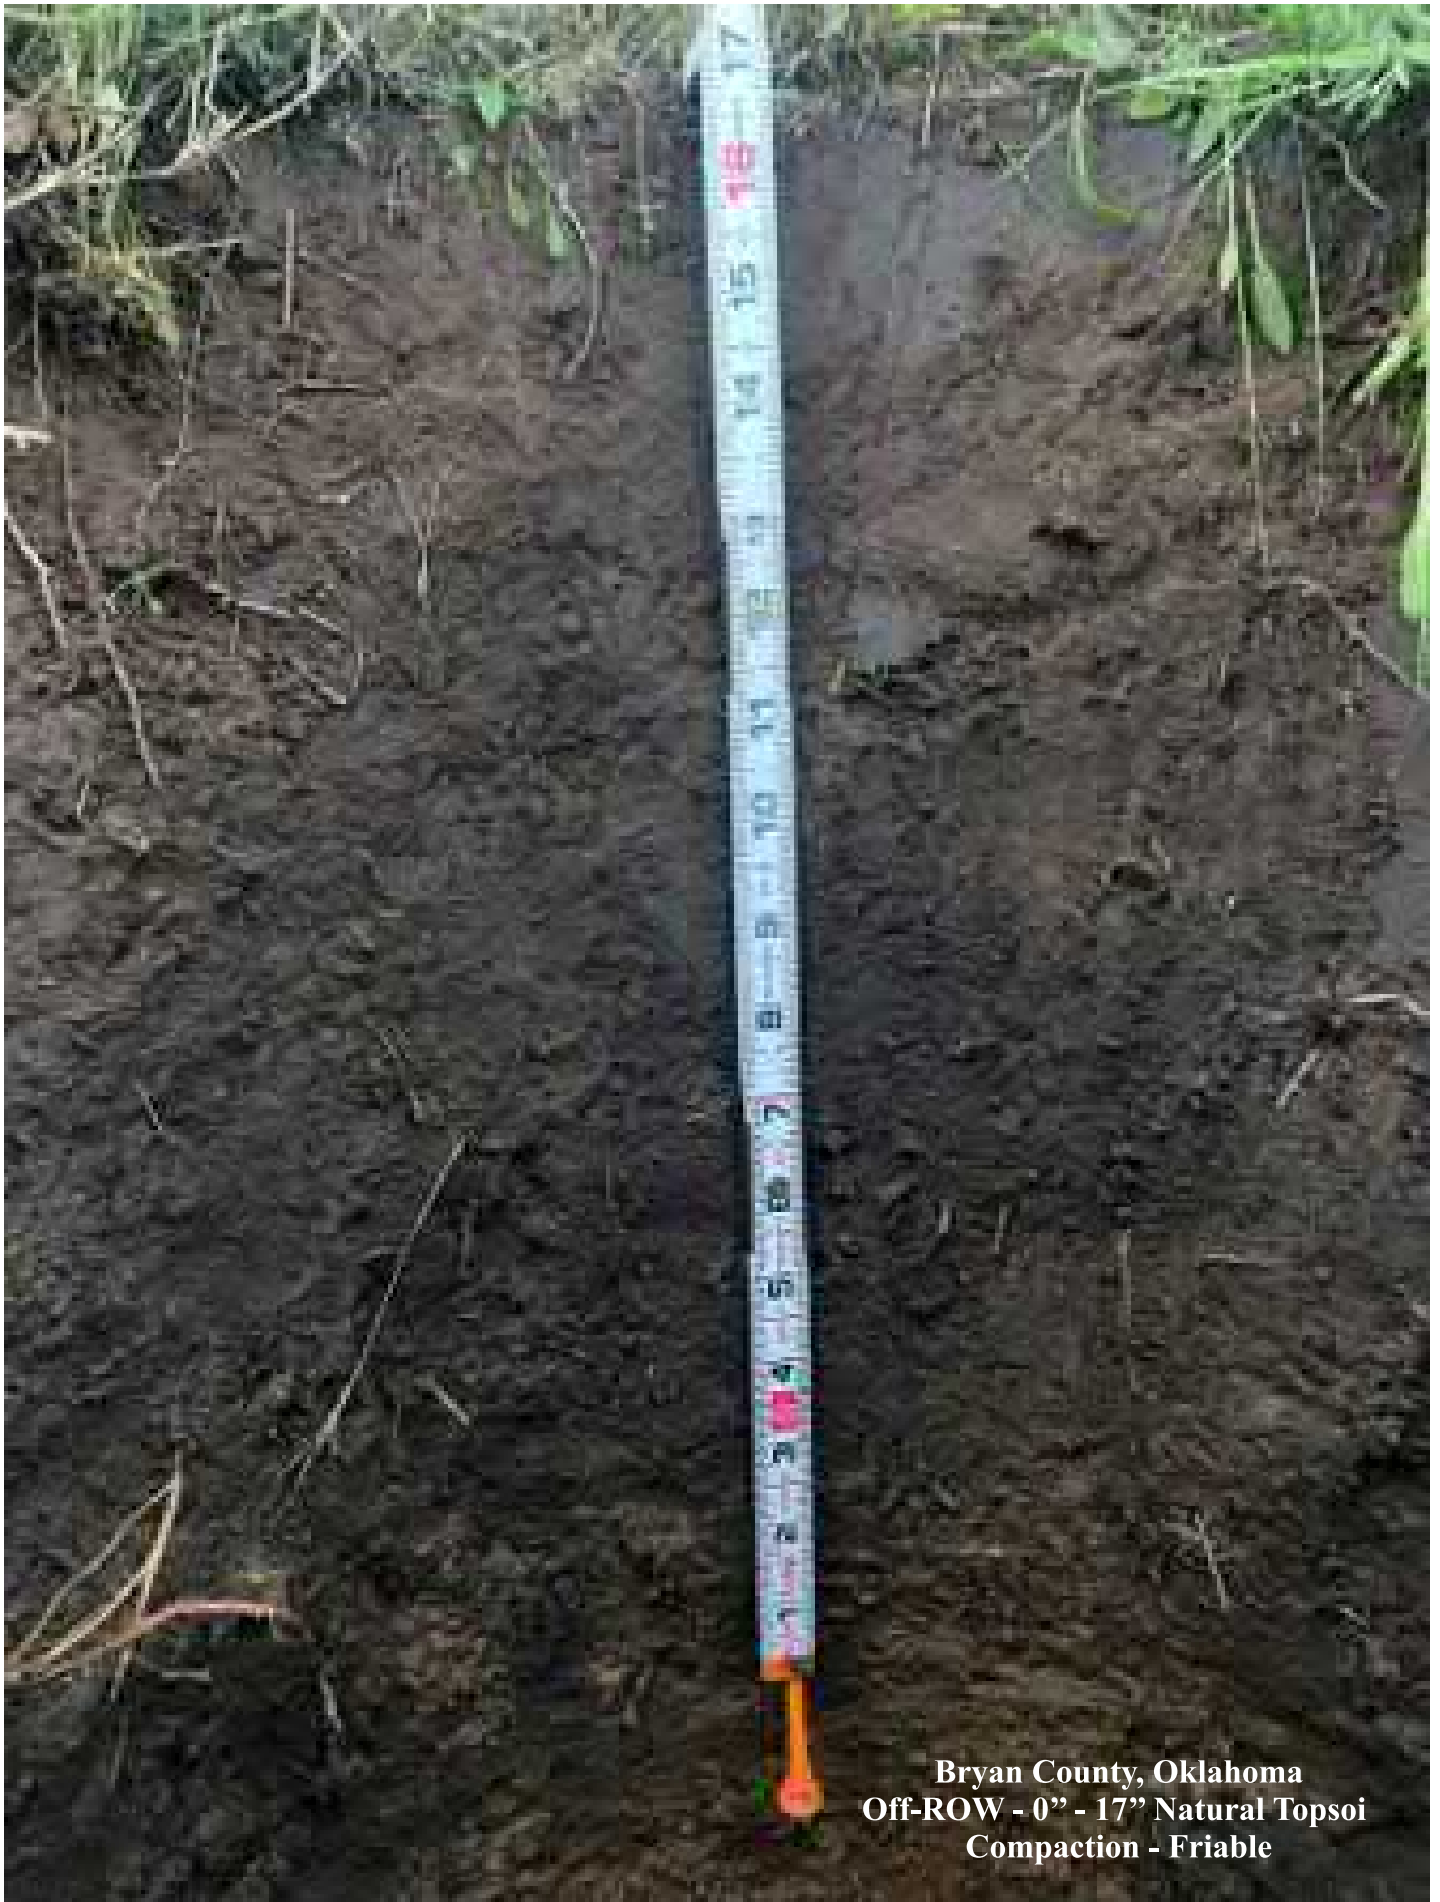
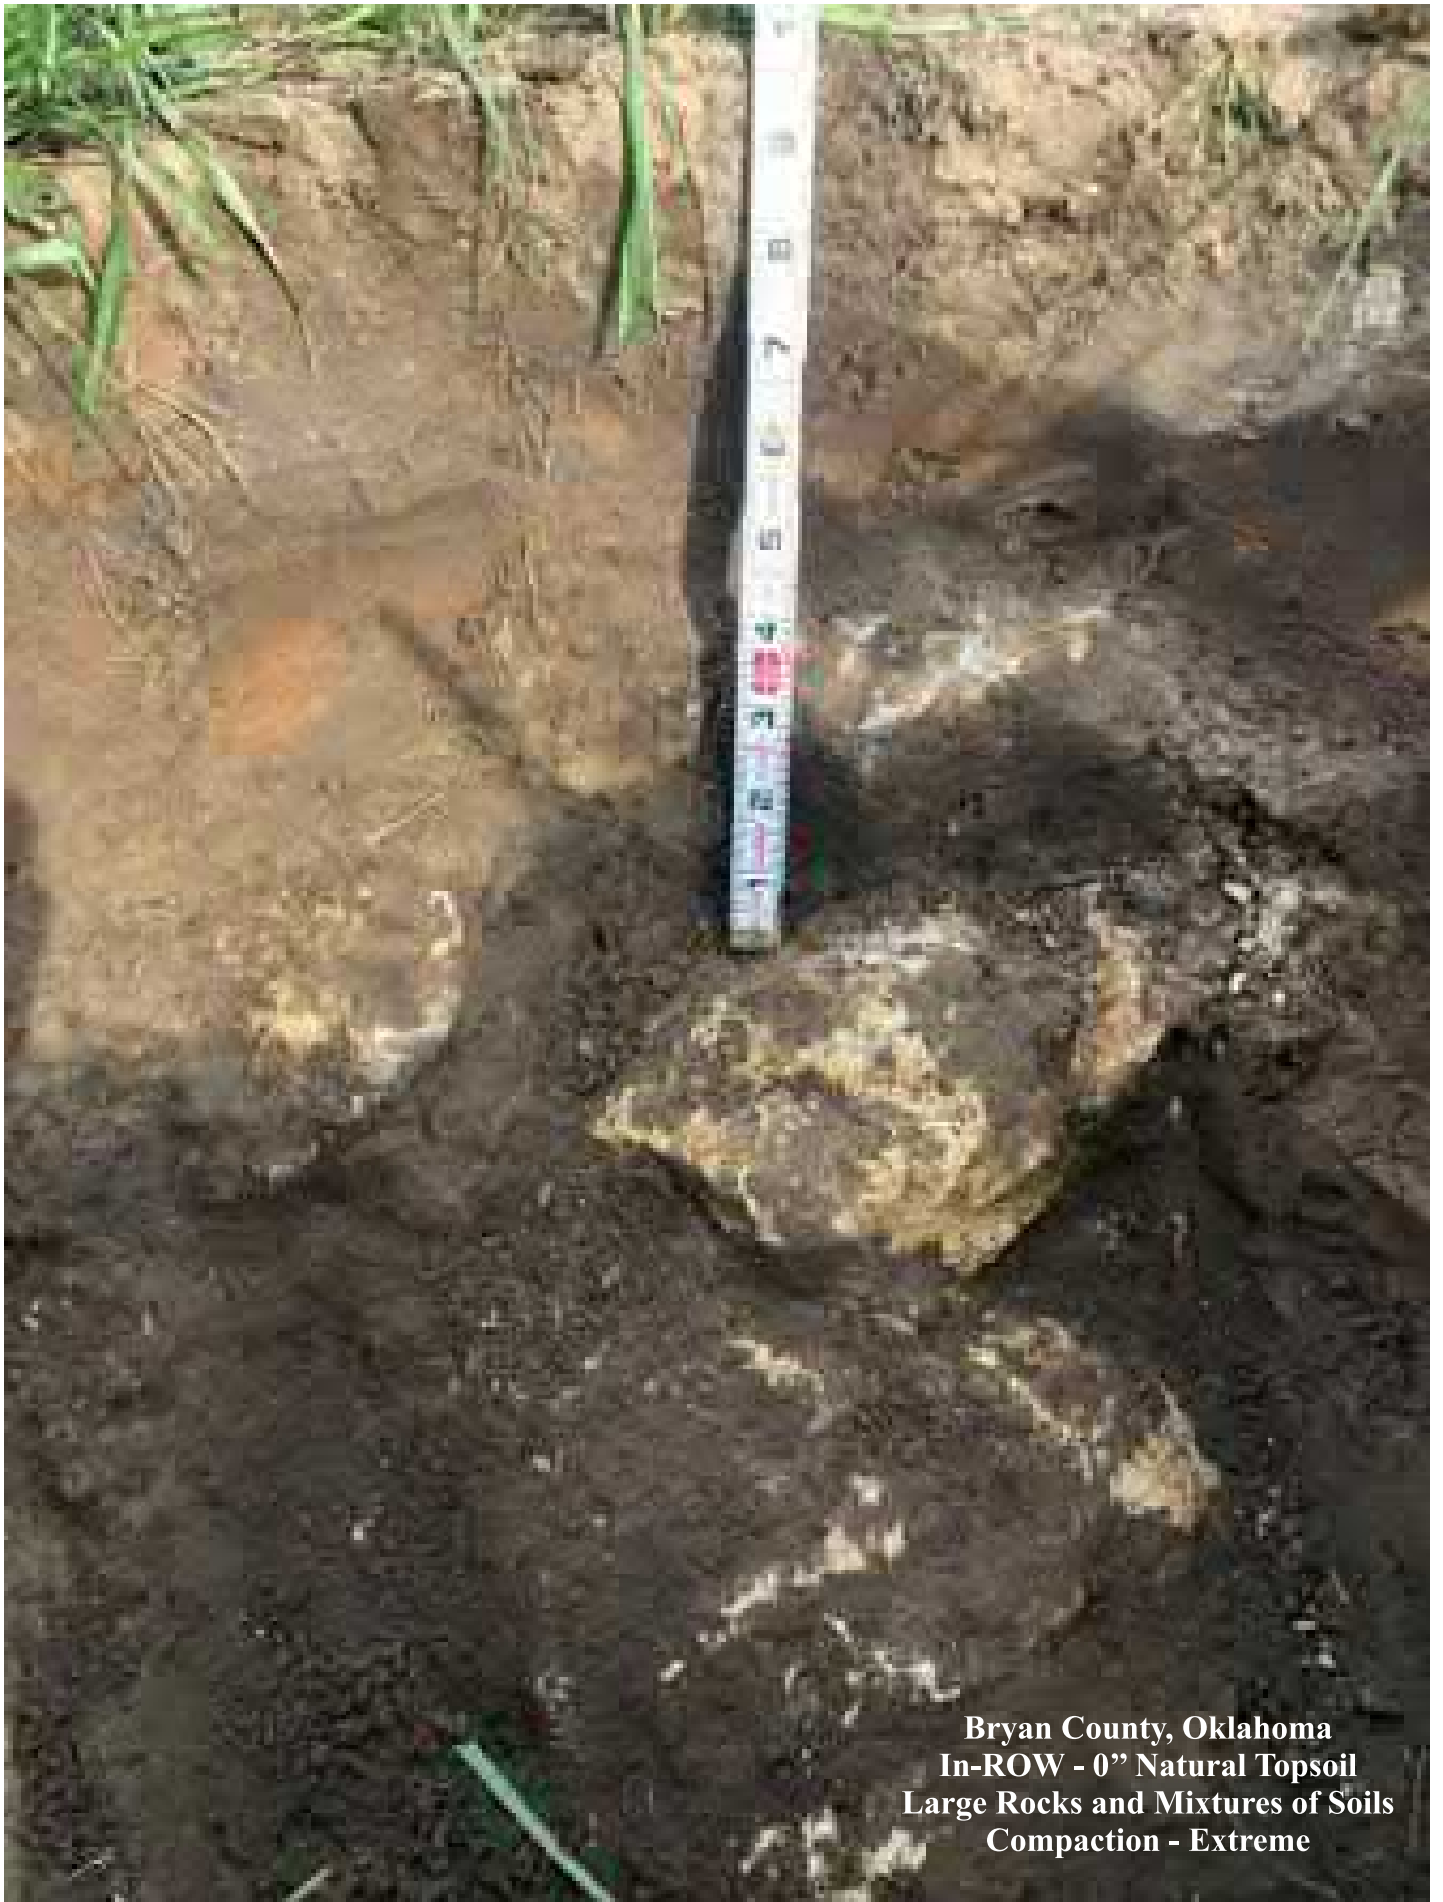
**Bryan County, Oklahoma
James Anderson Soil Investigation
Off-ROW Topsoil is up to 17" Deep
Midship Easement has No Natural Topsoil
and Extremely Compacted with Several
Large Rocks.**

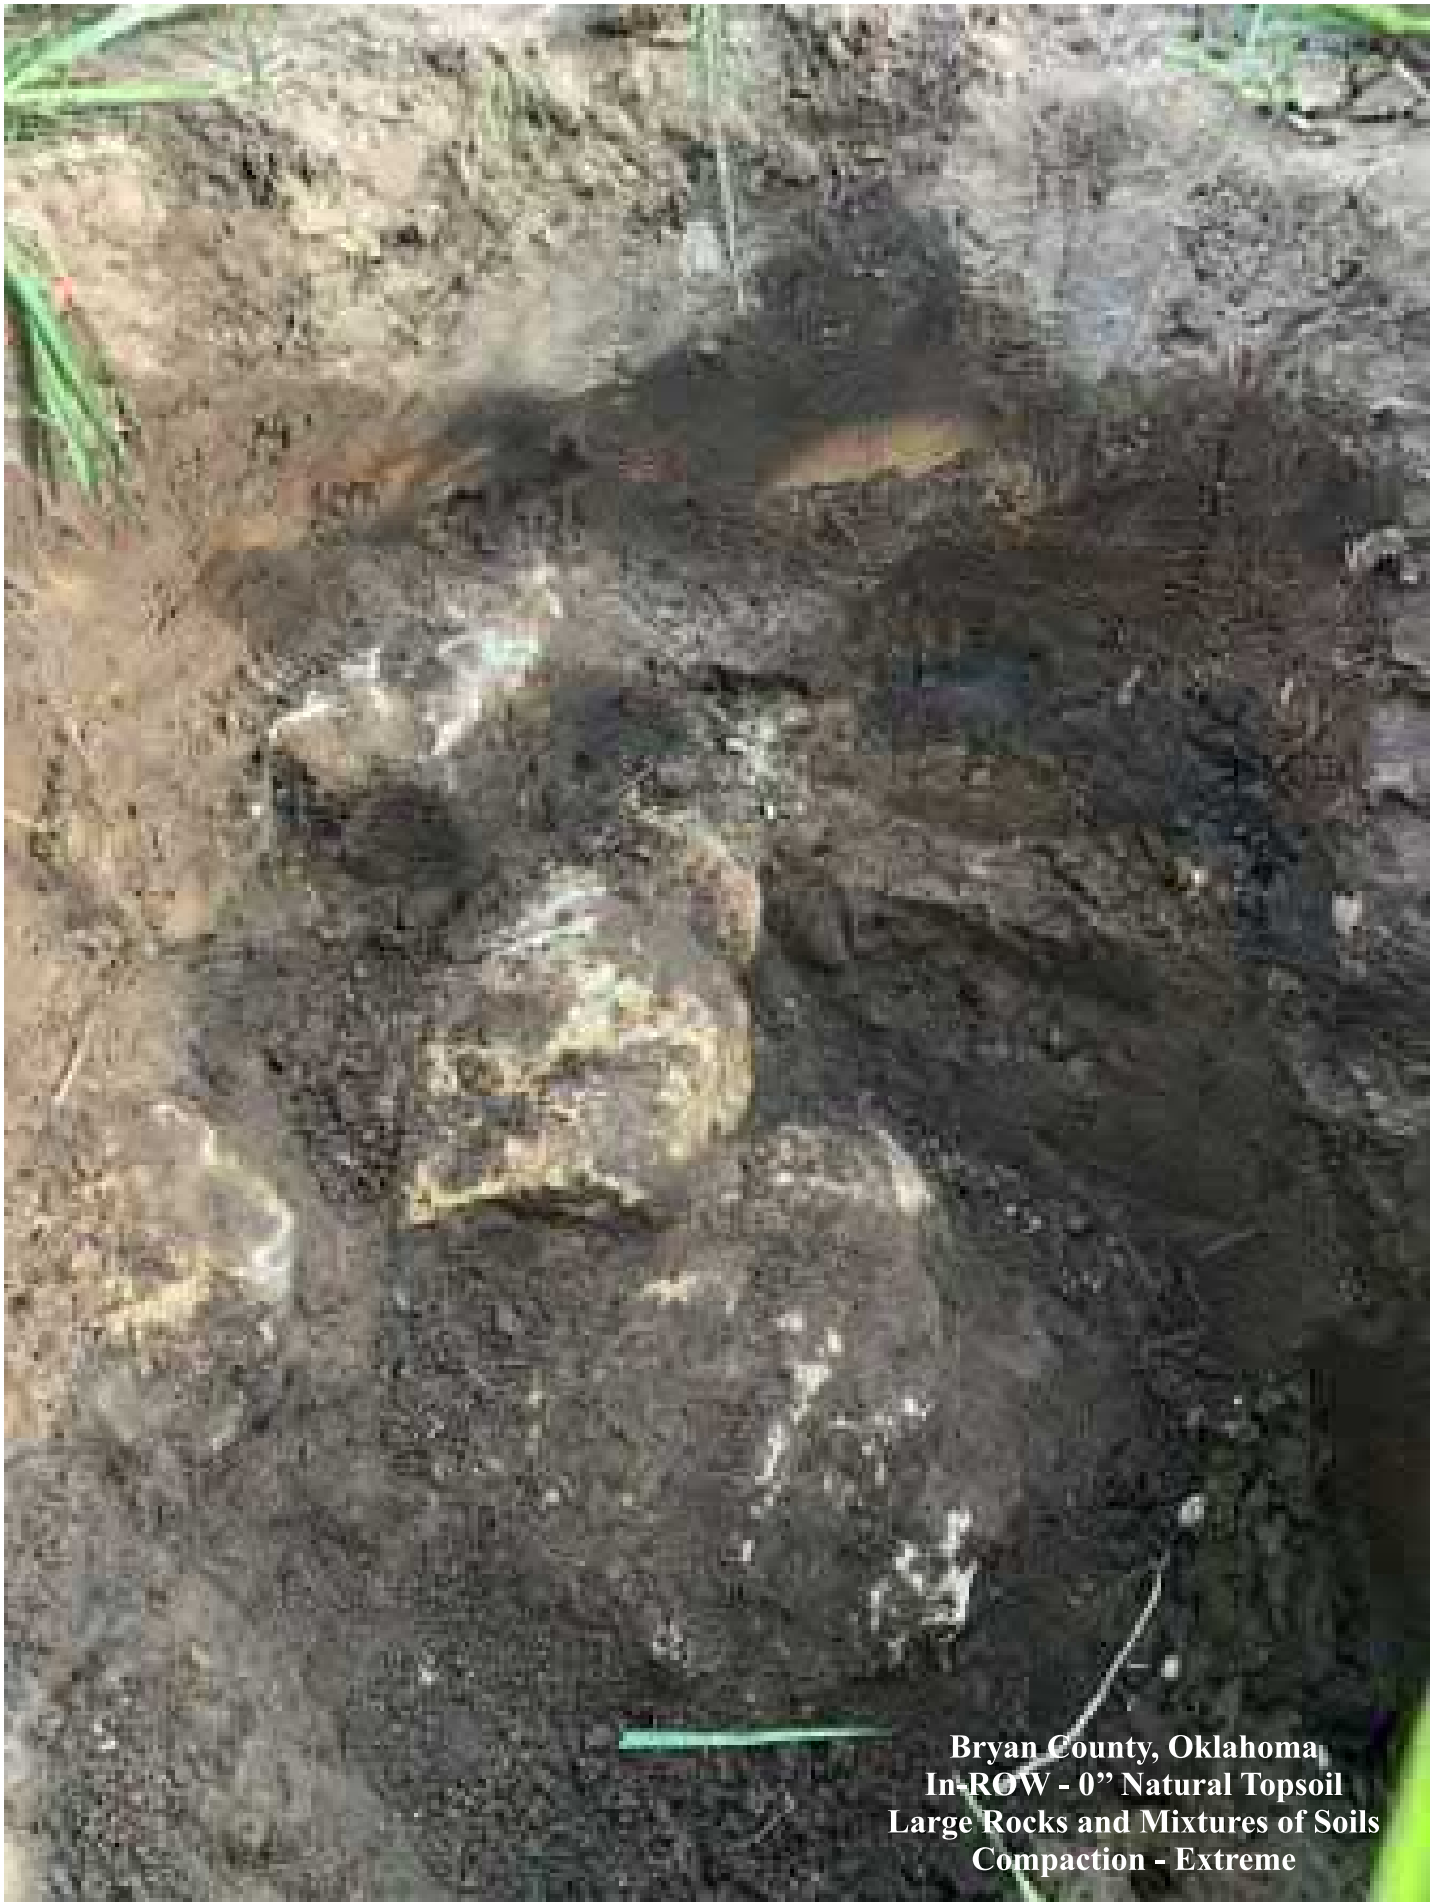
**Bryan County, Oklahoma
In-ROW - 0" Natural Topsoil
Large Rocks and Mixtures of Soils
Compaction - Extreme**
