Robert Squires - Squires Consulting LLC
Landowner Advocate

Opening Statement for May 5, 2021 Subcommittee on Civil Rights and Civil Liberties Hearing:
“Pipelines Over People (Part II): Midship Pipeline’s Disregard for Landowners in Its Pathway”

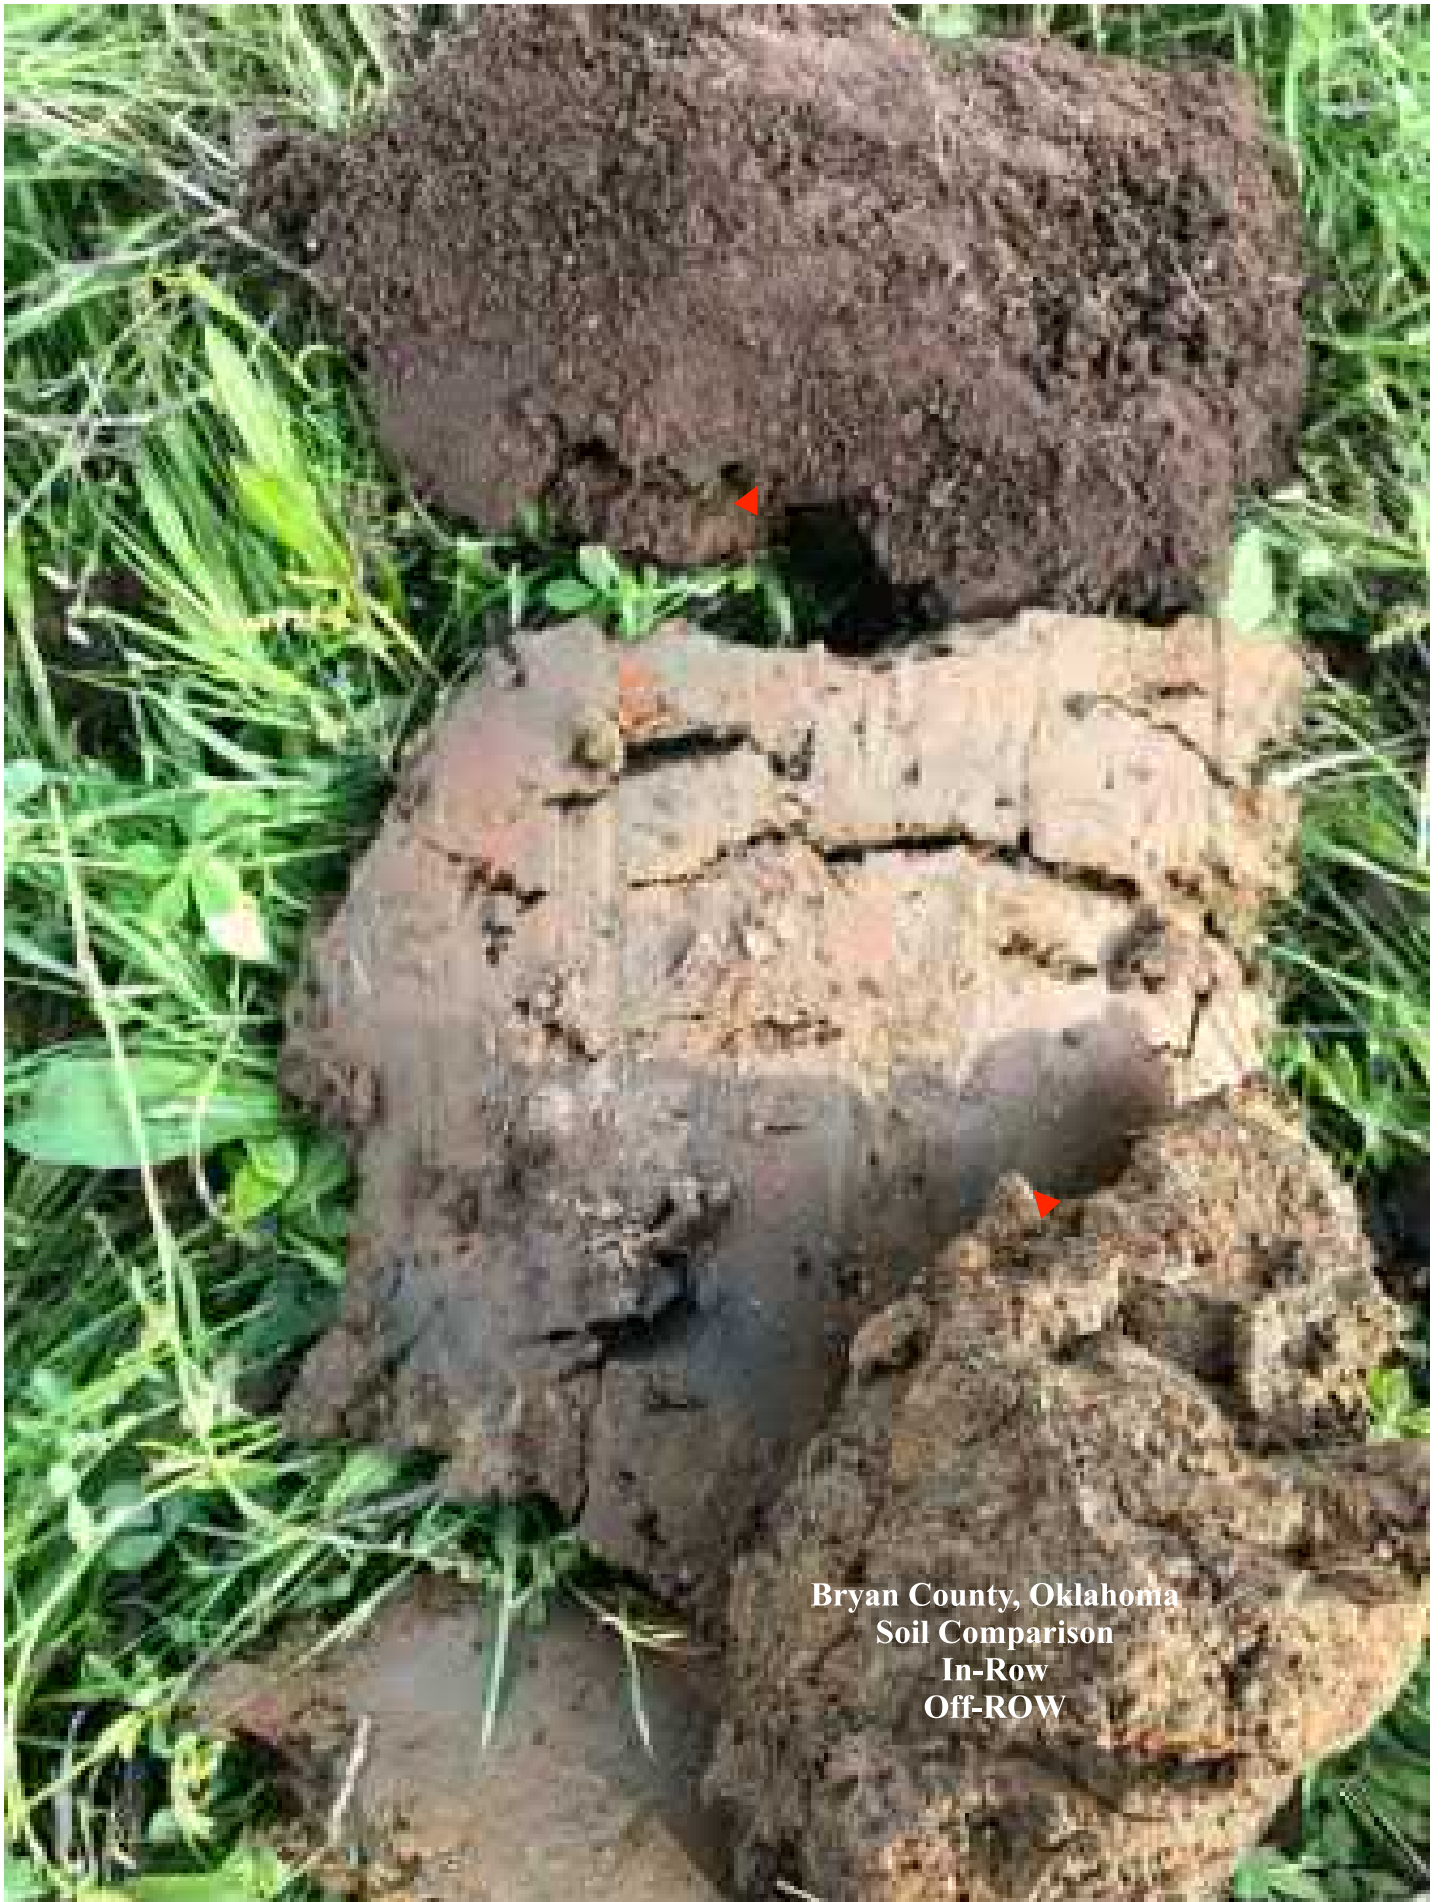
**Bryan County, Oklahoma
In-ROW - 0" Natural Topsoil
Large Rocks and Mixtures of Soils
Compaction - Extreme**

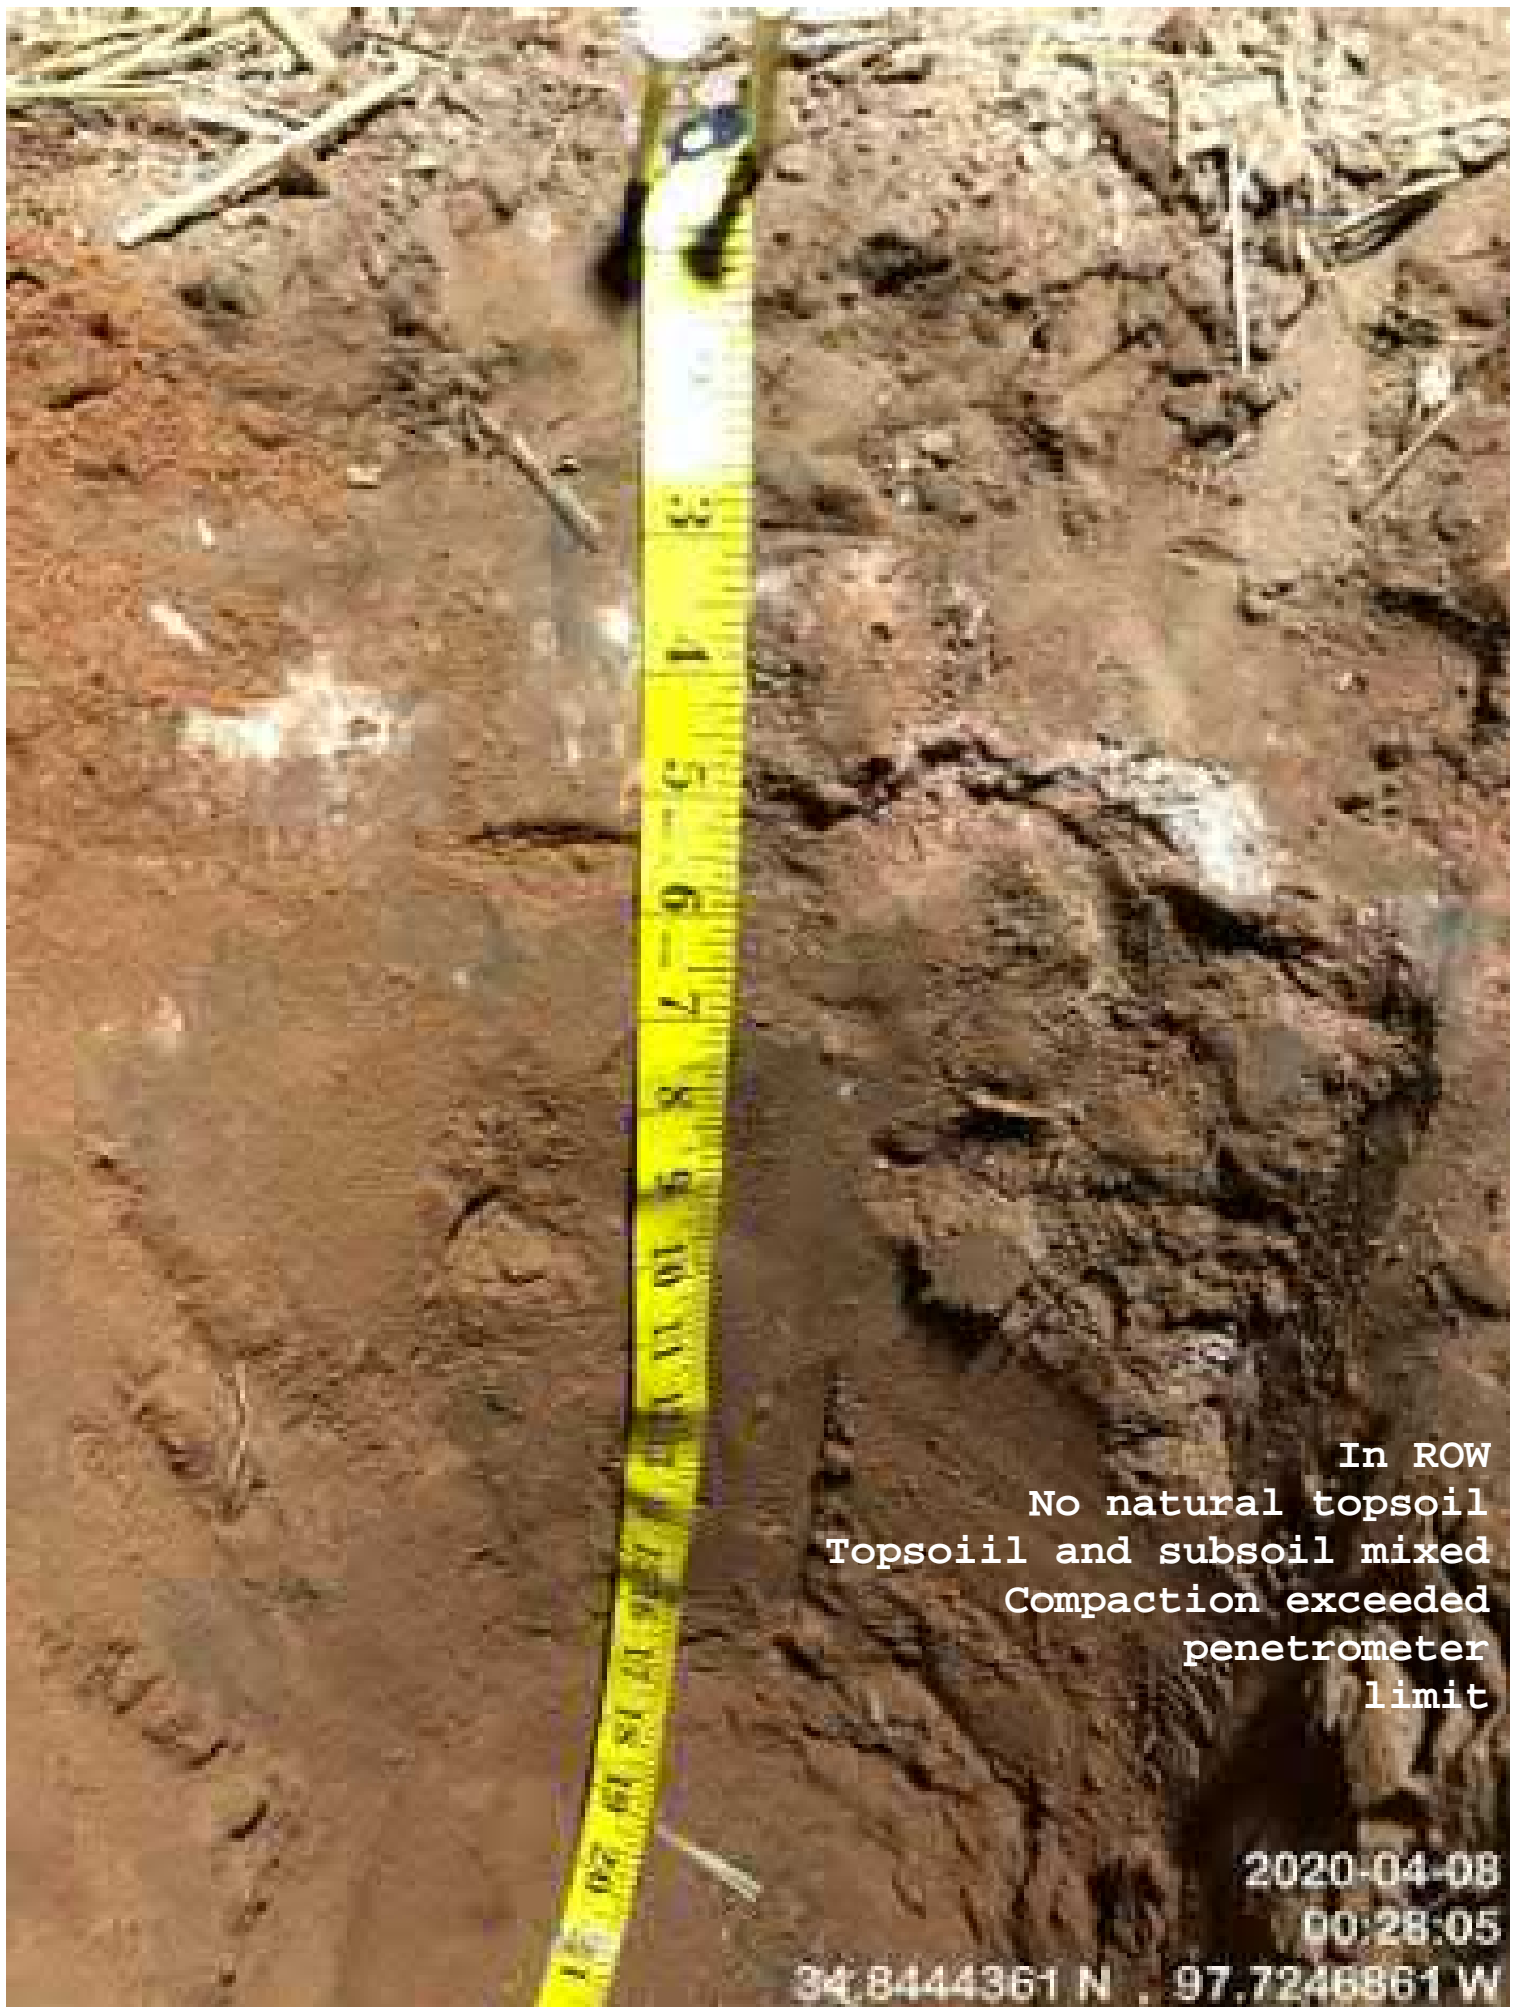
In ROW
No natural topsoil
Topsoil and subsoil mixed
Compaction exceeded
penetrometer
limit

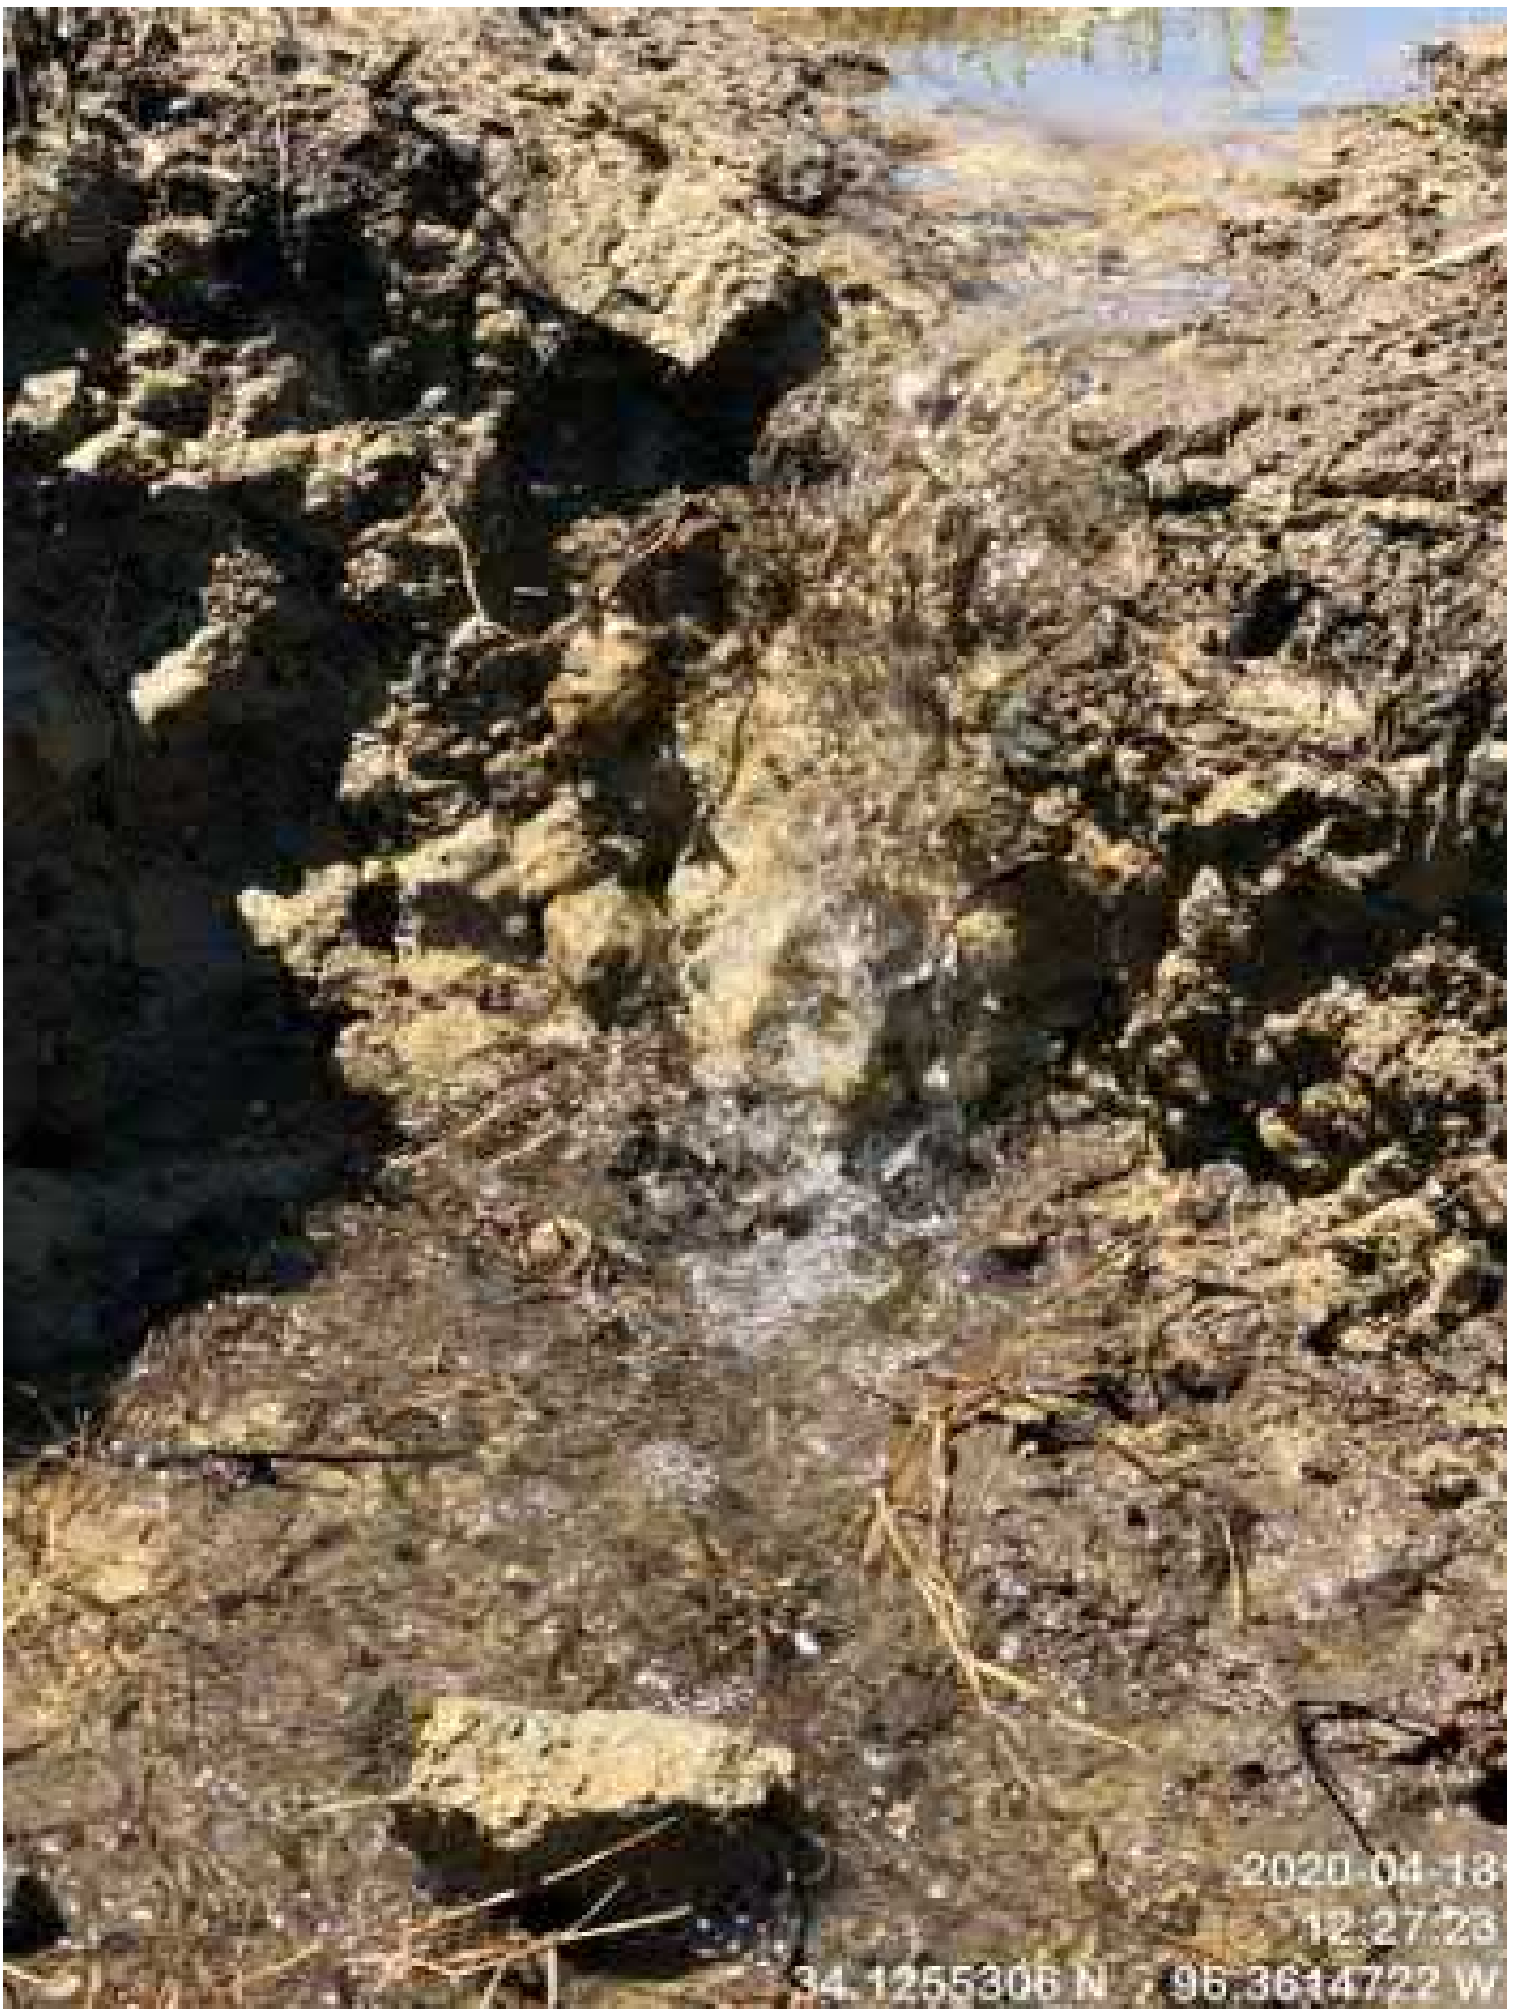
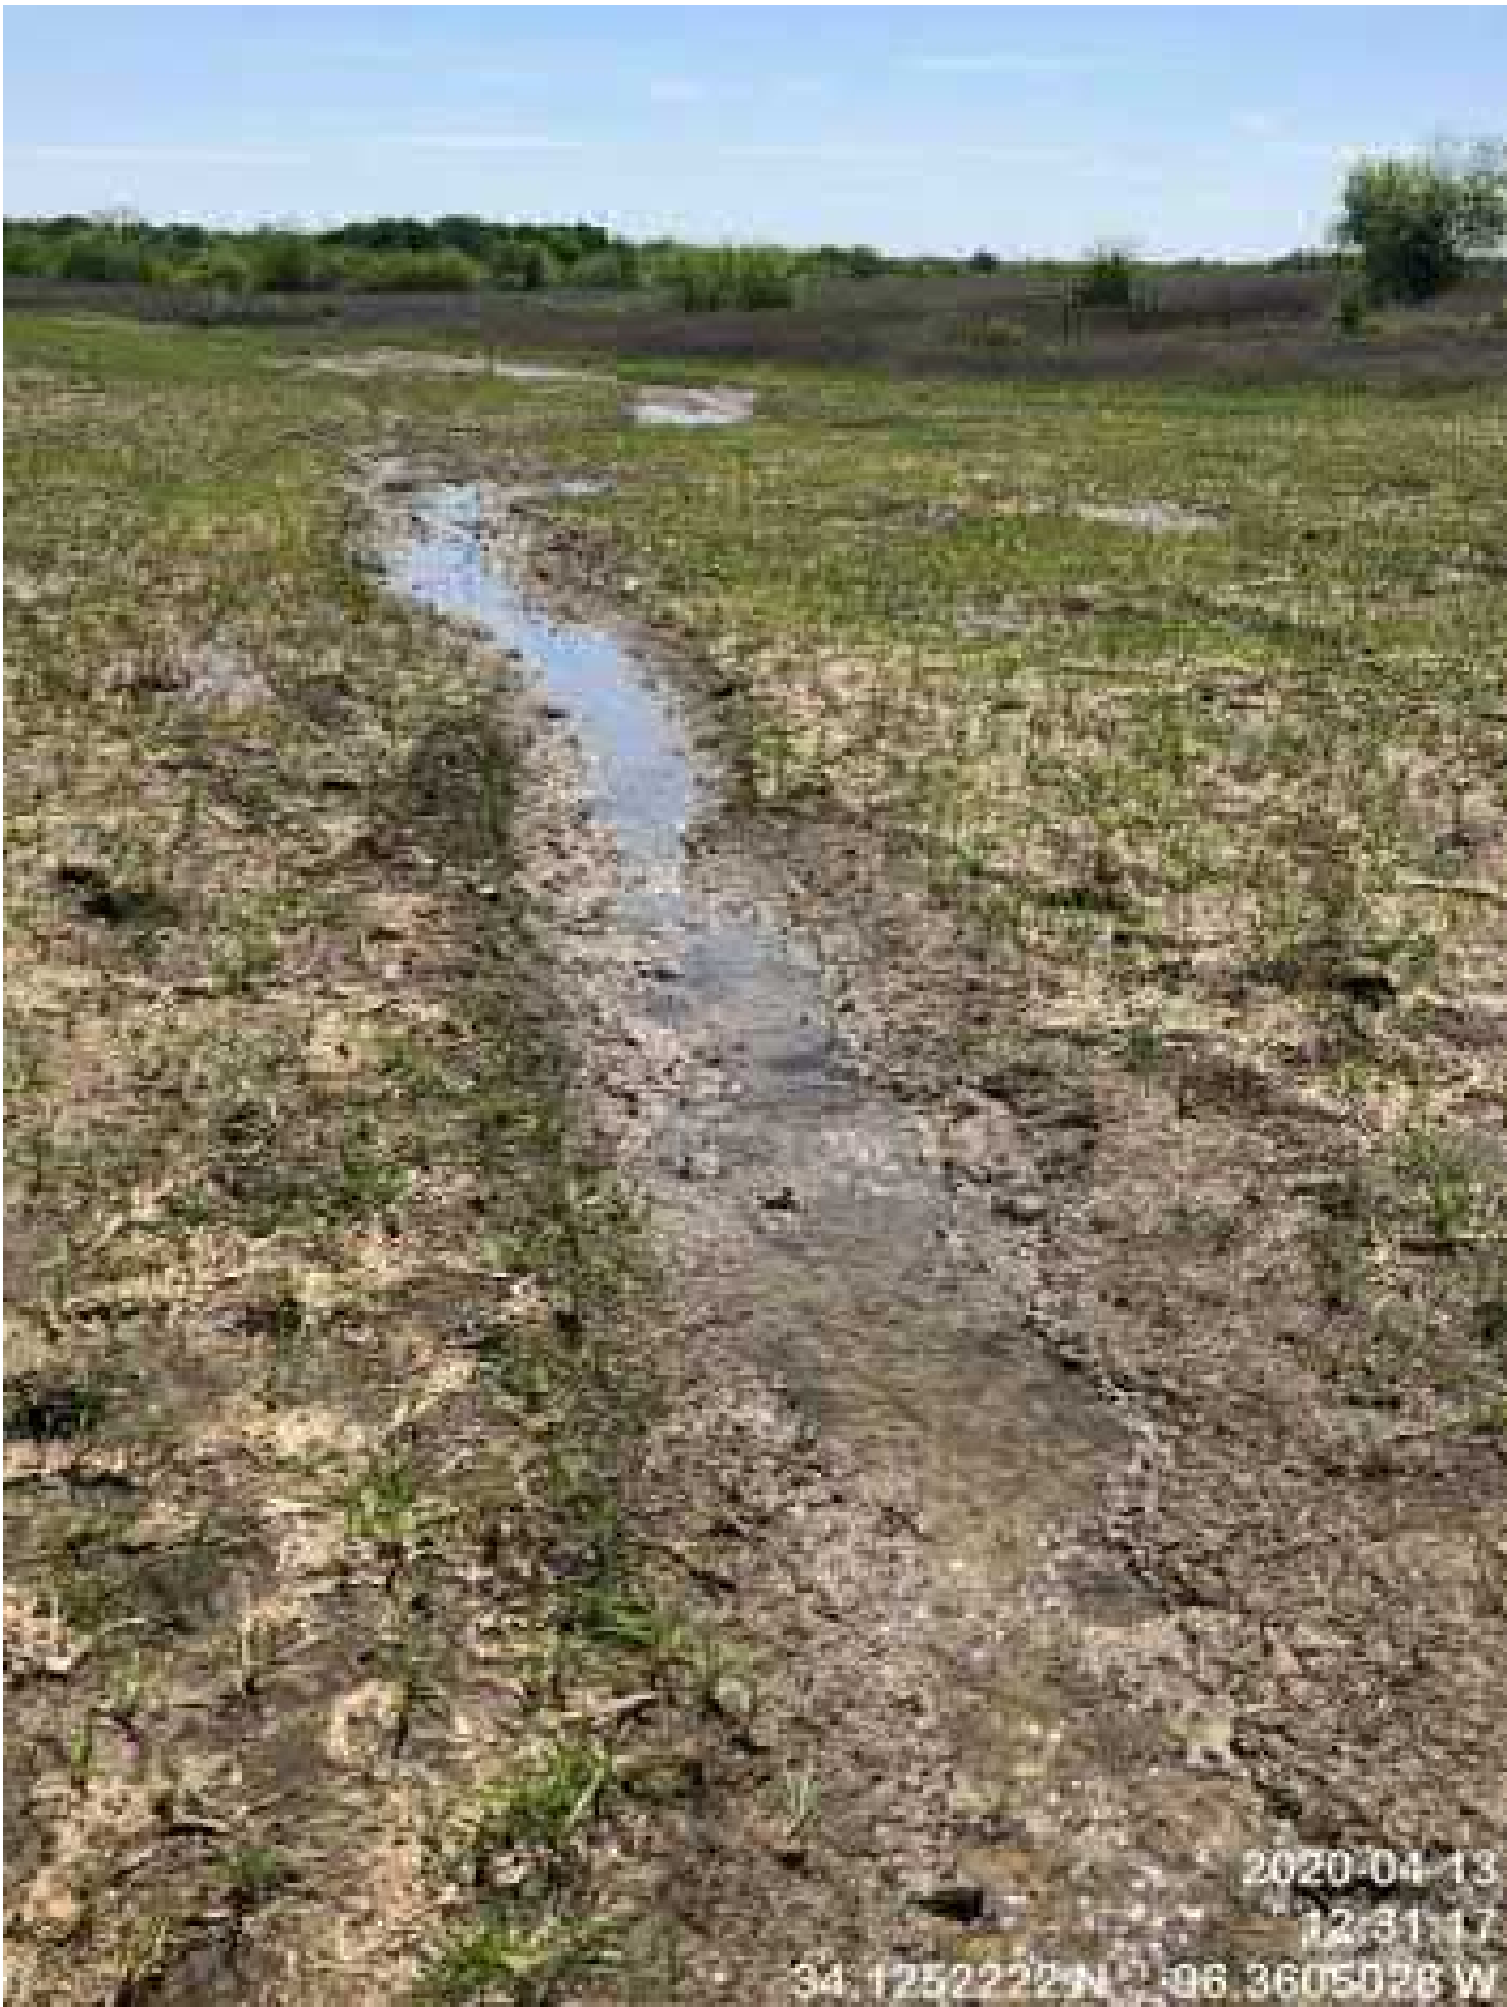
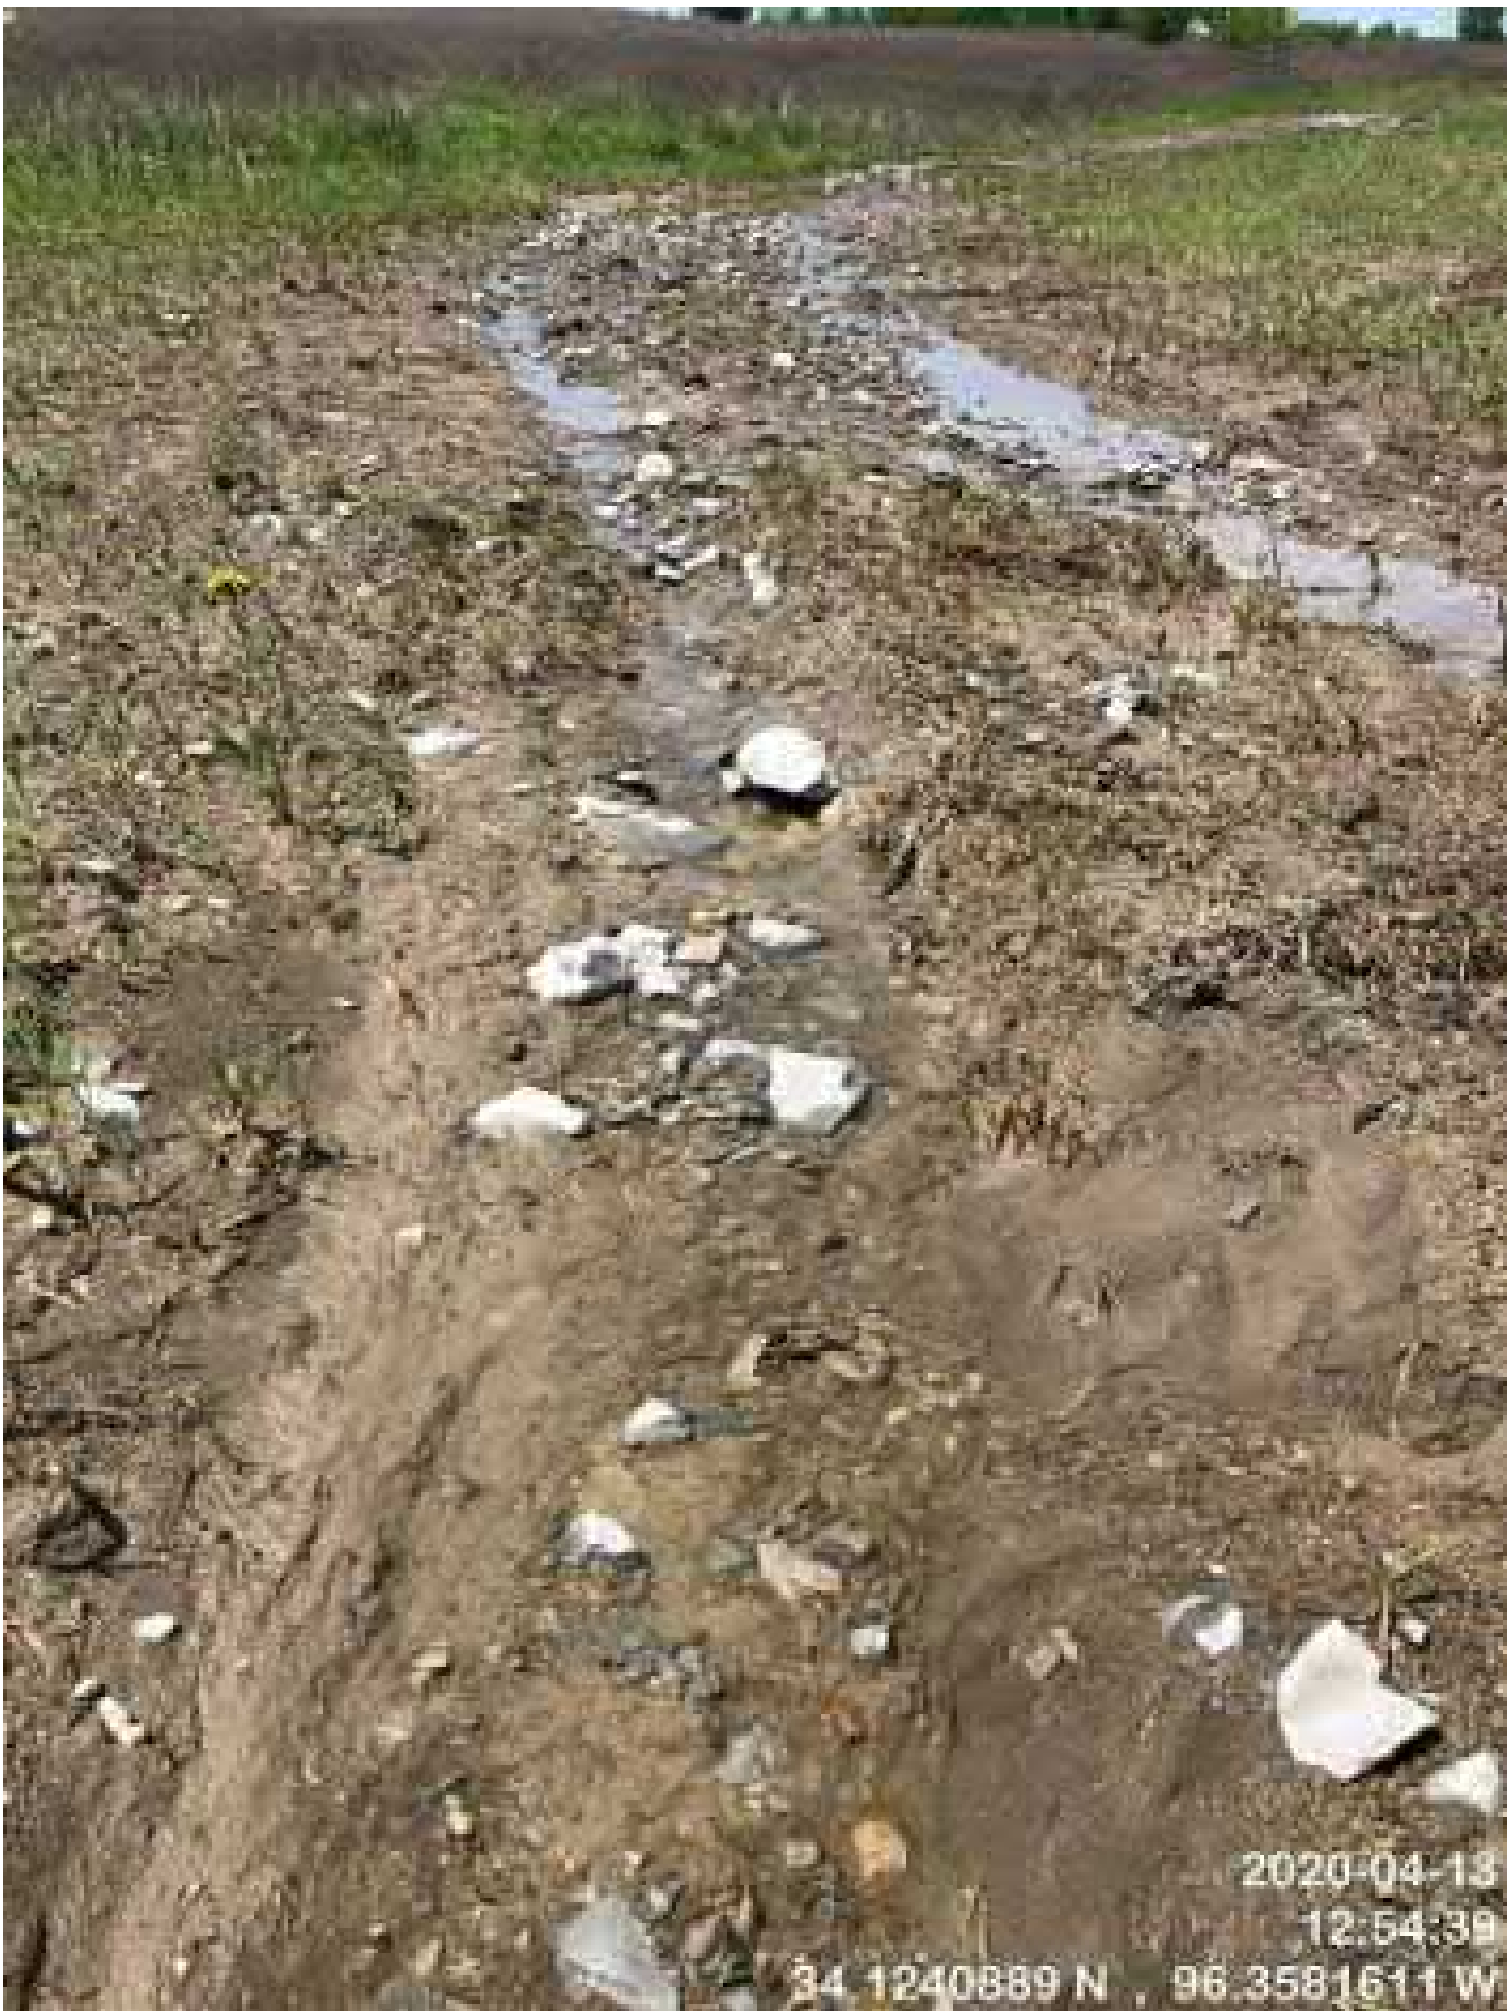
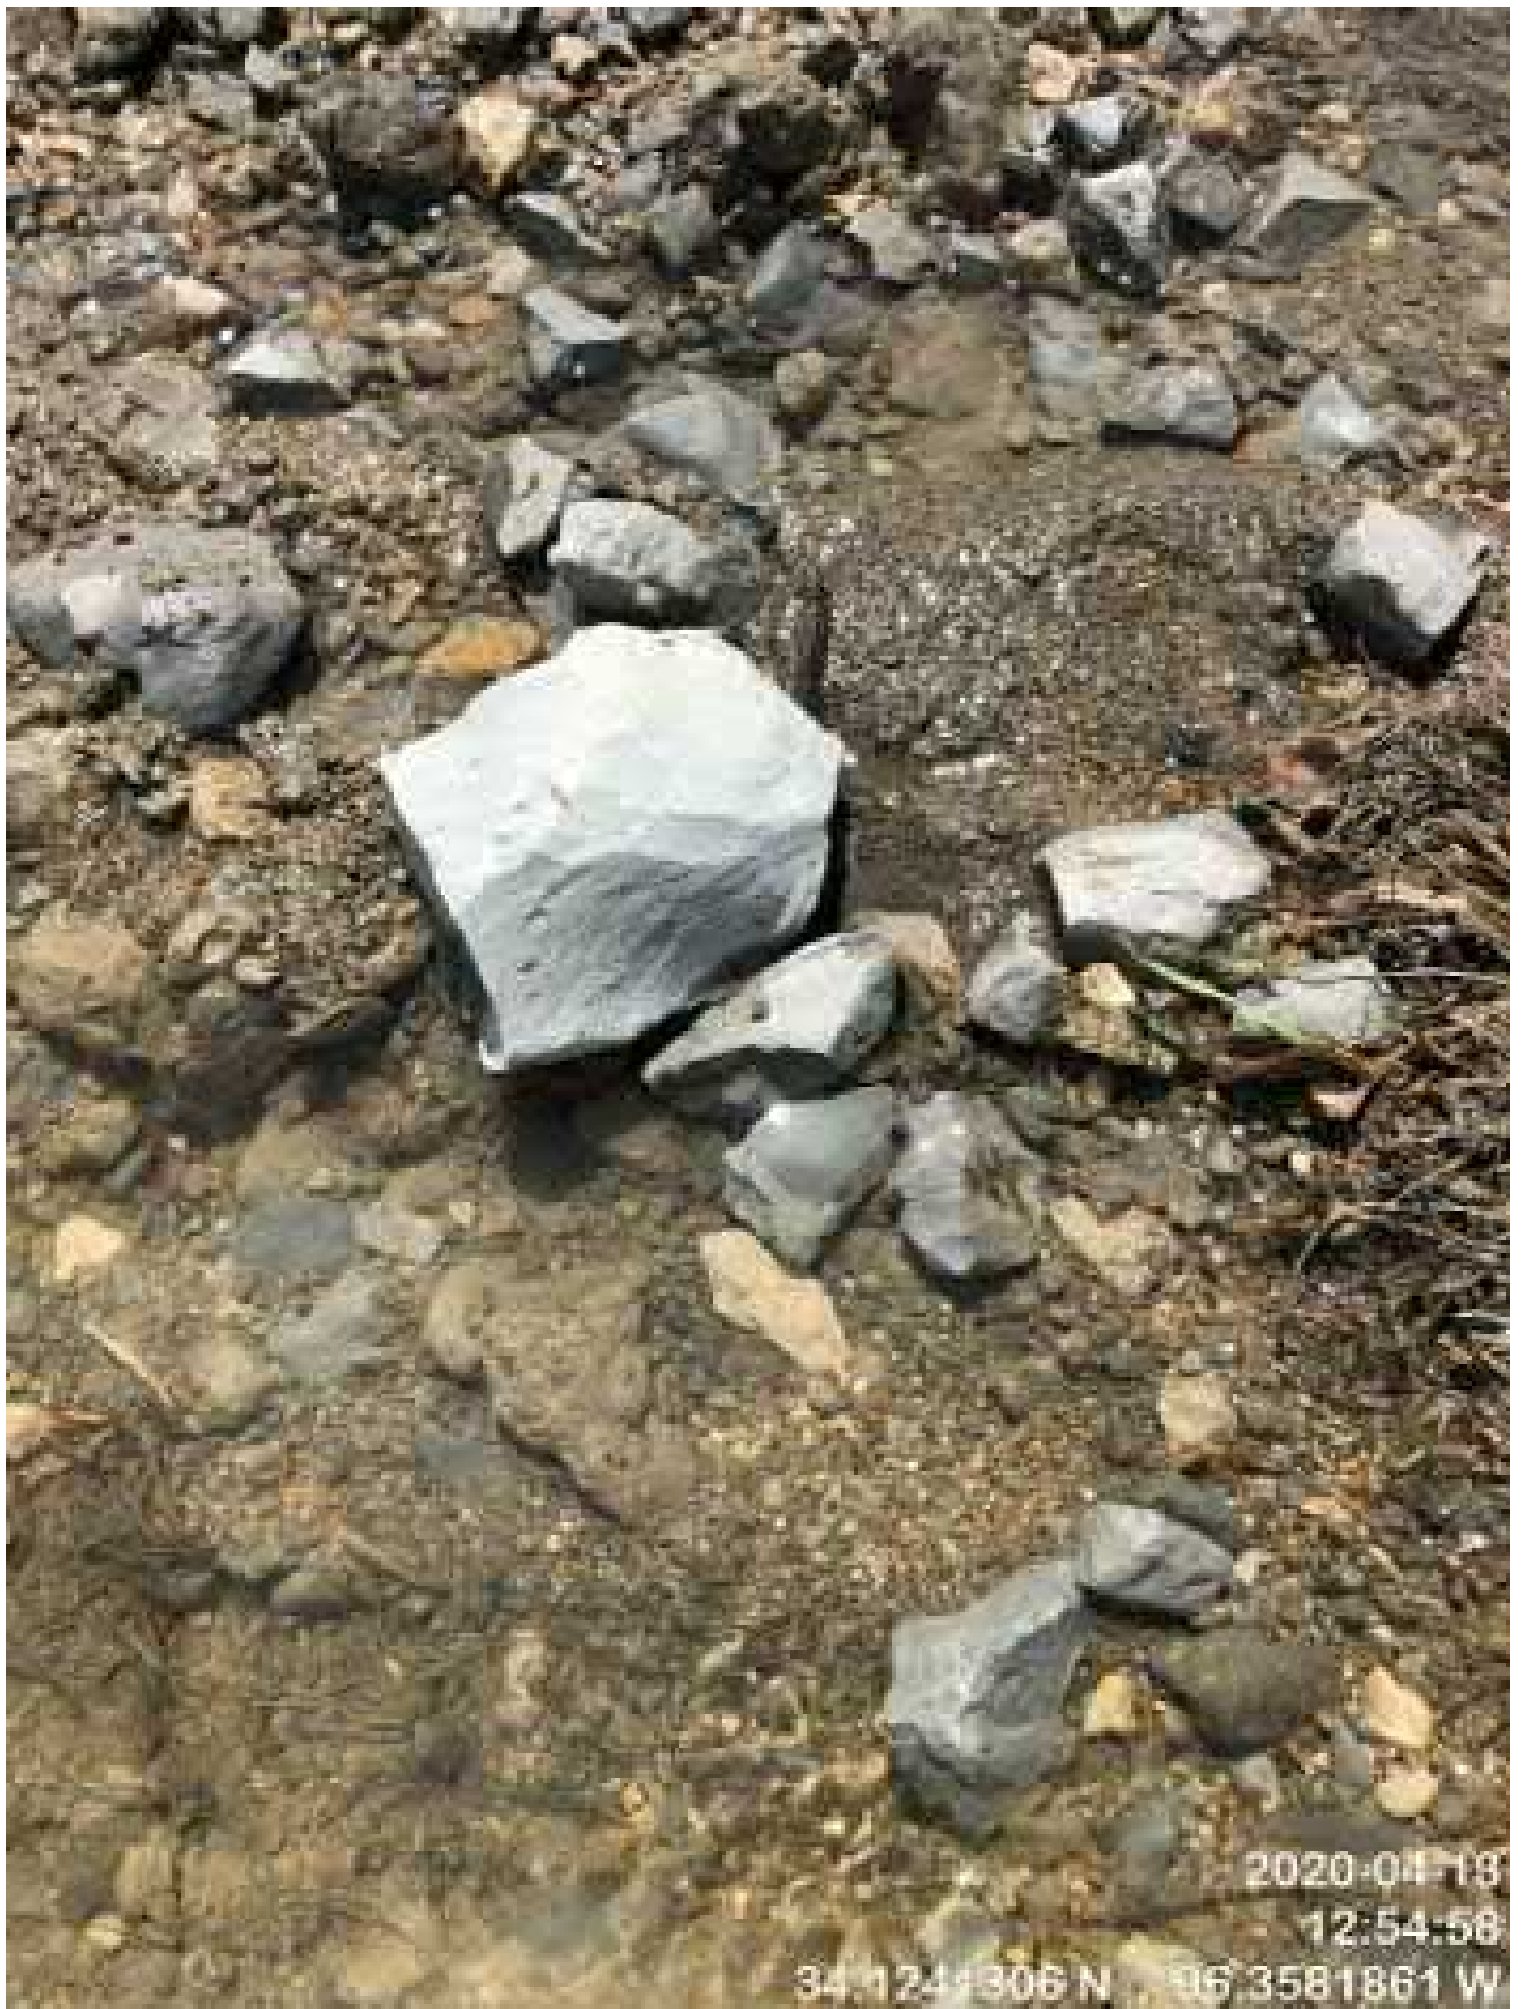
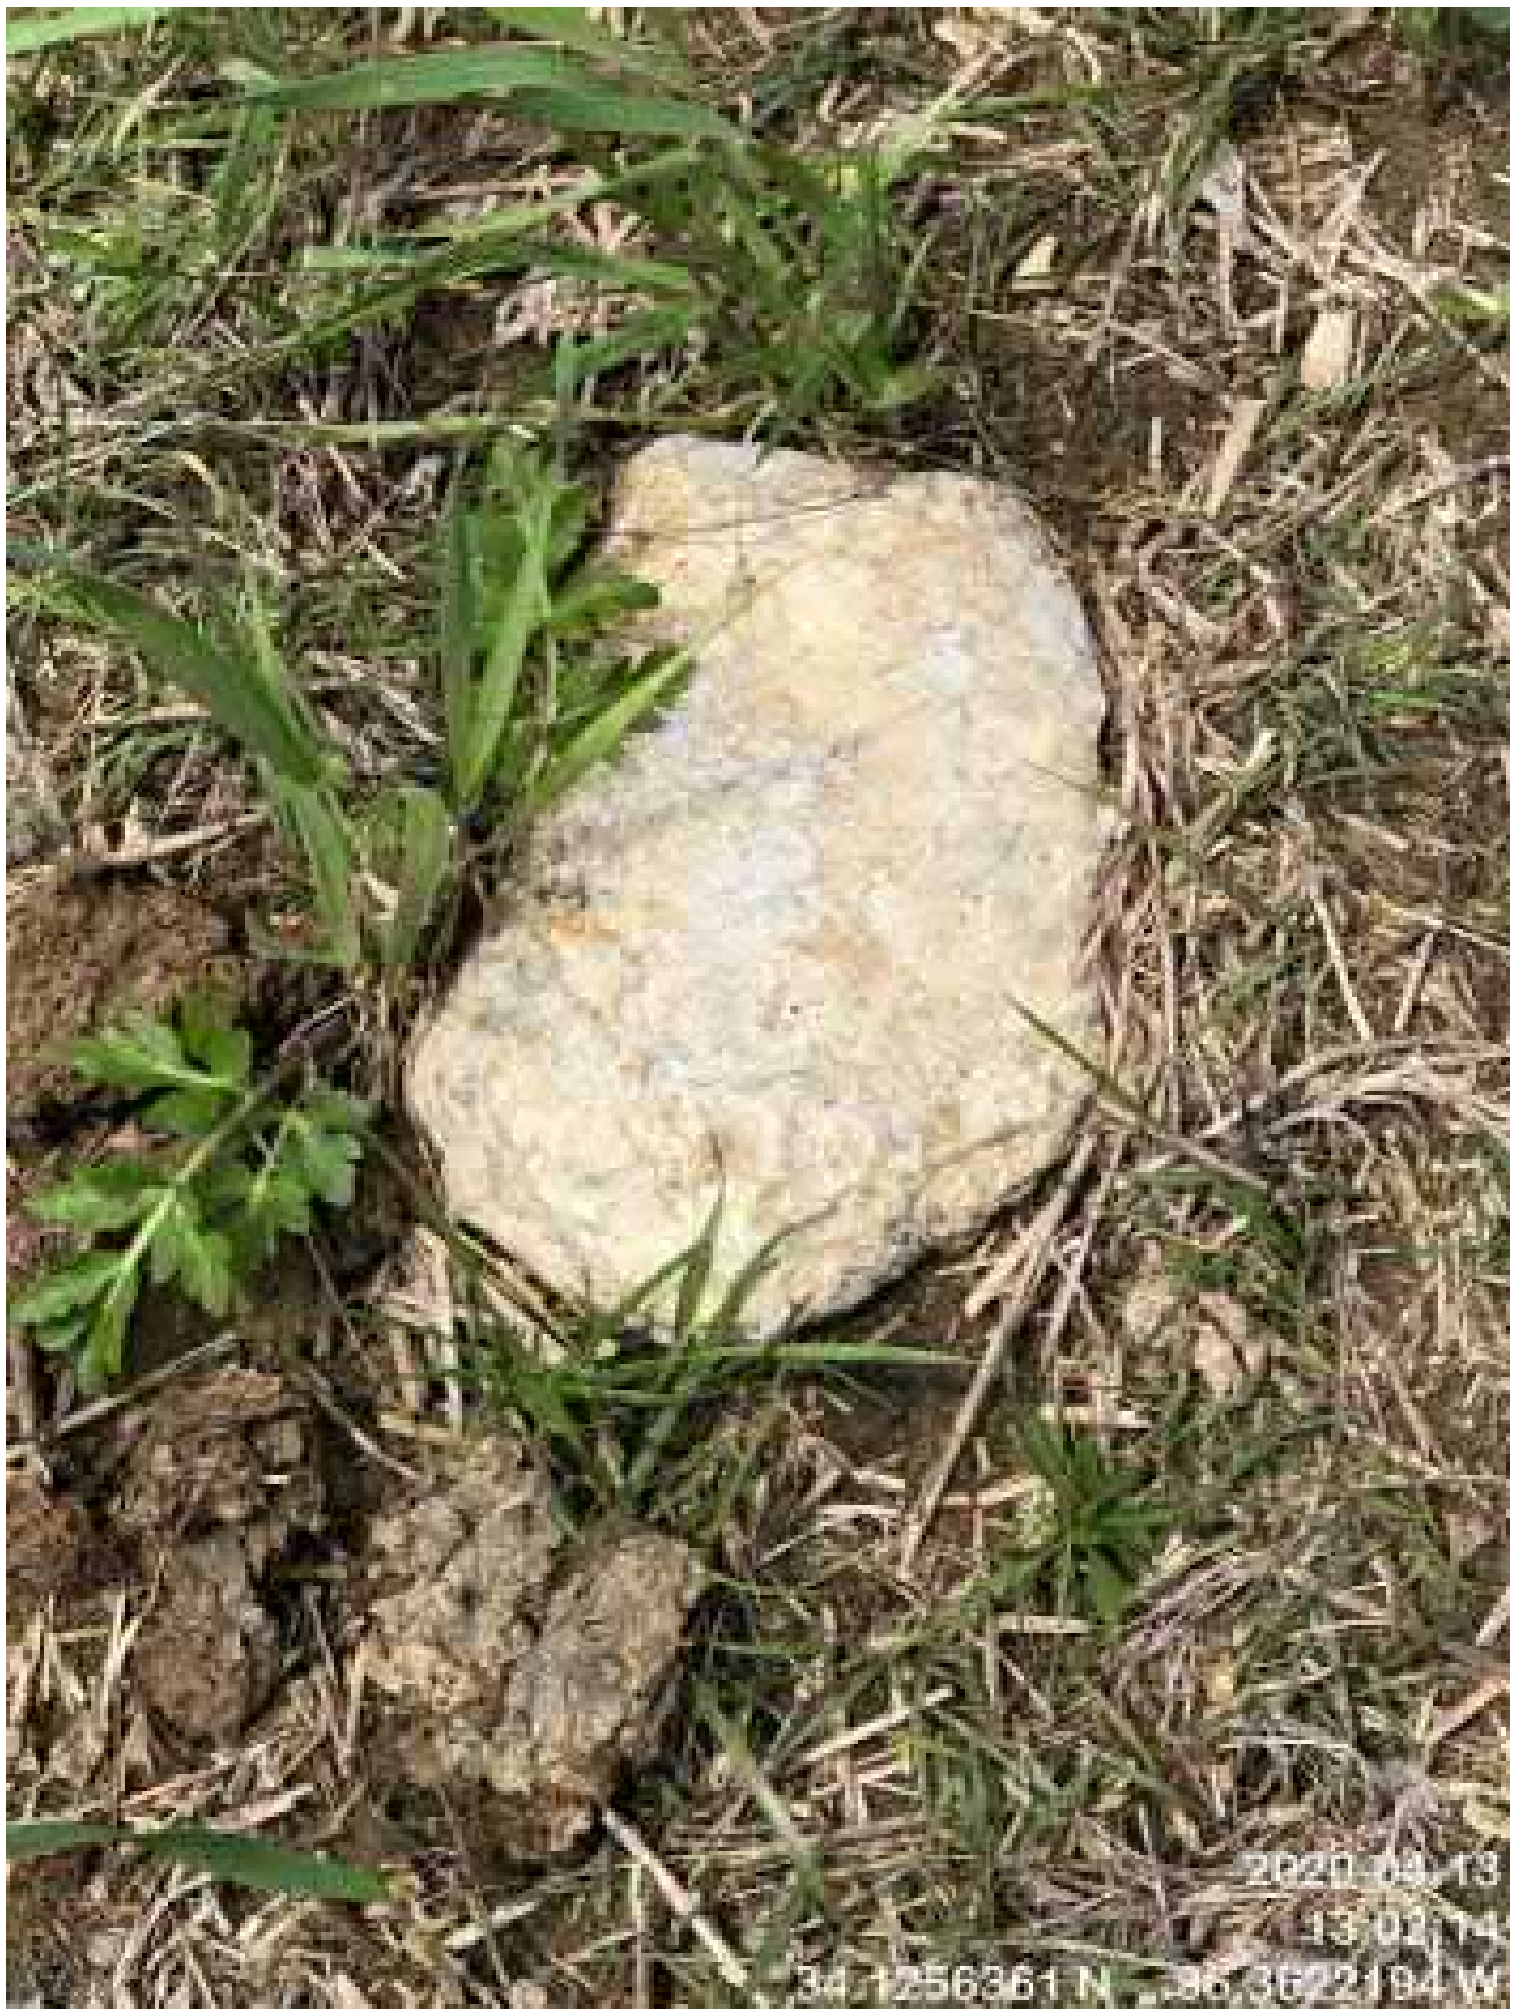
April 13, 2020 Site Inspection
Lee & Anna Chappa
BR-0890.000
Mile Post: MP 176
Bryan County, Oklahoma

- 1.) High levels of rock and blasting material mixed into soil. (FERC Plan: V. A. 3-6.)
 - a. Affected areas naturally have between 4 - 6% rock fragments with a maximum size of 74 mm.
 - b. Affected areas naturally have less than 1% rock fragments with a maximum size of 249 mm.
- 2.) Soil Compaction (FERC Plan: V. C. 1-3.)
 - a. Off-ROW Penetrometer reading: Around 160 psi in multiple locations.
 - b. In-ROW Penetrometer reading: 300 psi limit exceeded in every on-ROW location.
- 3.) Severe erosion on and off ROW (FERC Plan: IV. F. 1, 3-4.)
- 4.) Ponding
