Robert Squires - Squires Consulting LLC
Landowner Advocate

Opening Statement for May 5, 2021 Subcommittee on Civil Rights and Civil Liberties Hearing:
“Pipelines Over People (Part II): Midship Pipeline’s Disregard for Landowners in Its Pathway”

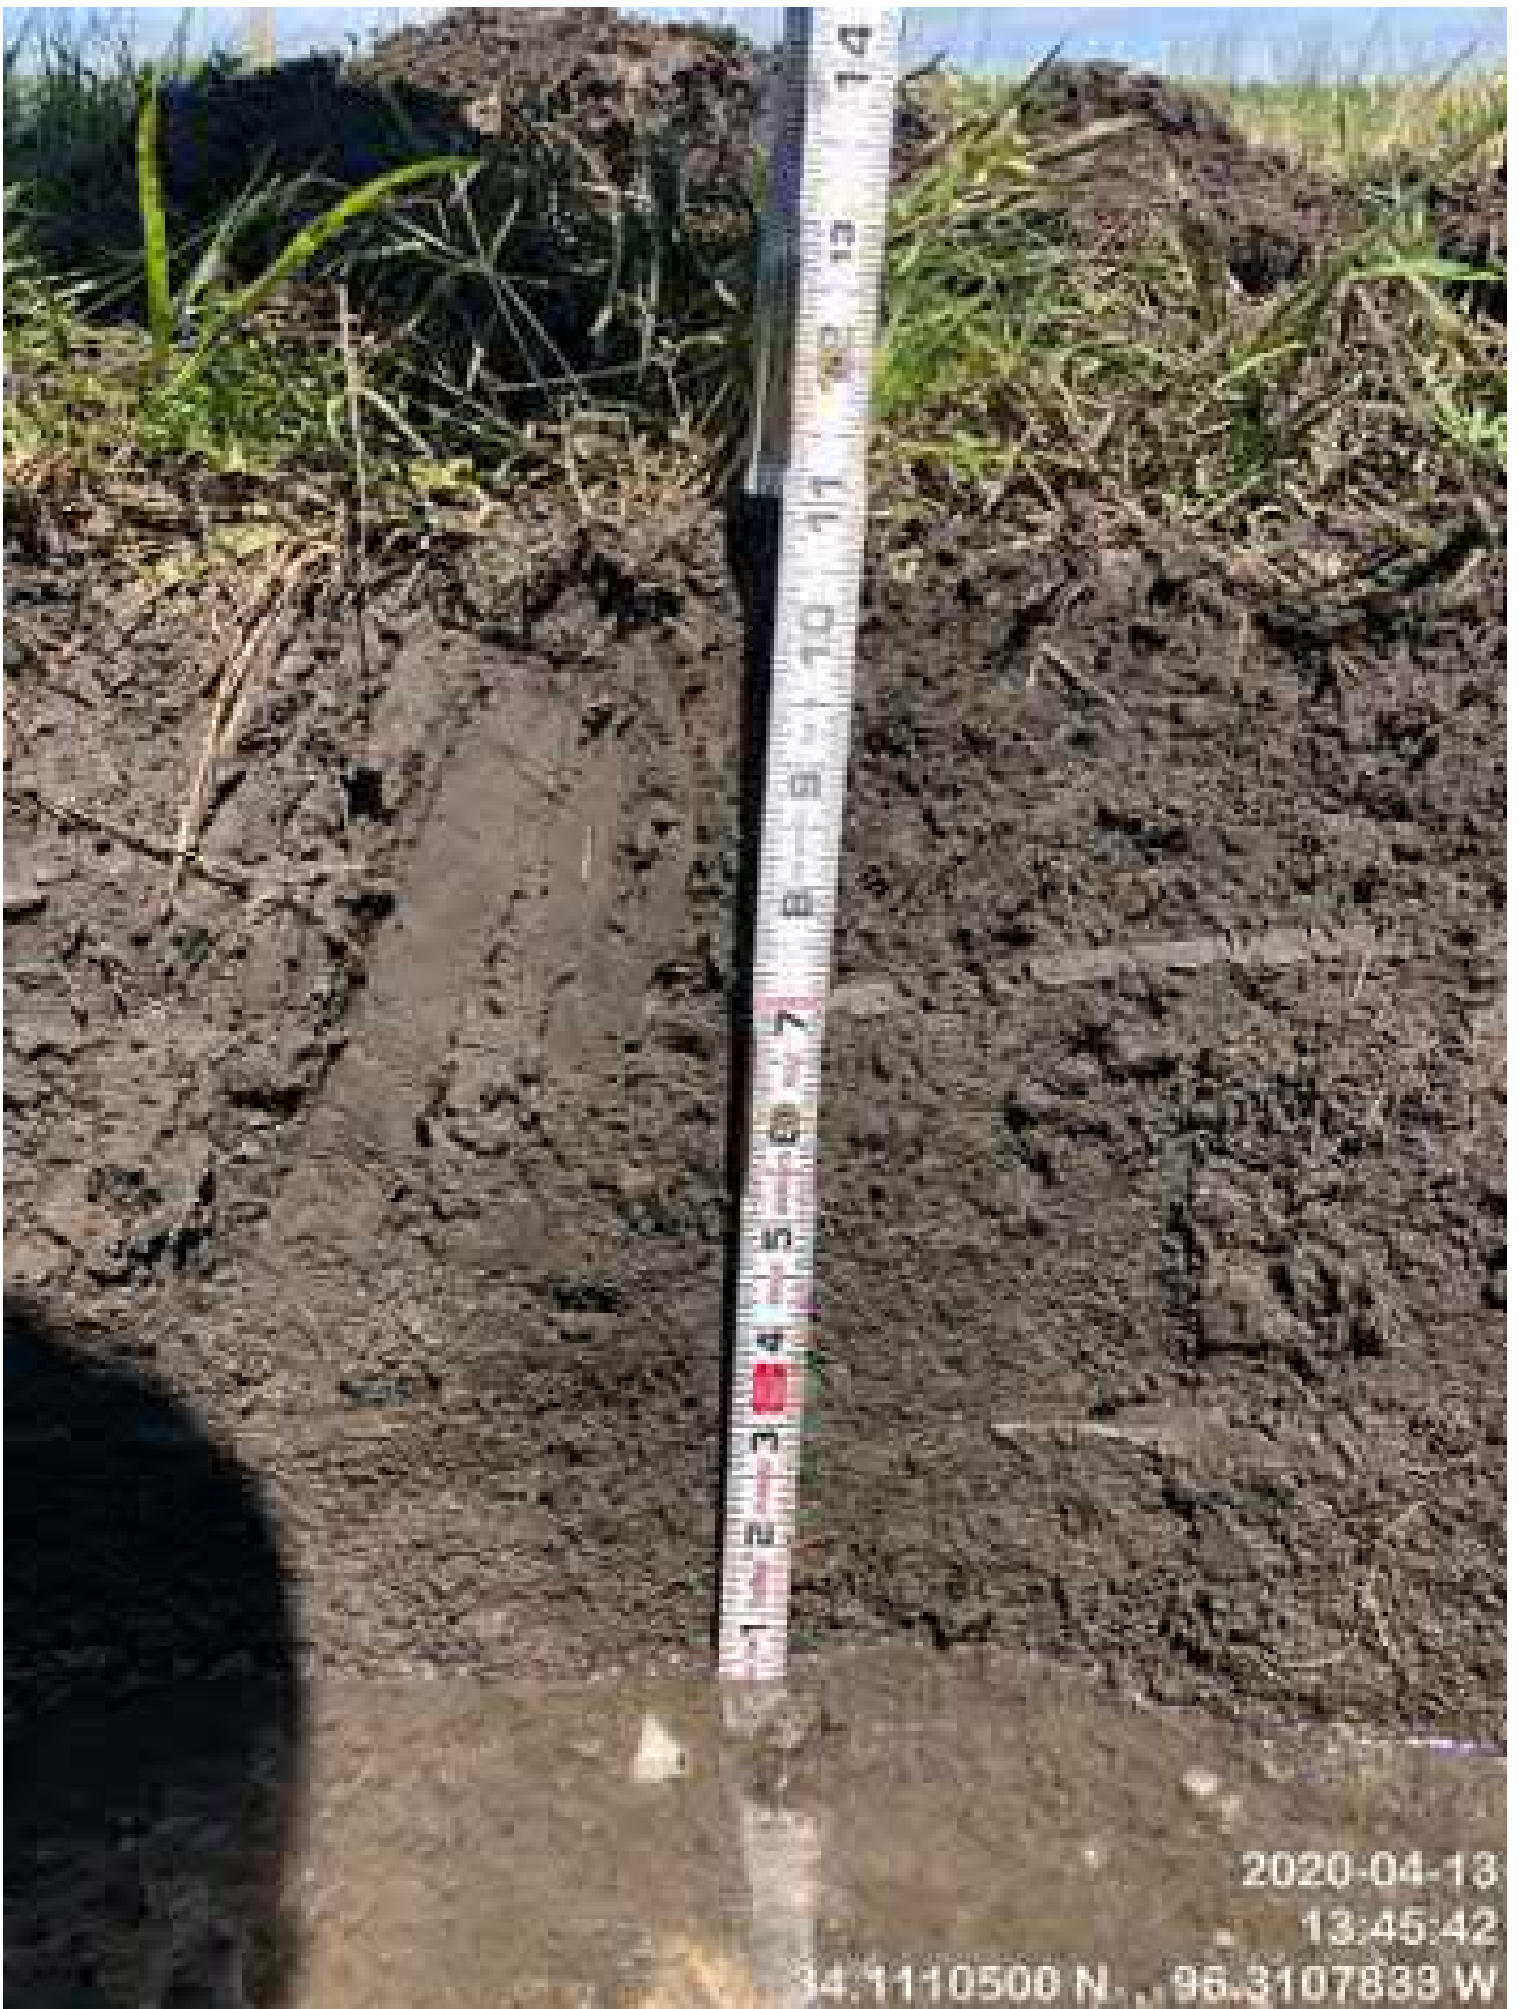
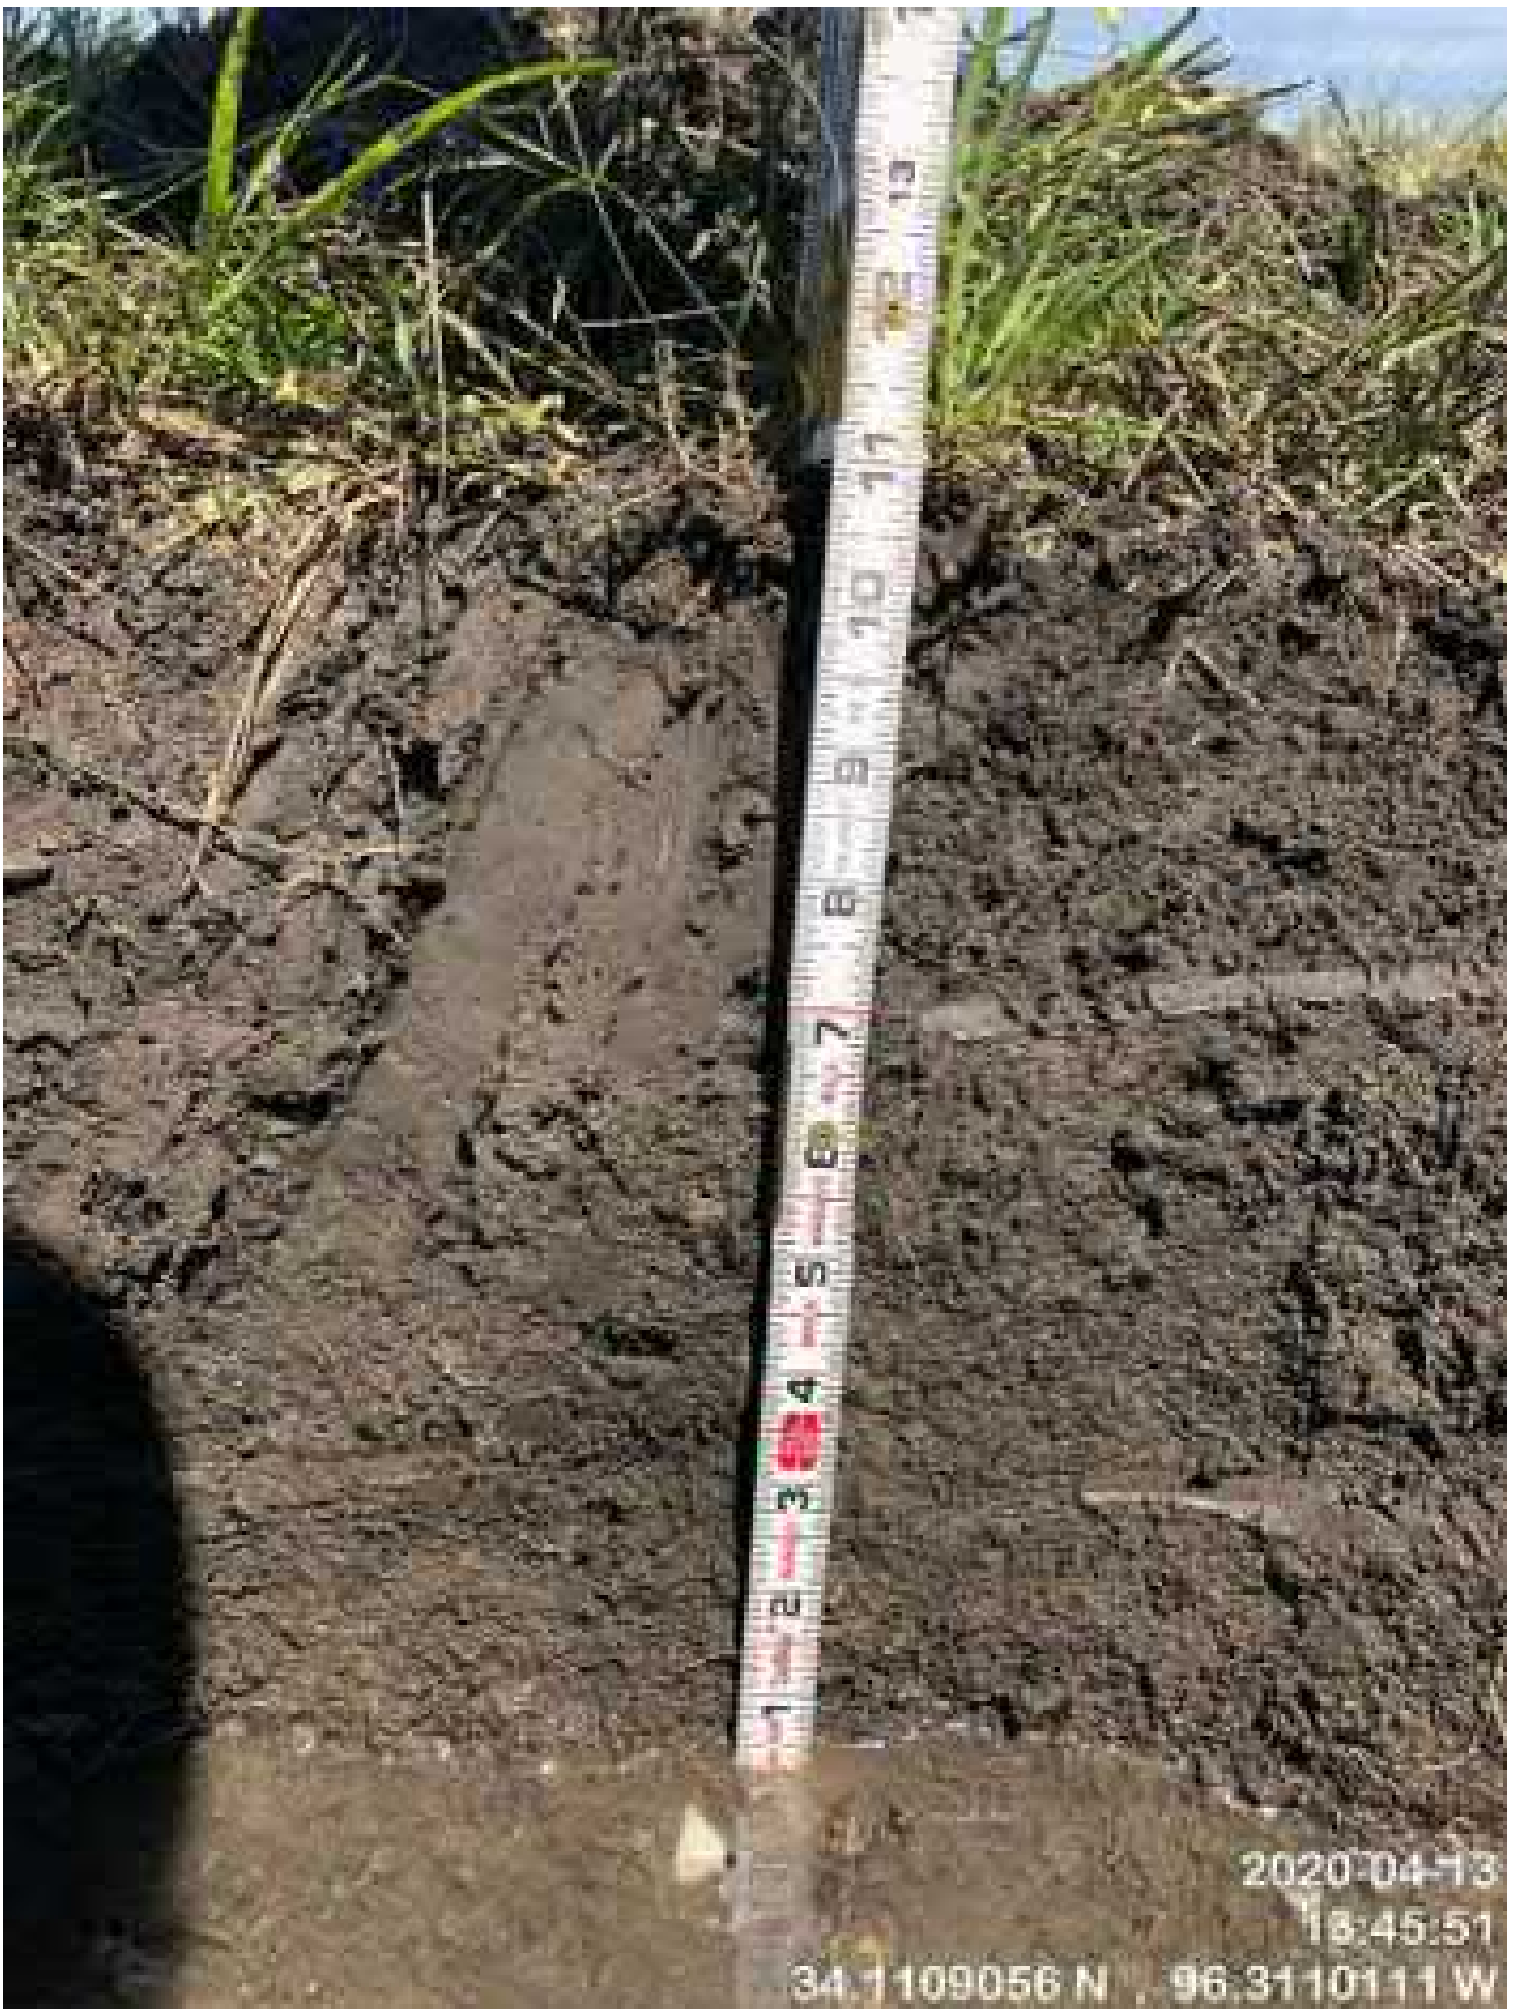
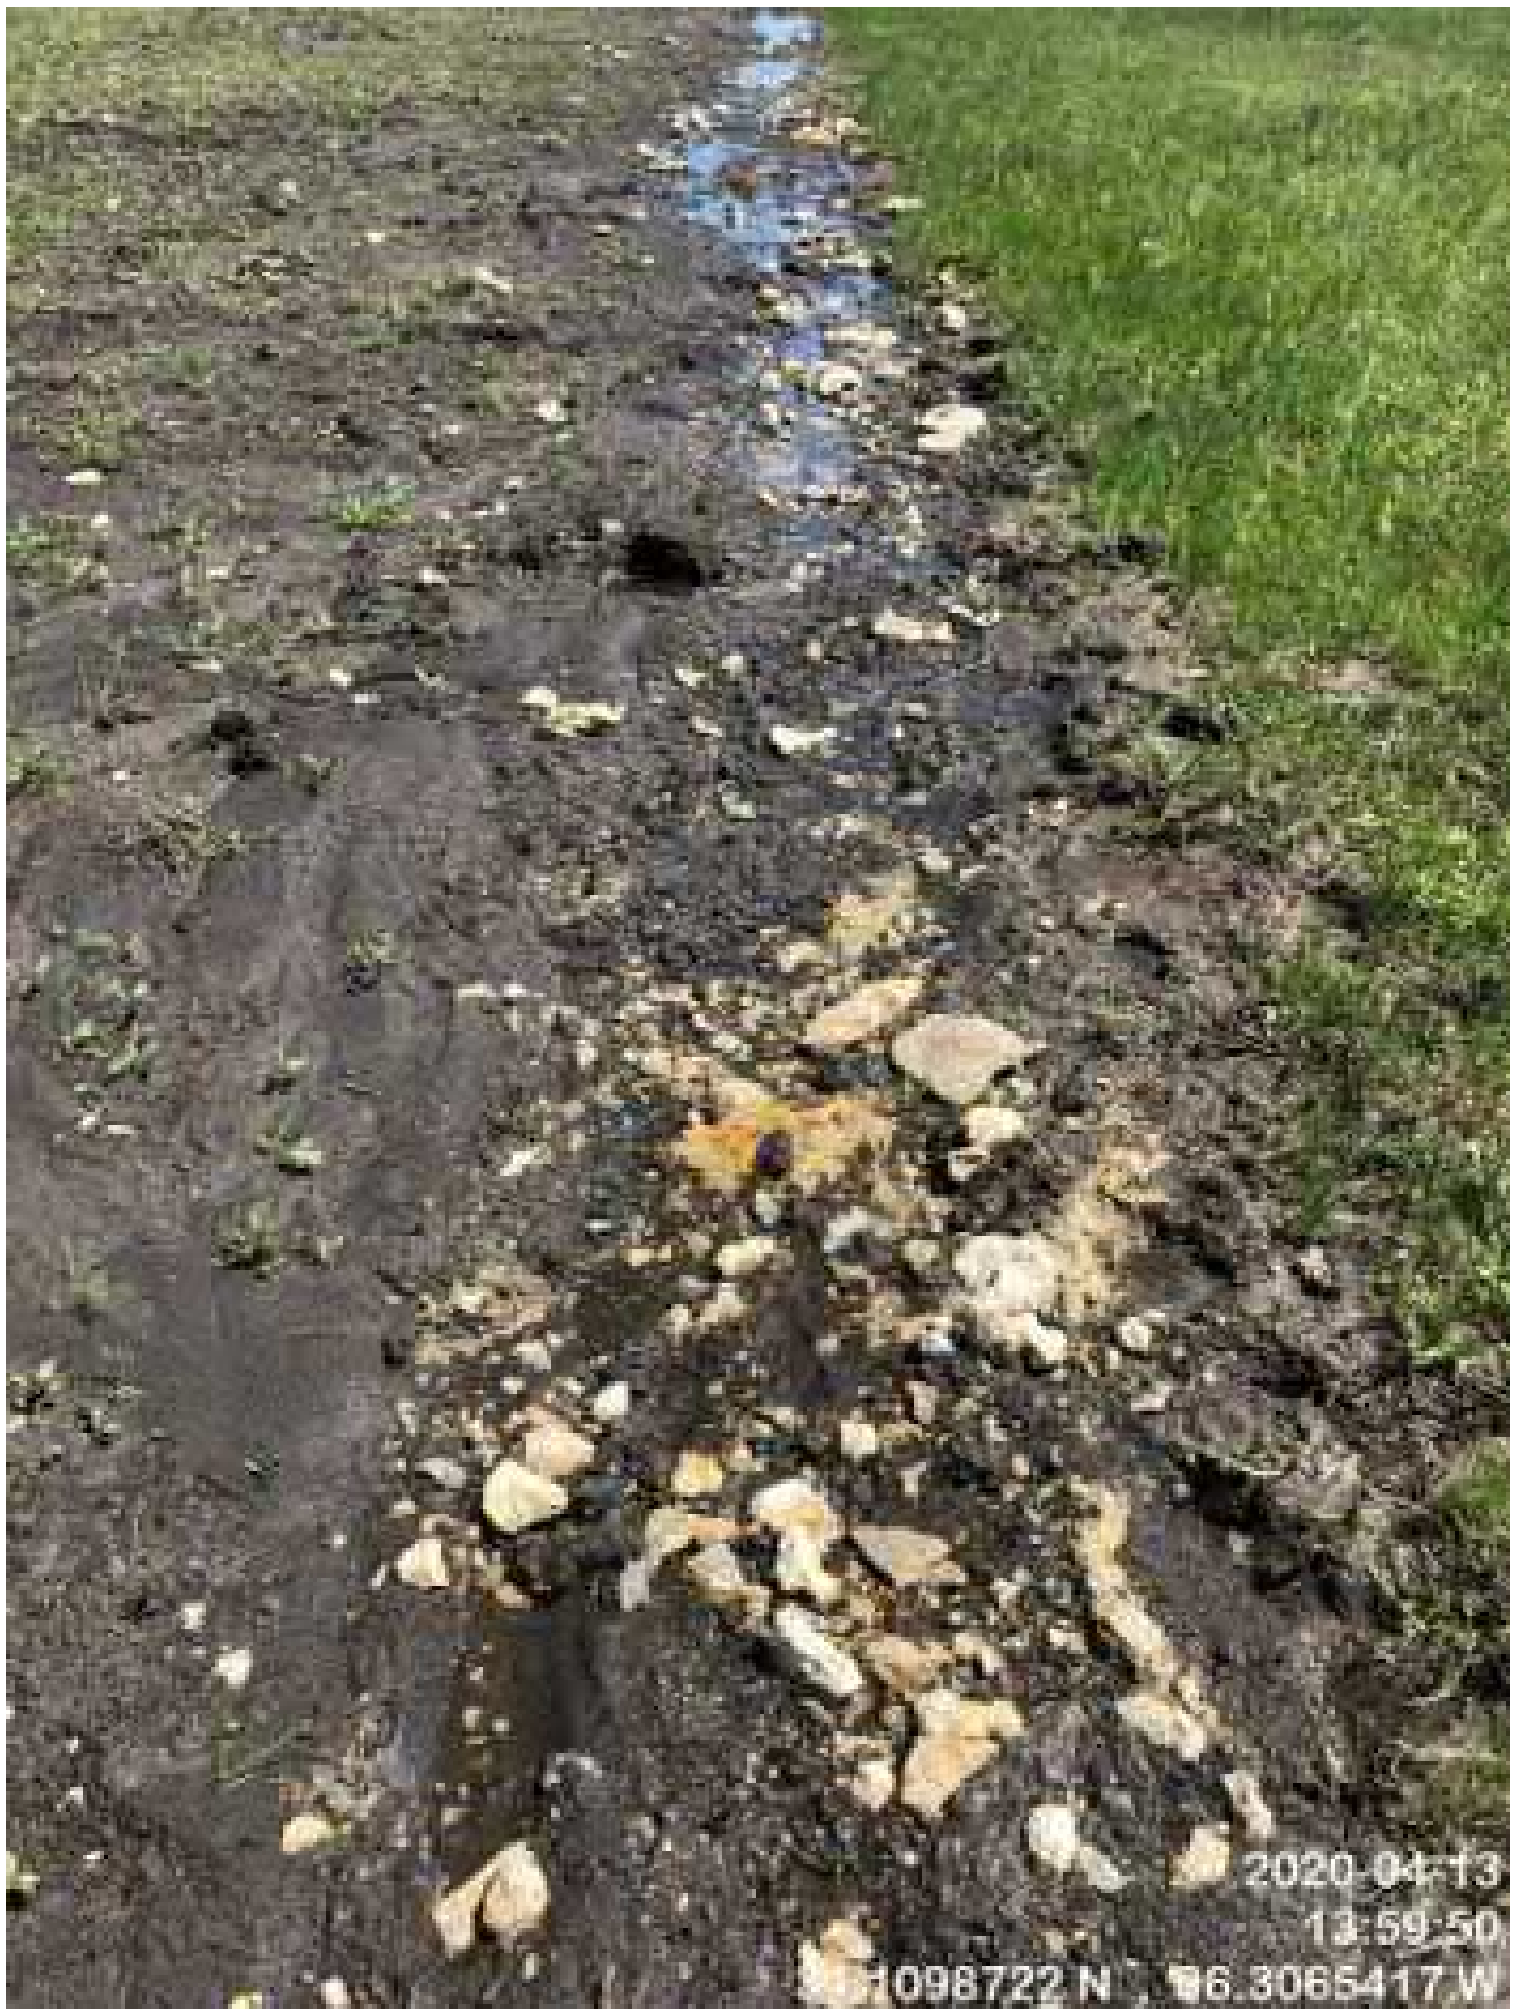
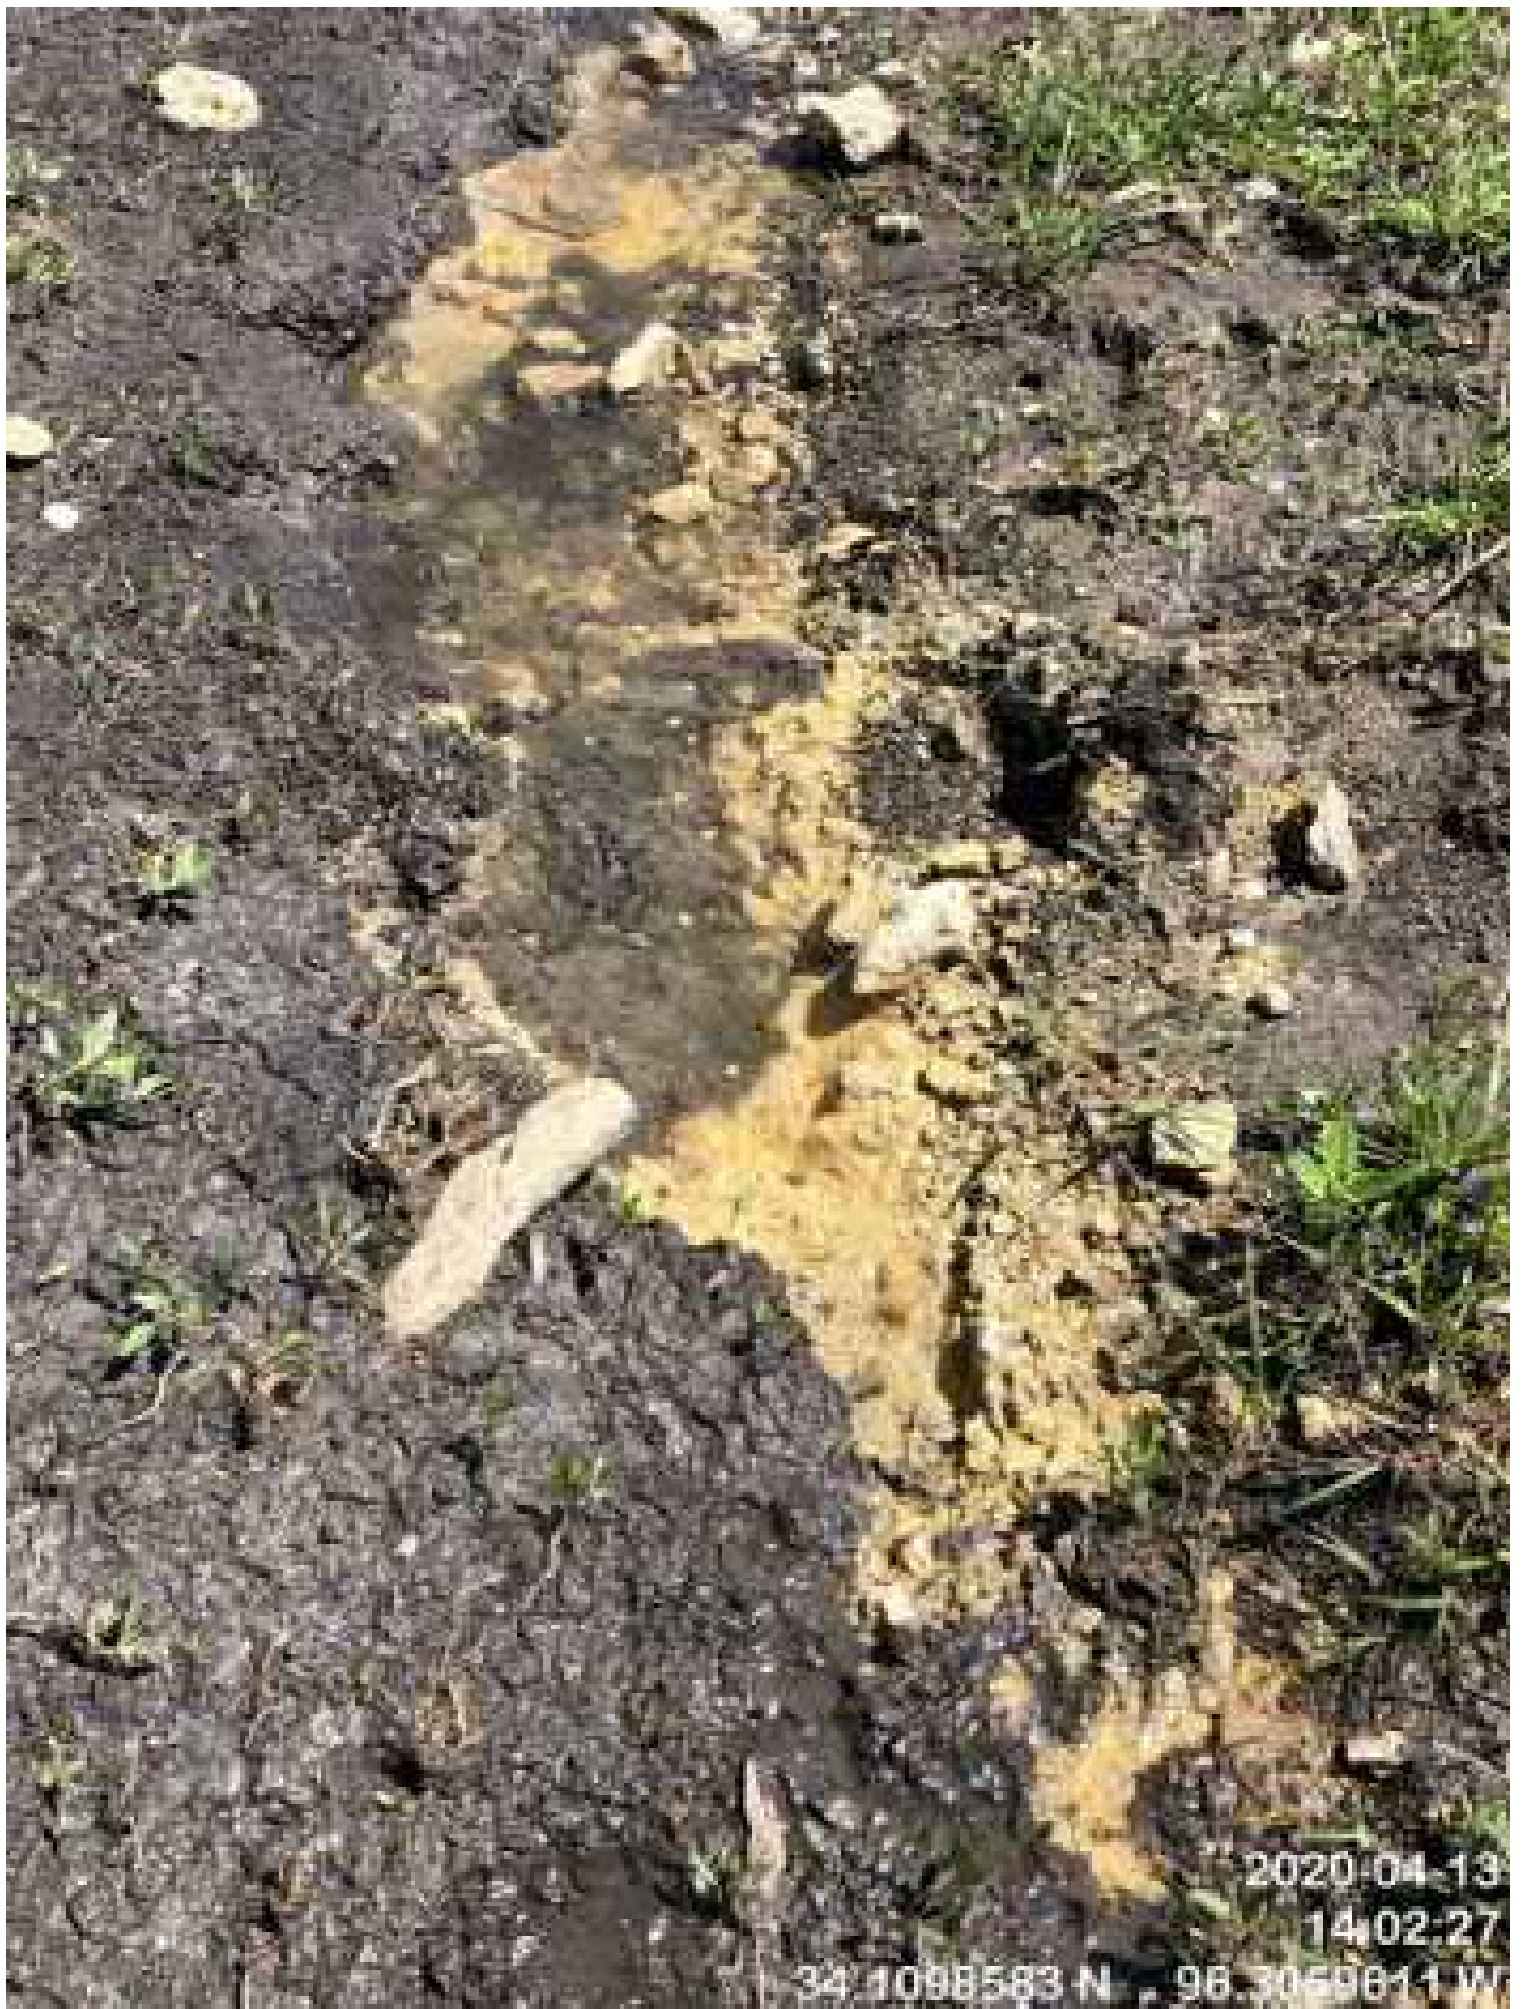
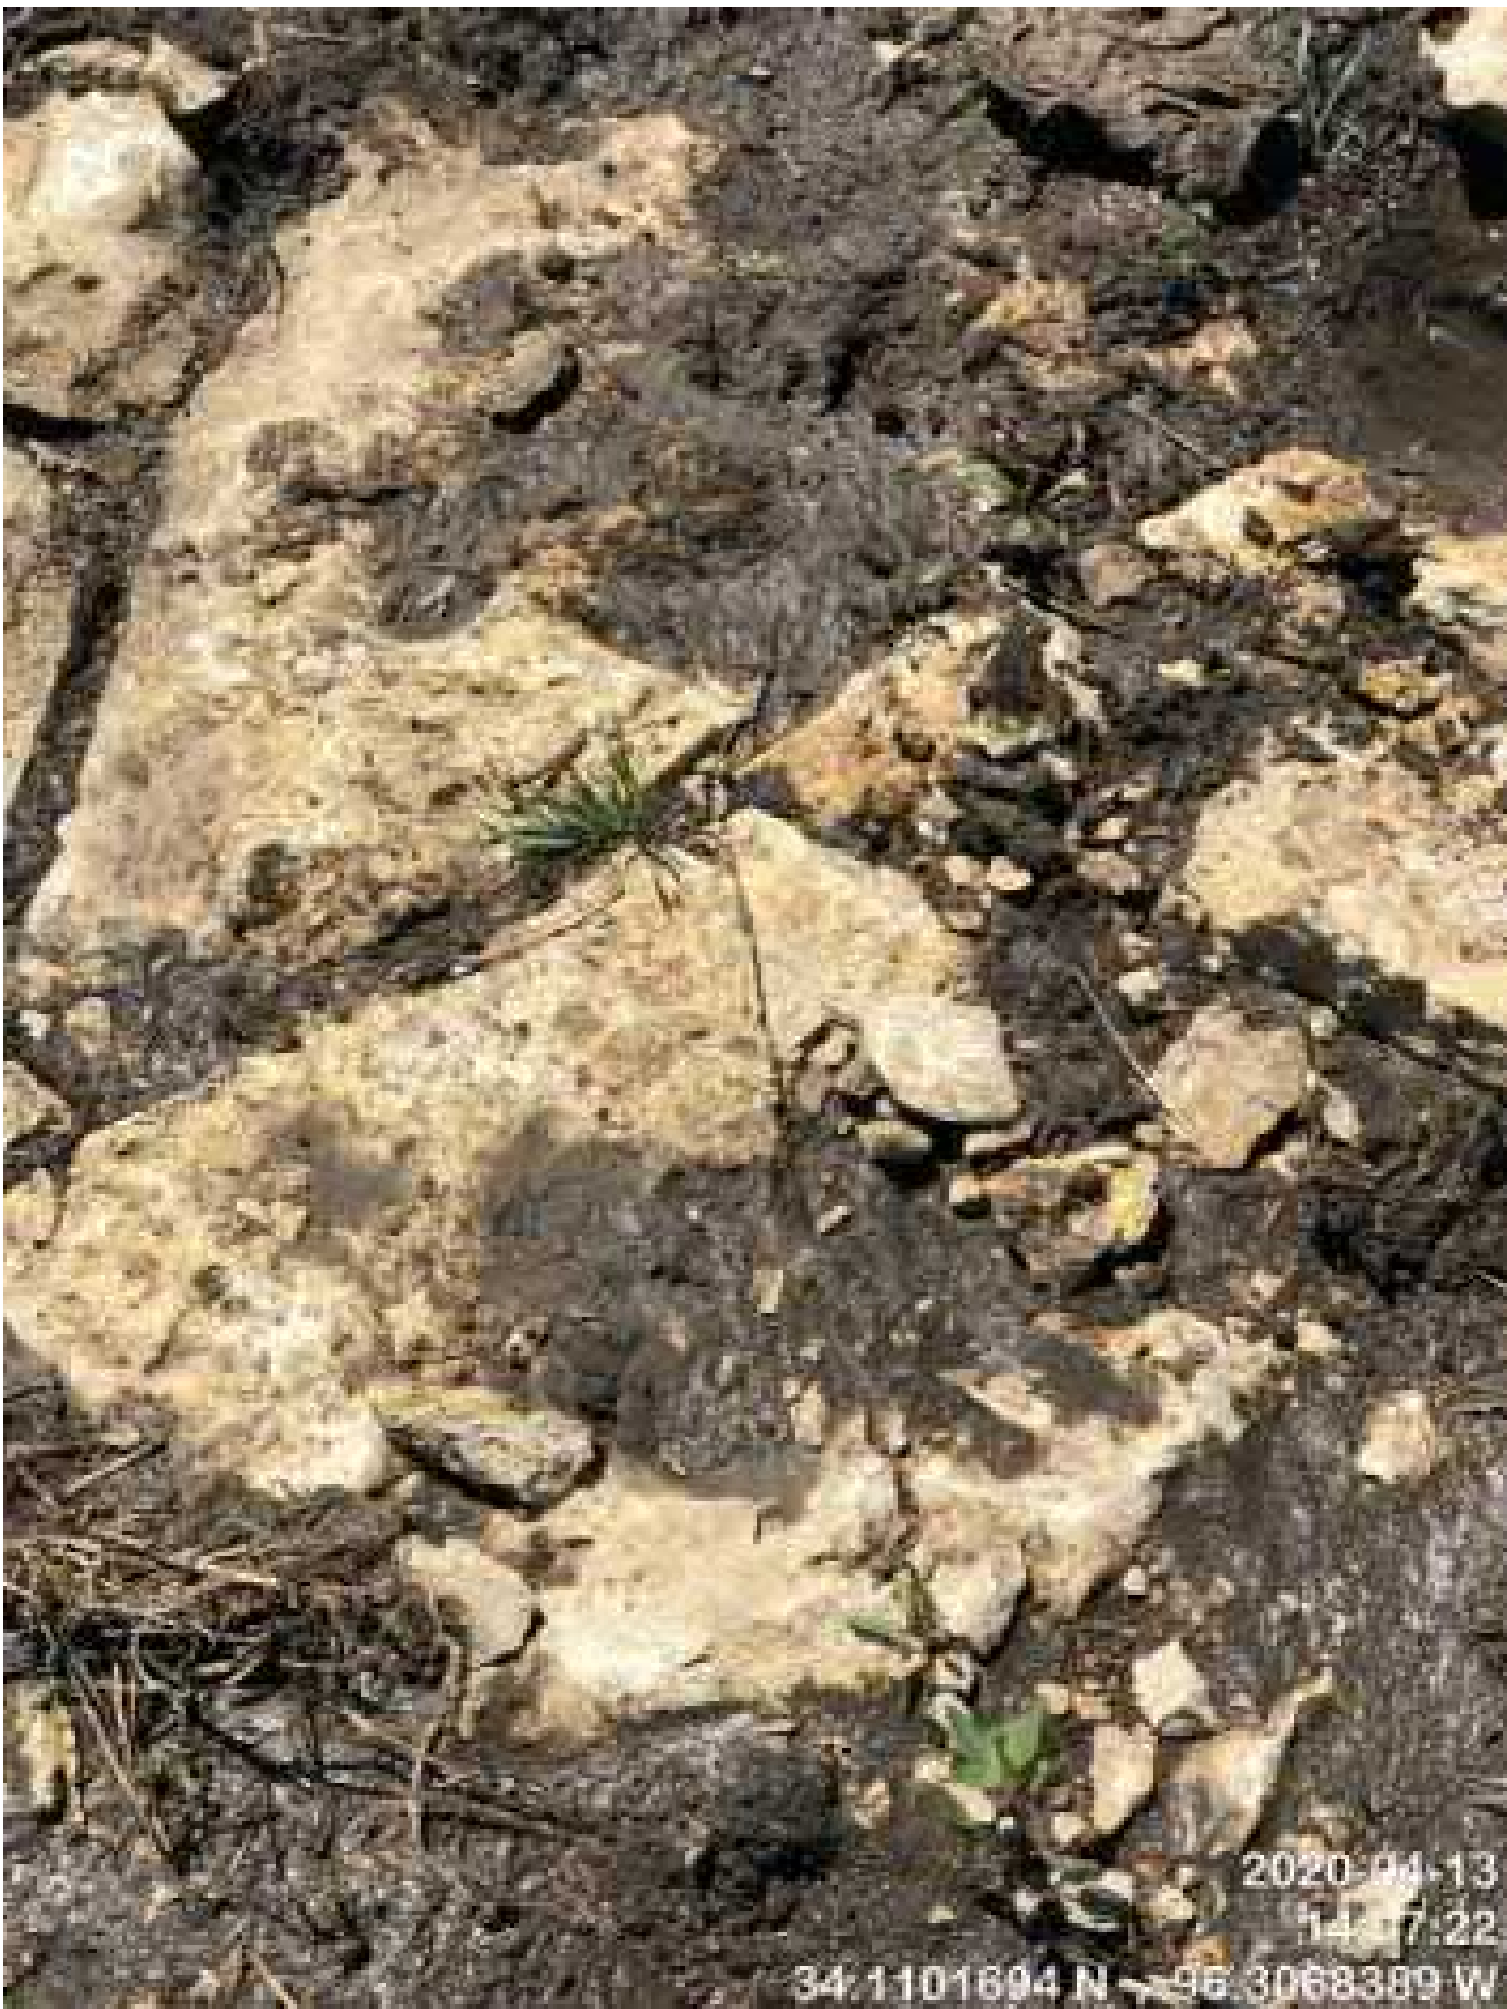
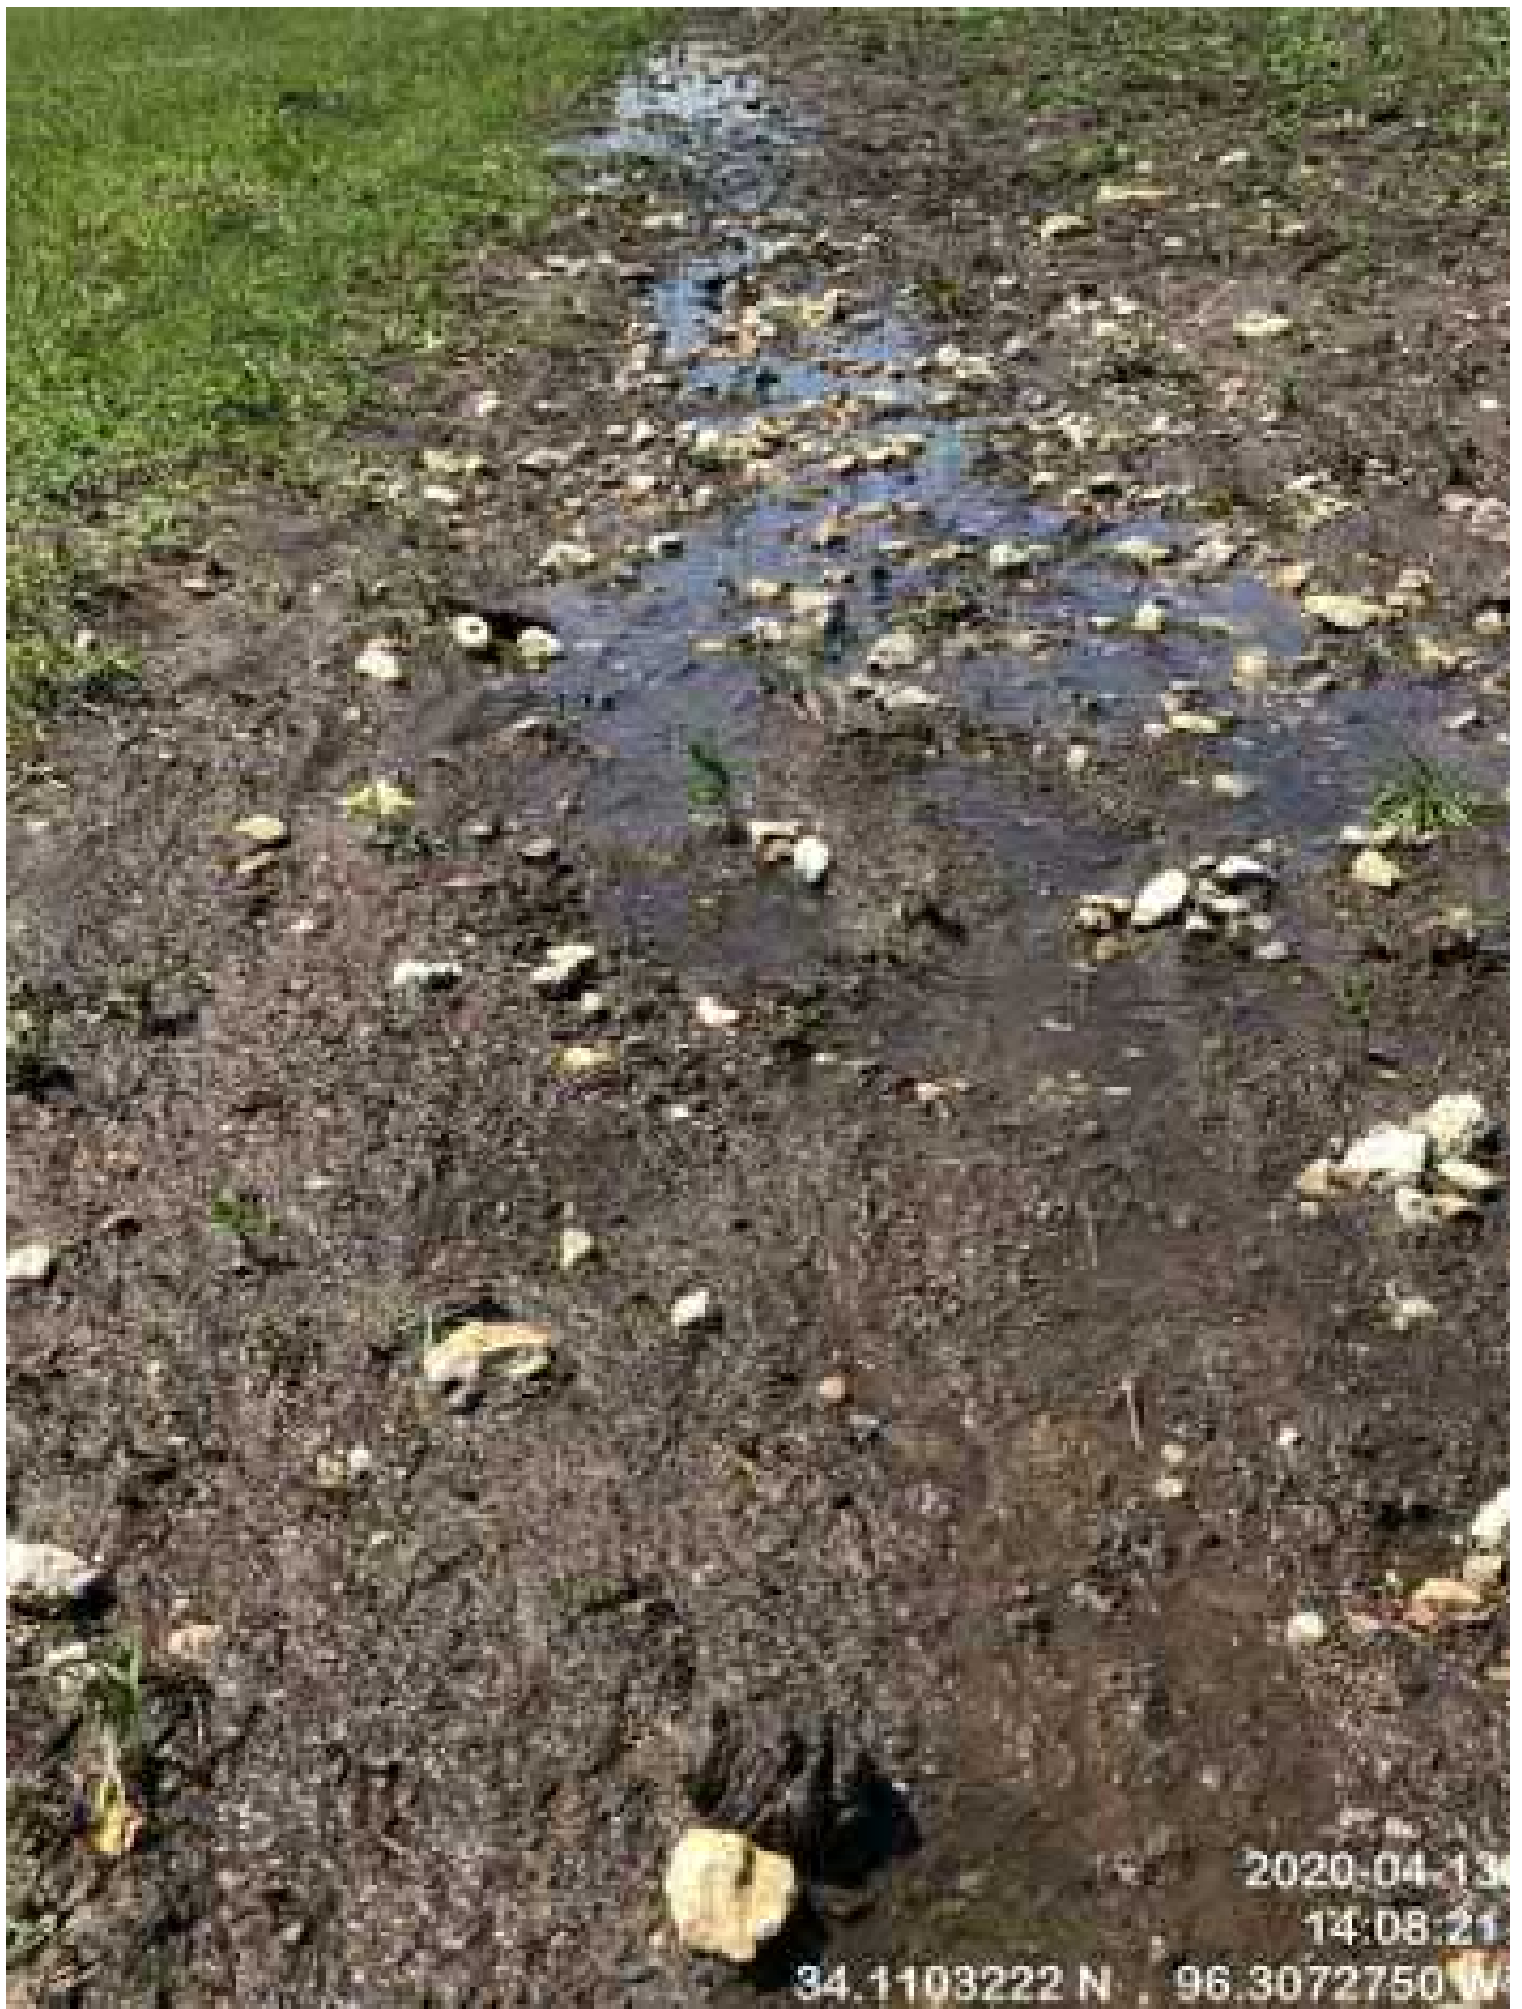
**April 13, 2020 Site Inspection
Misty Tally & Marla Childers
BR-0903.000, BR-0904.000, BR-0905.000
Mile Post: MP 179 - 179.5
Bryan County, Oklahoma**

- 1.) Midship has backfilled and conducted rough cleanup while not replacing the damaged topsoil that has been mixed with the subsoil. In addition, the contractors did not remove the shale, large rocks, and ongoing erosion in the easement.
- 2.) Erosion and lack of revegetation due to Blasting material, subsoil, and topsoil mixing; Remove all mixed soils, large rocks, blasting material. Conduct de-compaction in subsoil and topsoil.

- 1.) Soil Compaction (FERC Plan: V. C. 1-3.)
 - a. Off-ROW Penetrometer reading: Around 175 psi in multiple locations.
 - b. In-ROW Penetrometer reading: 300 psi limit exceeded in every on-ROW location.
- 2.) High levels of rock and blasting material mixed into soil. (FERC Plan: V. A. 3-6.)
 - a. In top 20" affected areas naturally have around 6% rock fragments with a maximum size of 74 mm.
 - b. In top 20" affected areas naturally have around 1% rock fragments with a maximum size of 249 mm.
