Robert Squires - Squires Consulting LLC
Landowner Advocate

Opening Statement for May 5, 2021 Subcommittee on Civil Rights and Civil Liberties Hearing:
“Pipelines Over People (Part II): Midship Pipeline’s Disregard for Landowners in Its Pathway”

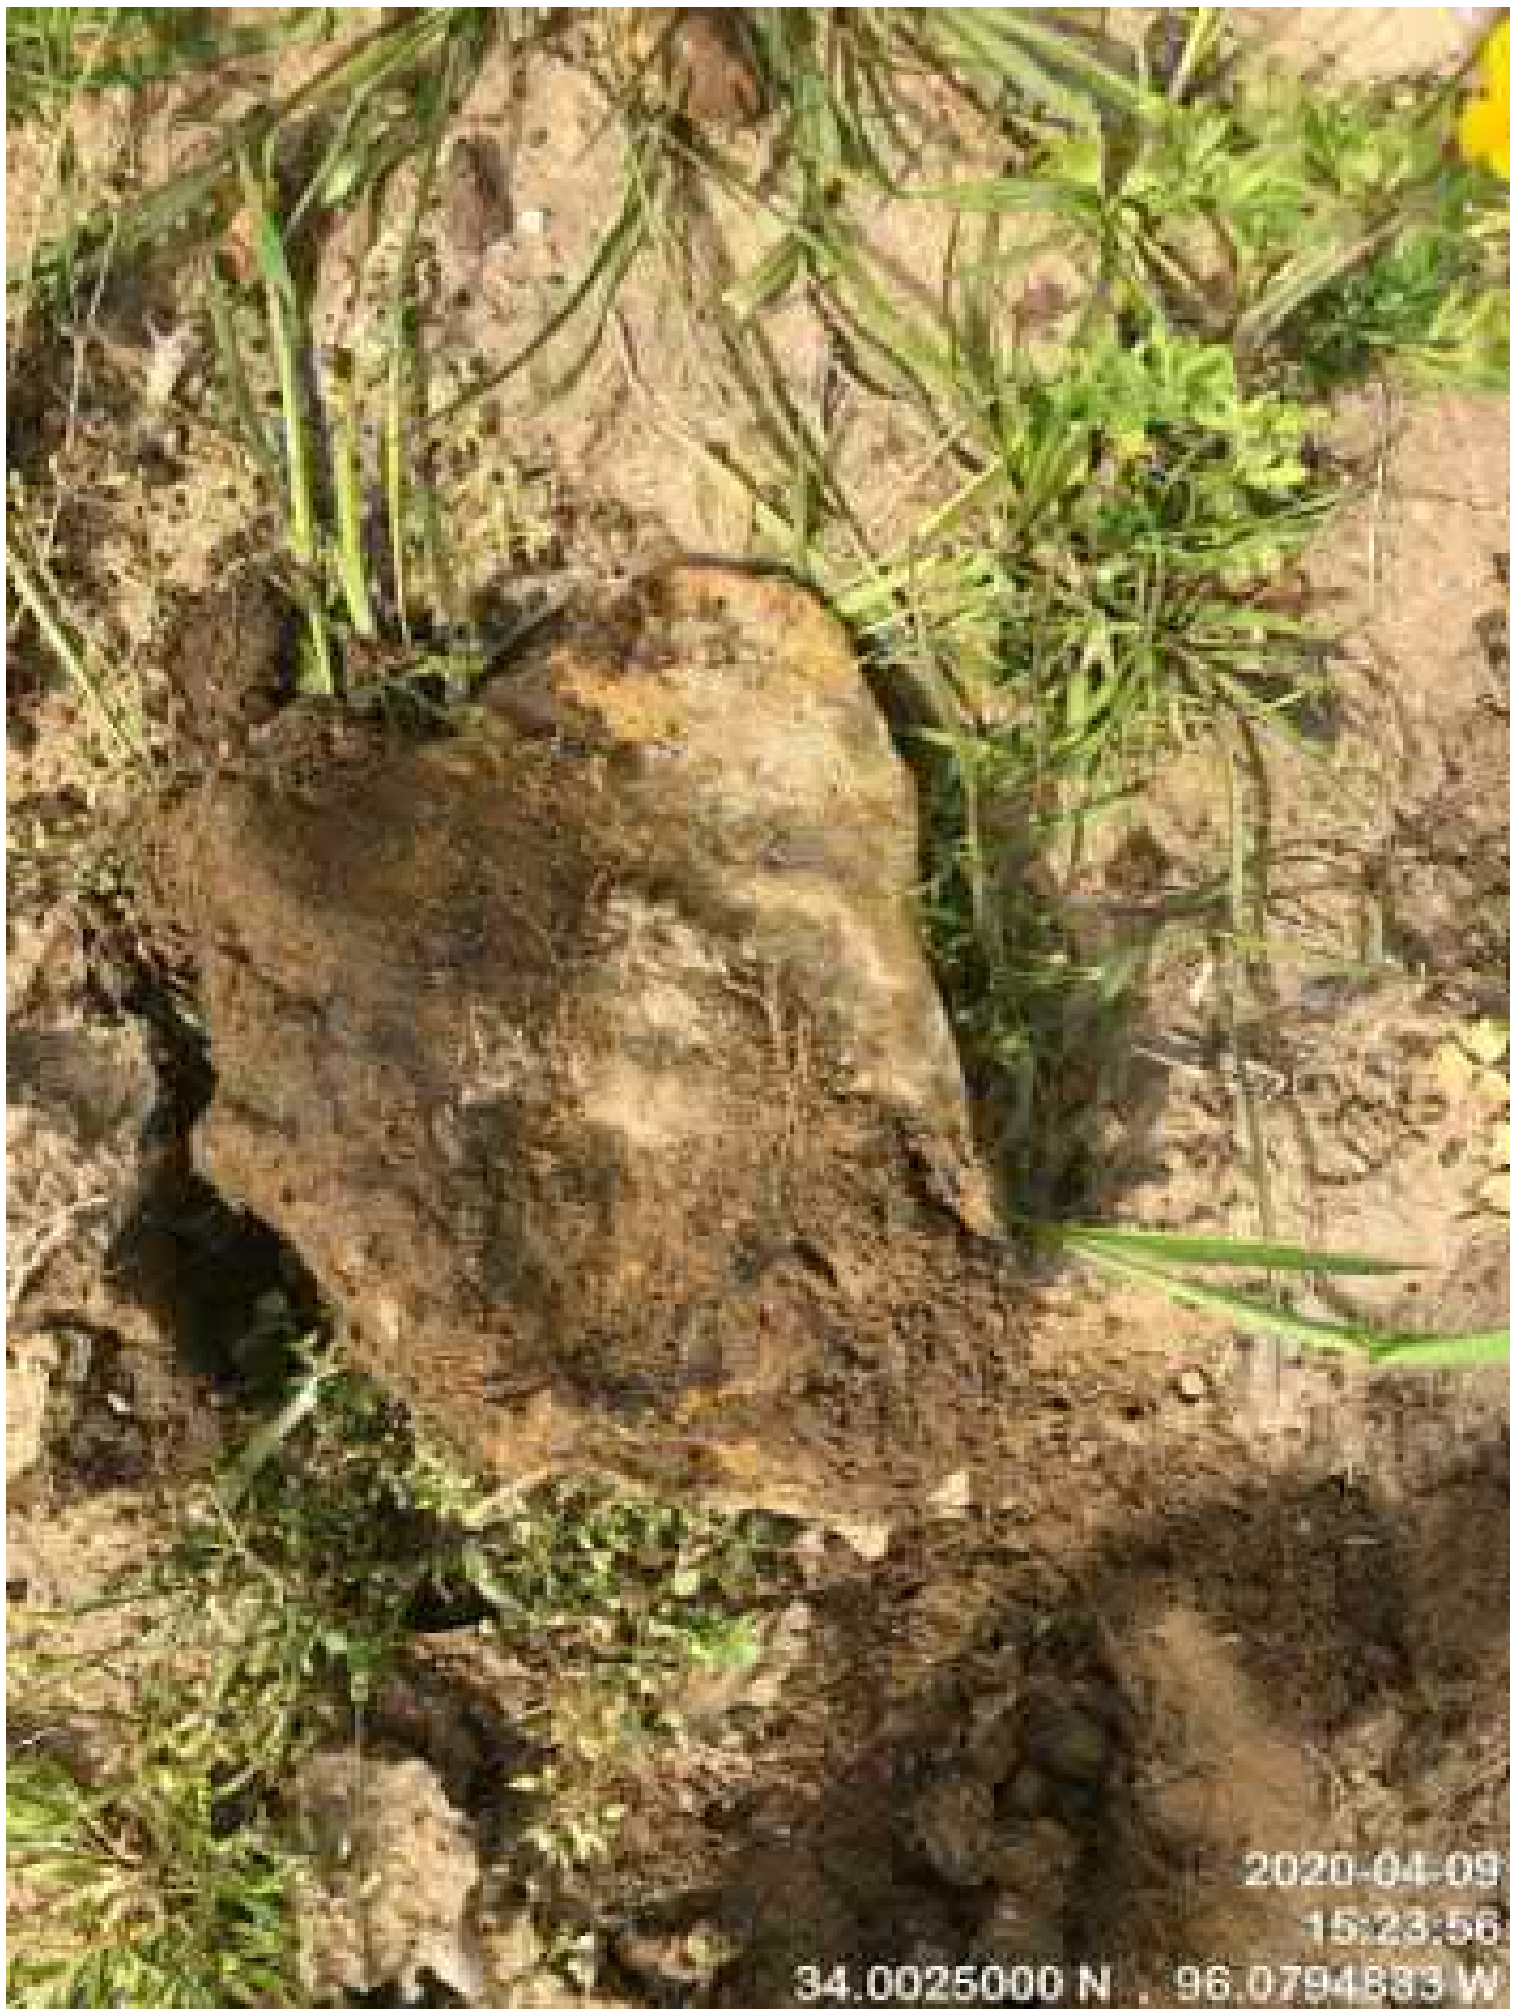
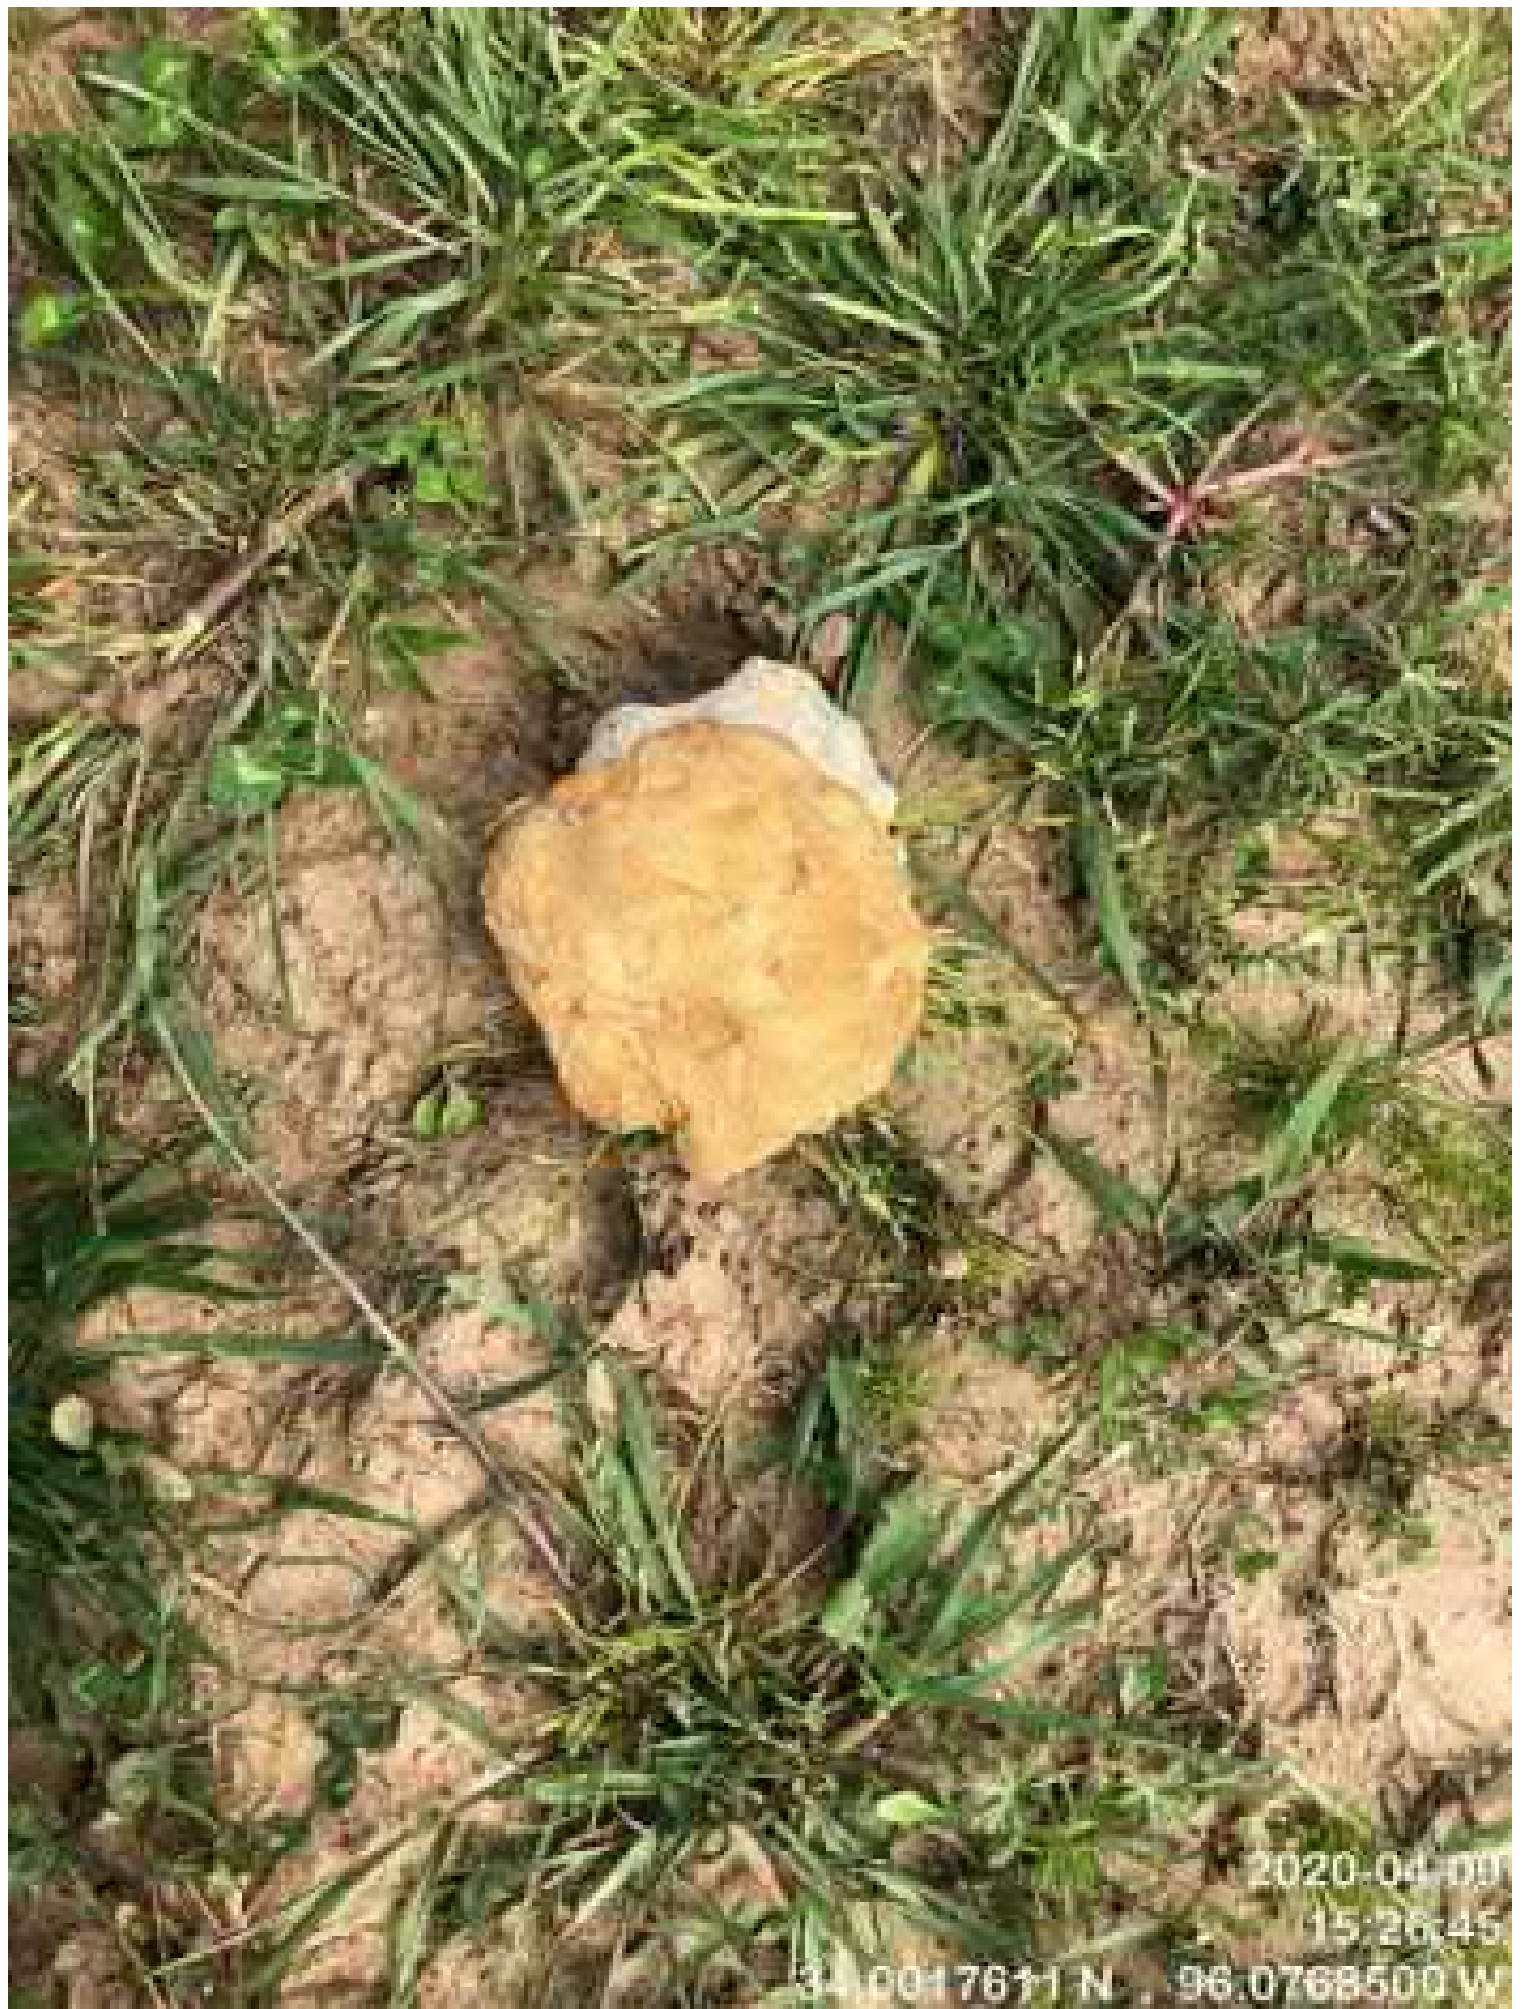
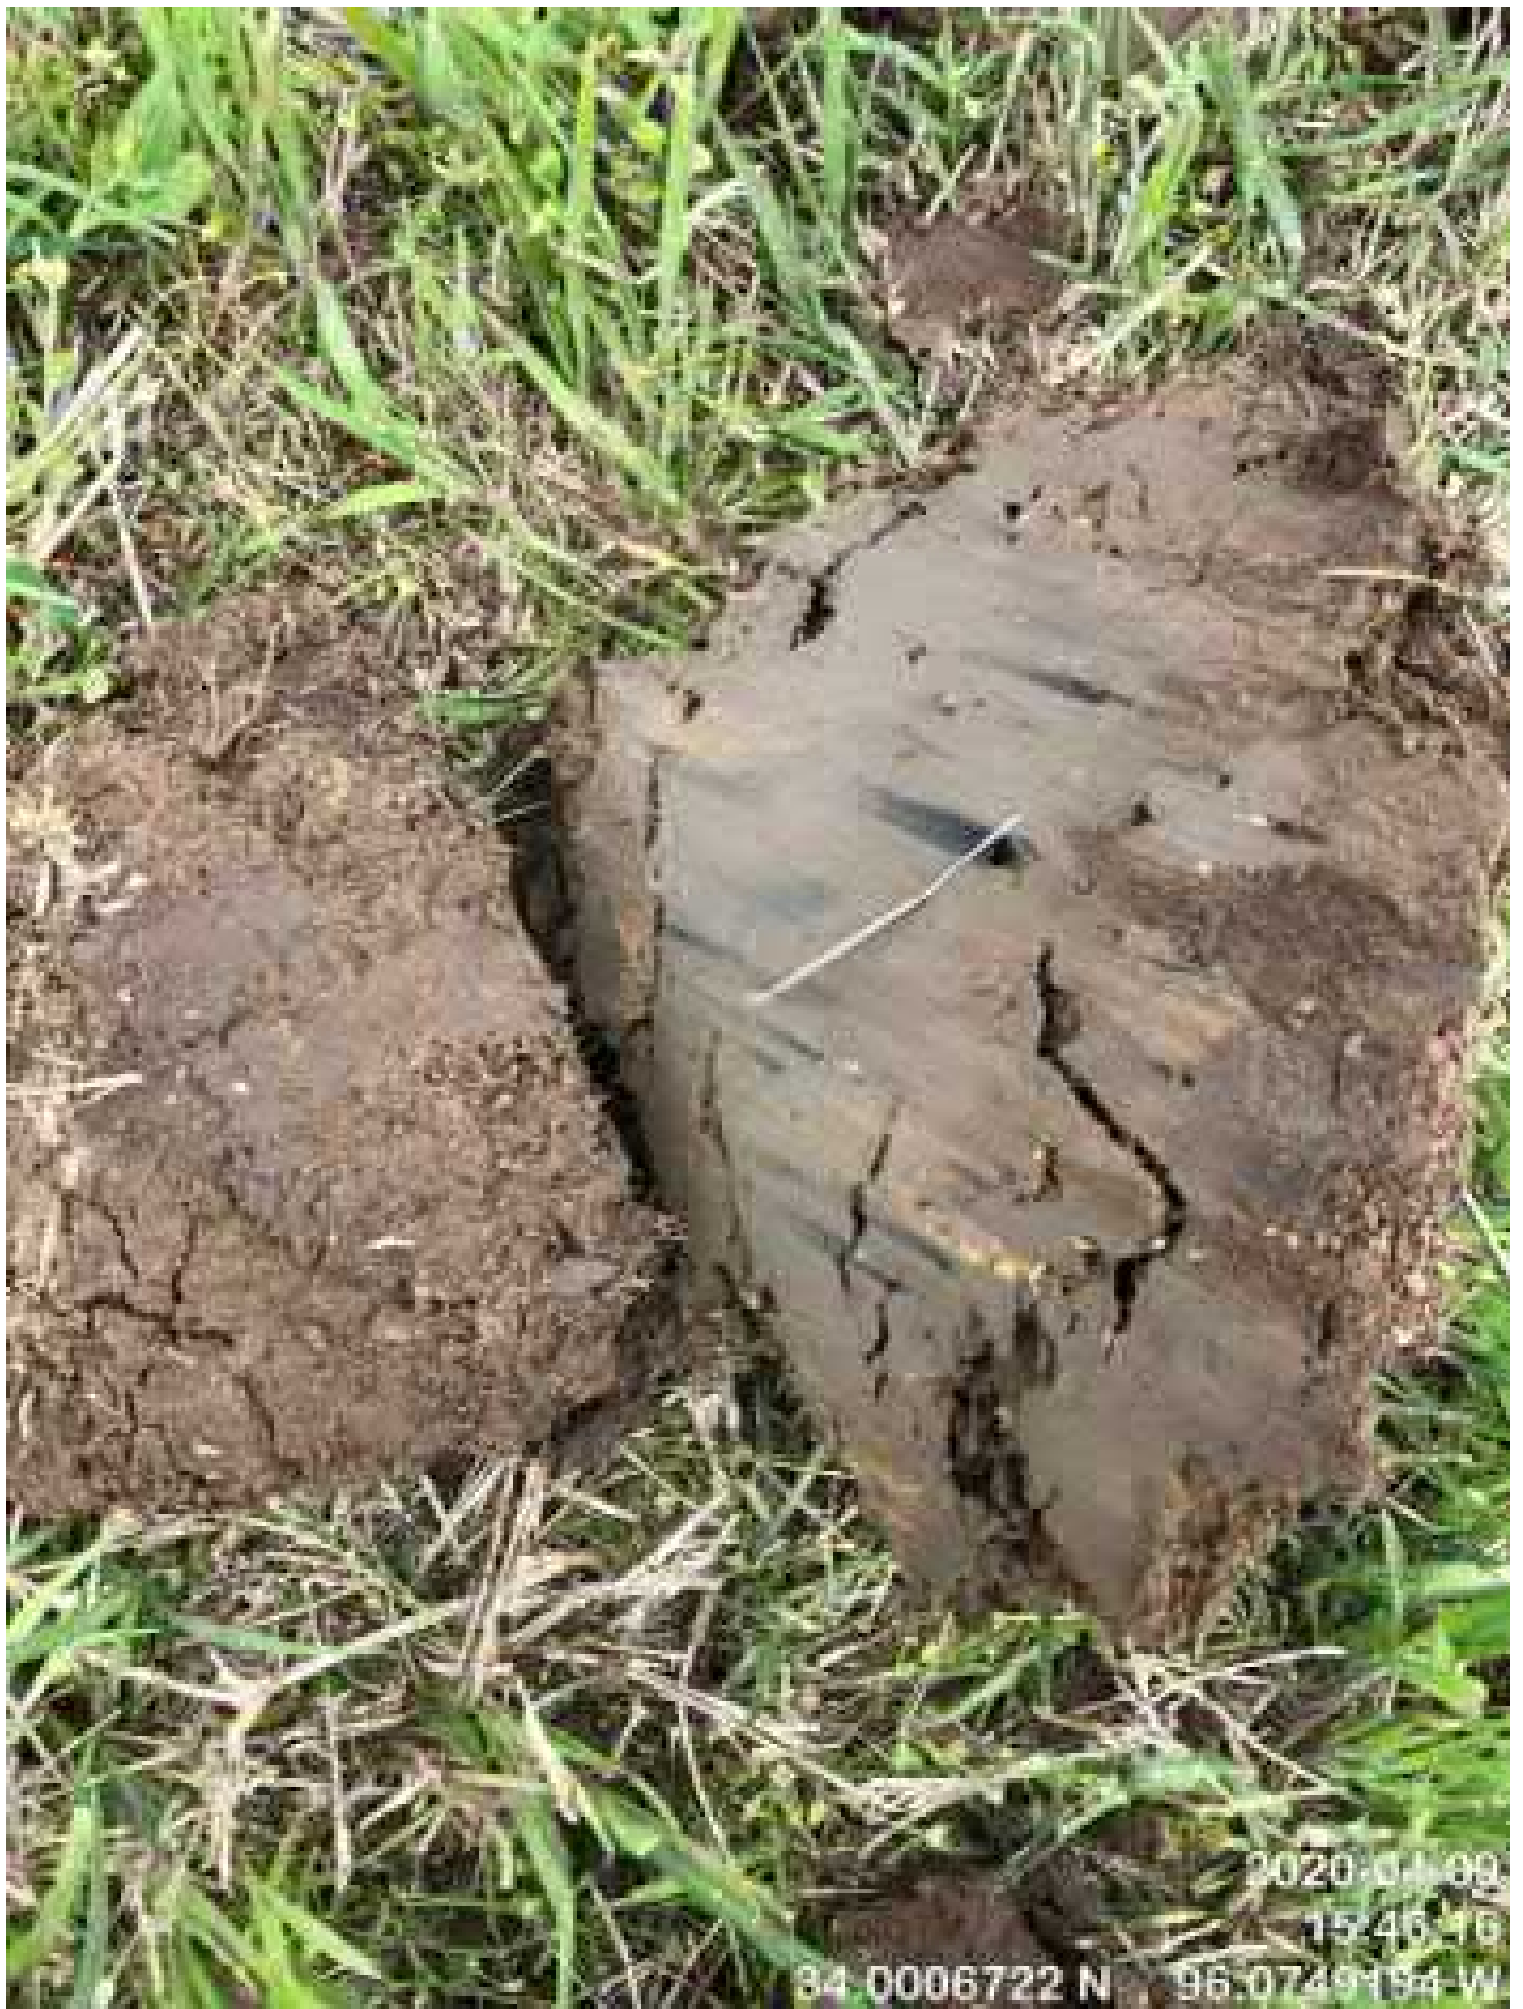
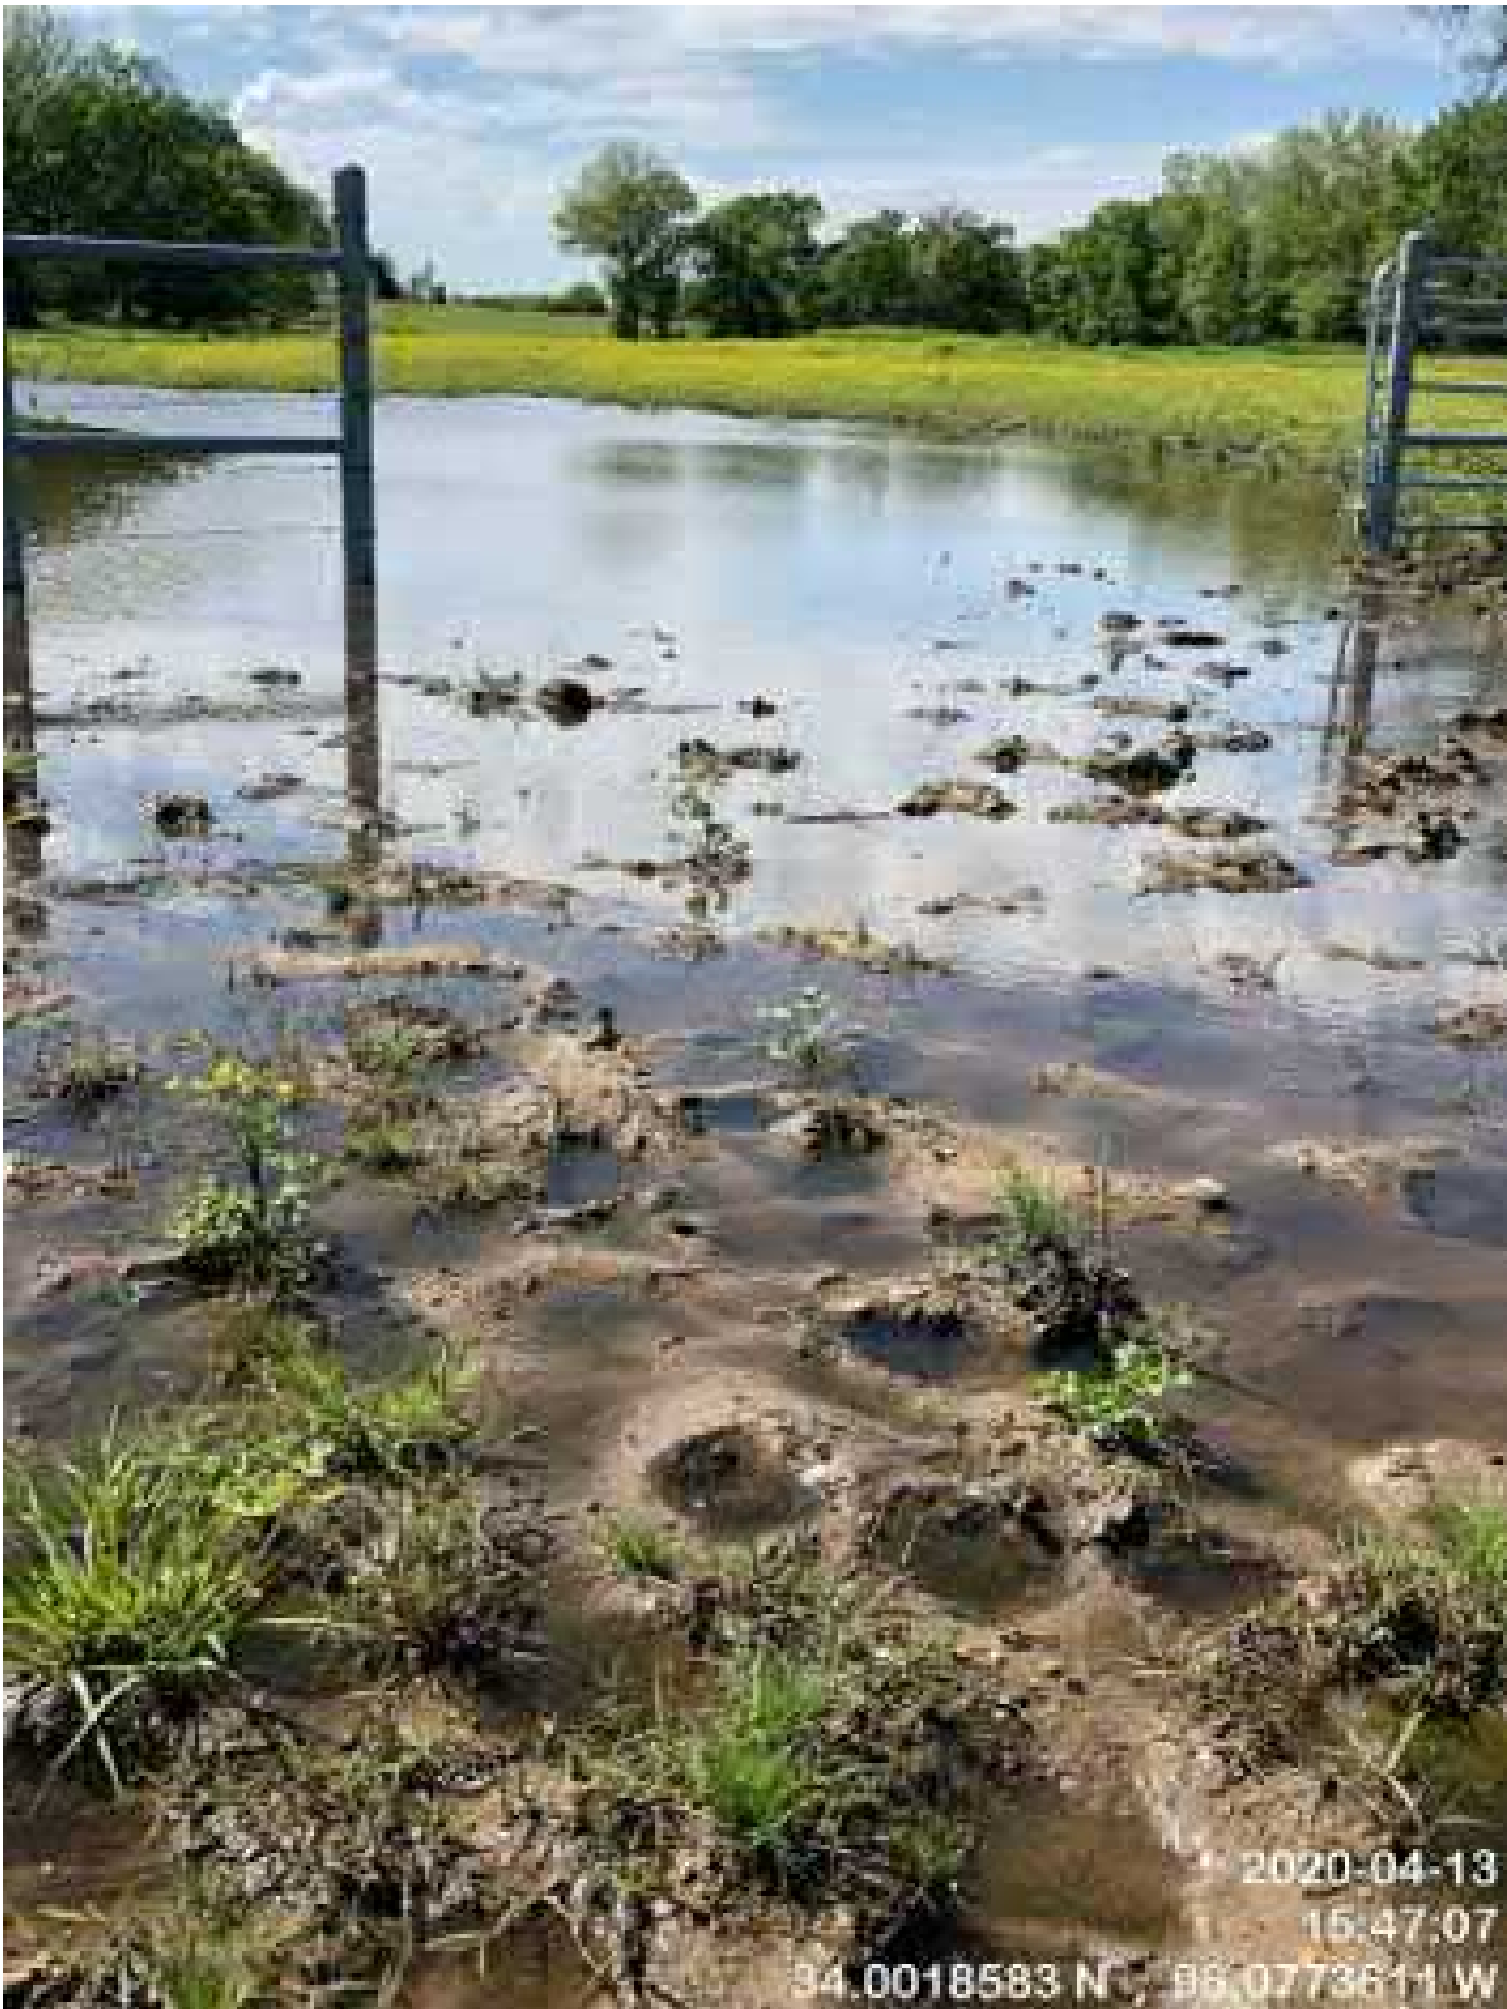
**April 13, 2020 Site Inspection
James & Linda Ingram
BR-0988.000, BR-0990.000, BR-0992.000
Mile Post: MP 194.5 - 195.5
Bryan County, Oklahoma**

- 1.) Midship has backfilled and conducted rough cleanup while not replacing the damaged topsoil that has been mixed with the subsoil. In addition, the contractors did not remove the shale, large rocks, and ongoing erosion in the easement.
- 2.) Midship has changed the lay of the land affecting the topography and drainage patterns. Due to construction not returning the land to its pre-construction condition ponding and additional erosion is occurring.
- 3.) Erosion and lack of revegetation due to blasting material, subsoil, and topsoil mixing; Remove all mixed soils, large rocks, blasting material. Conduct de-compaction in subsoil and topsoil.

- 1.) High levels of rock and blasting material mixed into soil. (FERC Plan: V. A. 3-6.)
 - a. Affected areas naturally have less than 1% rock fragments with a maximum size of 74 mm (NRCS).
- 2.) Importation of approx. 31,000 cubic yards of topsoil for 16.69 acres of ROW. (FERC Plan: IV. B. 1-6.)
 - a. Off-ROW topsoil: 14" (verified by existing NRCS soil surveys)
 - b. In-ROW topsoil: 0" found in multiple locations.
- 3.) Soil Compaction (FERC Plan: V. C. 1-3.)
 - a. Off-ROW Penetrometer reading: Around 180 psi in multiple locations.
 - b. In-ROW Penetrometer reading: 300 psi limit exceeded in every off-ROW location.
