Robert Squires - Squires Consulting LLC
Landowner Advocate

Opening Statement for May 5, 2021 Subcommittee on Civil Rights and Civil Liberties Hearing:
“Pipelines Over People (Part II): Midship Pipeline’s Disregard for Landowners in Its Pathway”

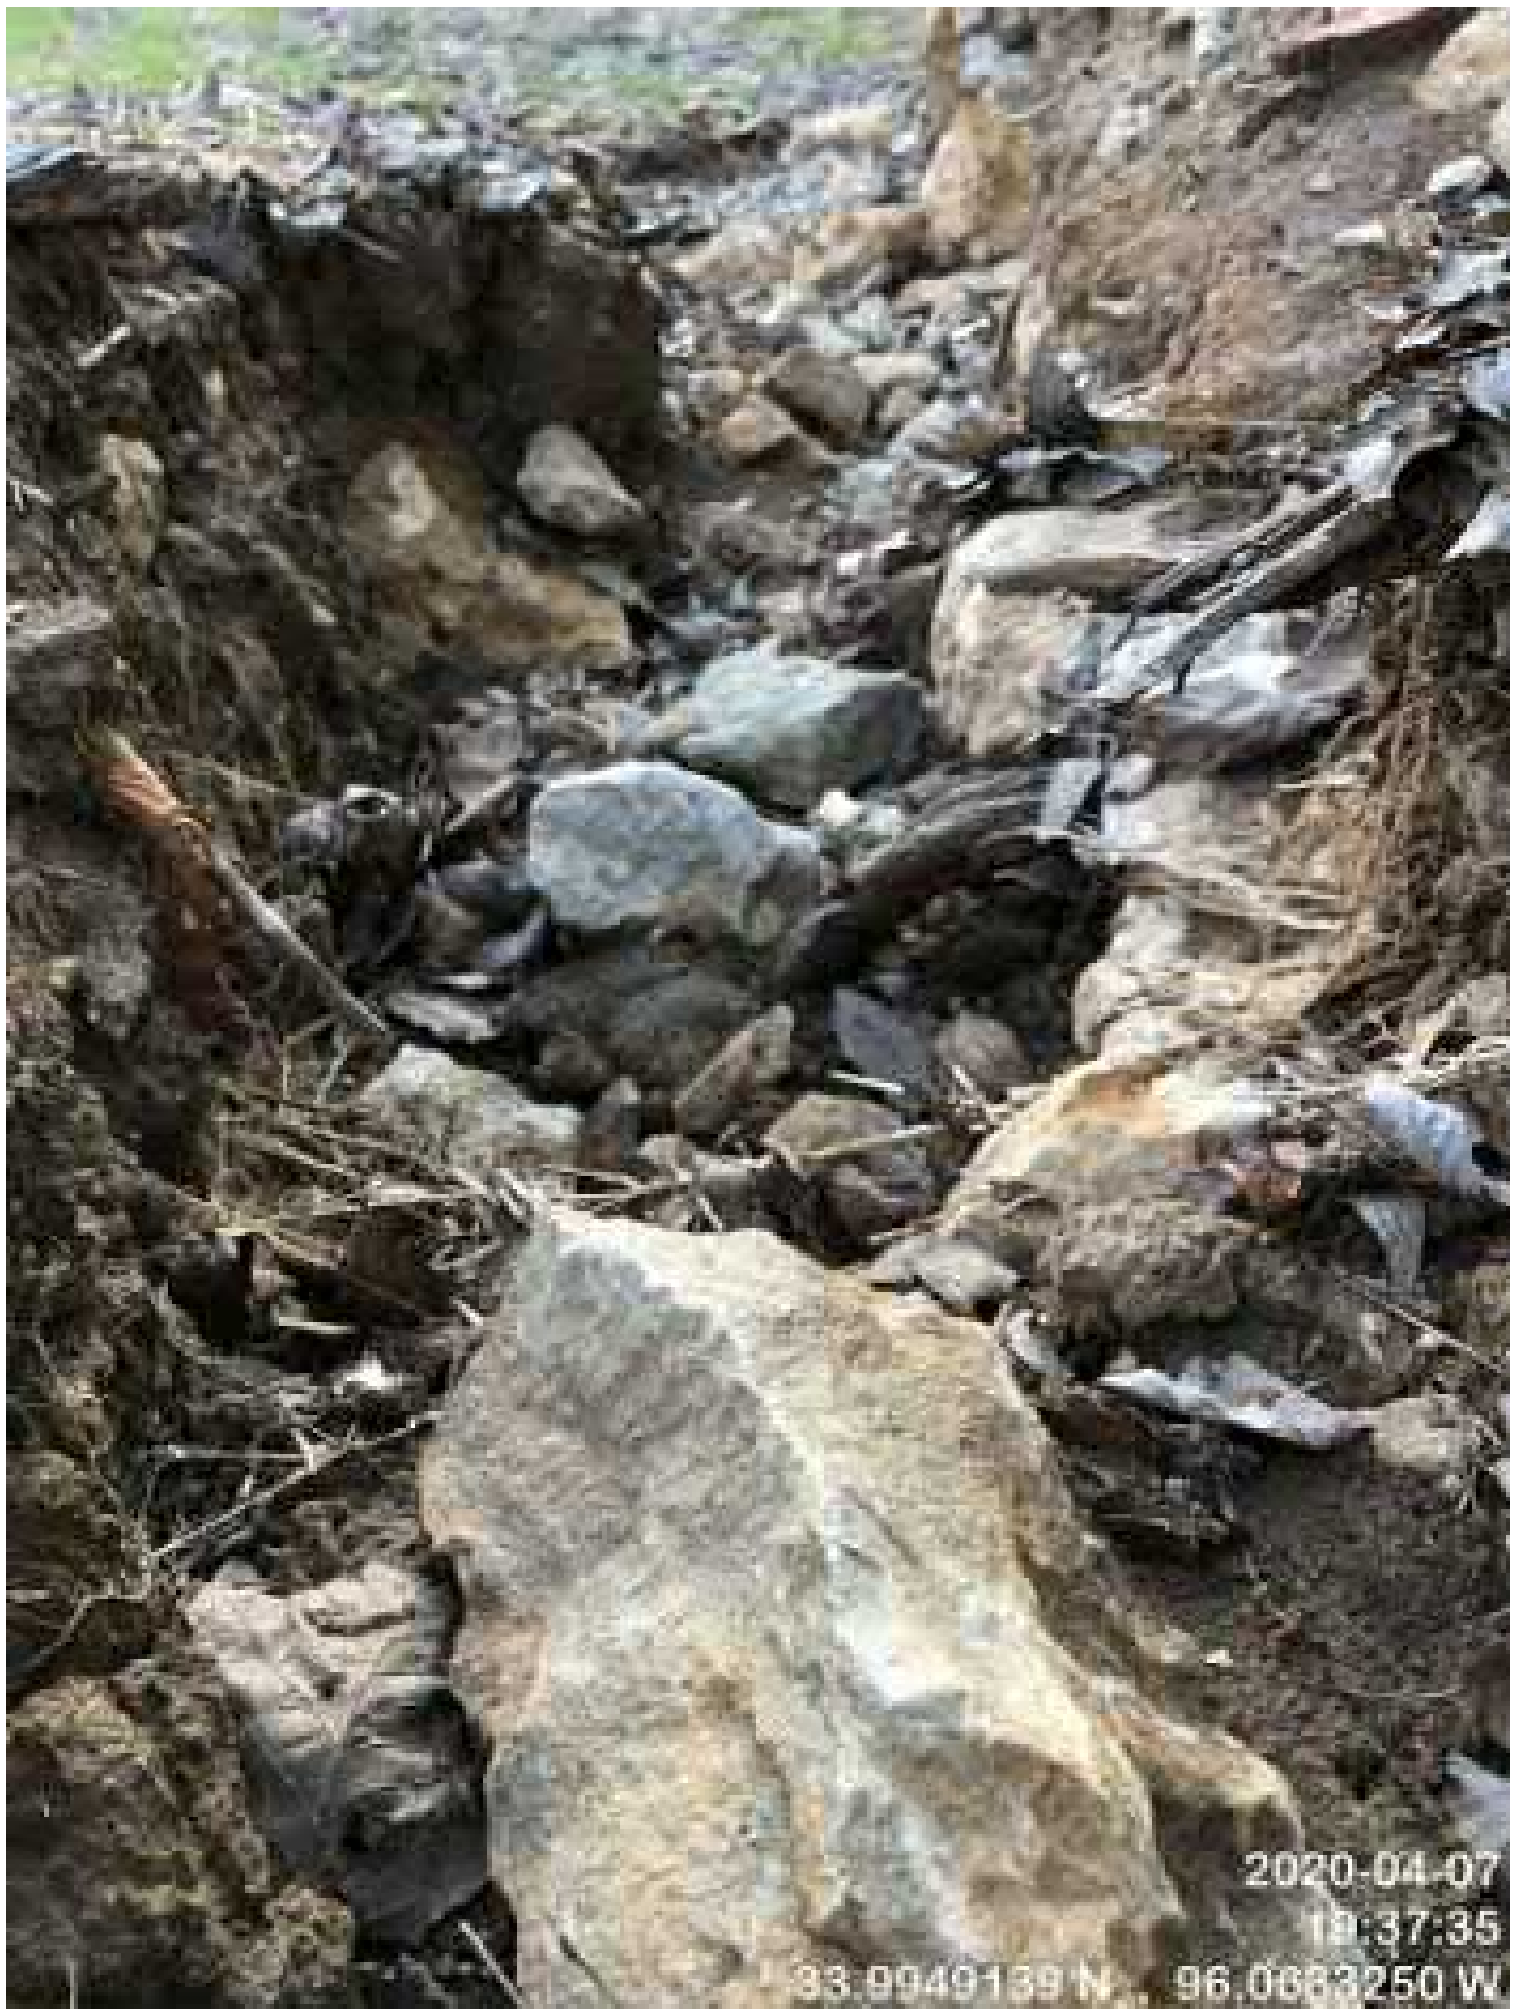
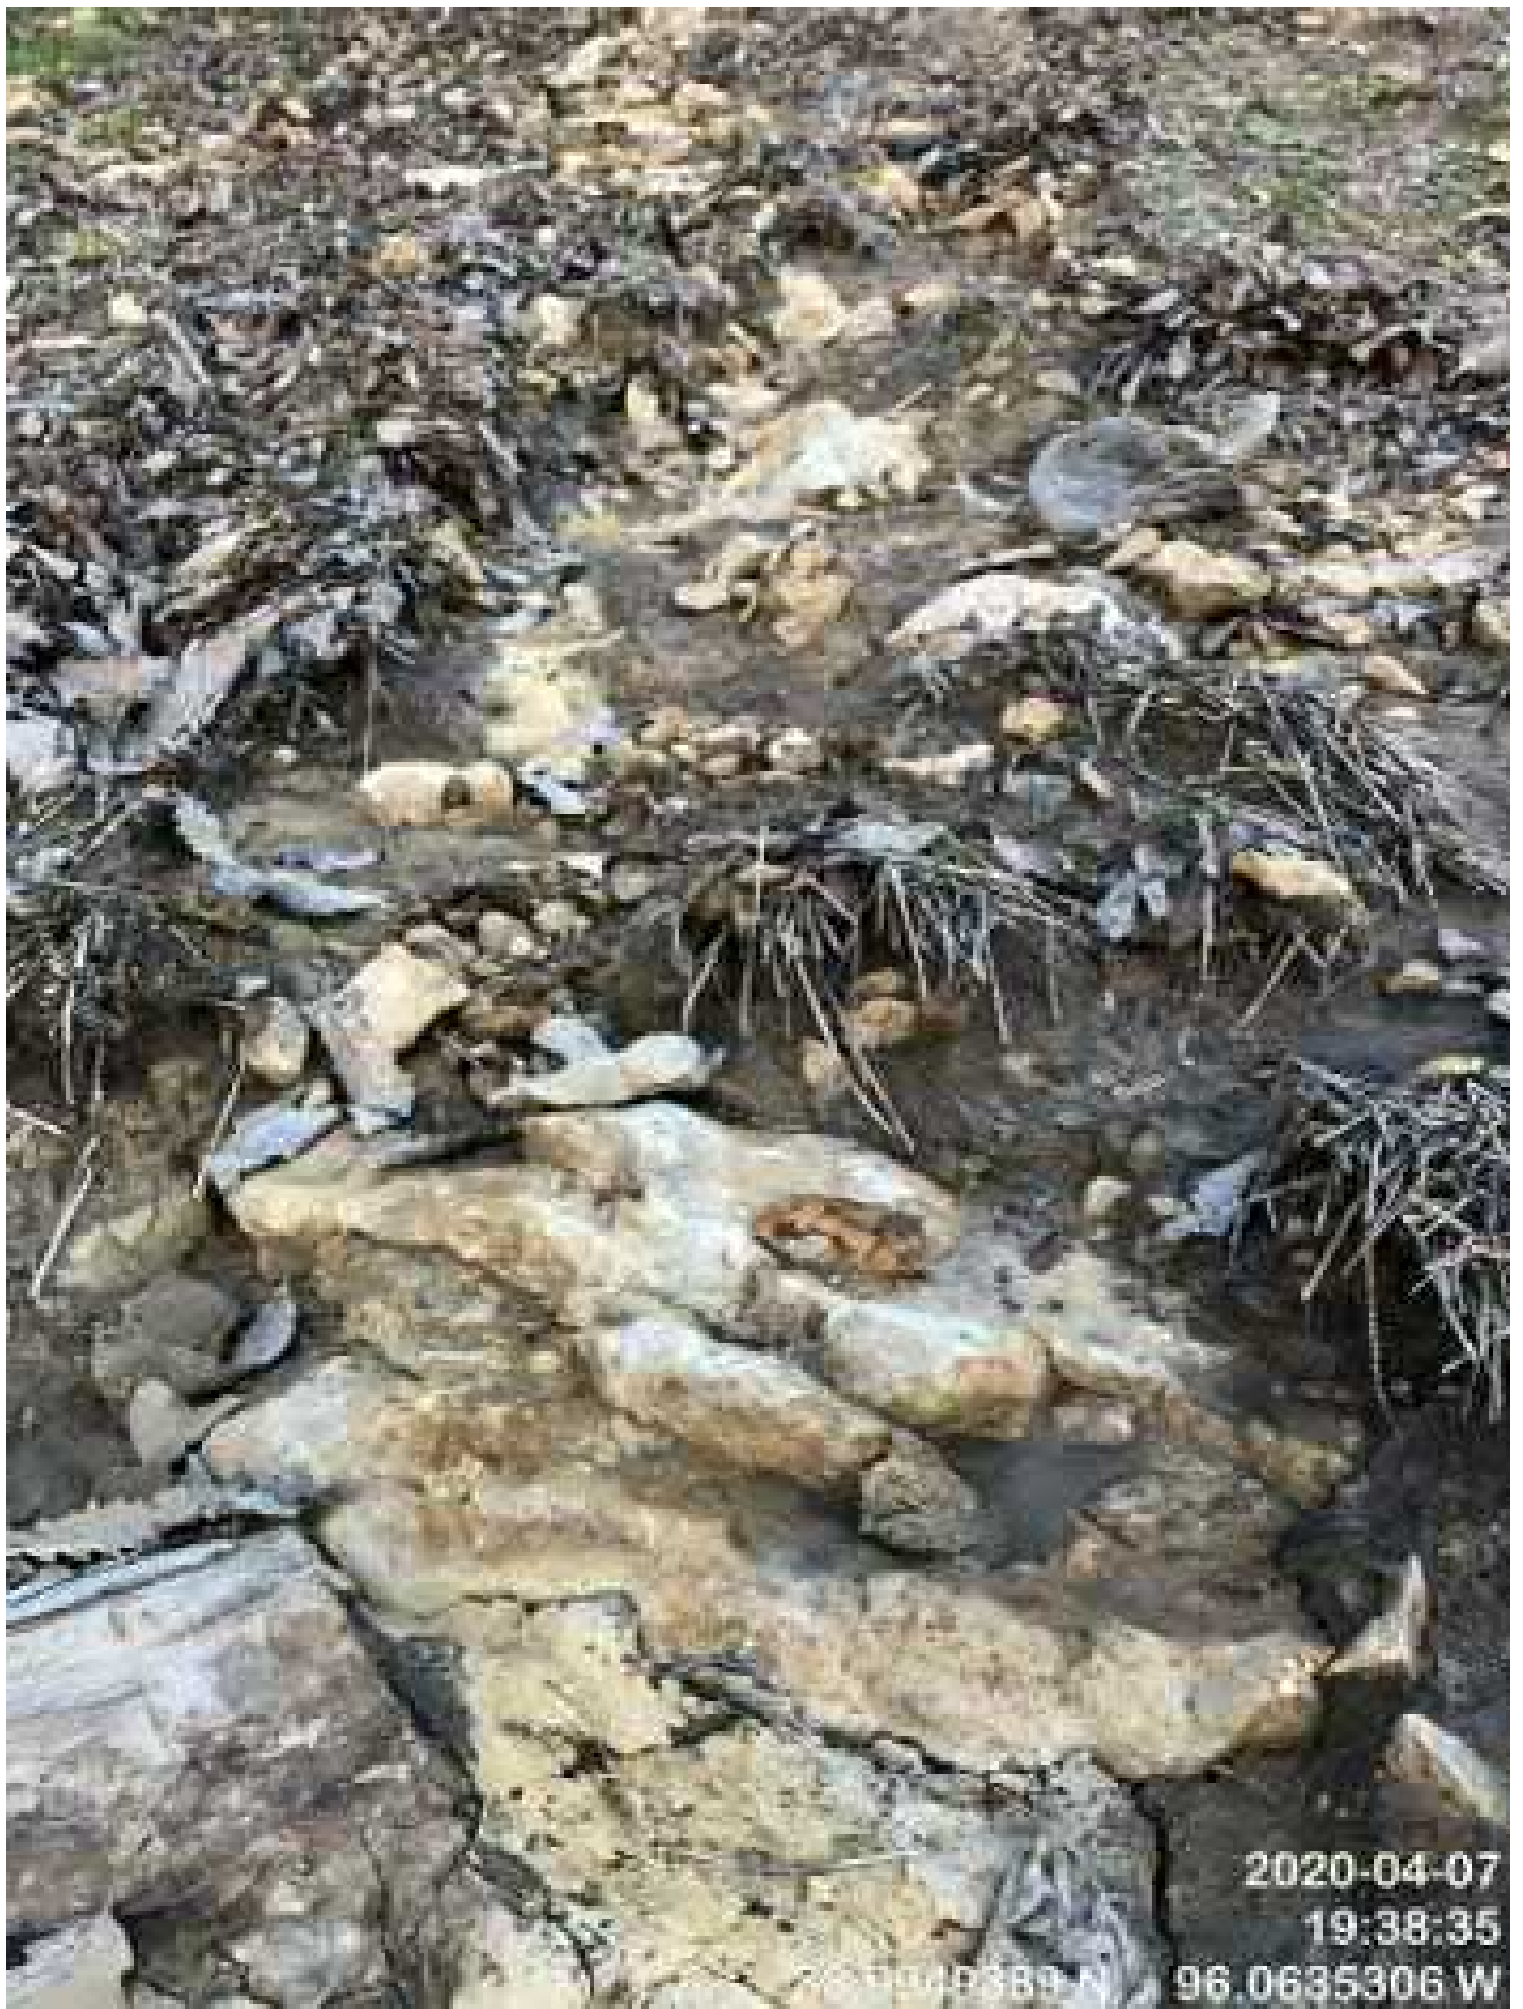
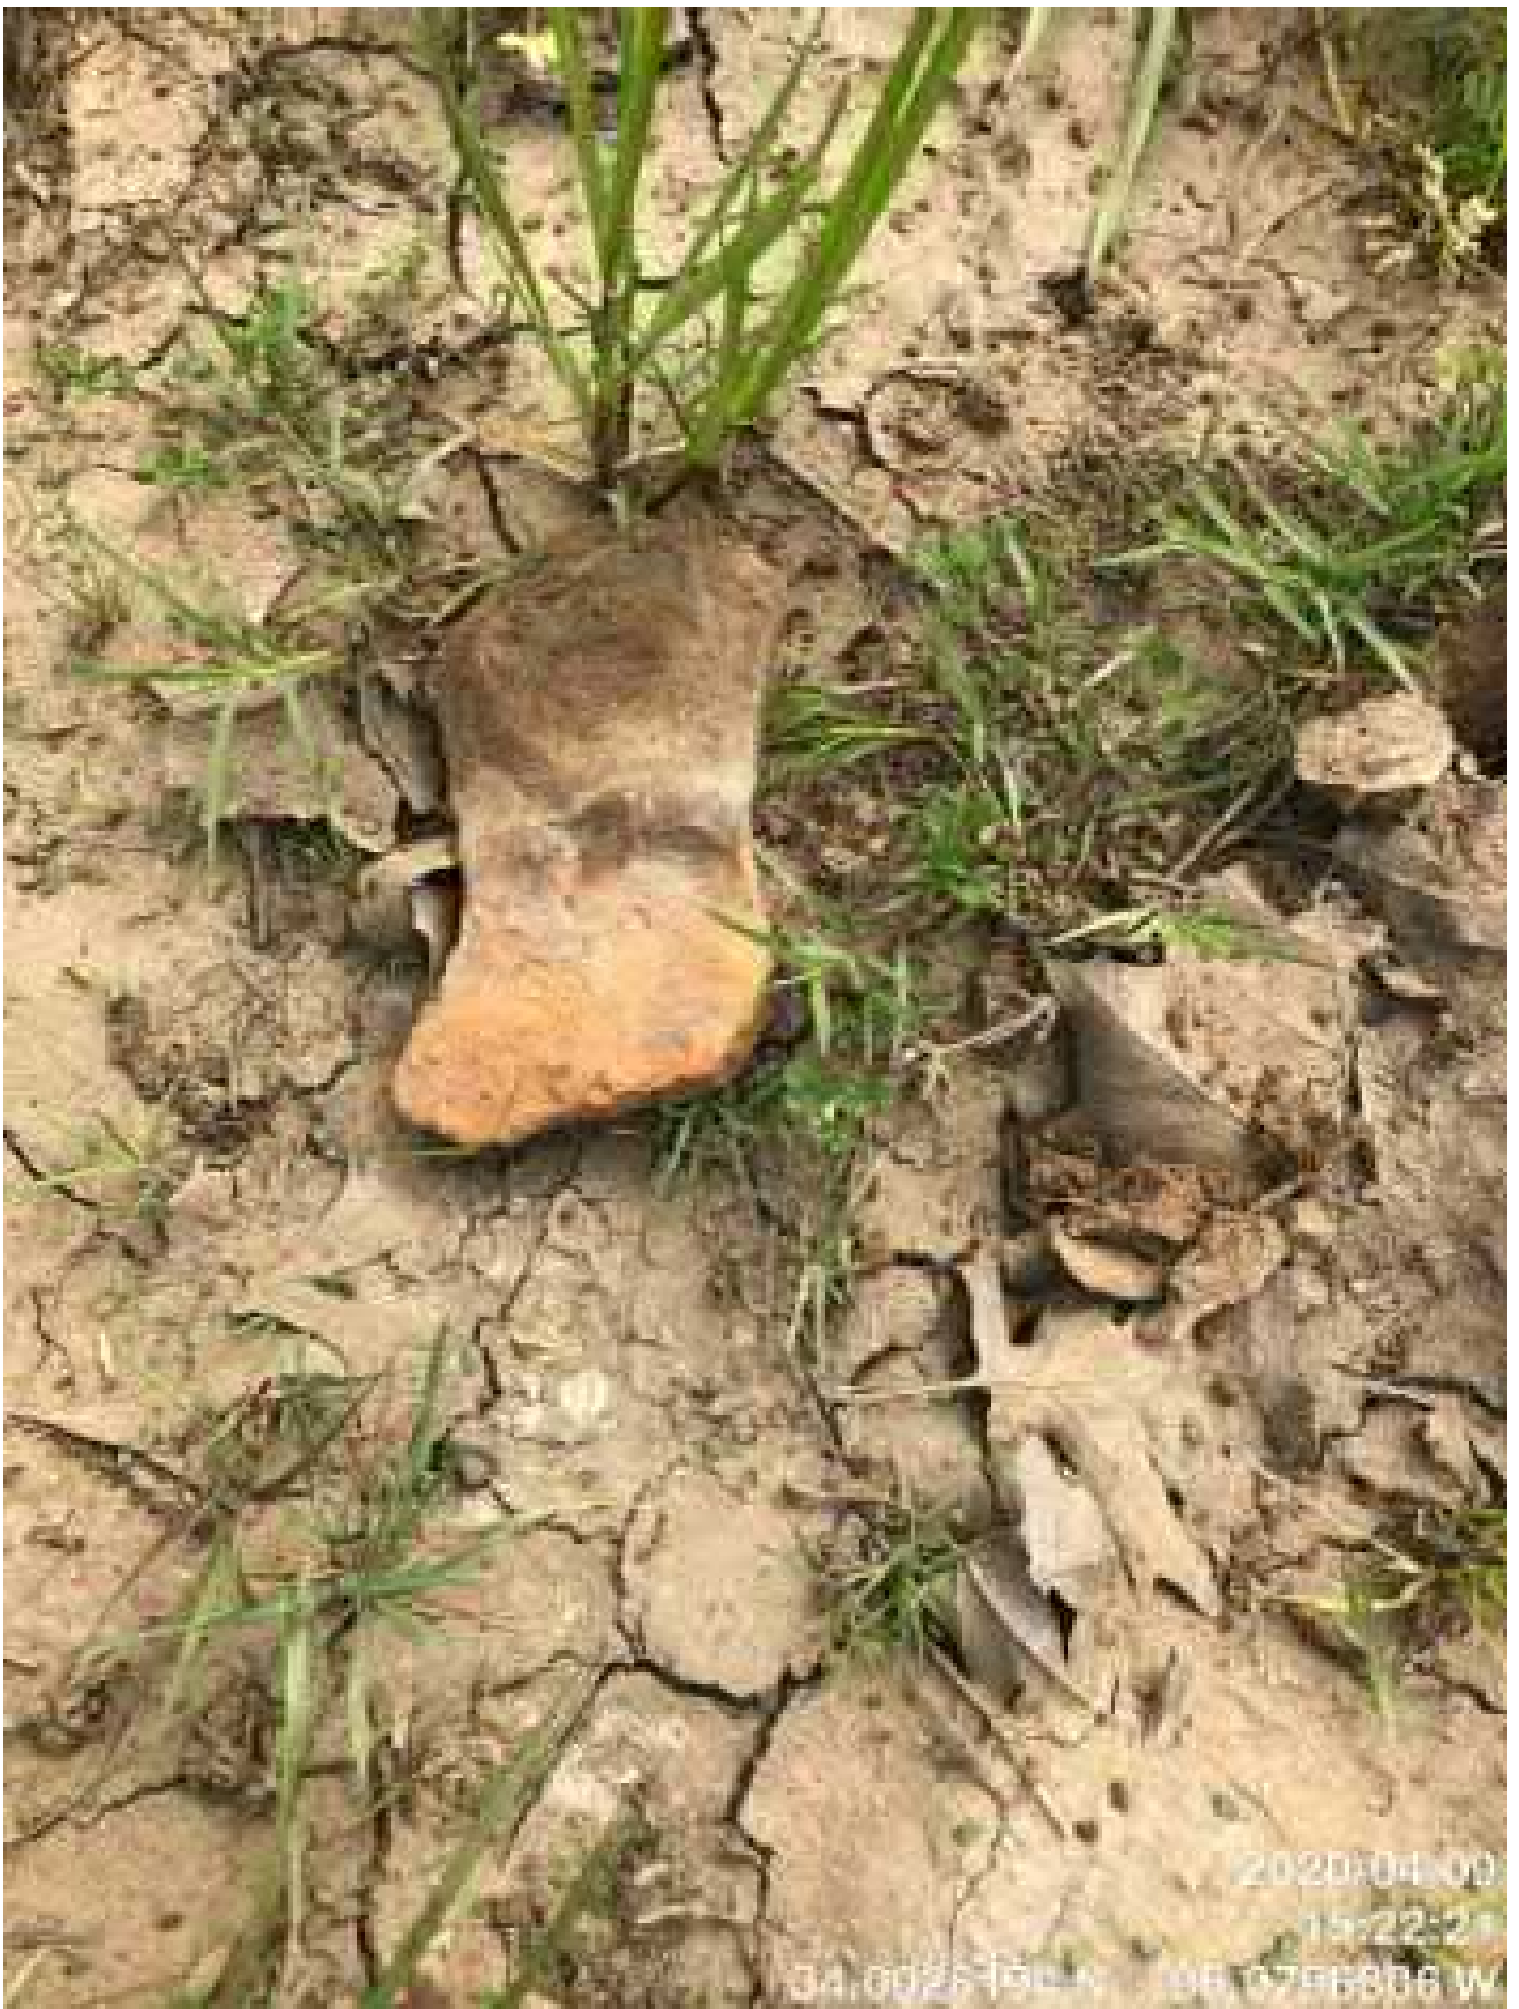
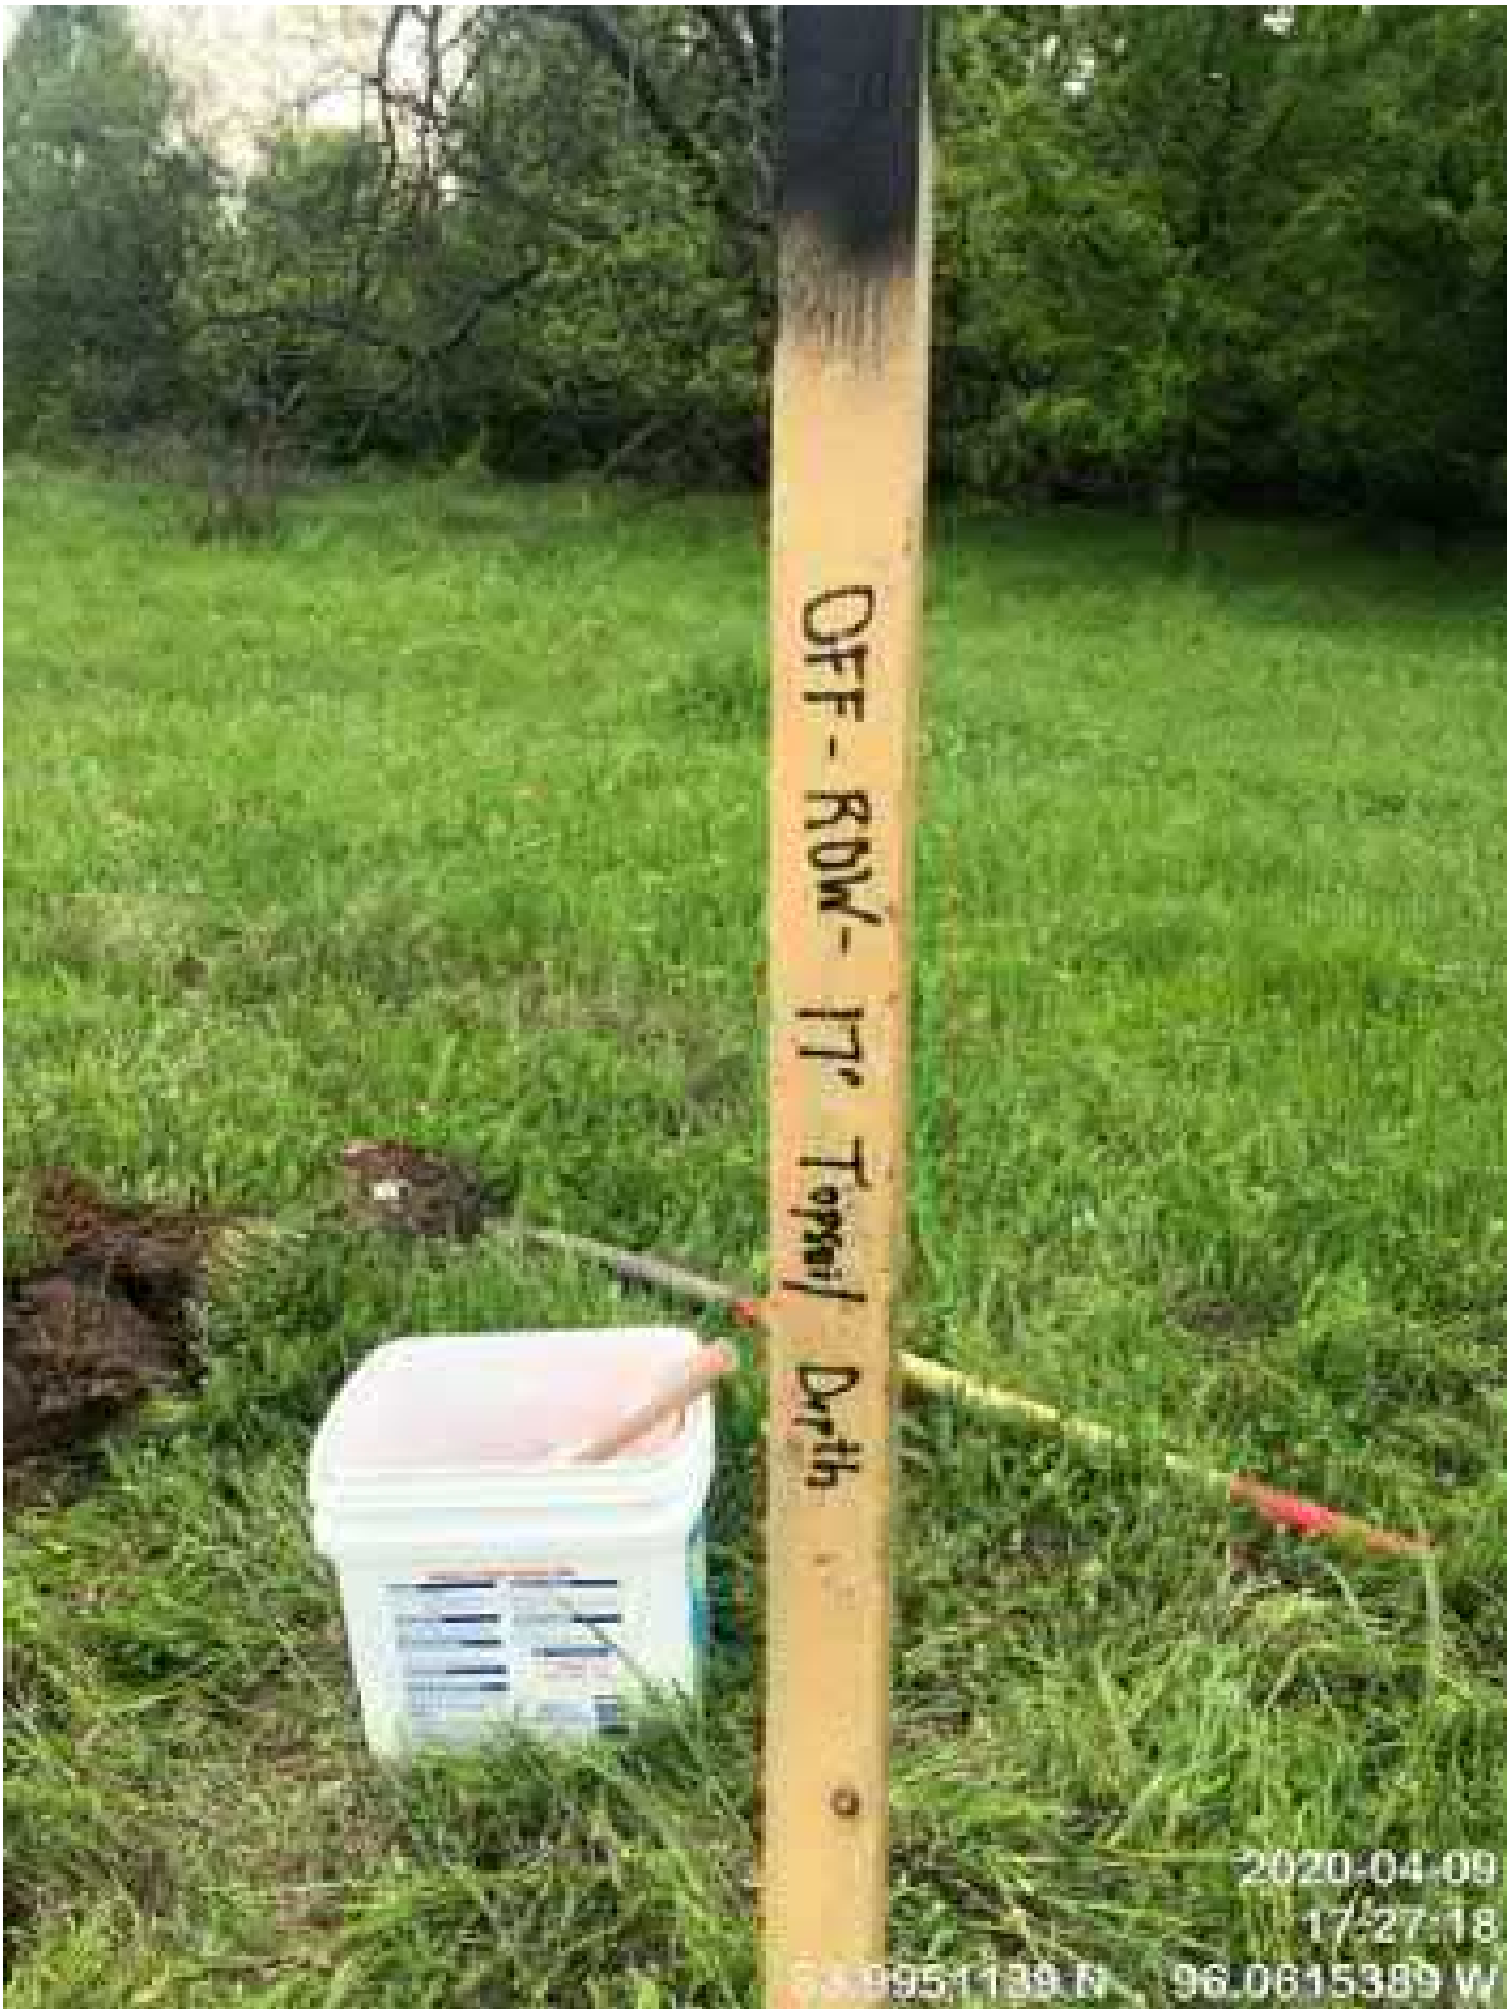
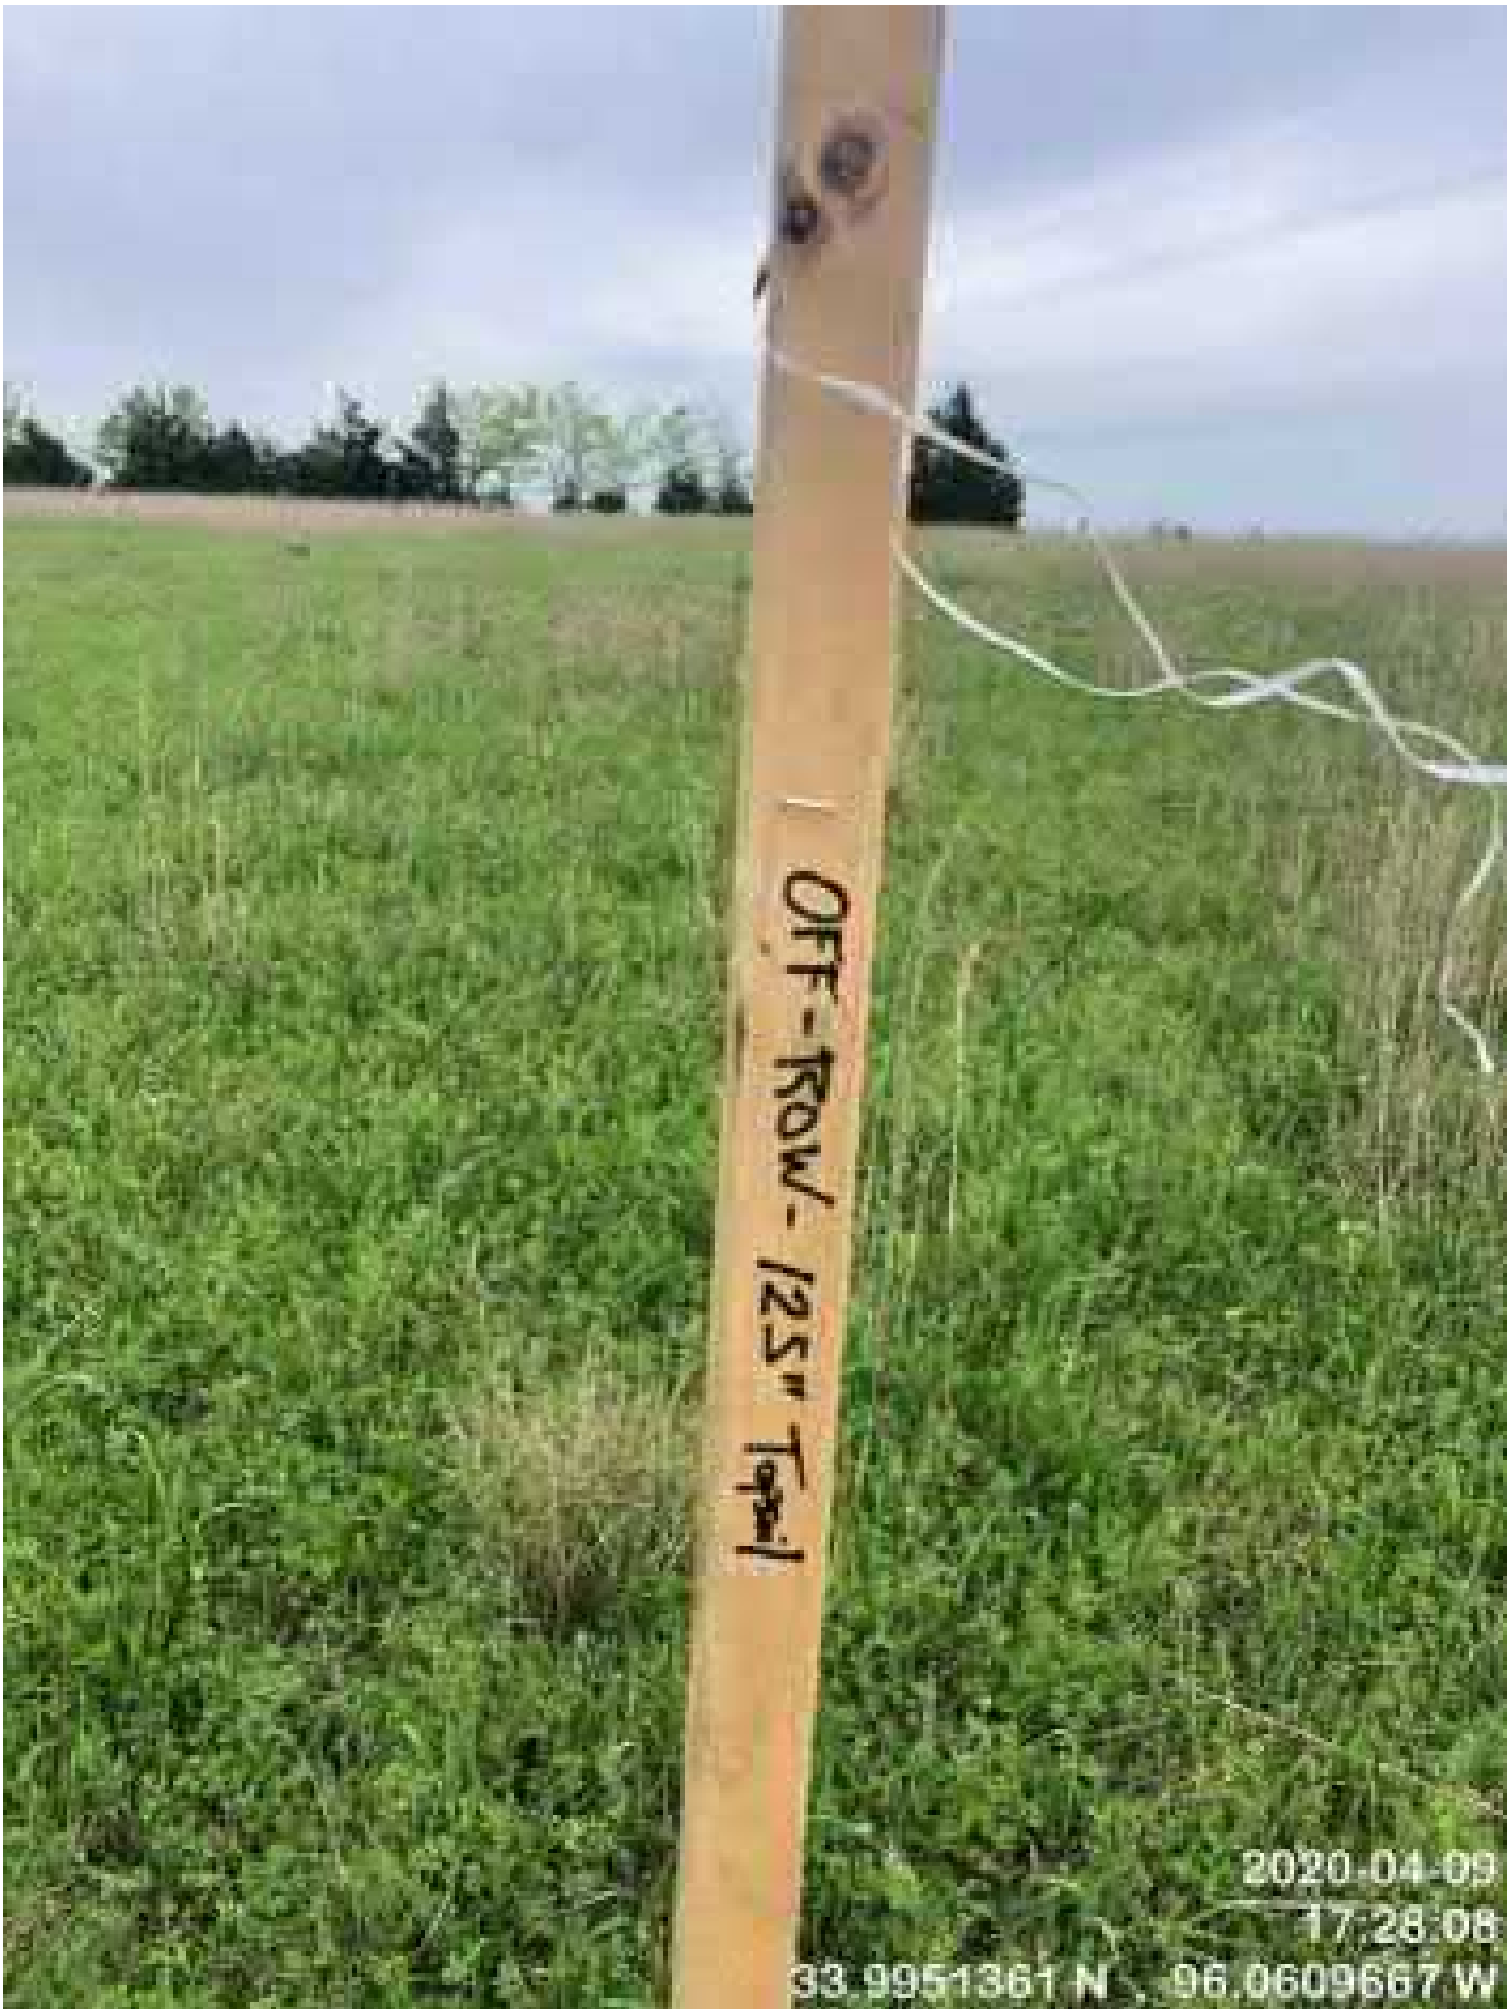
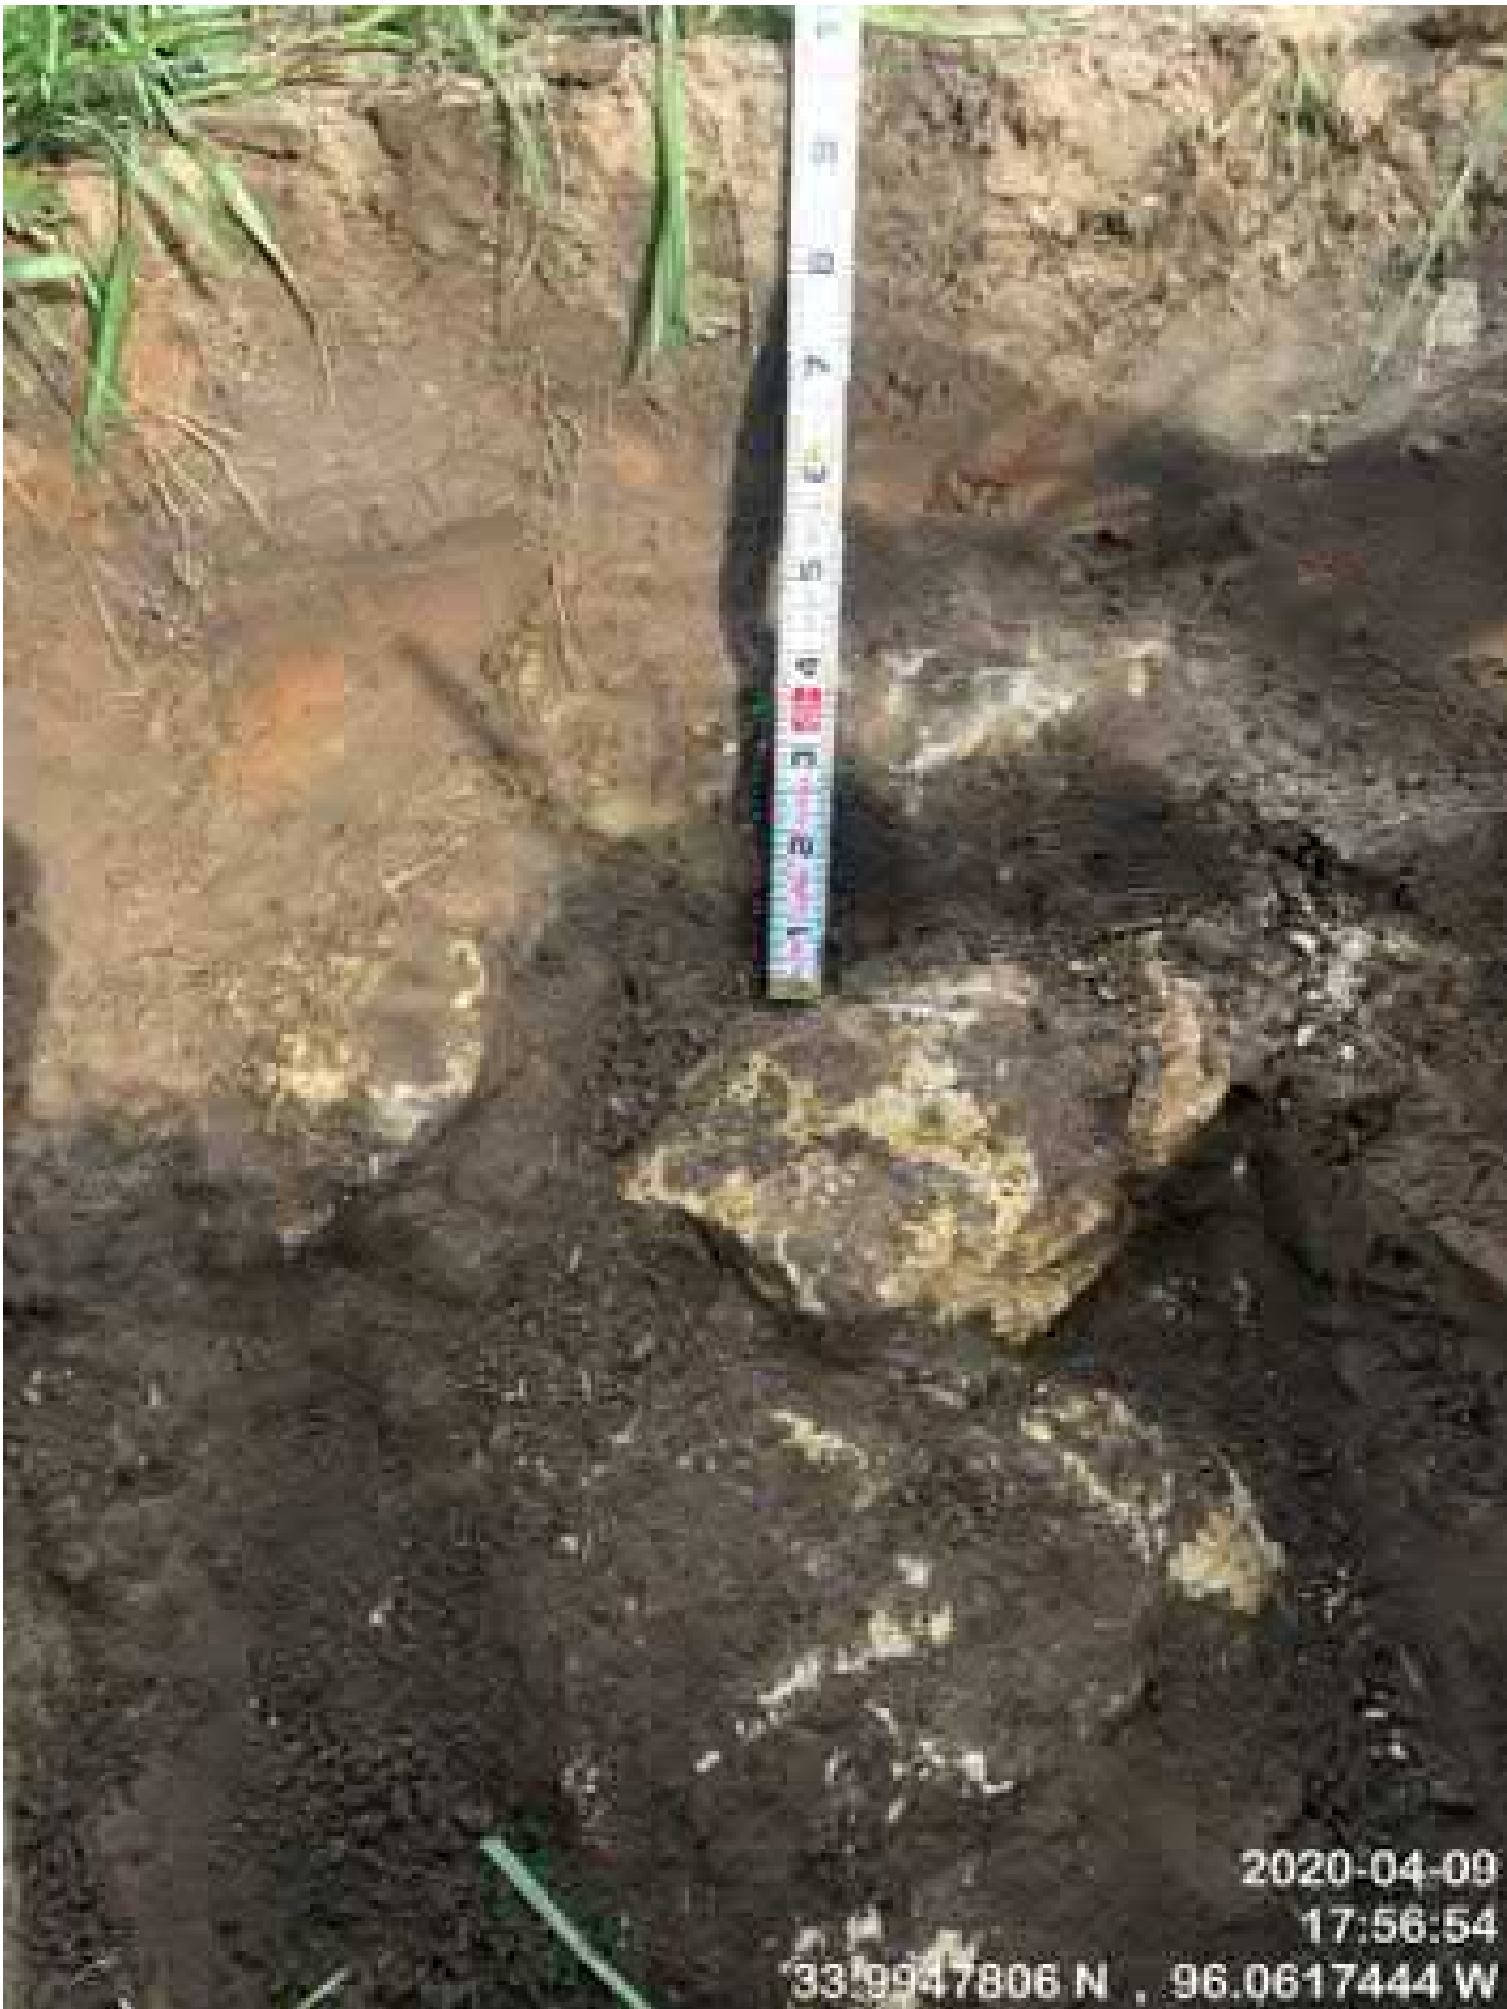
**April 13, 2020 Site Inspection
Anderson Family Trust
BR-0994.000, BR-0995.000, BR-0996.000
Mile Post: MP 195.75 - 196.25
Bryan County, Oklahoma**

- 1.) Midship has backfilled and conducted rough cleanup while not replacing the damaged topsoil that has been mixed with the subsoil. In addition, the contractors did not remove the shale, large rocks, and ongoing erosion in the easement. Gravel road destroyed and creek crossing off of ROW damaged. Midship has not replaced gravel road.

- 1.) High levels of rock and blasting material mixed into soil. (FERC Plan: V. A. 3-6.)
 - a. Affected areas naturally have less than 1% rock fragments with a maximum size of 74 mm (NRCS).
- 2.) Importation of approx. 27.860 cubic yards of topsoil for 12.19 acres of ROW. (FERC Plan: IV. B. 1-6.)
 - a. Off-ROW topsoil: 17" (verified by existing NRCS soil surveys)
 - b. In-ROW topsoil: 0" found in multiple locations.
- 3.) Soil Compaction (FERC Plan: V. C. 1-3.)
 - a. Off-ROW Penetrometer reading: Around 150-180 psi in multiple locations.
 - b. In-ROW Penetrometer reading: 300 psi limit exceeded in every off-ROW location.
- 4.) Construction debris used for creek lining without landowner permission. (FERC Plan: V. A. 3.)
