Robert Squires - Squires Consulting LLC
Landowner Advocate

Opening Statement for May 5, 2021 Subcommittee on Civil Rights and Civil Liberties Hearing:
“Pipelines Over People (Part II): Midship Pipeline’s Disregard for Landowners in Its Pathway”

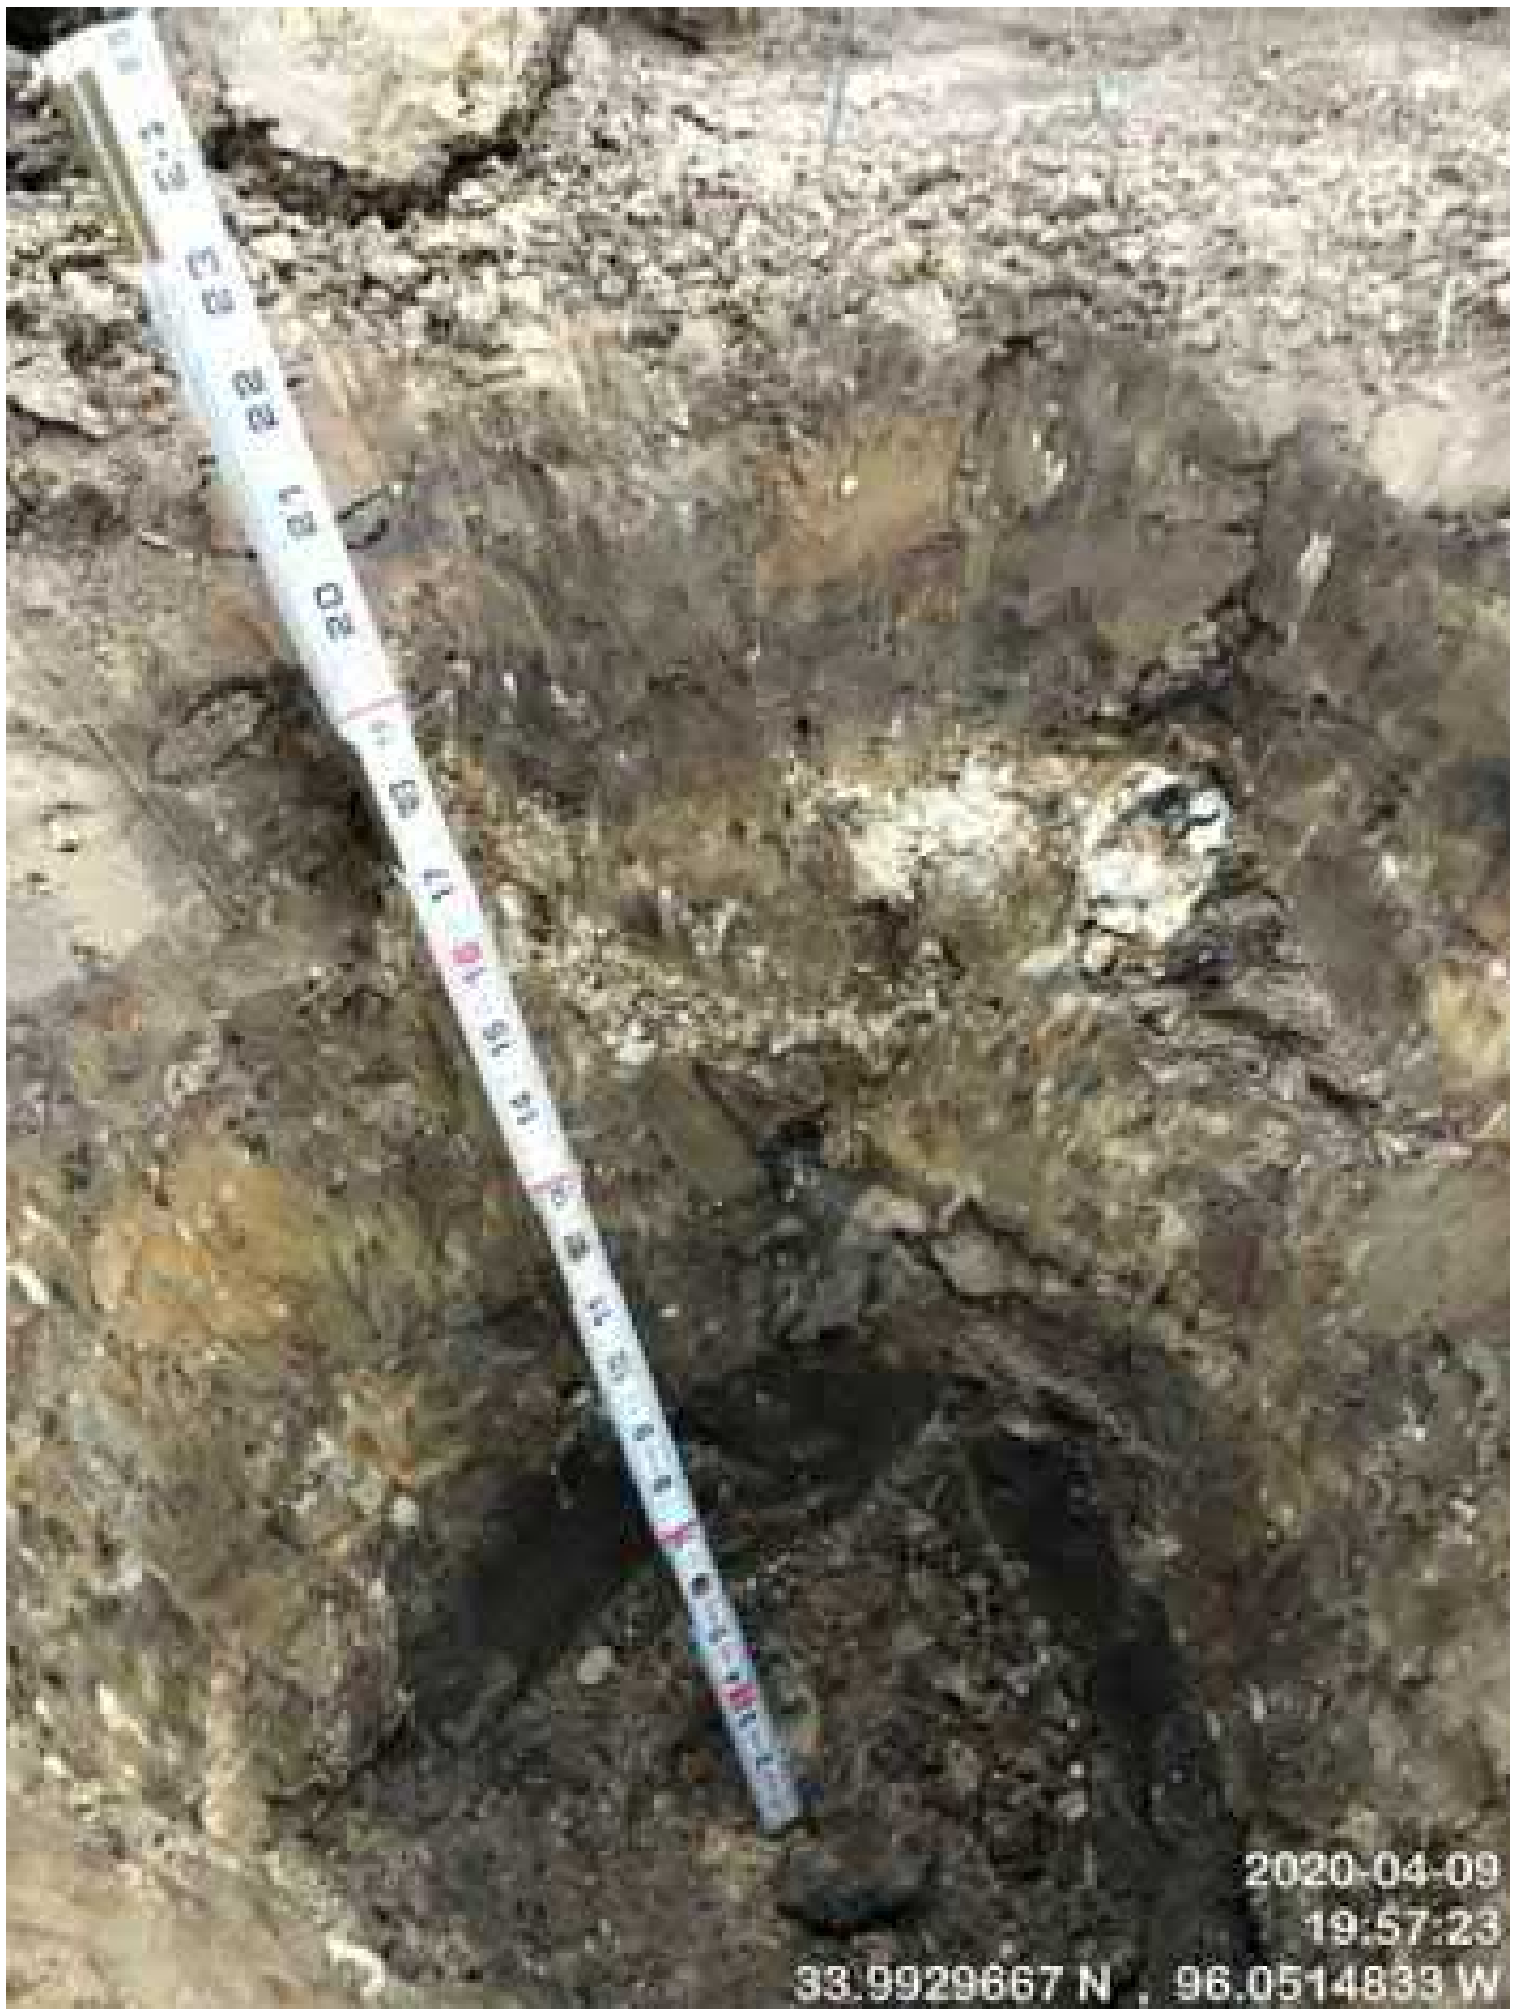
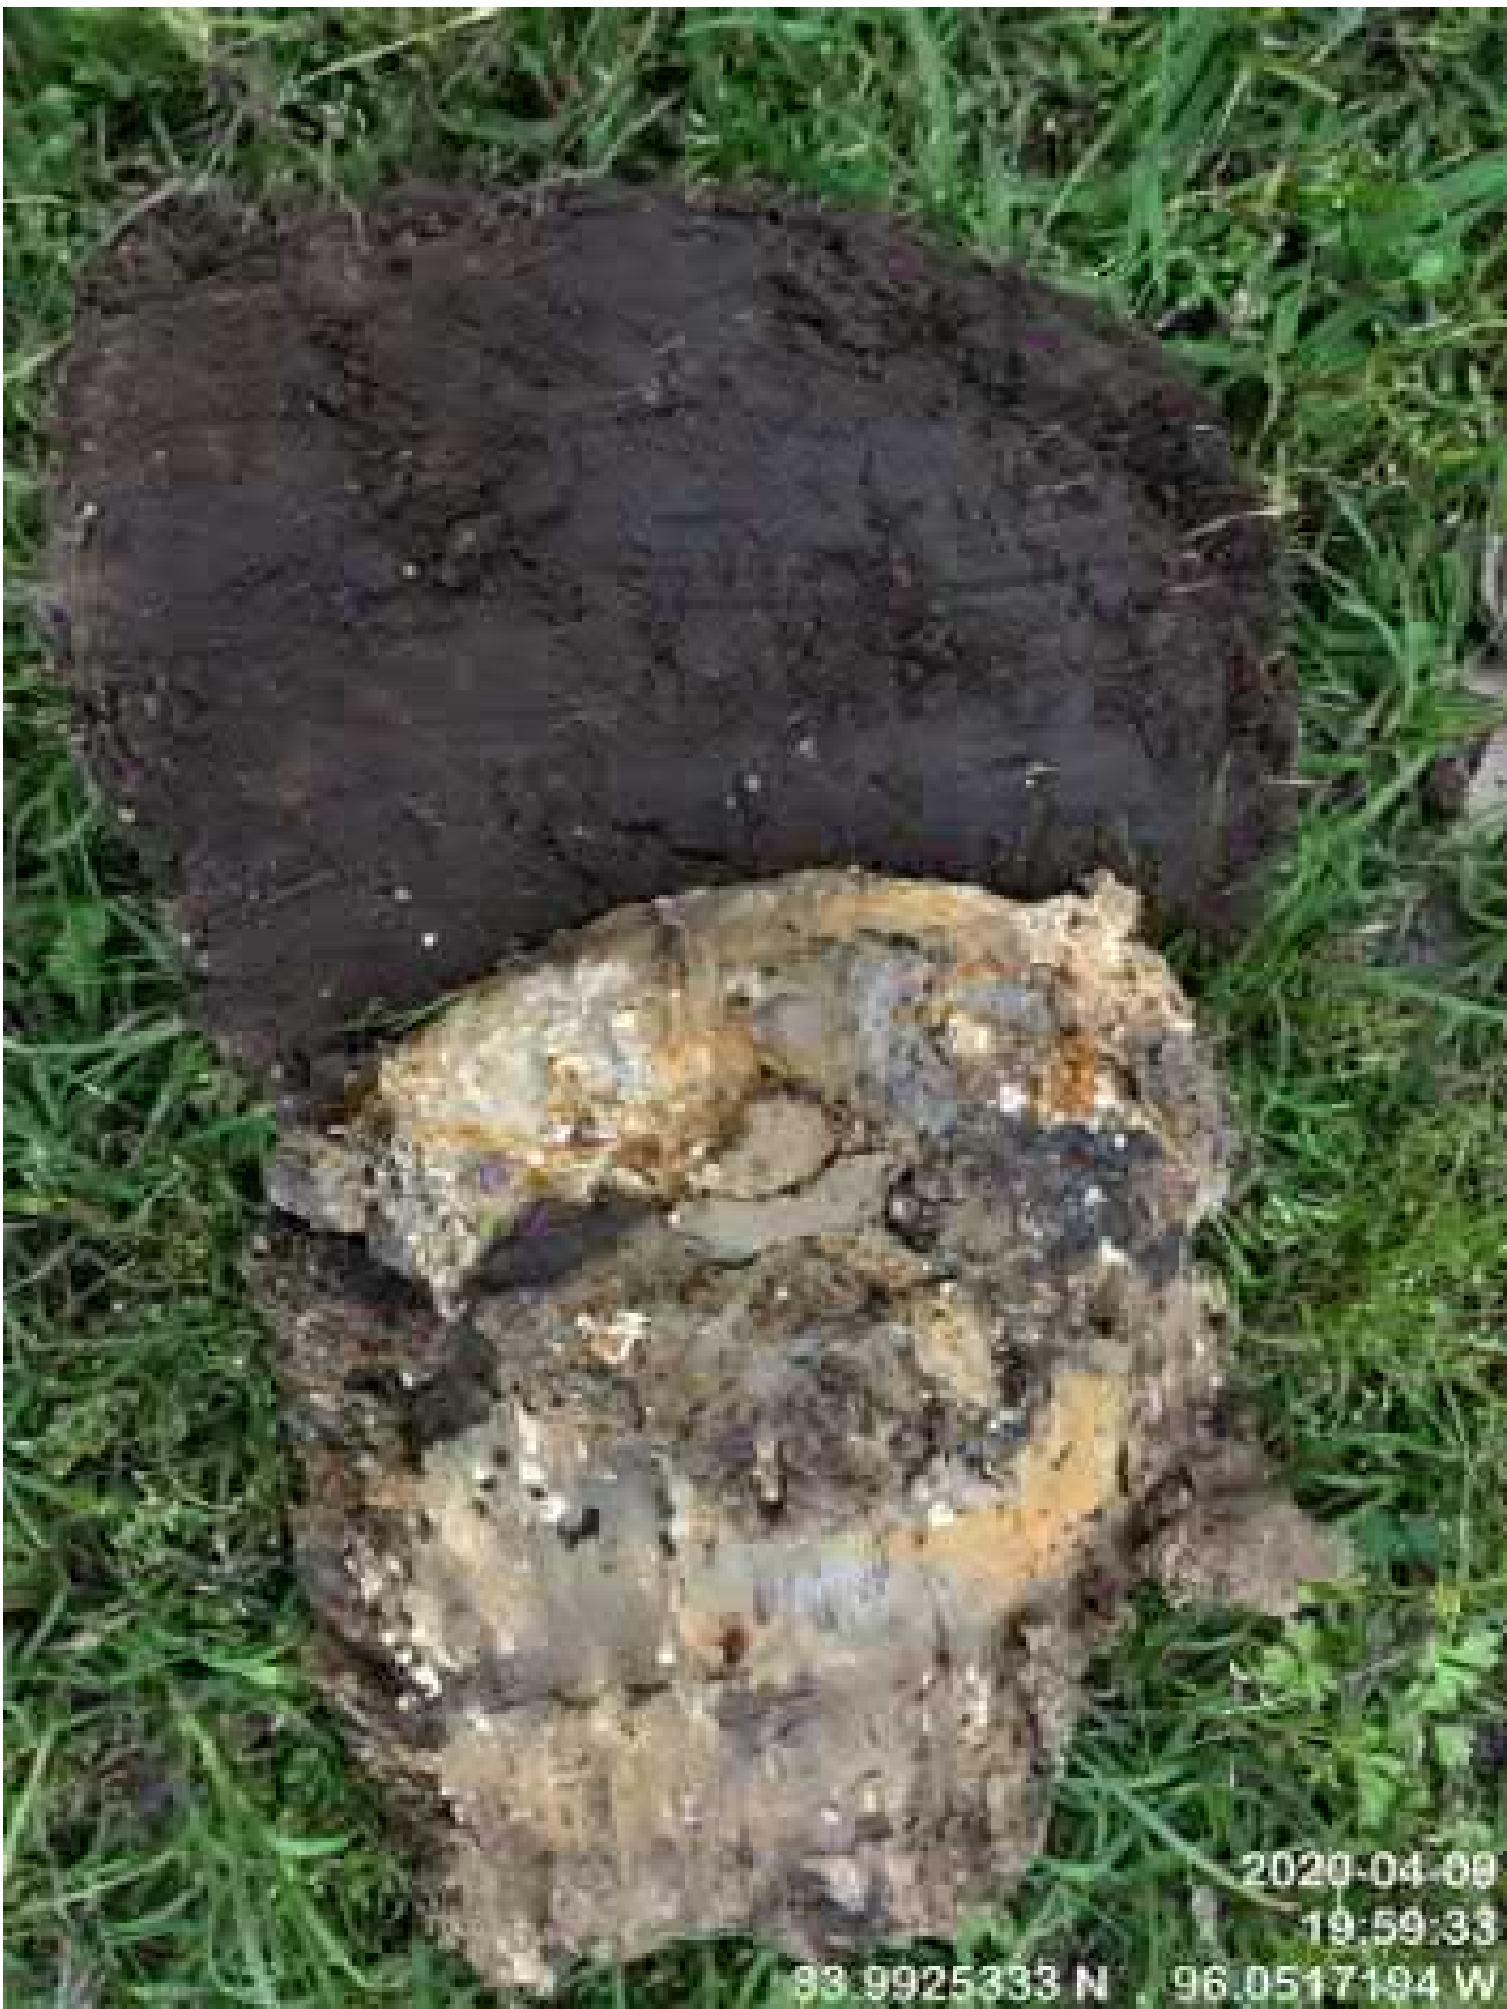
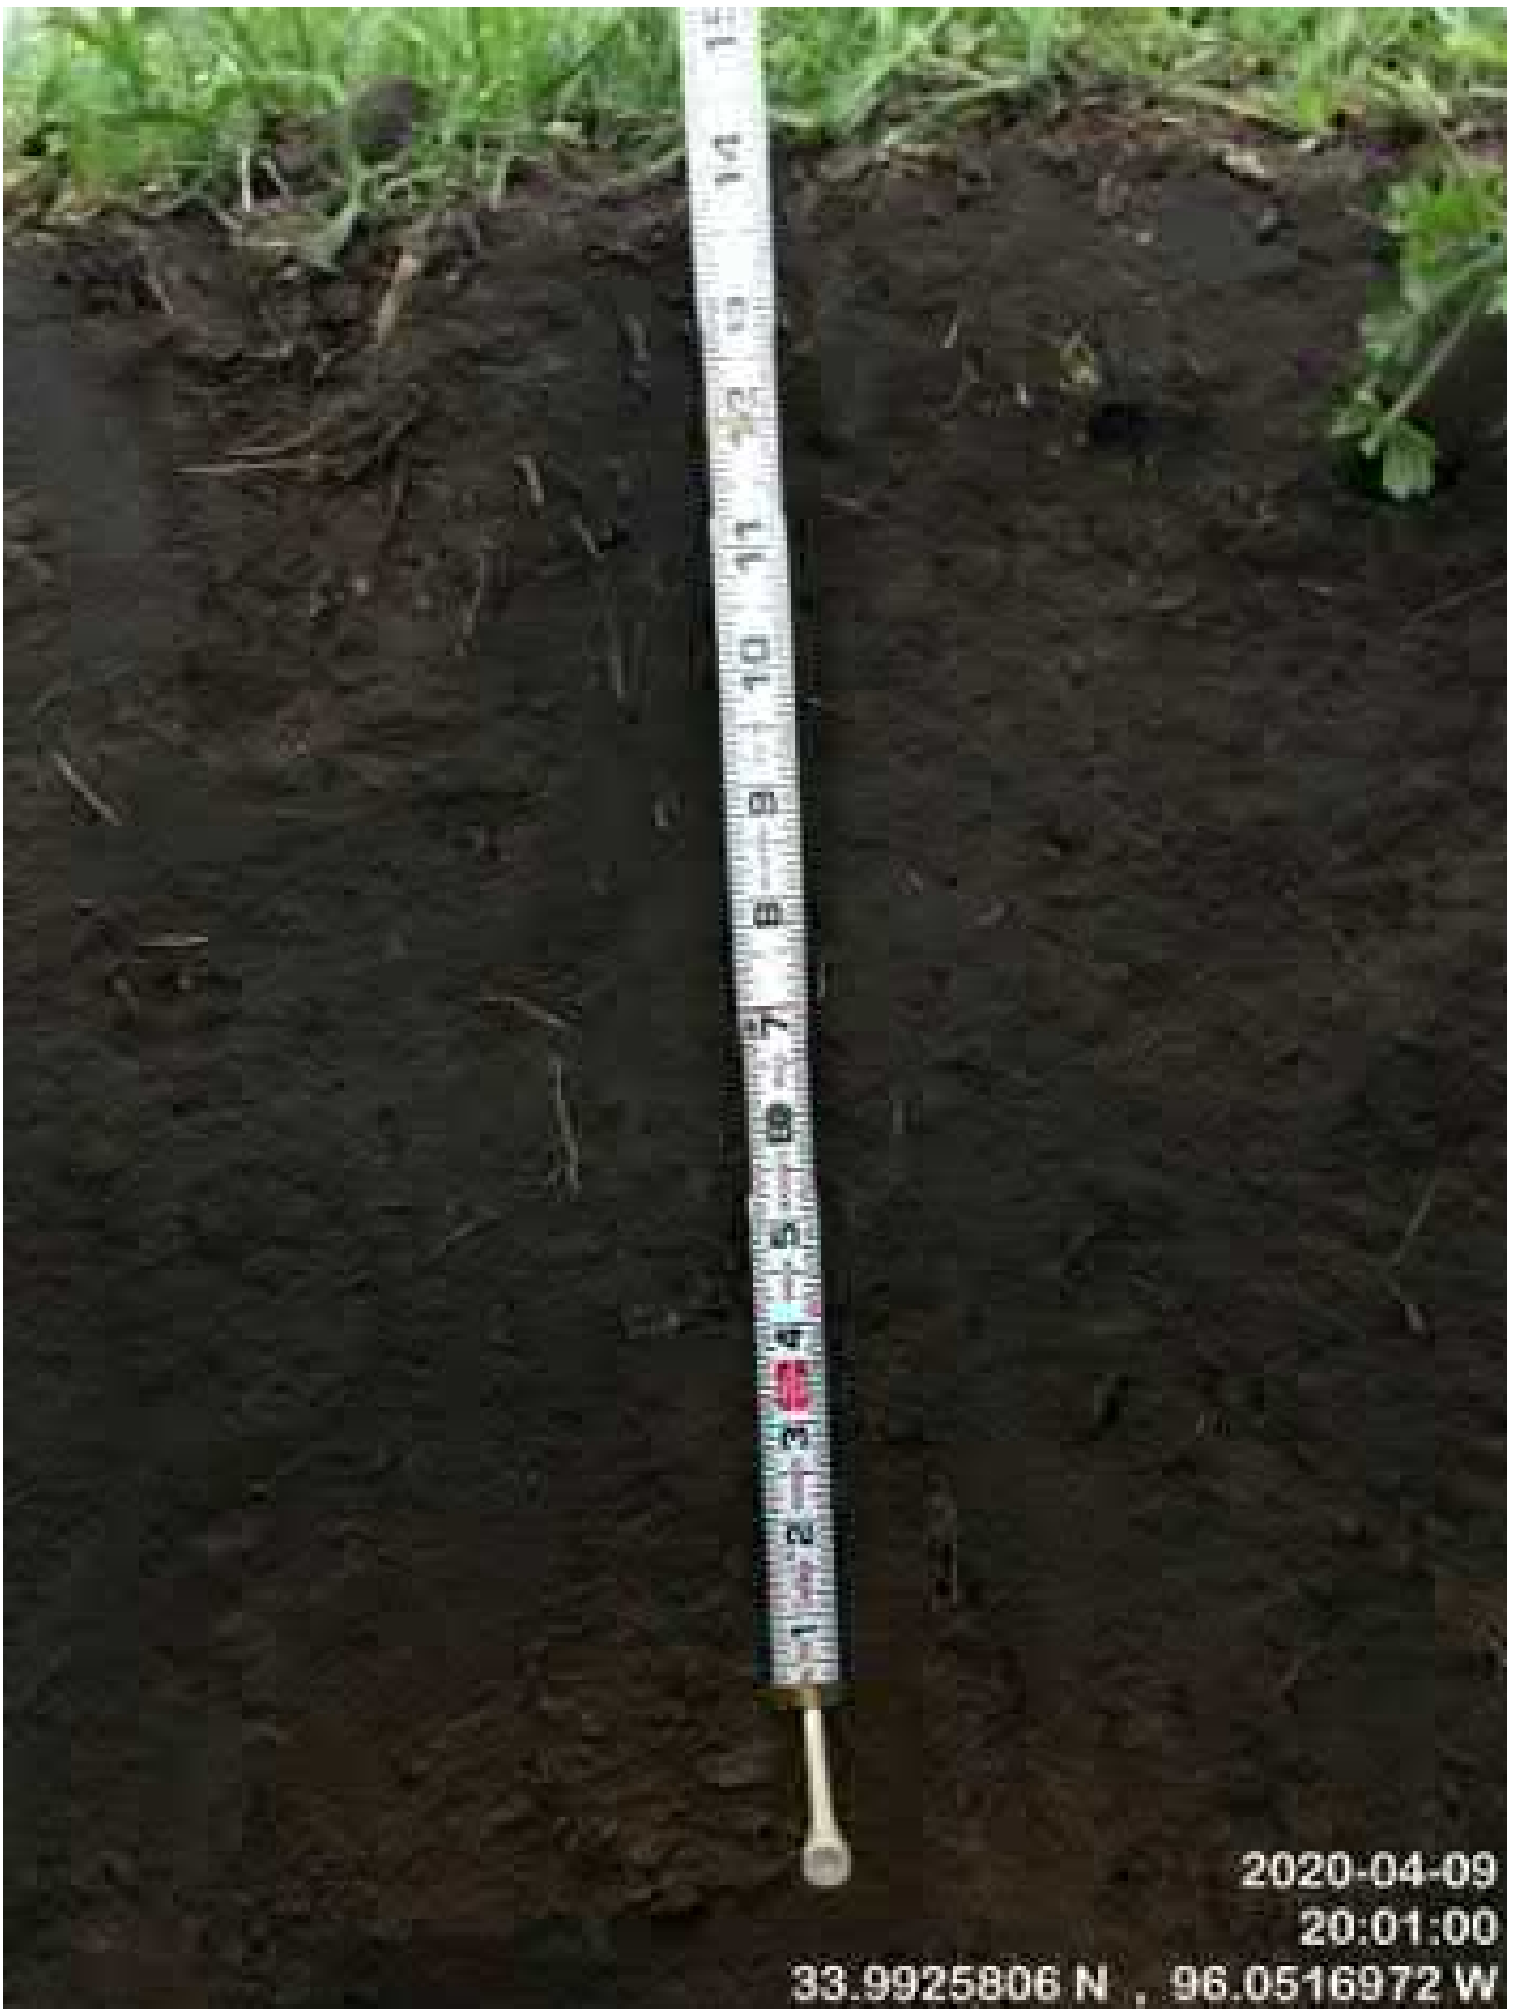
**April 13, 2020 Site Inspection
Nolen & Jackie Grounds
BR-1000.000, BR-1001.000
Mile Post: MP 196.5
Bryan County, Oklahoma**

- 1.) Midship has backfilled and conducted rough cleanup while not replacing the damaged topsoil that has been mixed with the subsoil. In addition, the contractors did not remove the shale, large rocks, and ongoing erosion in the easement.
- 2.) The surface is suffering severe settling and erosion from Midship dewatering operations causing damage to the easement area and private property.
- 3.) Erosion and lack of revegetation due to Blasting material, subsoil, and topsoil mixing; Remove all mixed soils, large rocks, blasting material. Conduct de-compaction in subsoil and topsoil.

- 1.) High levels of rock and blasting material mixed into soil. (FERC Plan: V. A. 3-6.)
 - a. Affected areas naturally have around 1% rock fragments with a maximum size of 74 mm (NRCS)
- 2.) Importation of approx. 3,256 cubic yards of topsoil for 1.73 acres of ROW. (FERC Plan: IV. B. 1-6.)
 - a. Off-ROW topsoil: 14" (verified by existing NRCS soil surveys)
 - b. In-ROW topsoil: 0" found in multiple locations.
- 3.) Soil Compaction (FERC Plan: V. C. 1-3.)
 - a. Off-ROW Penetrometer reading: Around 150 psi in multiple locations.
 - b. In-ROW Penetrometer reading: 300 psi limit exceeded in every off-ROW location.

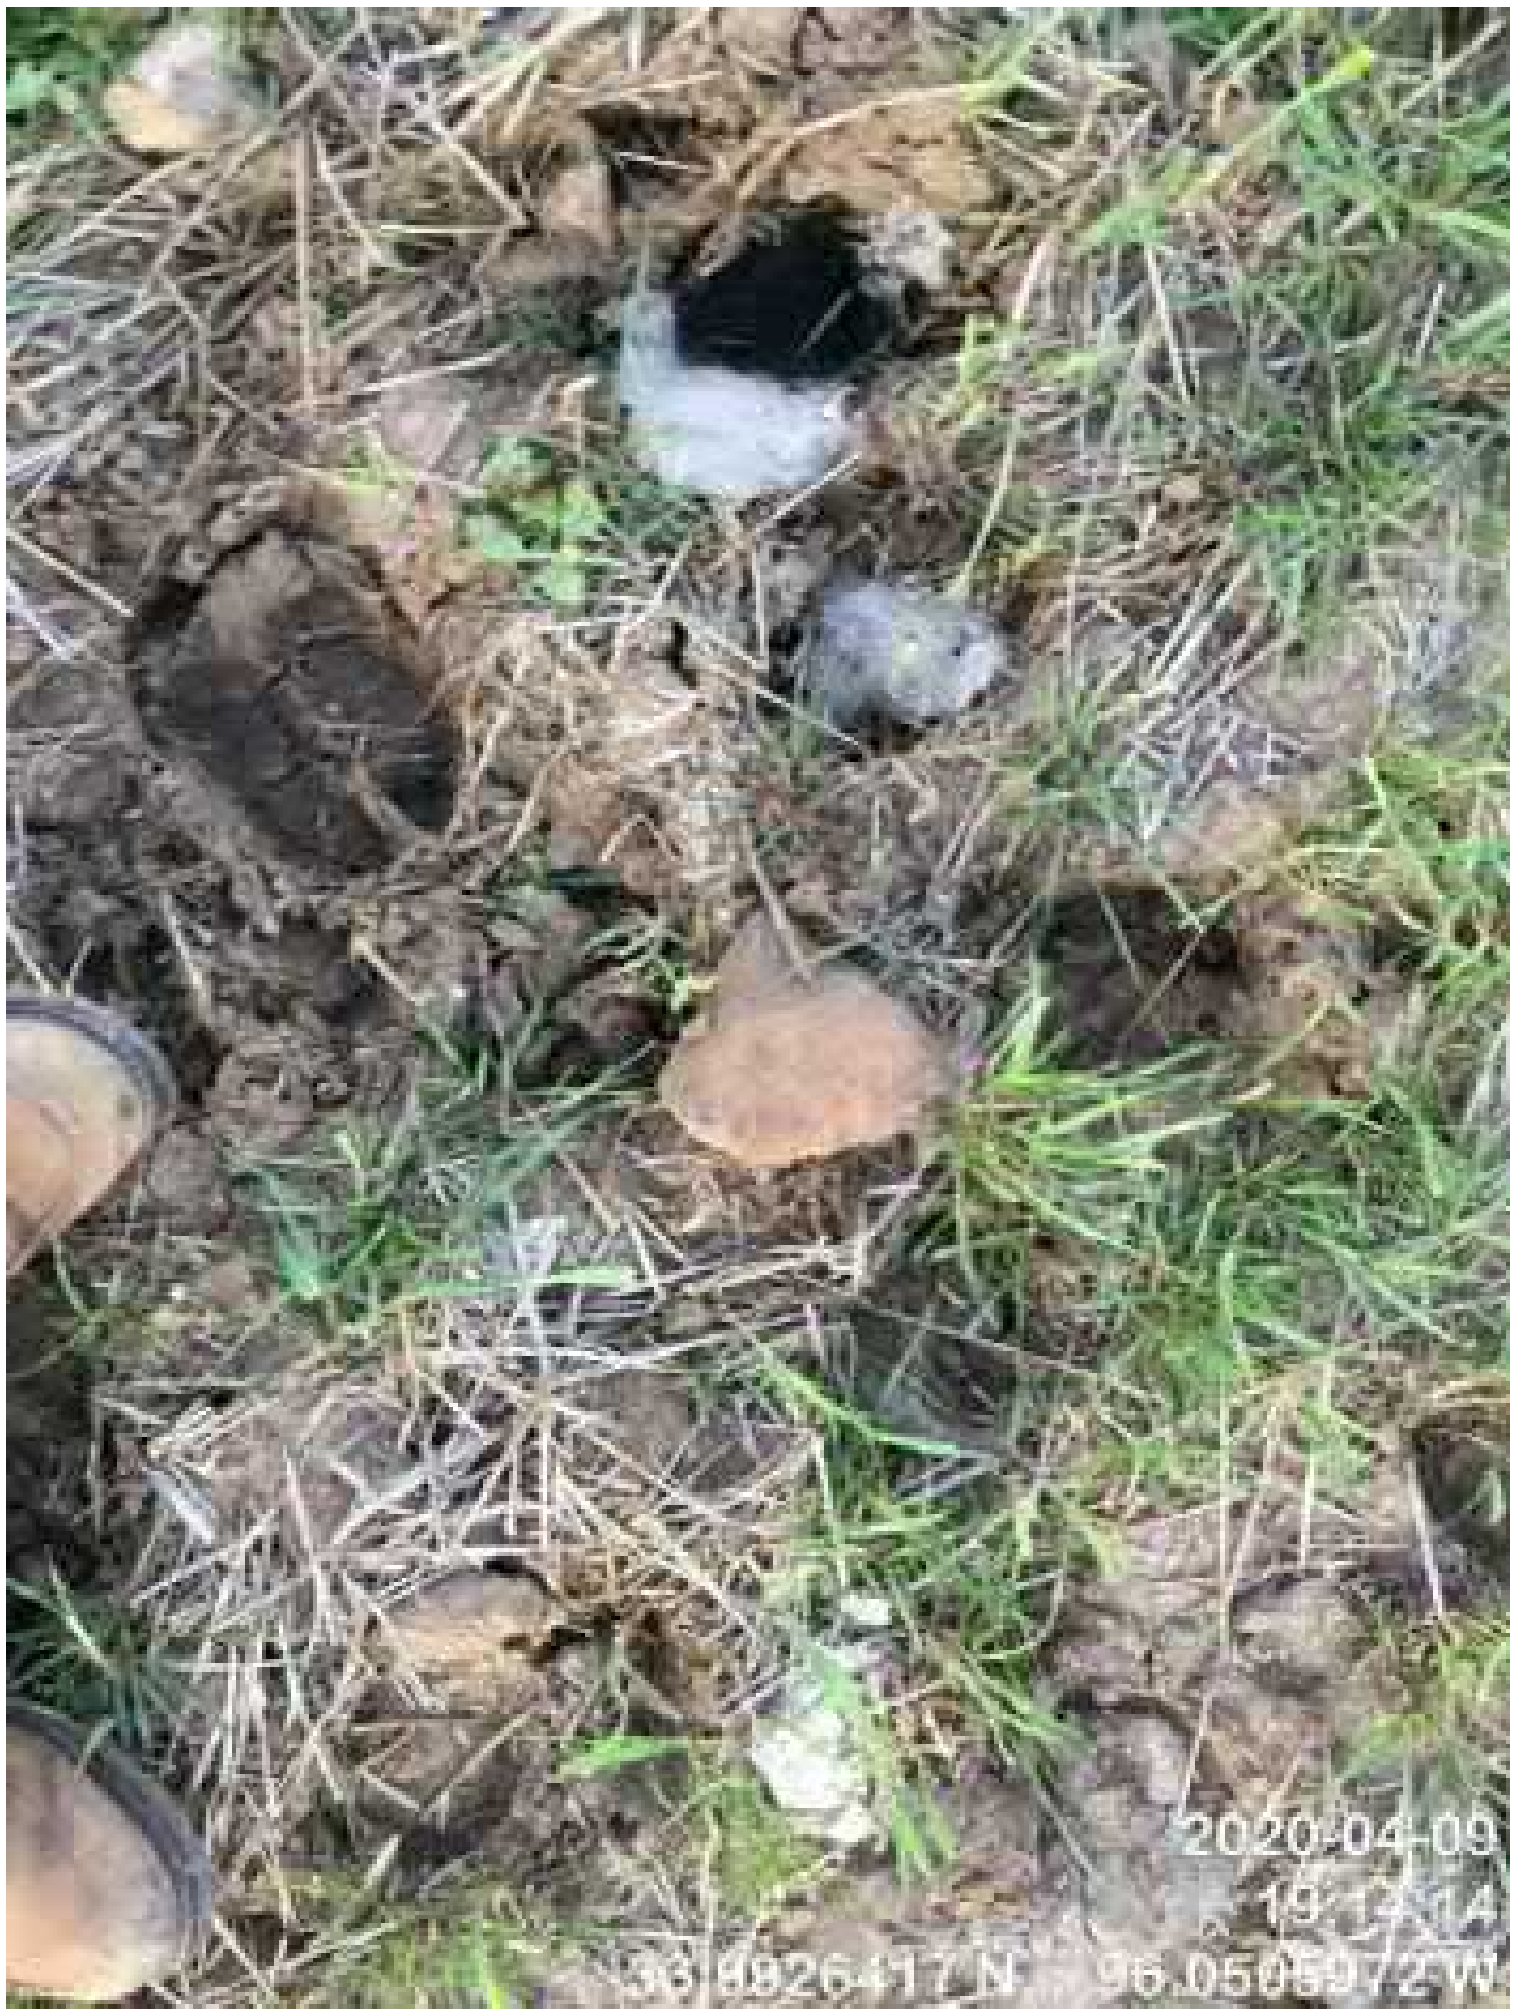
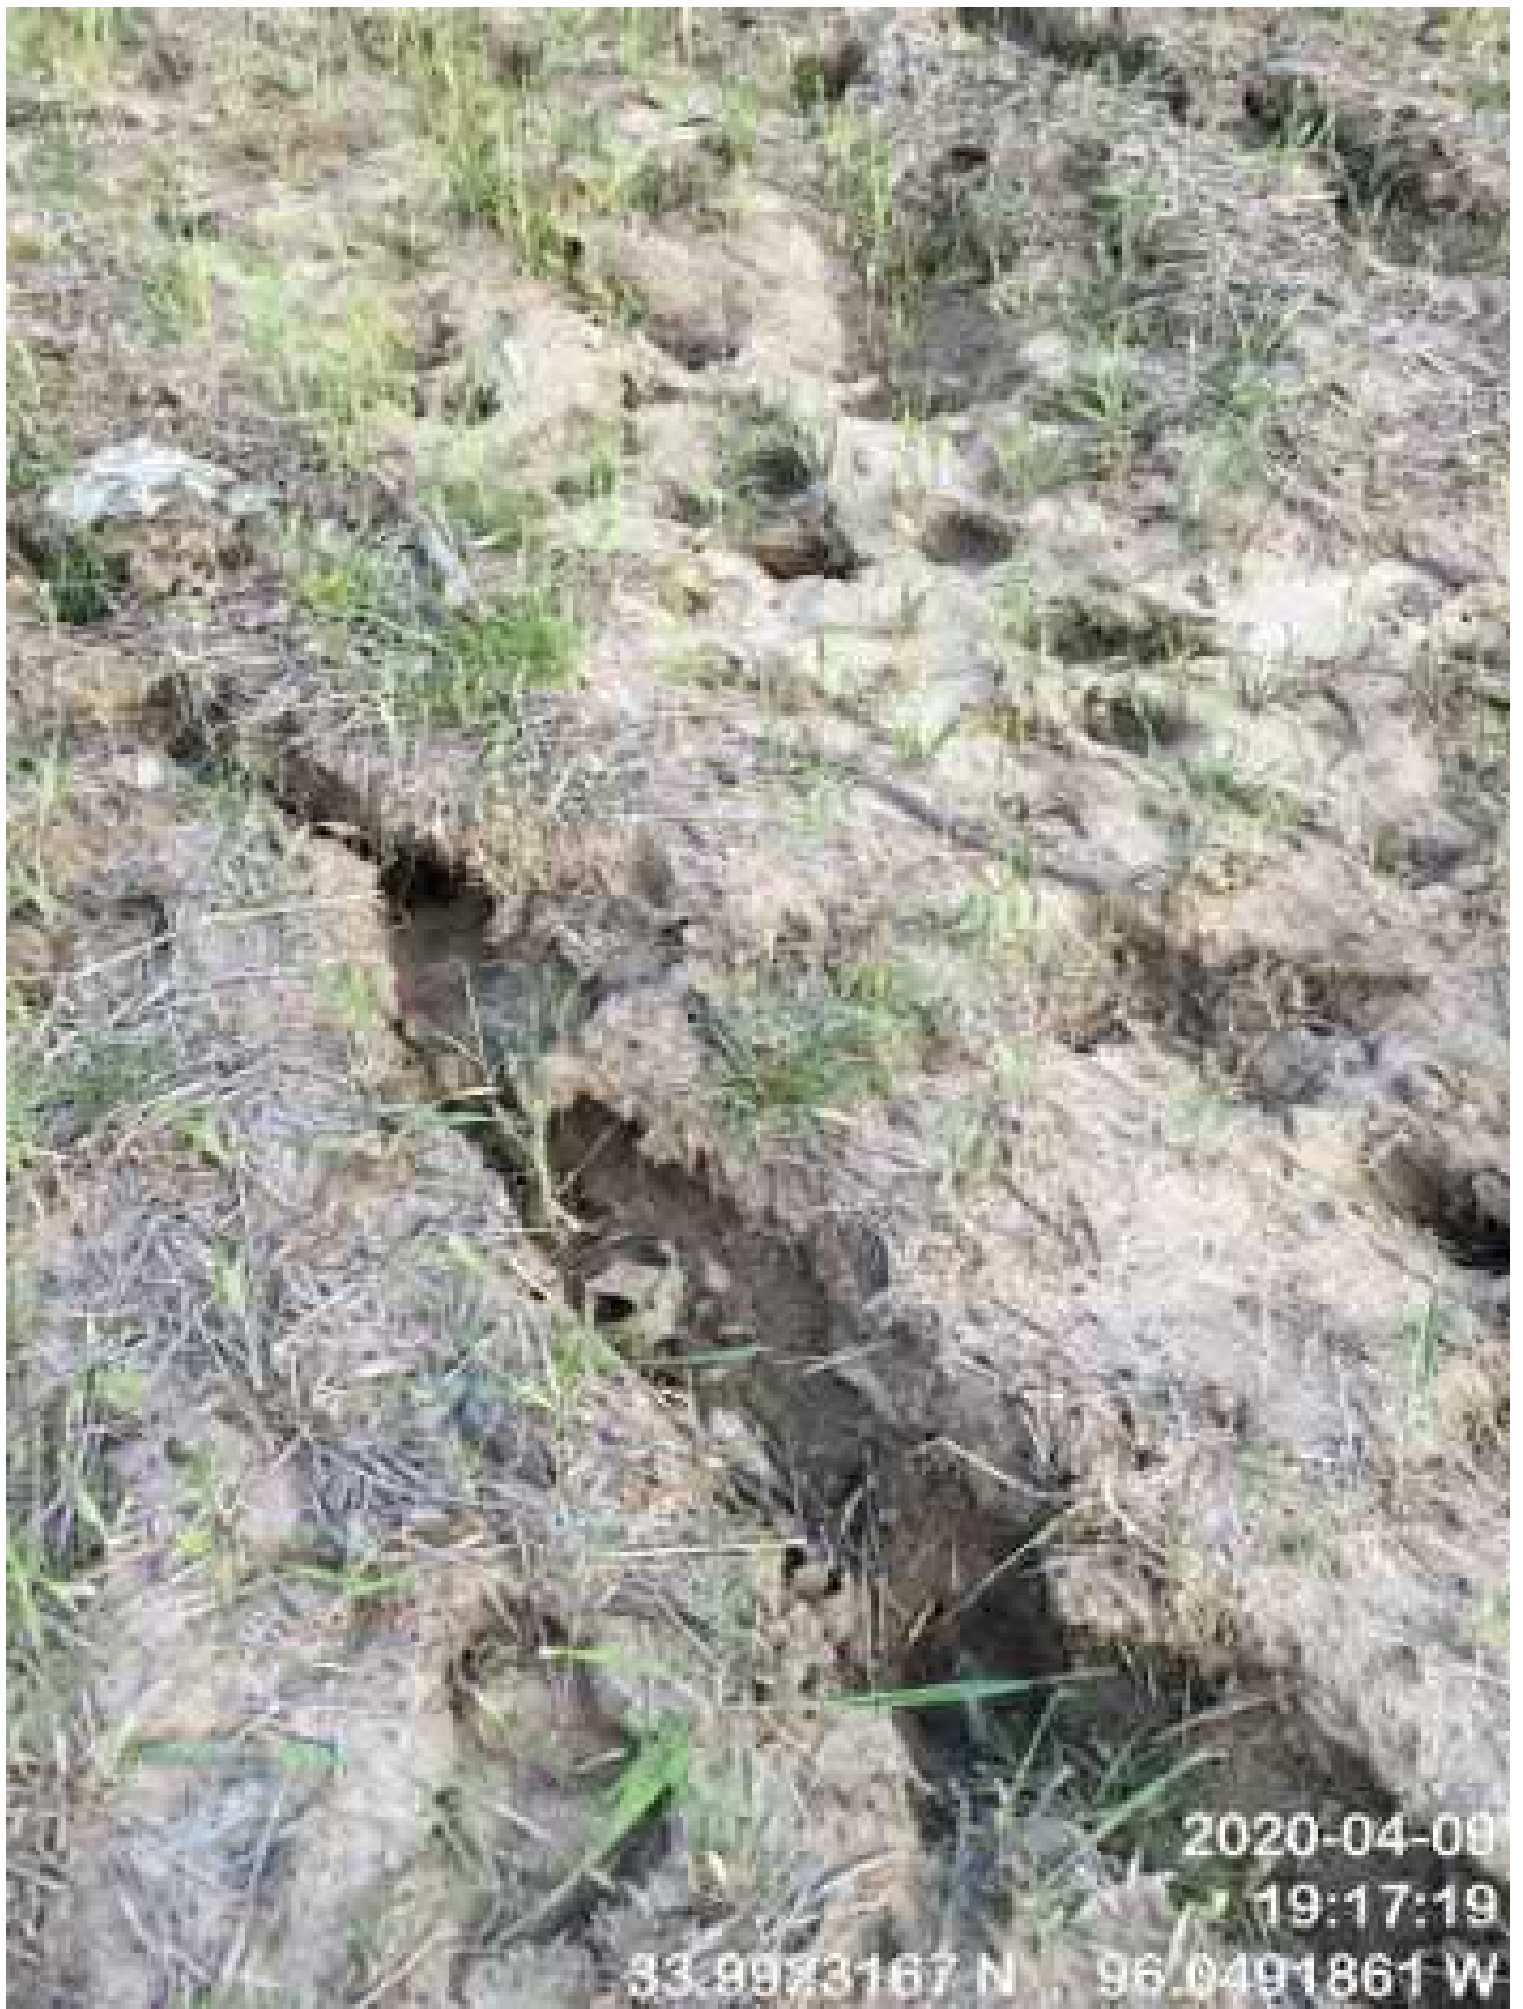
- 1.) High levels of rock and blasting material mixed into soil. (FERC Plan: V. A. 3-6.)
 - a. Affected areas naturally have around 1% rock fragments with a maximum size of 74 mm (NRCS)
- 2.) Soil Compaction (FERC Plan: V. C. 1-3.)
 - a. Off-ROW Penetrometer reading: Around 120-160 psi in multiple locations.
 - b. In-ROW Penetrometer reading: 300 psi limit exceeded in every on-ROW location.
- 3.) Severe soil settlement throughout ROW between 10" - 20" deep.
- 4.) Erosion throughout ROW.
