Robert Squires - Squires Consulting LLC
Landowner Advocate

Opening Statement for May 5, 2021 Subcommittee on Civil Rights and Civil Liberties Hearing:
“Pipelines Over People (Part II): Midship Pipeline’s Disregard for Landowners in Its Pathway”

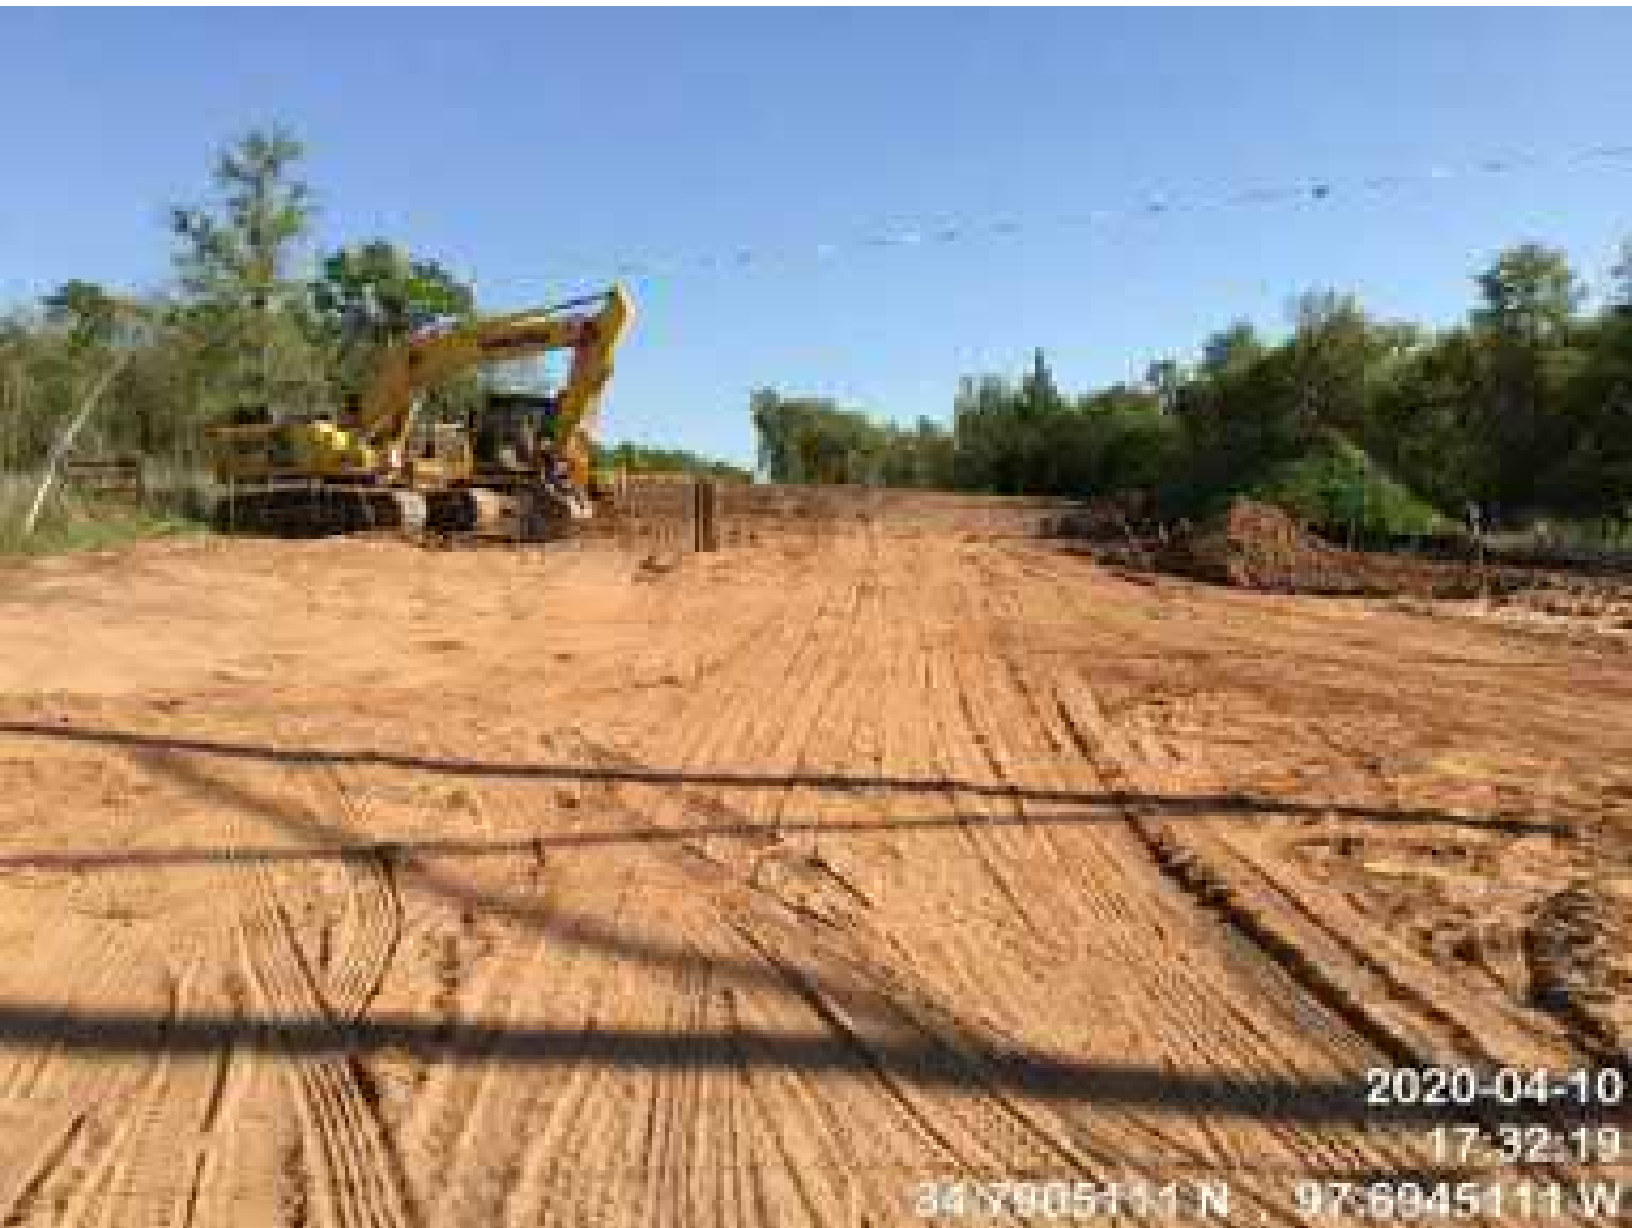
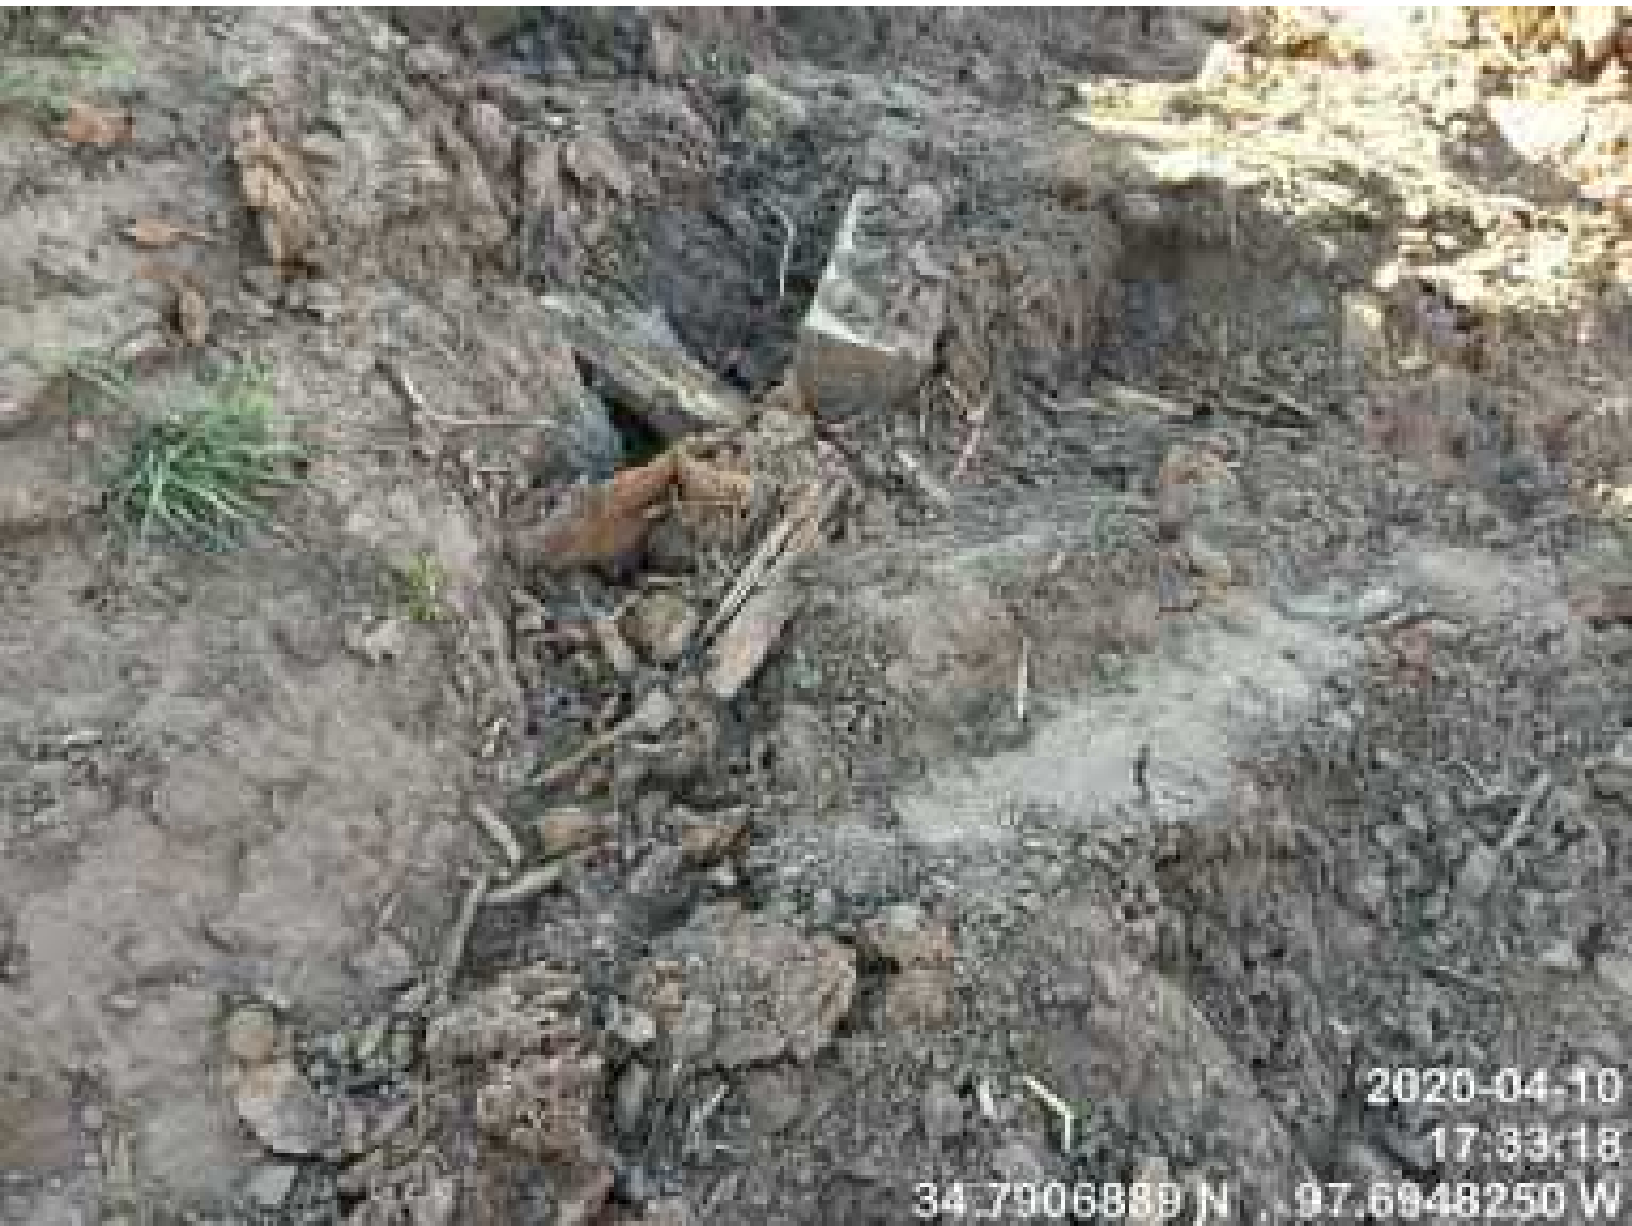
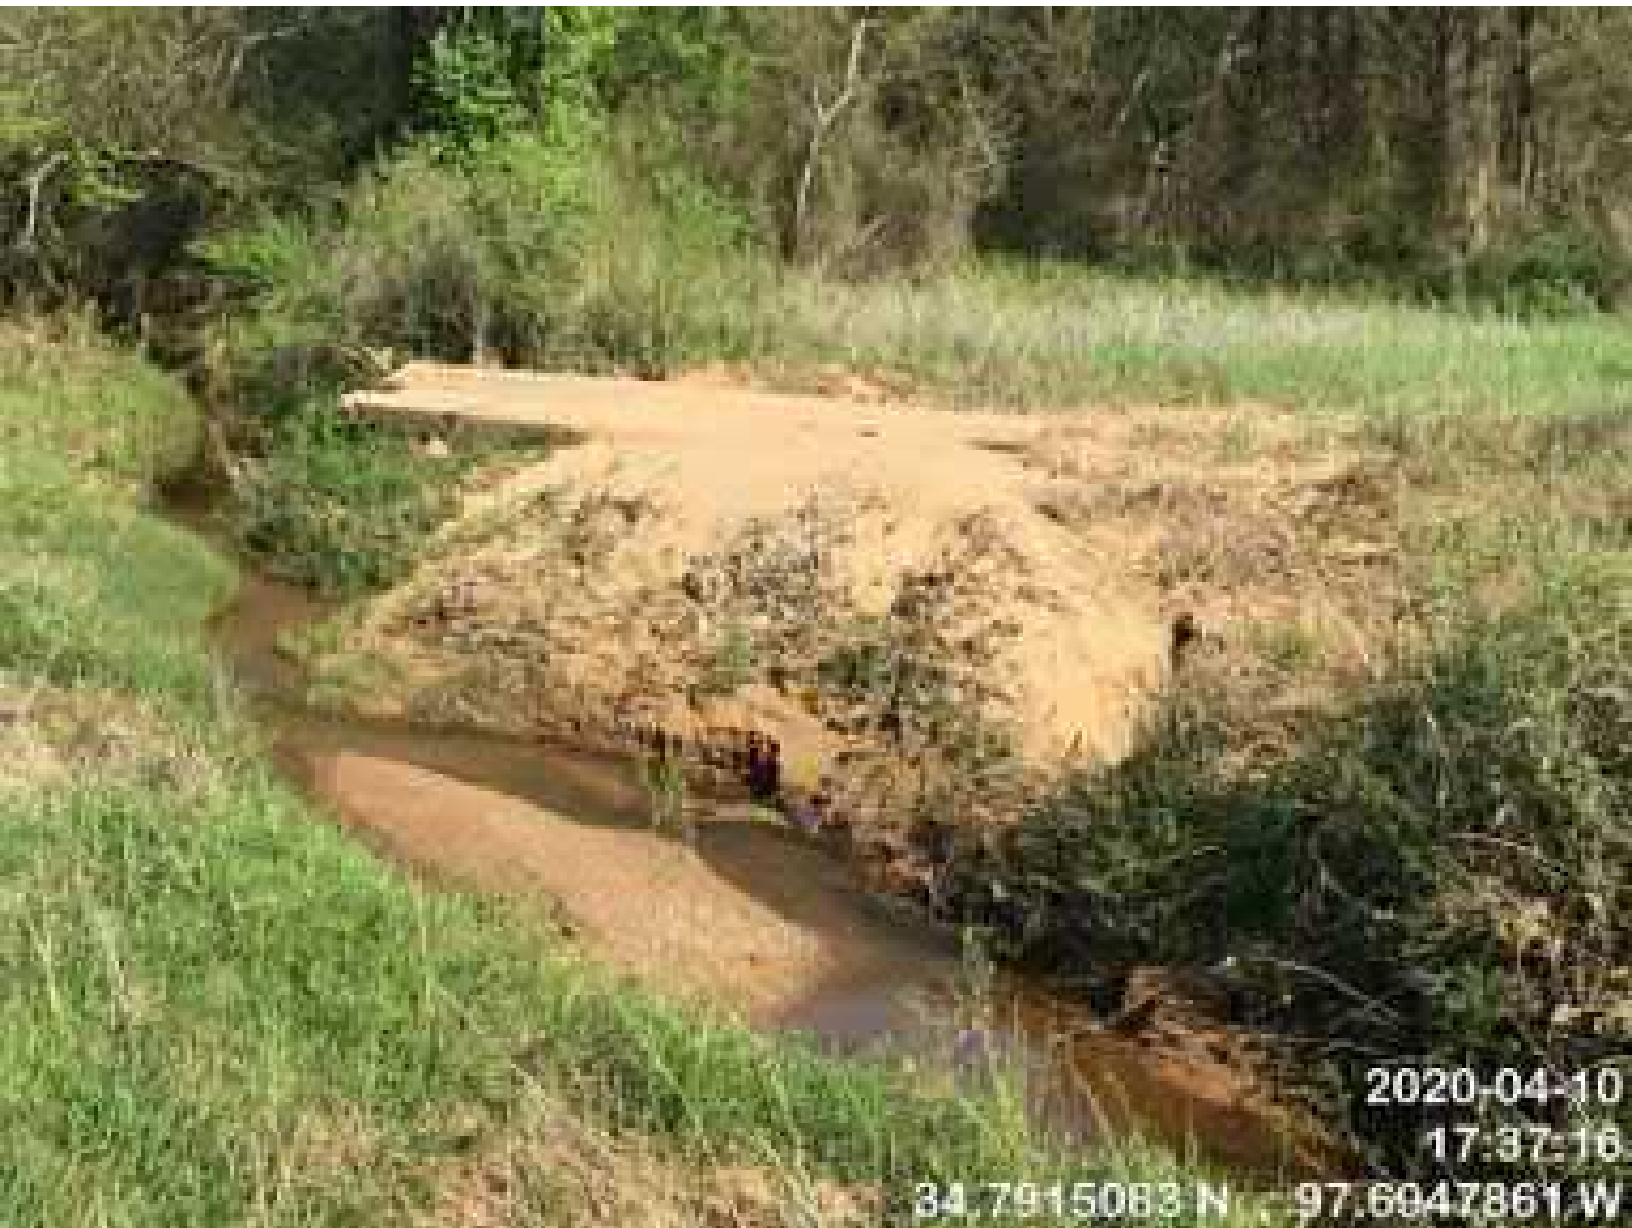
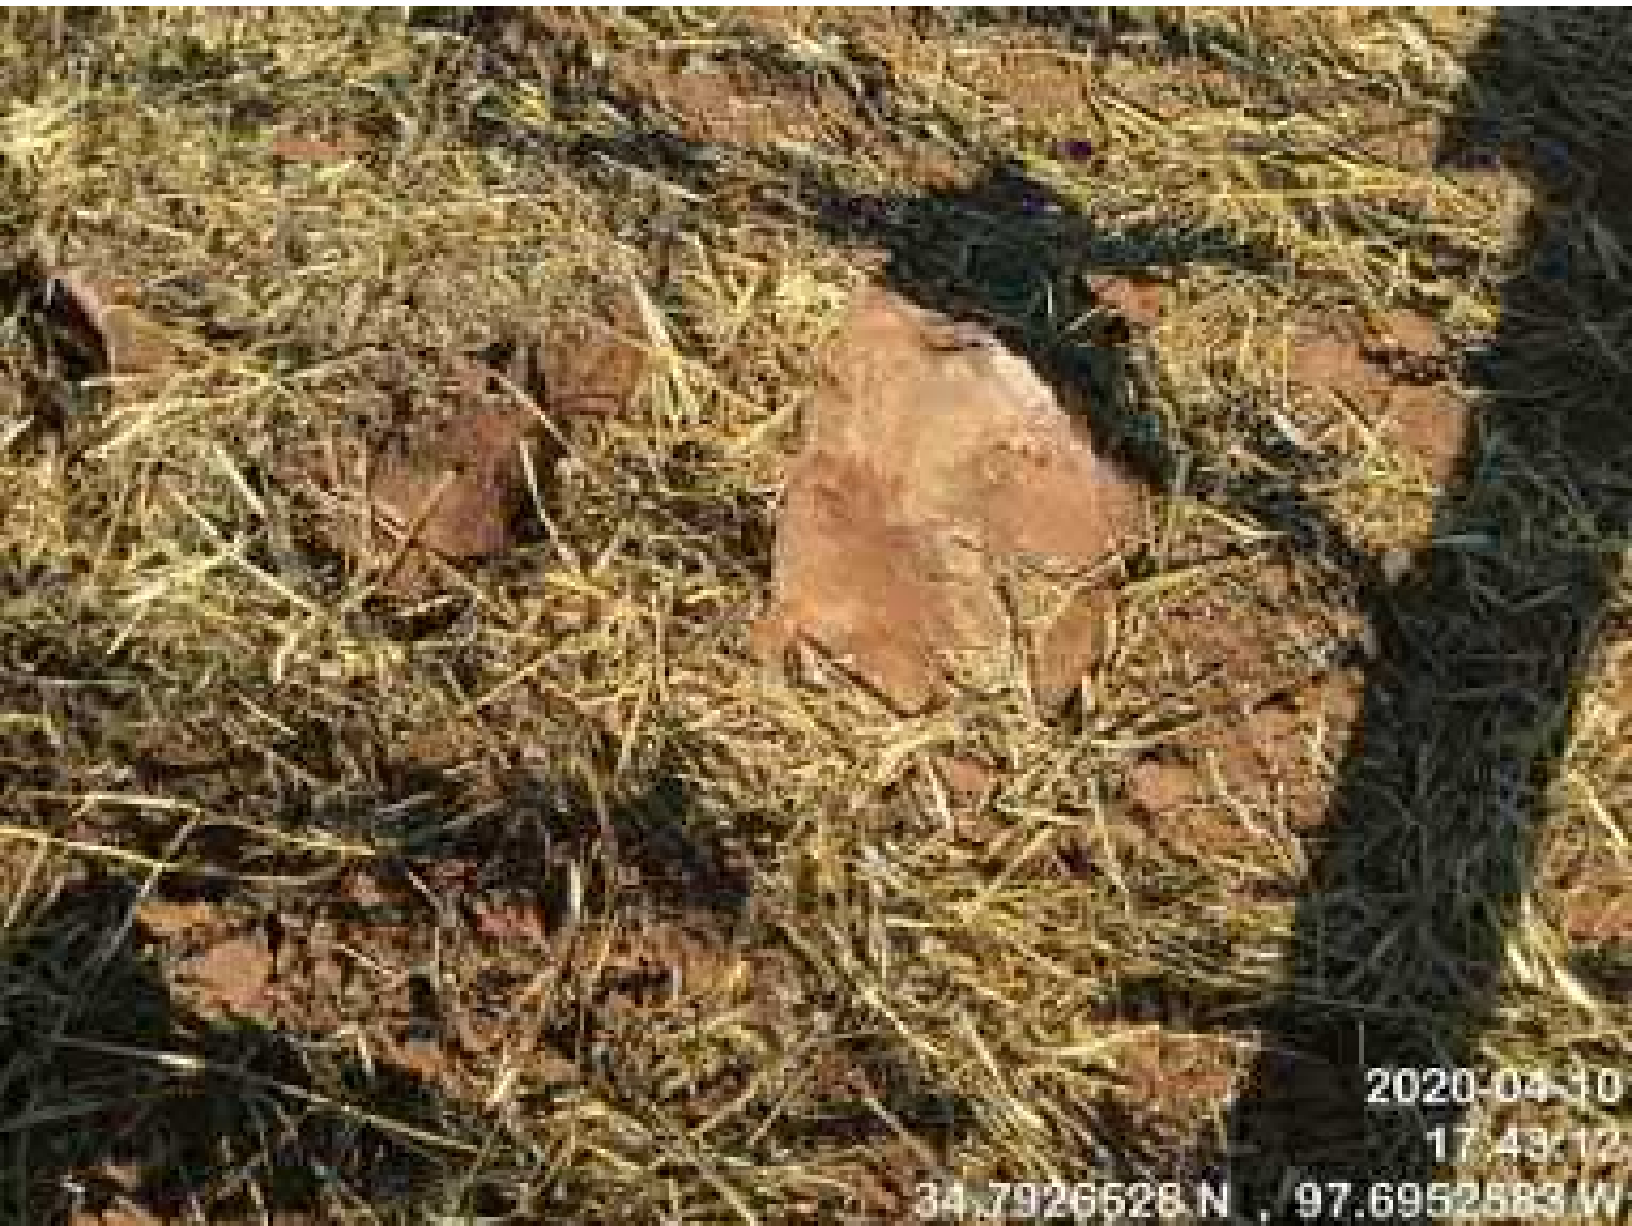
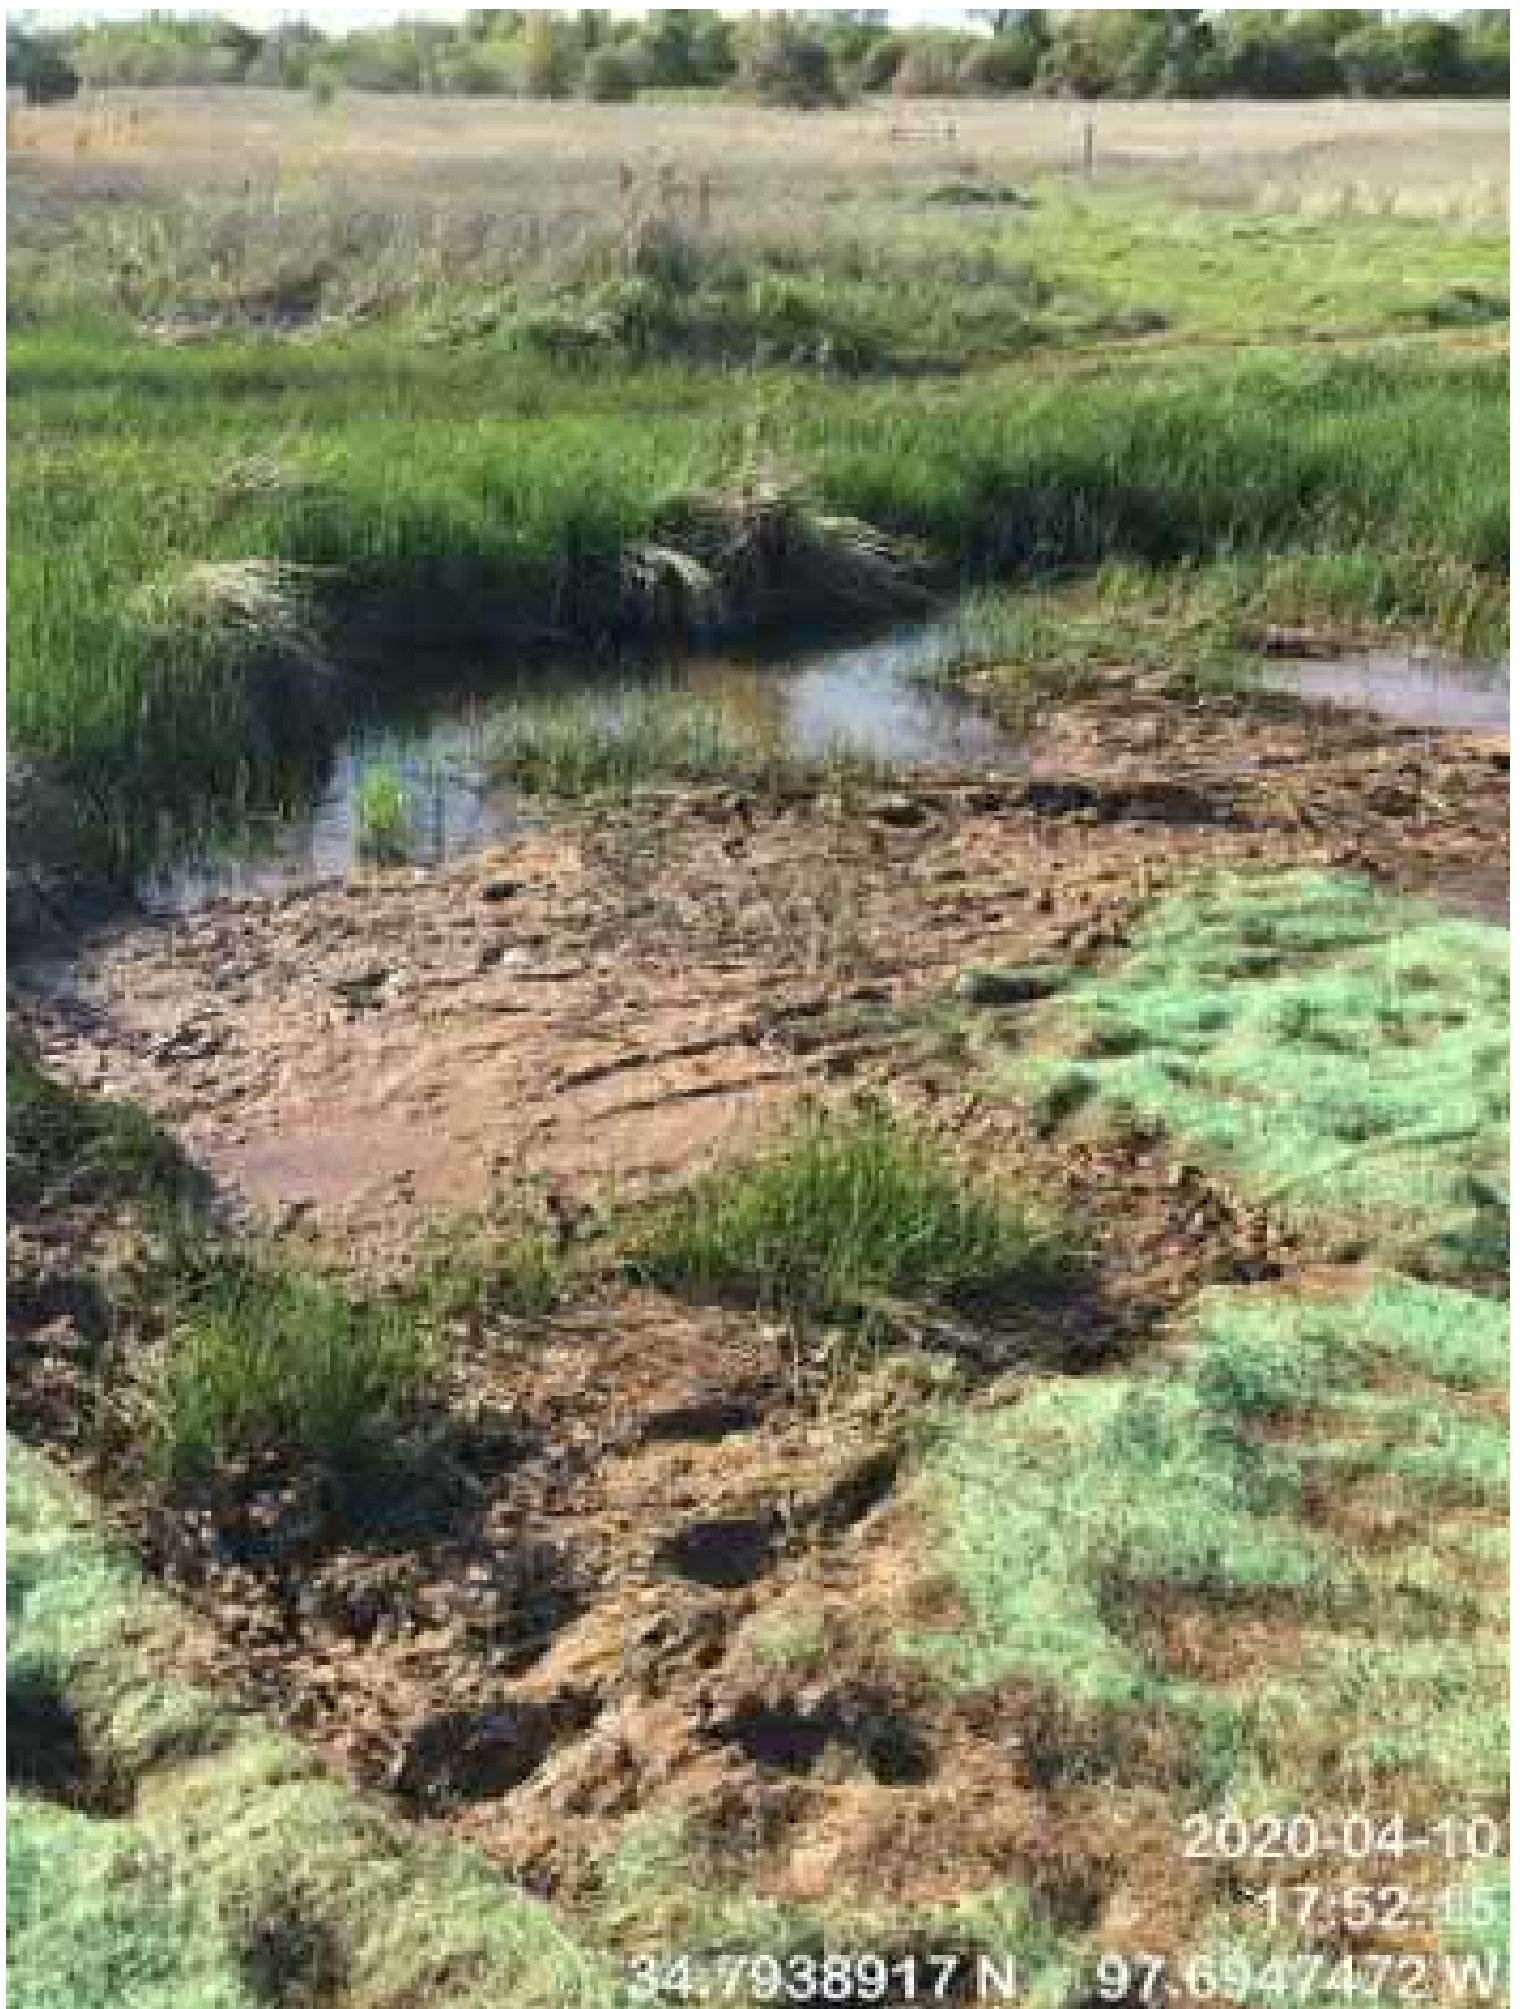
- 1.) Larimore Creek Tributary (SGR-019) is partially dammed with sediment that has entered stream and is impeding natural flow and causing drainage issues throughout the property. (FERC Procedures: V. C. 2-3.)
- 2.) Soil Compaction (FERC Plan: V. C. 1-3.)
 - a. Off-ROW Penetrometer reading: Around 180 psi in multiple locations.
 - b. In-ROW Penetrometer reading: 300 psi limit exceeded in every on-ROW location.
- 3.) Large rocks and construction debris buried in ROW and scattered throughout property. (FERC Plan: V. A. 3-6.)
- 4.) Ponding inside and outside ROW.
- 5.) Soil settlement above pipeline.

- 1.) Road crossing blocked for landowner access, flooded, erosion into the stream, and environmental mats scattered off-row; Dispose of contaminated water, topsoil replacement, removal of mats and wood debris. De-compaction will need to be conducted before replaces topsoil and backfills.
